Site/Project Location: MP 136 to 140 Spread 7-8 NW St. Anthony **Date of Inspection:** 4 October 2016
Inspected 4 miles of pipeline ROW approximately 8 miles NW of St. Anthony ND in Morton County.

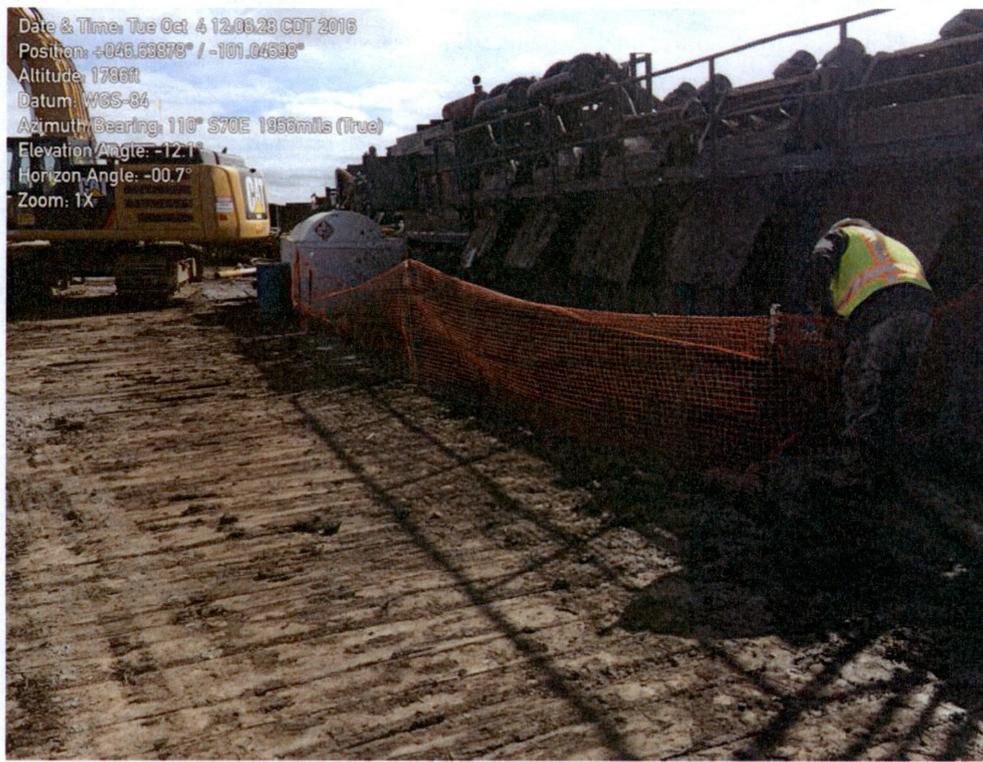
Report Photo #1 "M.P. 139 HDD Pad - Recycle Mud Pit & Diesel Tank":

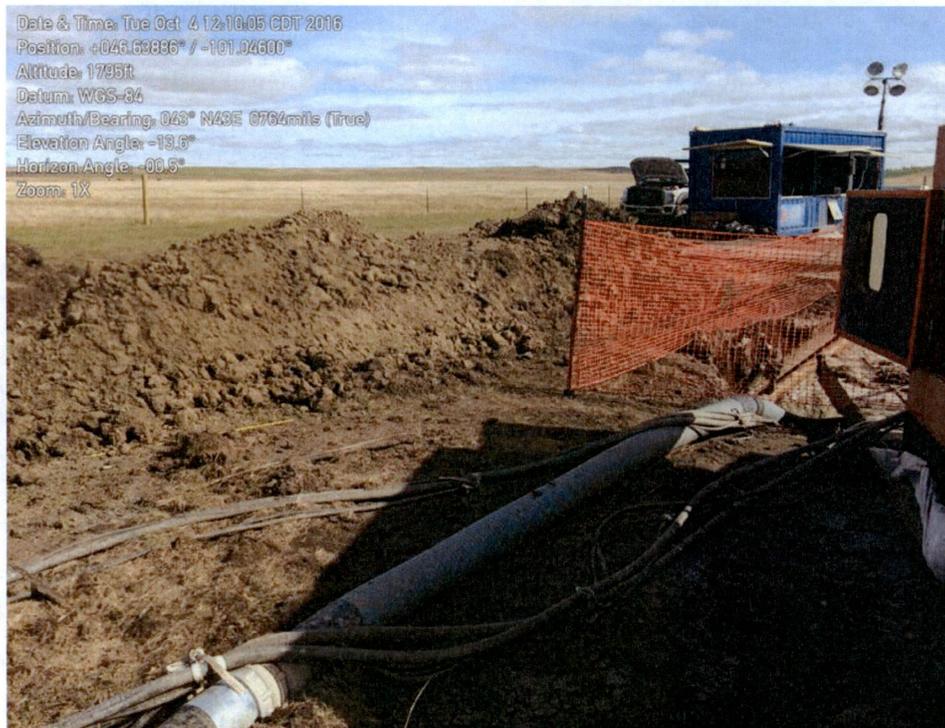
Most areas had subsoil trench pilings bordering the topsoil piles. As noted, previous day rainfall appeared to have caused some of this. A few areas had subsoil on topsoil pile most likely due to plowing, these areas were of short duration and infrequent. Small subsoil pile from bore entry pit was stored over unstripped ground. This practice is contrary to the construction's mitigation plan.

Report Photo #2 "Subsoils from HDD Bore Entry Pit on Unstripped Ground:

Keitu inspector advised Tie-in/Trenching Chief to practice having a definitive gap between topsoil and subsoil piles. Follow-up with the North Dakota Department of Agriculture to confirm if they advised contractor to place straw beneath subsoil stacked on topsoil.

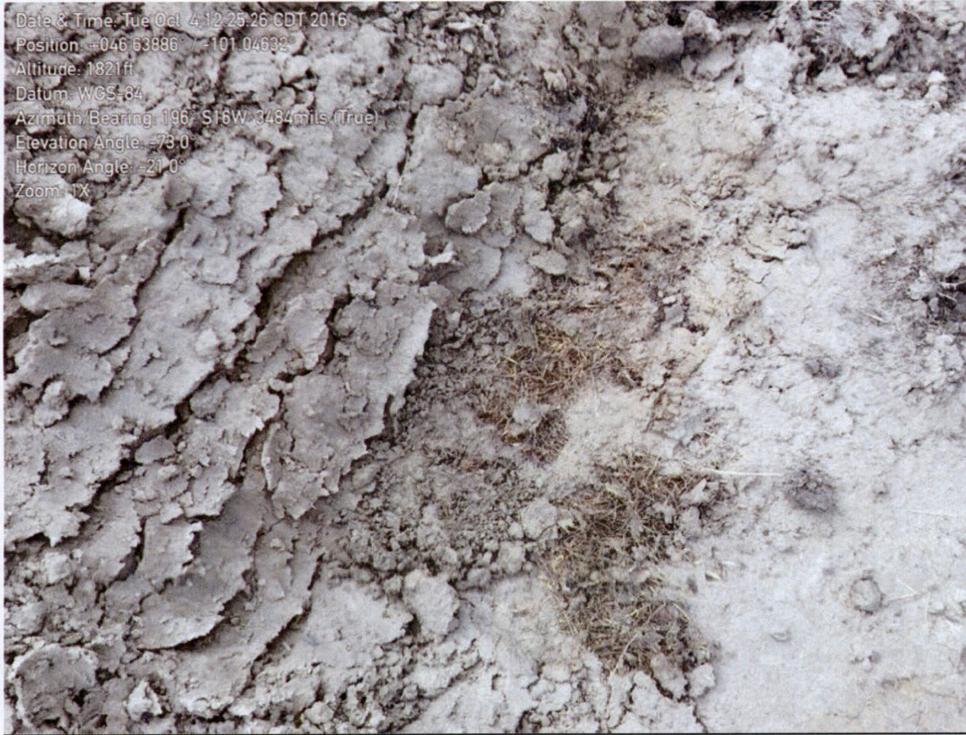
Report Photo #3 "No Straw Mulch Visible Under Bore Pit's Subsoil Pile:

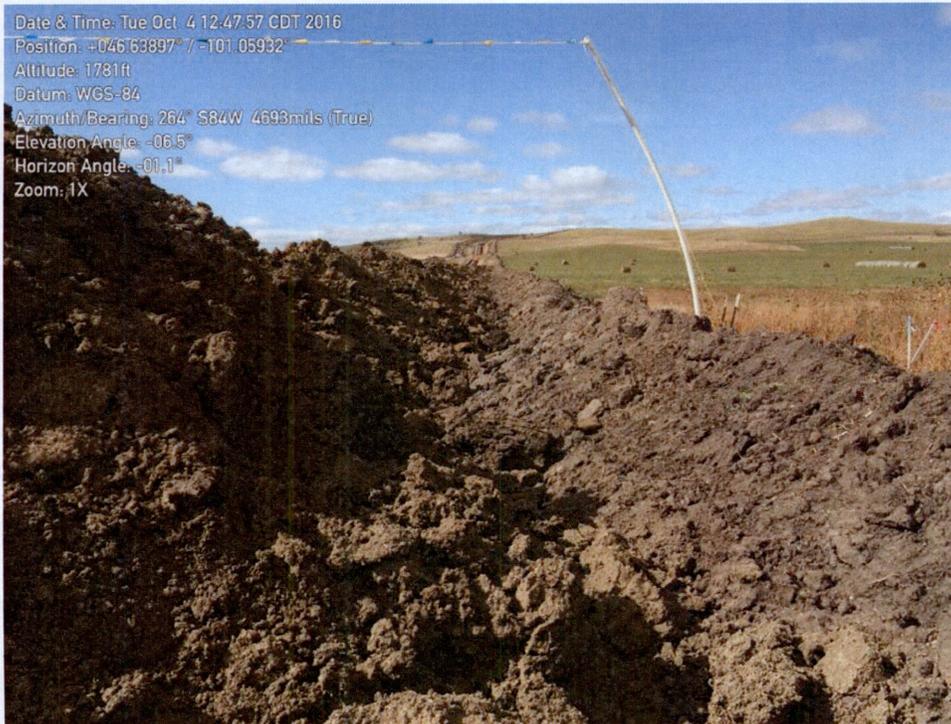
Topsoil and subsoil segregation appeared to be adequate. Topsoil depth was 3-4" on hilltops while up to 12" on the bottom of hill slopes. Subsoil piles from trenching were bordering and partly overlapping with the topsoil pile (see photo 4). Subsoil pile from HDD bore entry pit was stored over unstripped ground (photos 2-3). Lead inspector claimed he was advised by an Ag Inspector to place straw mulch under the pile when piling on topsoil. Straw mulch was not visible during site visit in these areas. Previous day's rainfall appeared to have caused most of the overlapping. Two areas had subsoil cast on or plowed onto adjacent topsoil in limited duration. Storm water BMPs remain in place and in good repair. Drainage points protected with straw bales or silt fence were cleared of silt. One area observed had a few large soil chunks roll off ROW less than one foot.

Report Photo #4 "Trench Subsoils Bordering/Overlapping with Topsoil Pile: 46.63897°N 101.05932°W

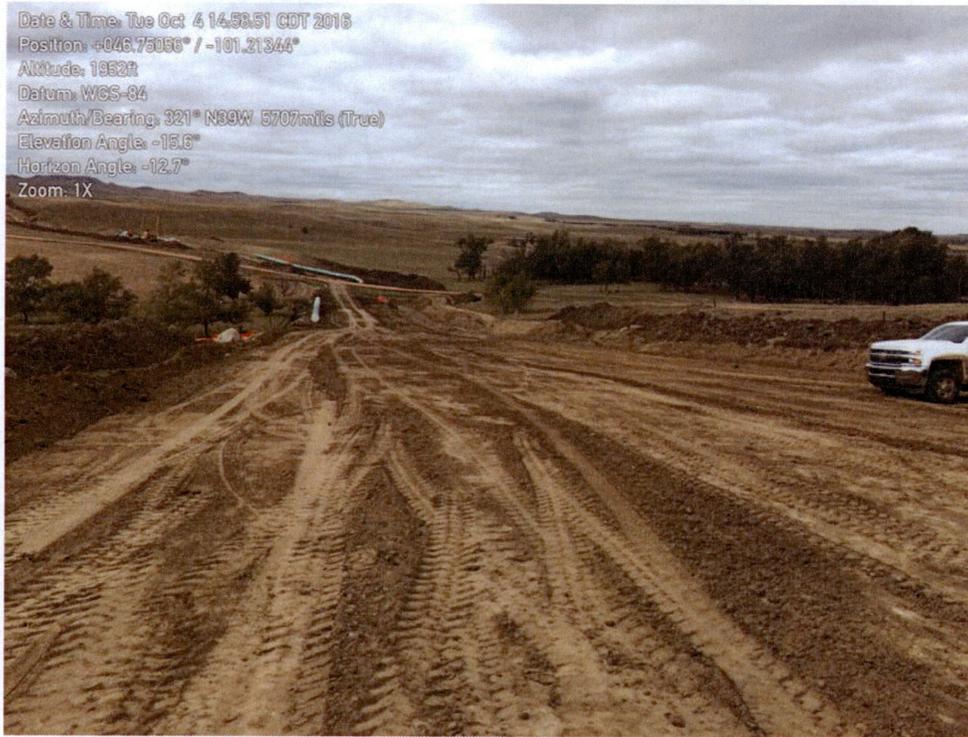
Report Photo #5 "Soil Separation & Tree Clearing Area Adequate":

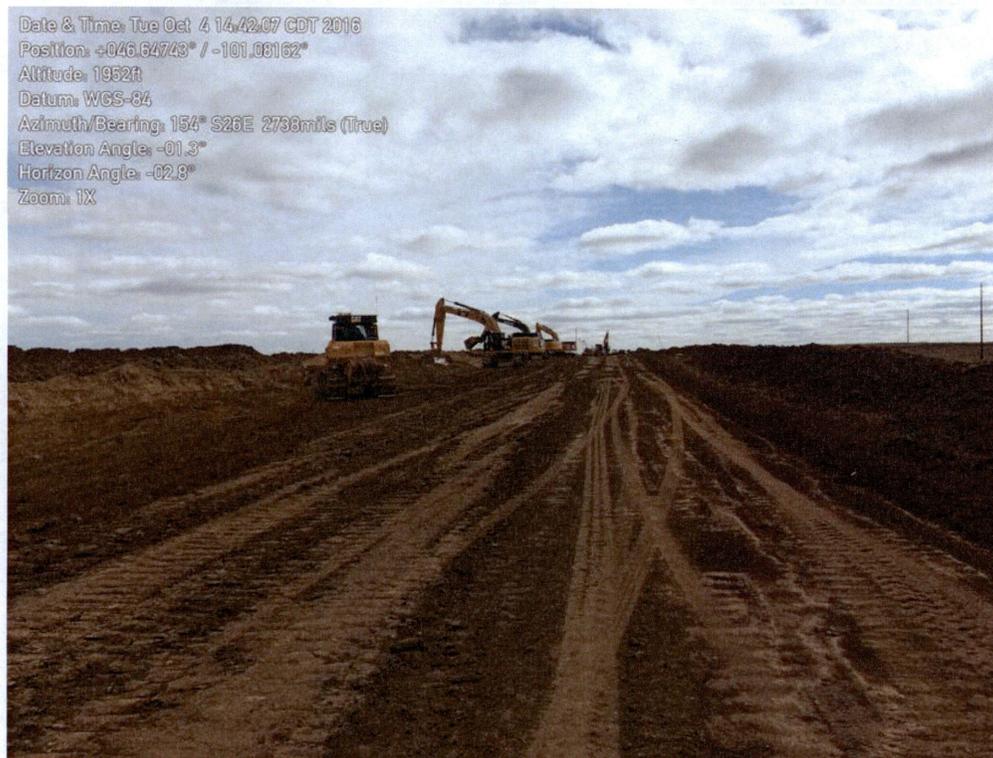
Report Photo #6 "Trench Back-filling":

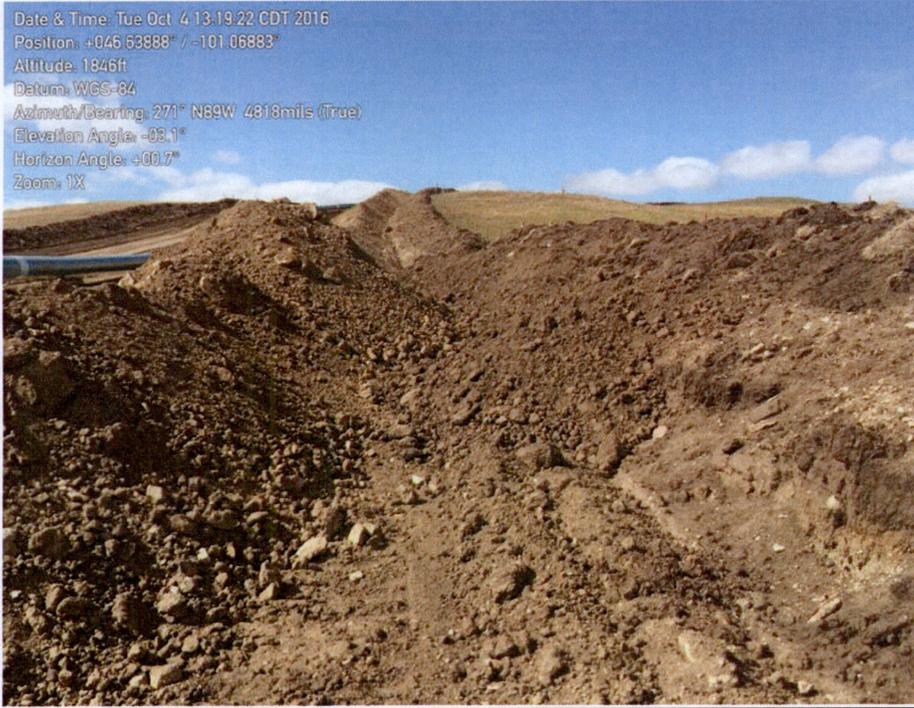
Report Photo #7 "Topsoil & Subsoil Pile Storage Overall Adequate":
