August 3, 2016

**Re: Notice of Potential Violation
Sacagawea Pipeline Company, LLC
16-inch Crude Oil Pipeline – McKenzie & Mountrail
Case No. PU-15-114**

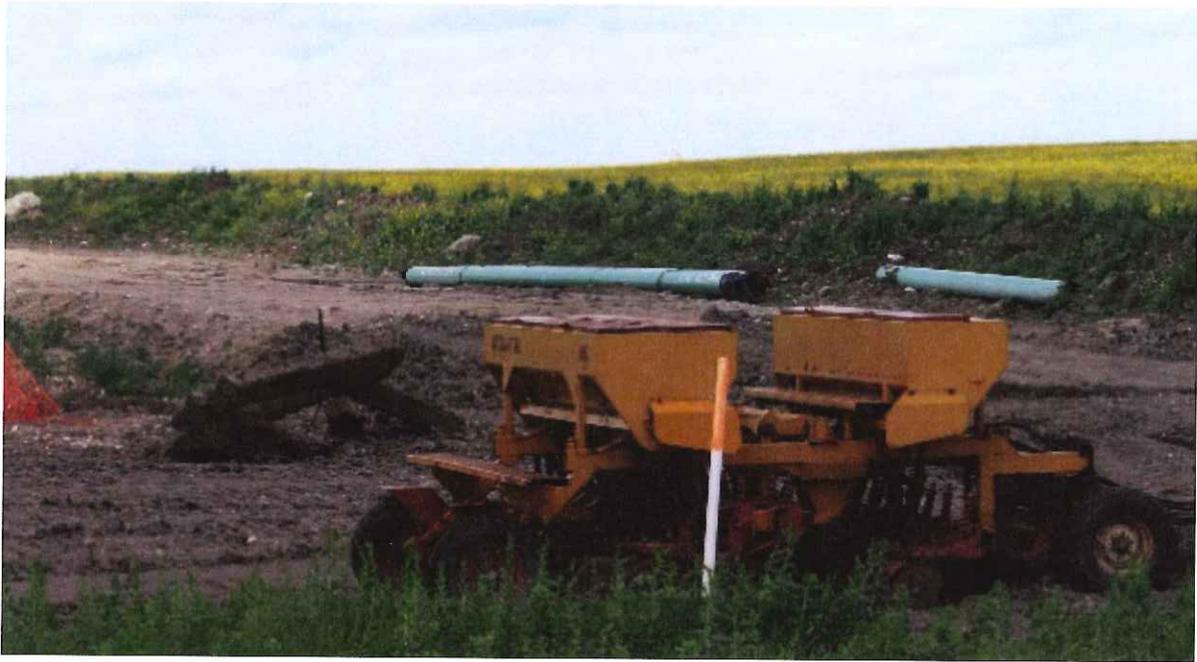
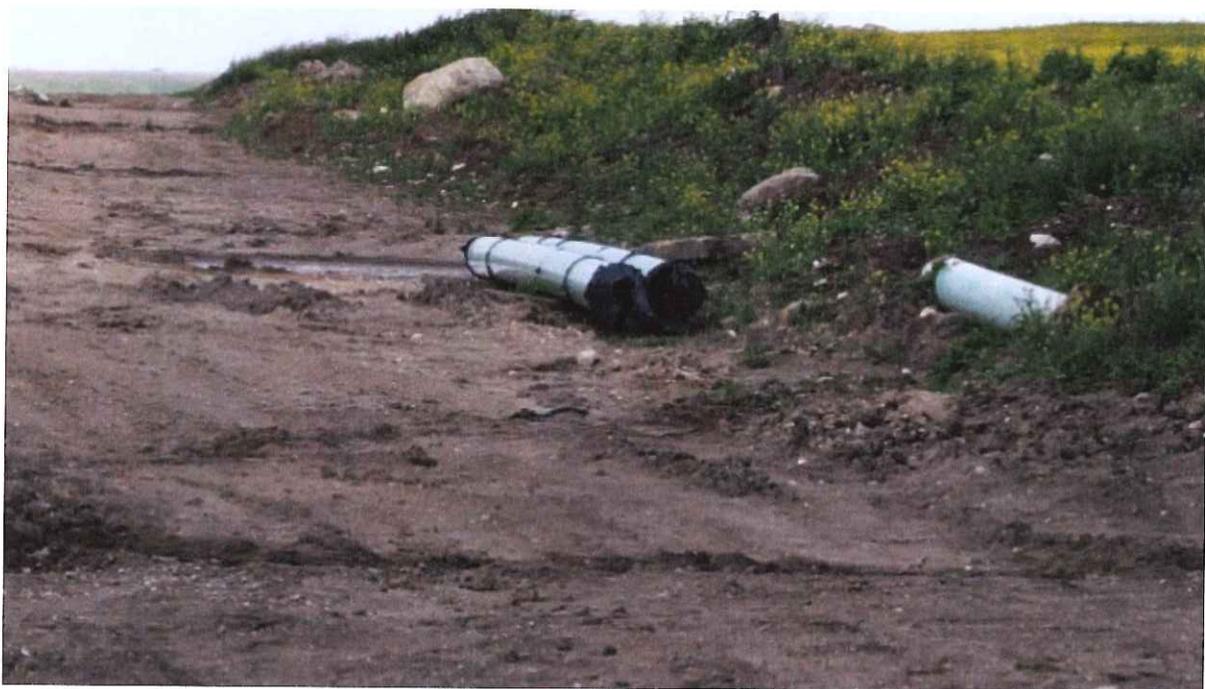
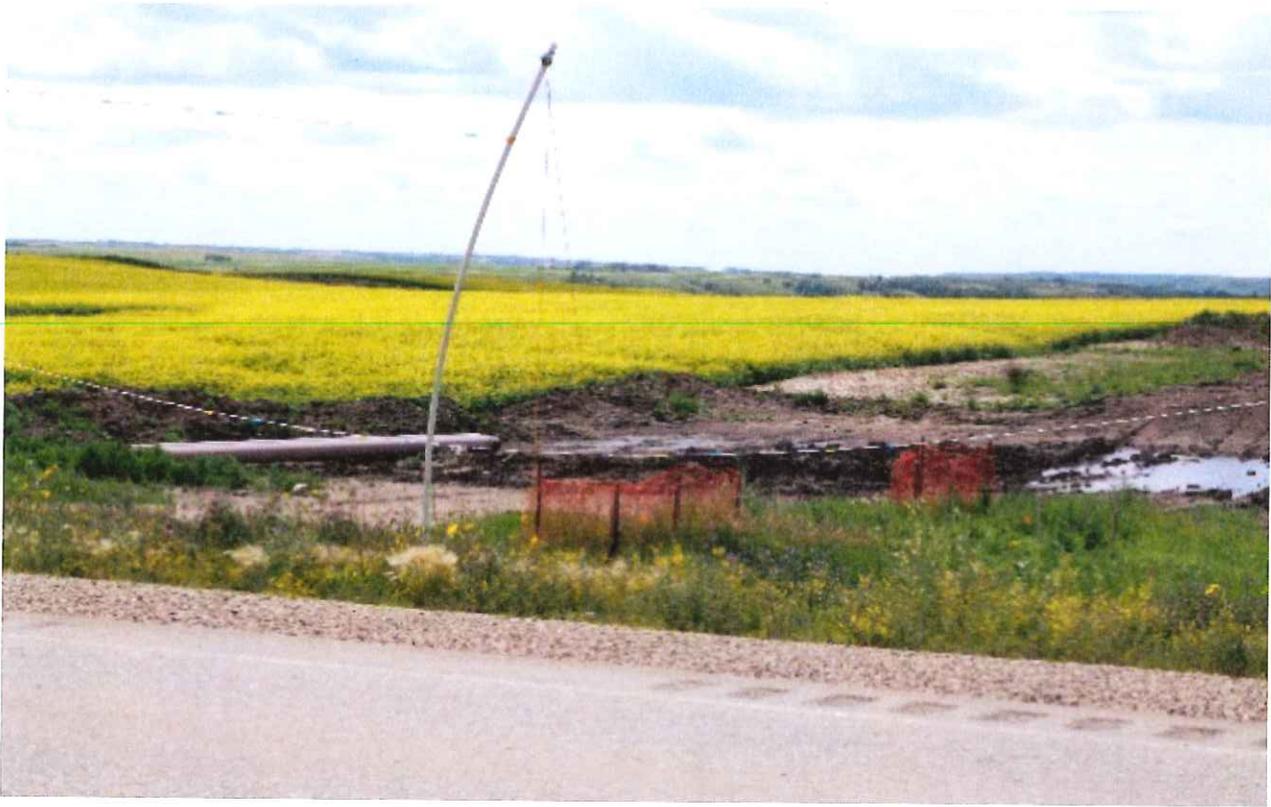
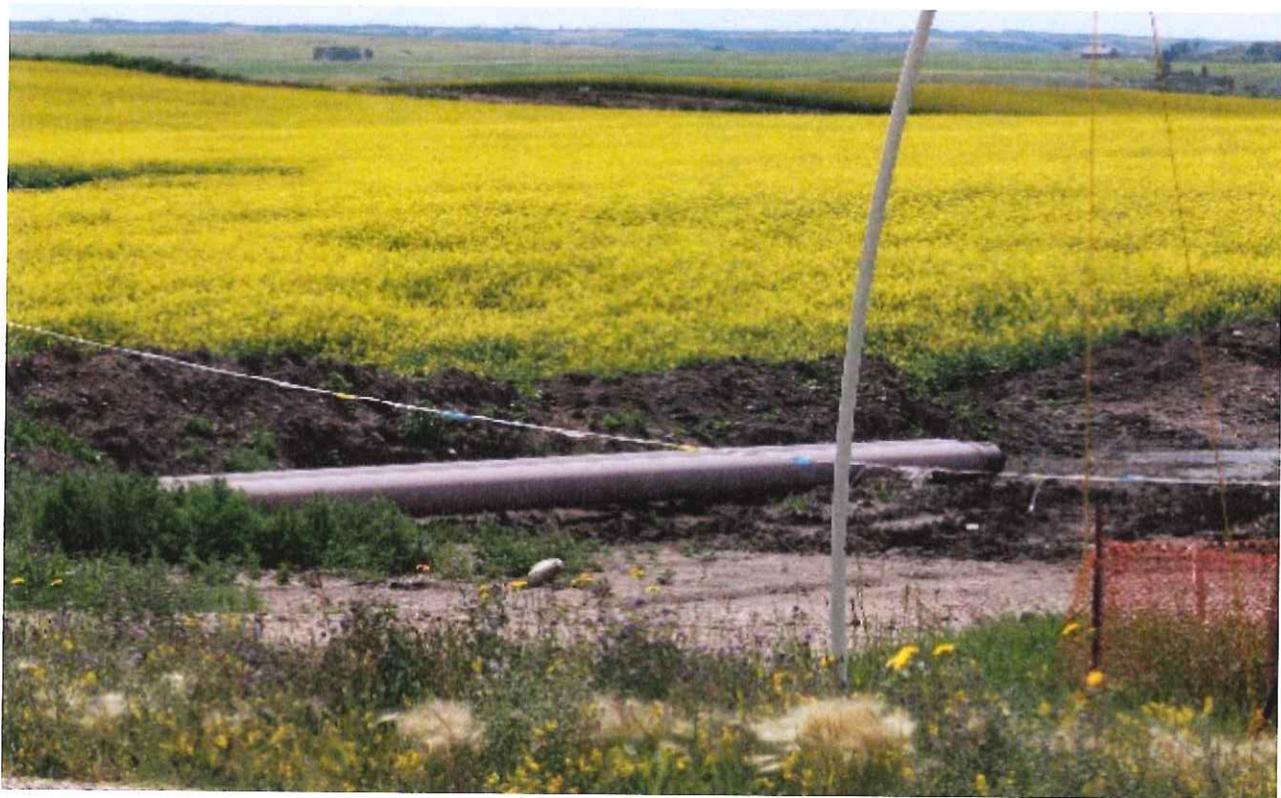
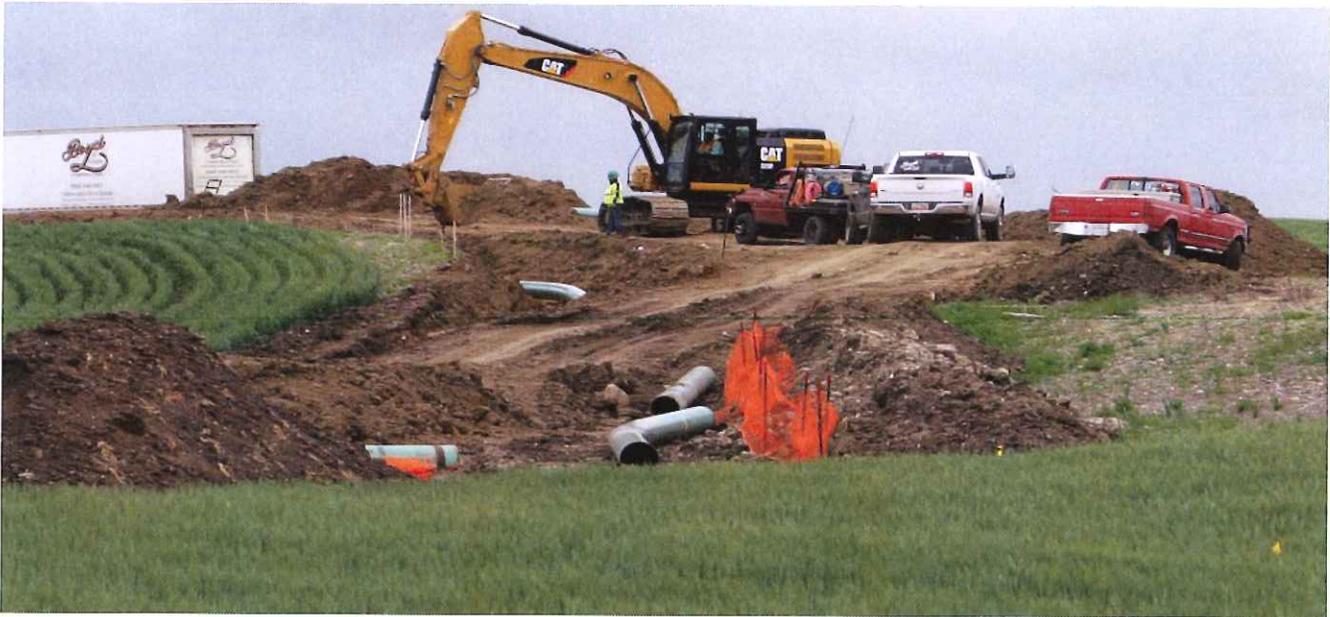
approximately two miles west of Highway 8, the second two were taken near Highway 8 south of 53rd Street NW, and the last was taken at 59th Street west of 80th Avenue NW. Skilled pipeline workers are taught never to place pipe on the ground because rocks and dirt can scratch the factory coating, which can contribute to corrosion and integrity problems down the line.

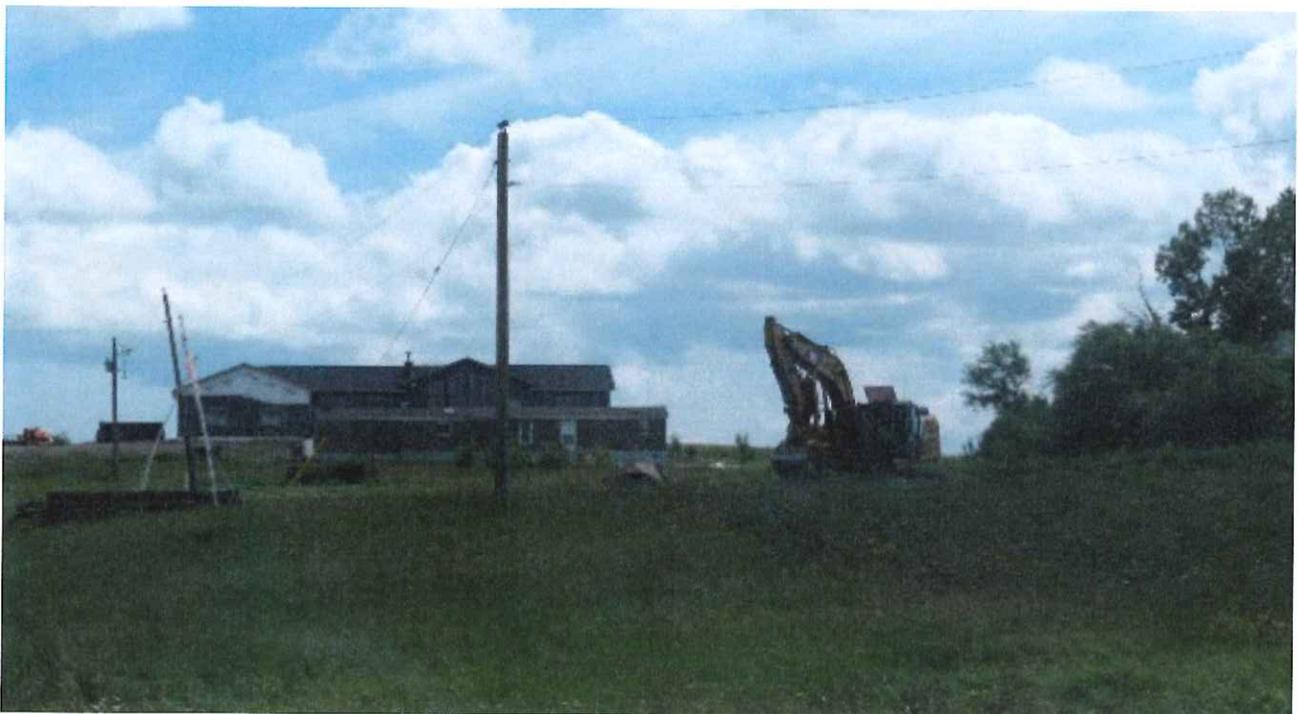
The photo below, taken near 53rd Street NE east of Highway 8 in Mountrail County, shows an excavator working near overhead power lines without a spotter. In my experience a responsible contractor will not allow use heavy equipment in the vicinity of a live power line without a spotter because contact with the line can injure or kill the operator in addition to the potential for damage to the equipment and the power system.

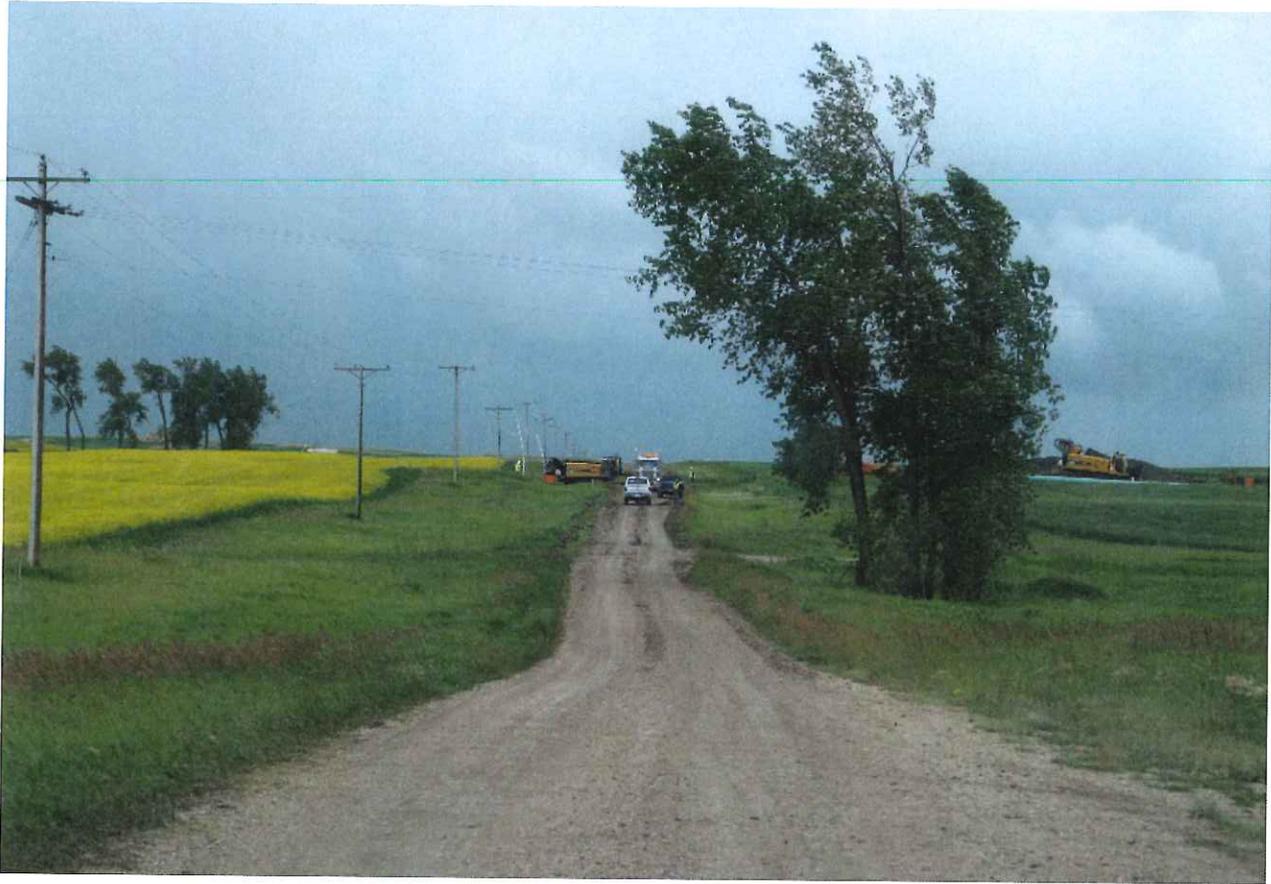
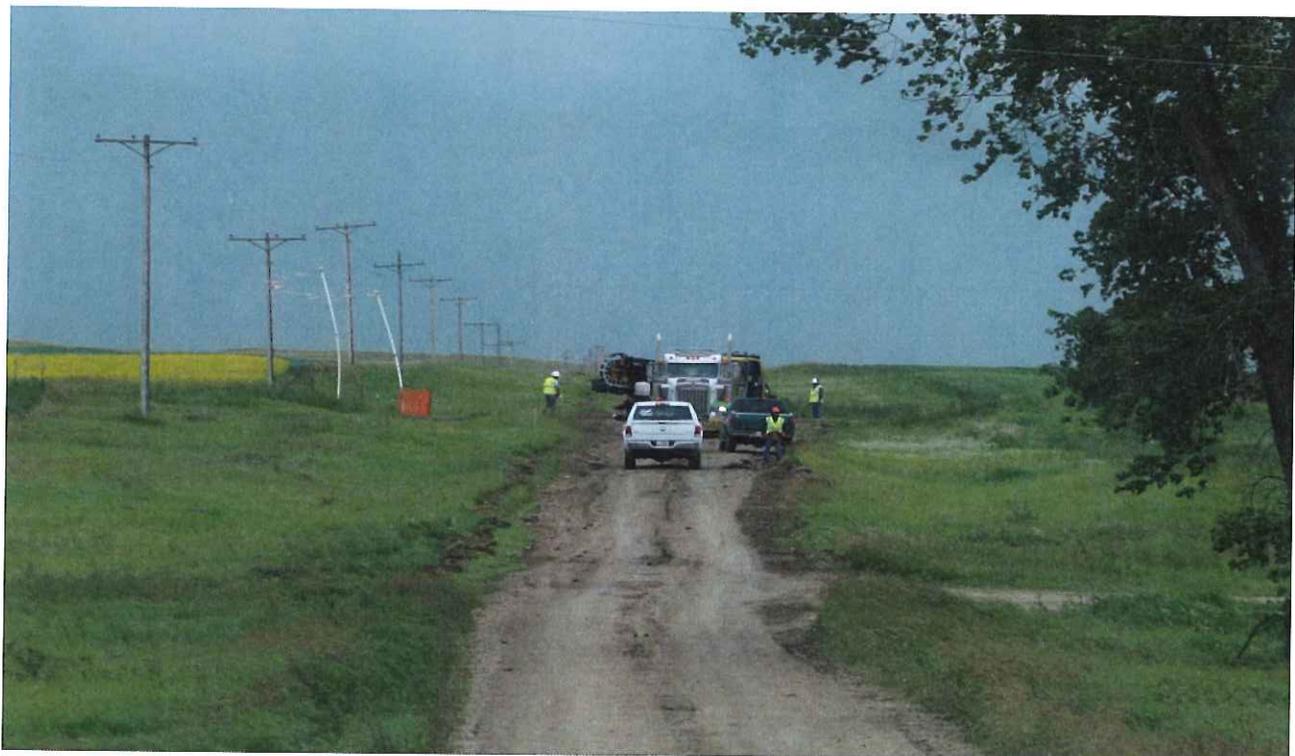
The next two photos, taken near 59th Street west of 80th Avenue NW, shows construction activity along a road that has not been adequately posted to warn drivers of potential hazards

ahead. In this situation, there should be signs and the flagger should be more visible for the safety of drivers and the crew.

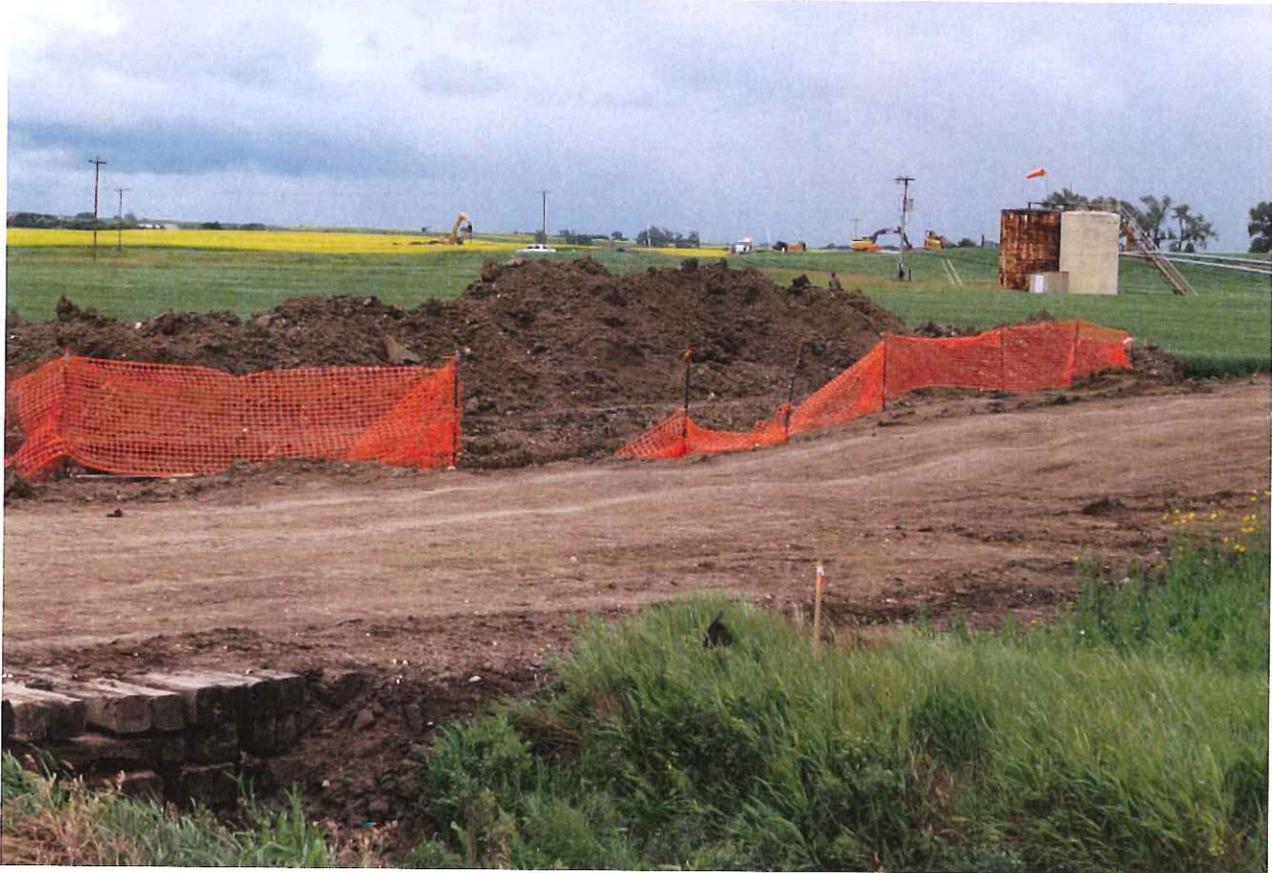
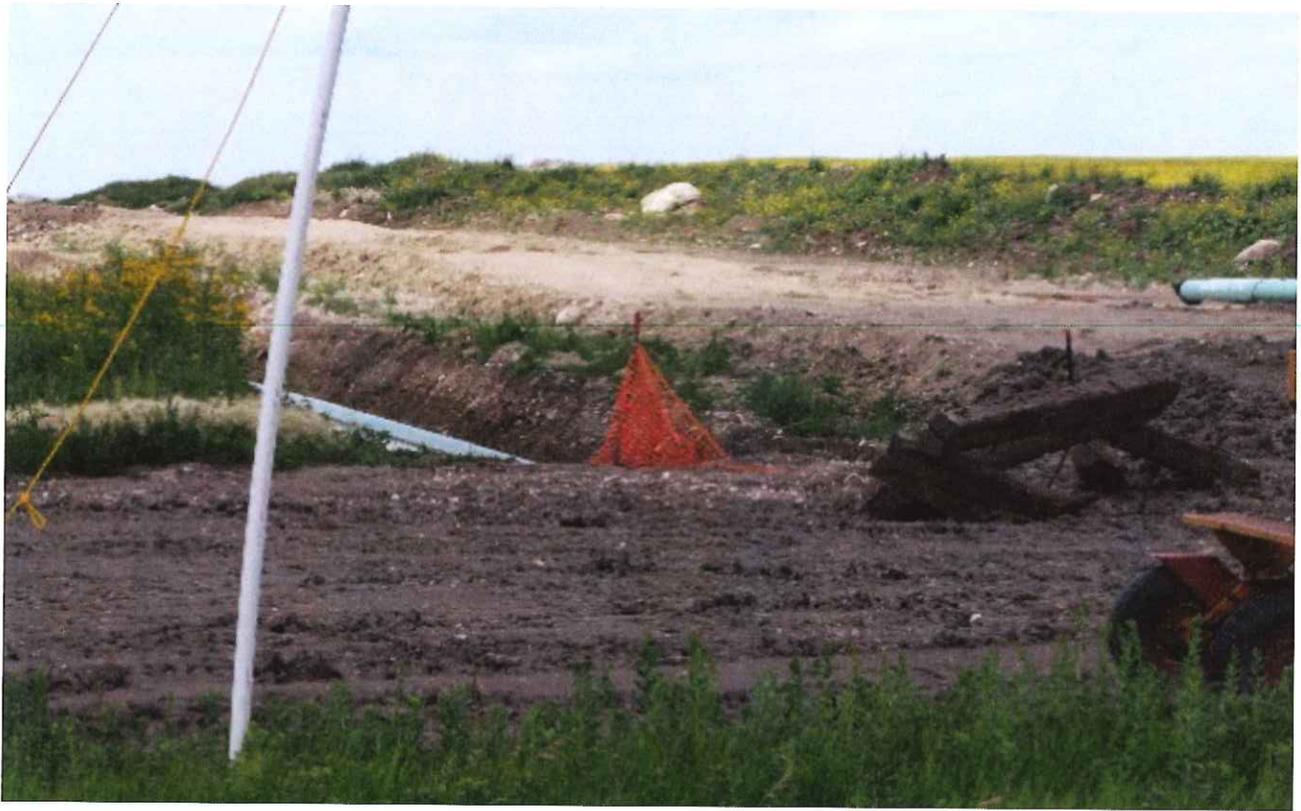
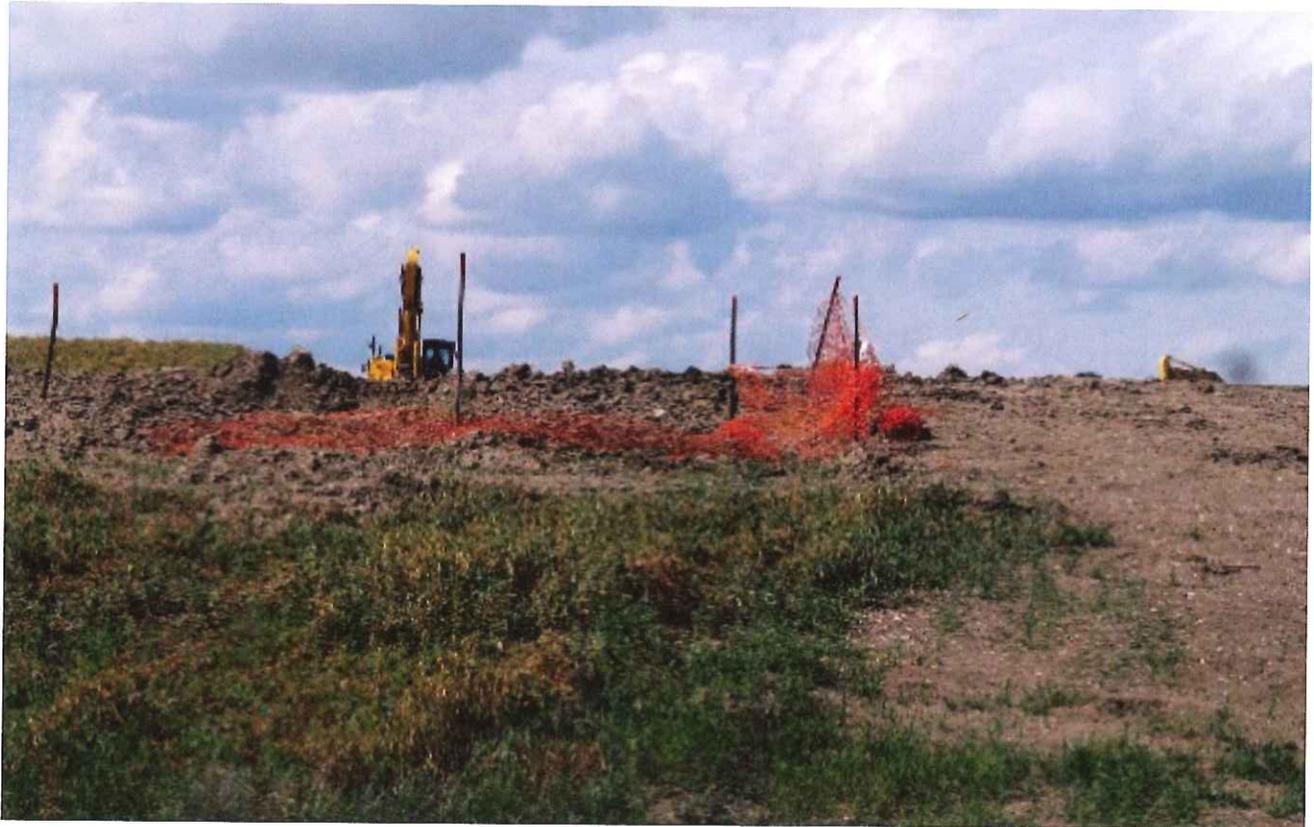
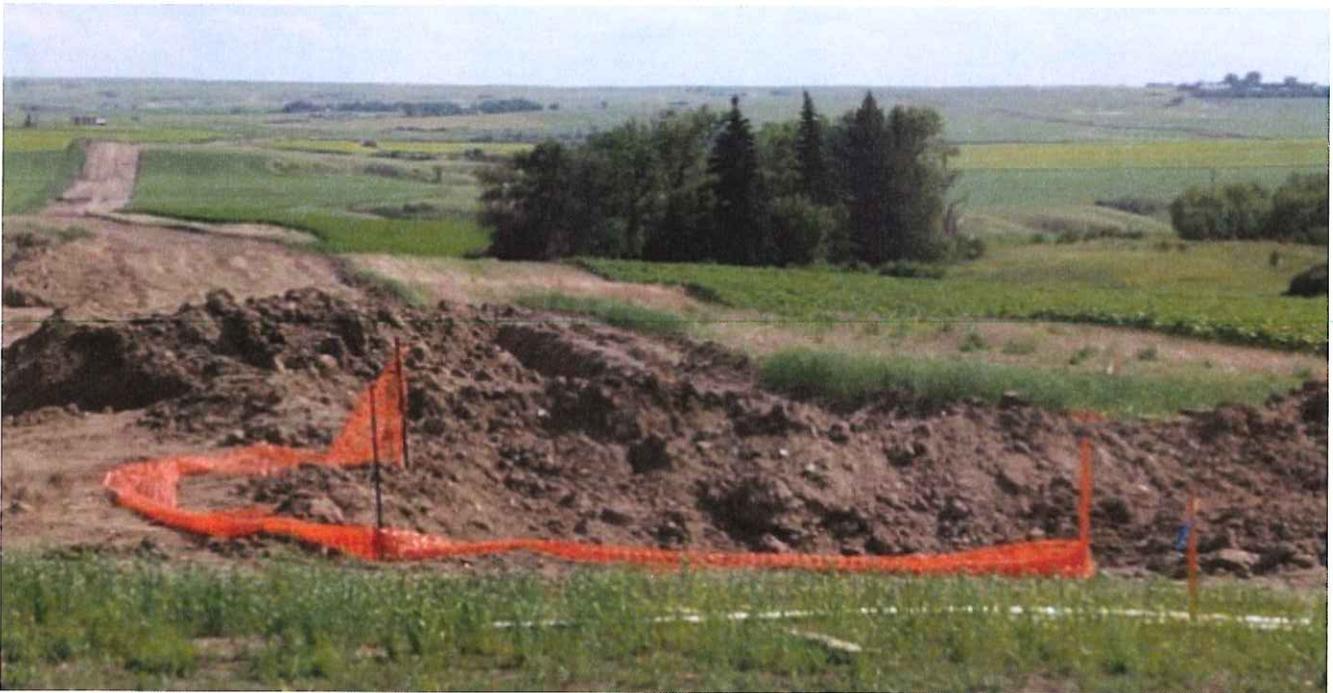
The photos below – the first taken 59th Street west of 80th Avenue, the second taken near 49th Street approximately two miles west of Highway 8, and the rest taken two miles west of 92nd Avenue NW on an unnamed road south of Newton – show collapsed safety fence near road crossings that is no longer helping to protect people, animals, or vehicles from injury or damage that can result from a fall into a bore pit.

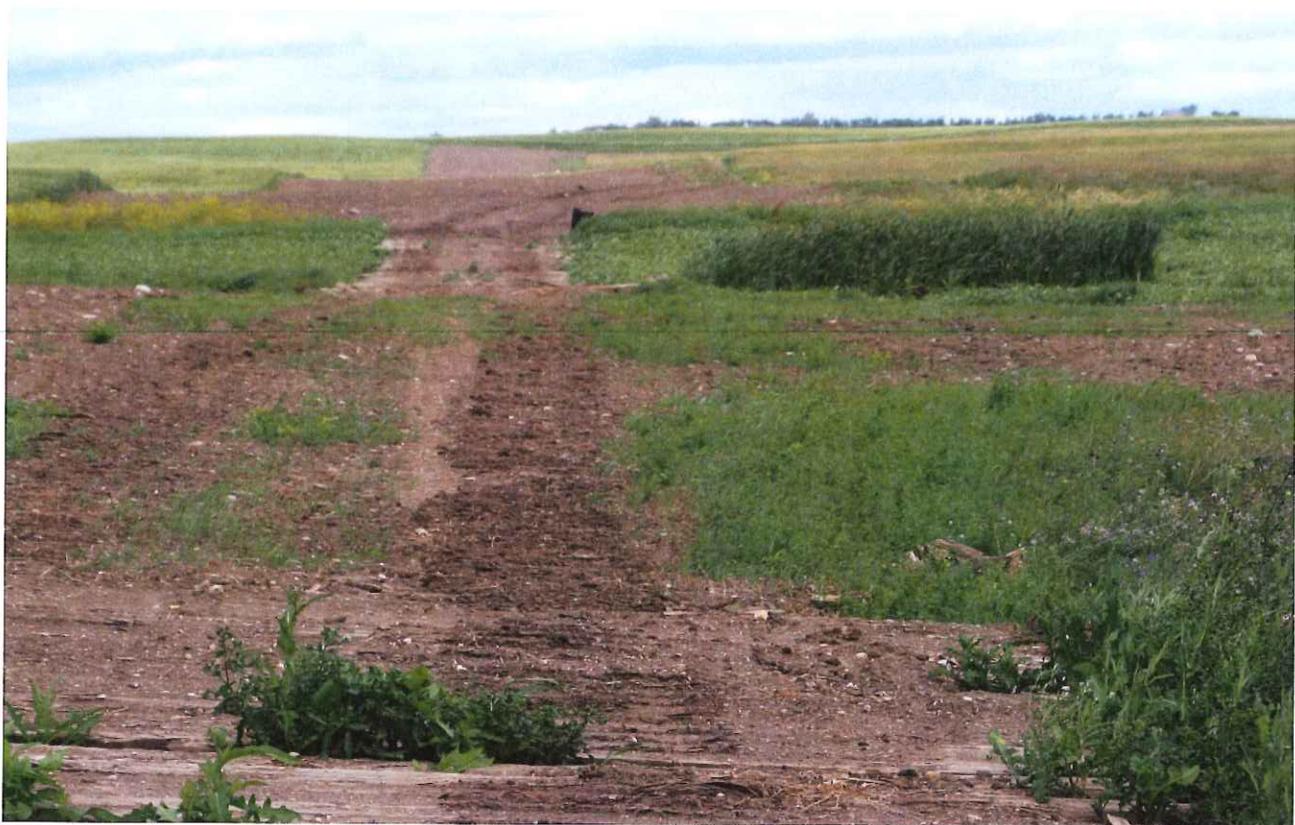
The next photo, taken in the vicinity of 60th Street a mile west of 79th Avenue, shows a section of the right-of way where heavy equipment has obviously been moved across unprotected wetland, leaving a clear set of tracks. Heavy equipment can permanently damage fragile wetland soil and vegetation, which is why a responsible contractor will use a mat bridge when wetland crossings are unavoidable.

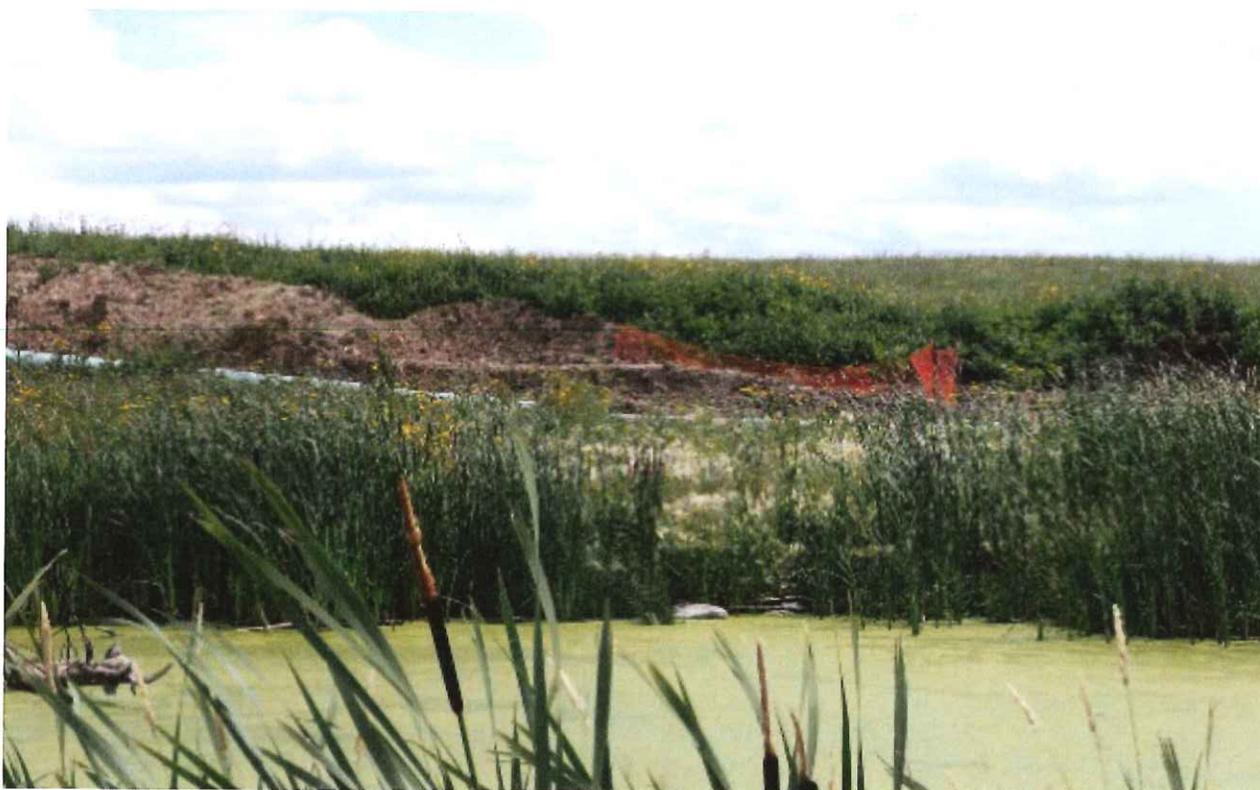
The photos below show areas where the contractor has failed to properly install or maintain silt fence or other erosion controls. Skilled pipeliners are trained to install and maintain proper erosion controls, because erosion can kill wetland vegetation, while removing topsoil necessary to sustain native plant life or cultivation on exposed areas. The following photo shows a section of the right-of-way on 53rd Street NW East of Highway 8 in Mountrail County where no silt fence has been put in place to prevent runoff into a wetland.

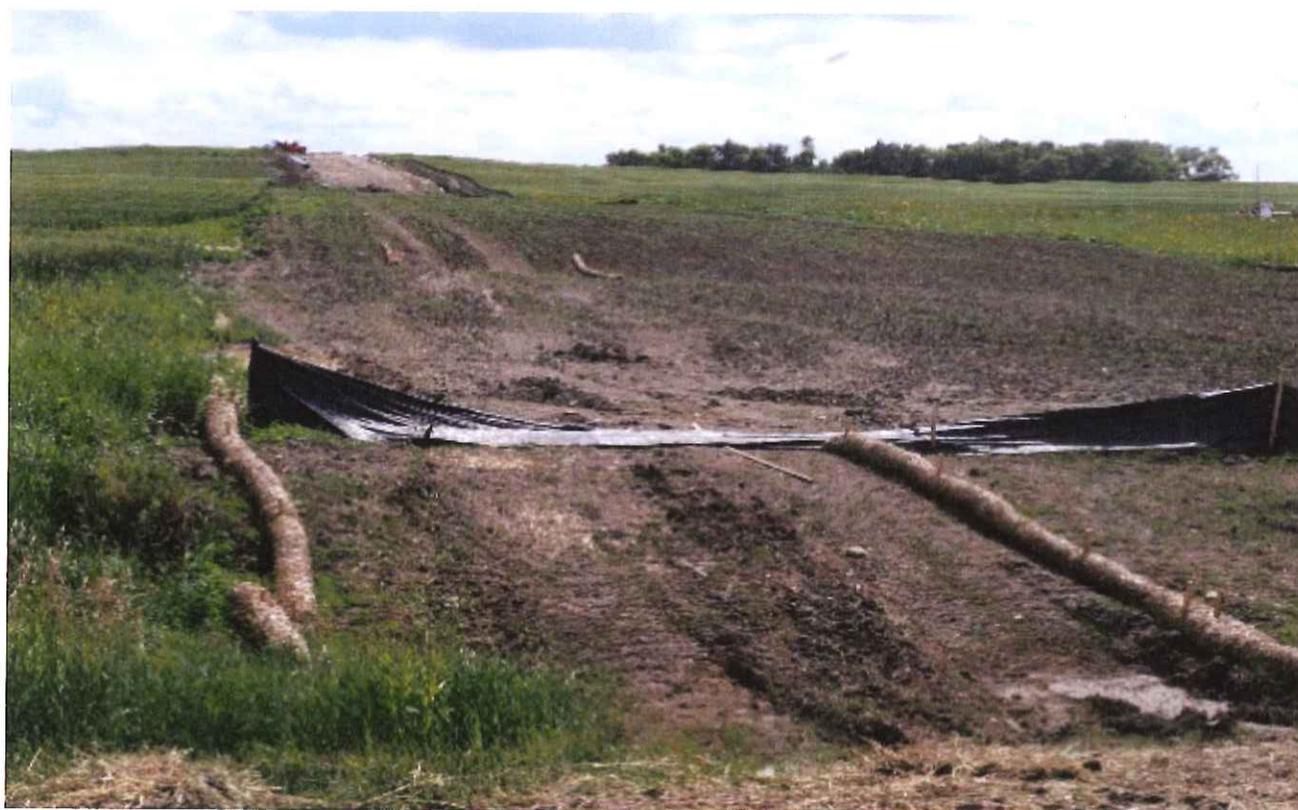
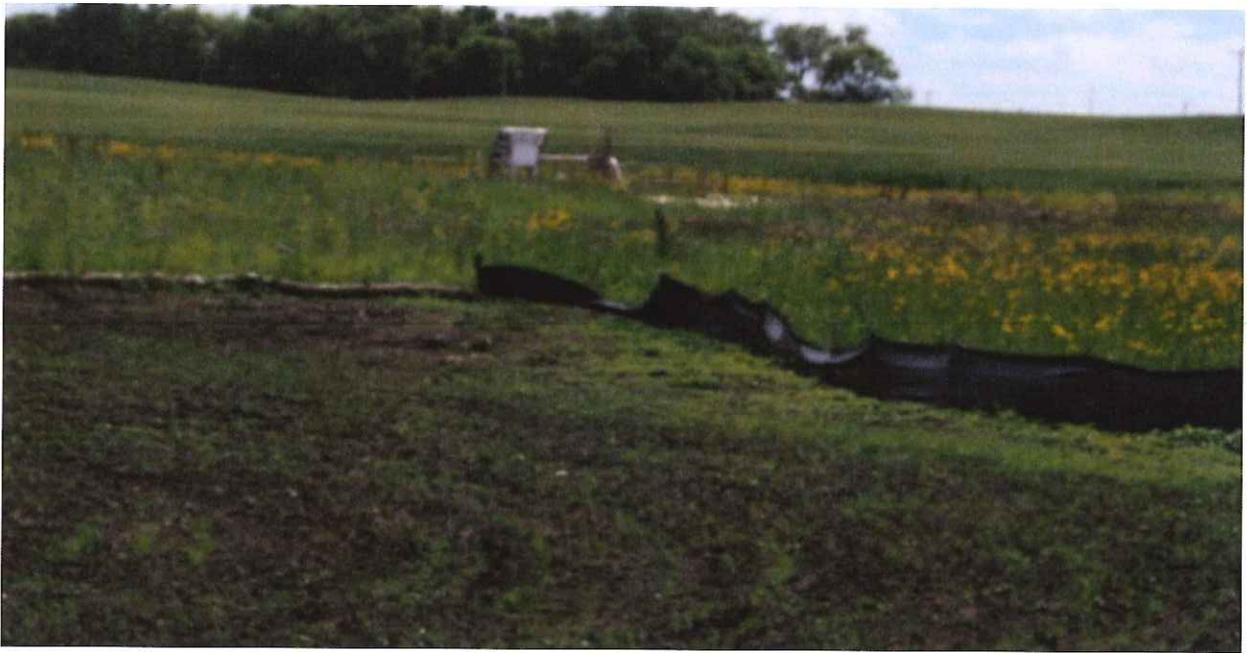
The next two photos, taken at a location east of 87th Avenue on an unnamed road in Mountrail County, show an area where silt fence was installed but then evidently run over and neglected.

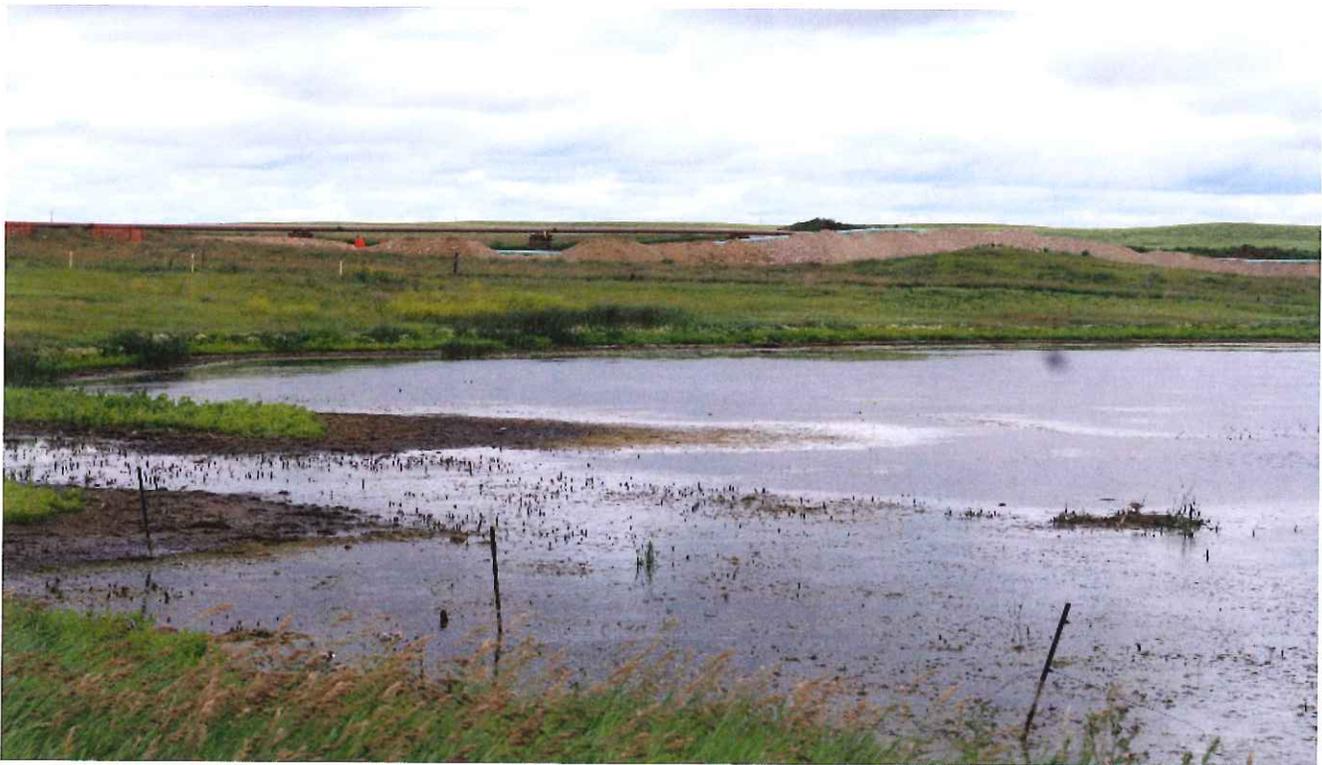
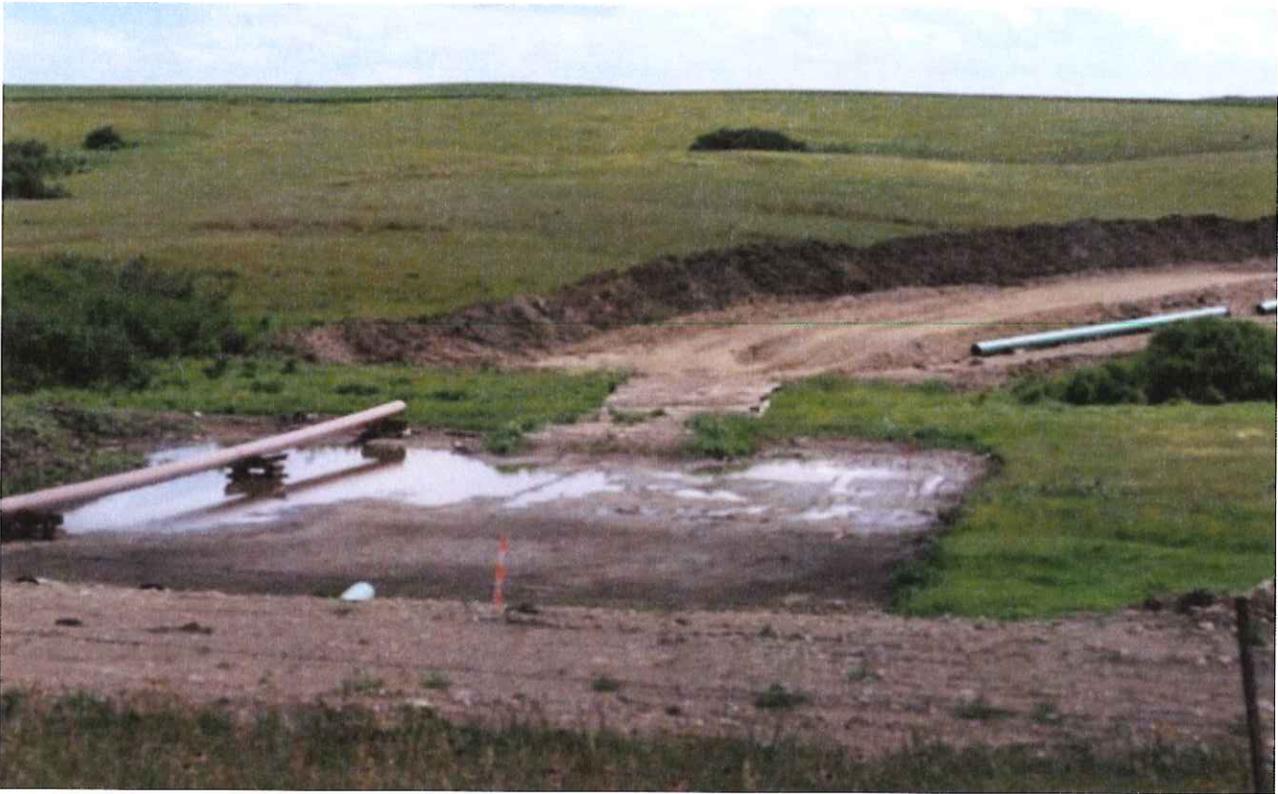
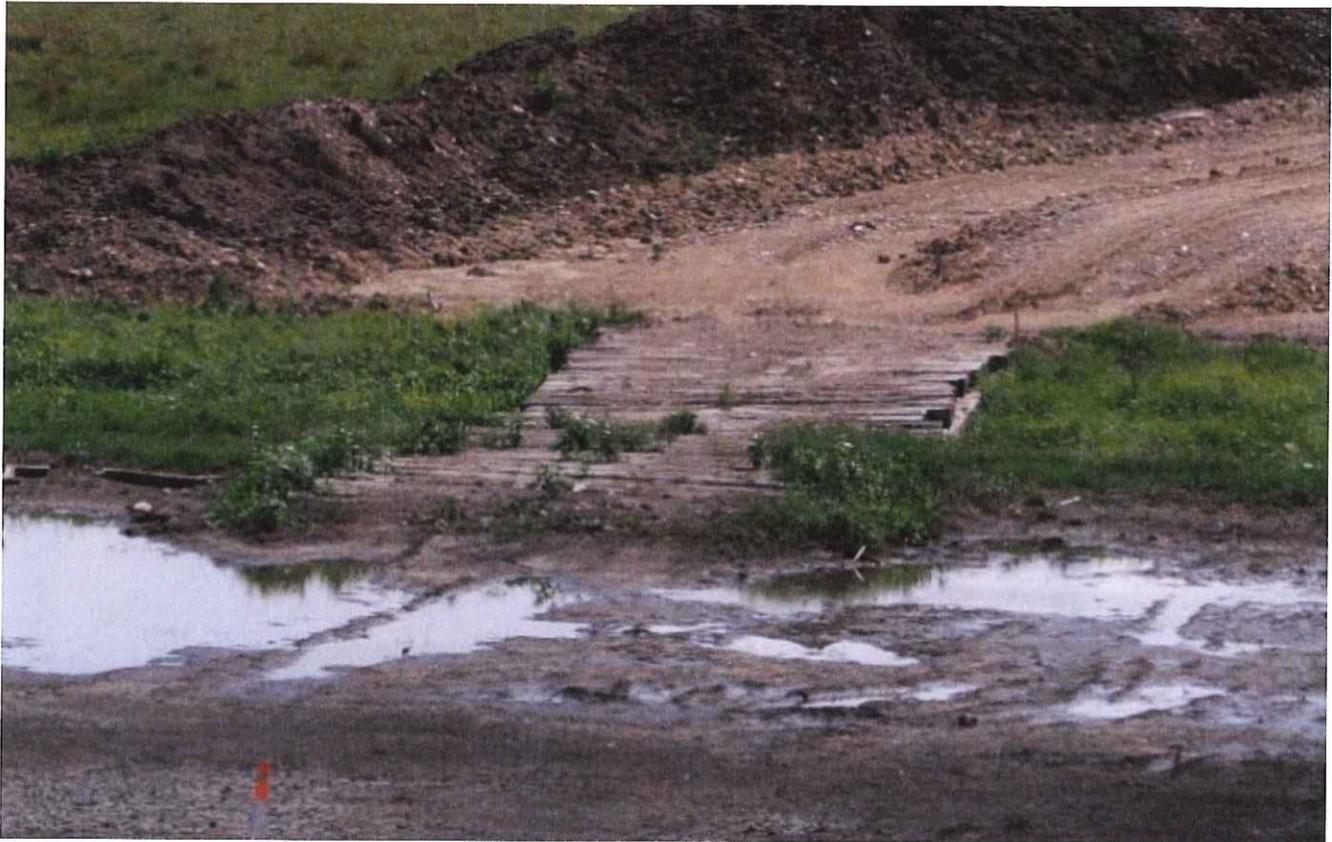
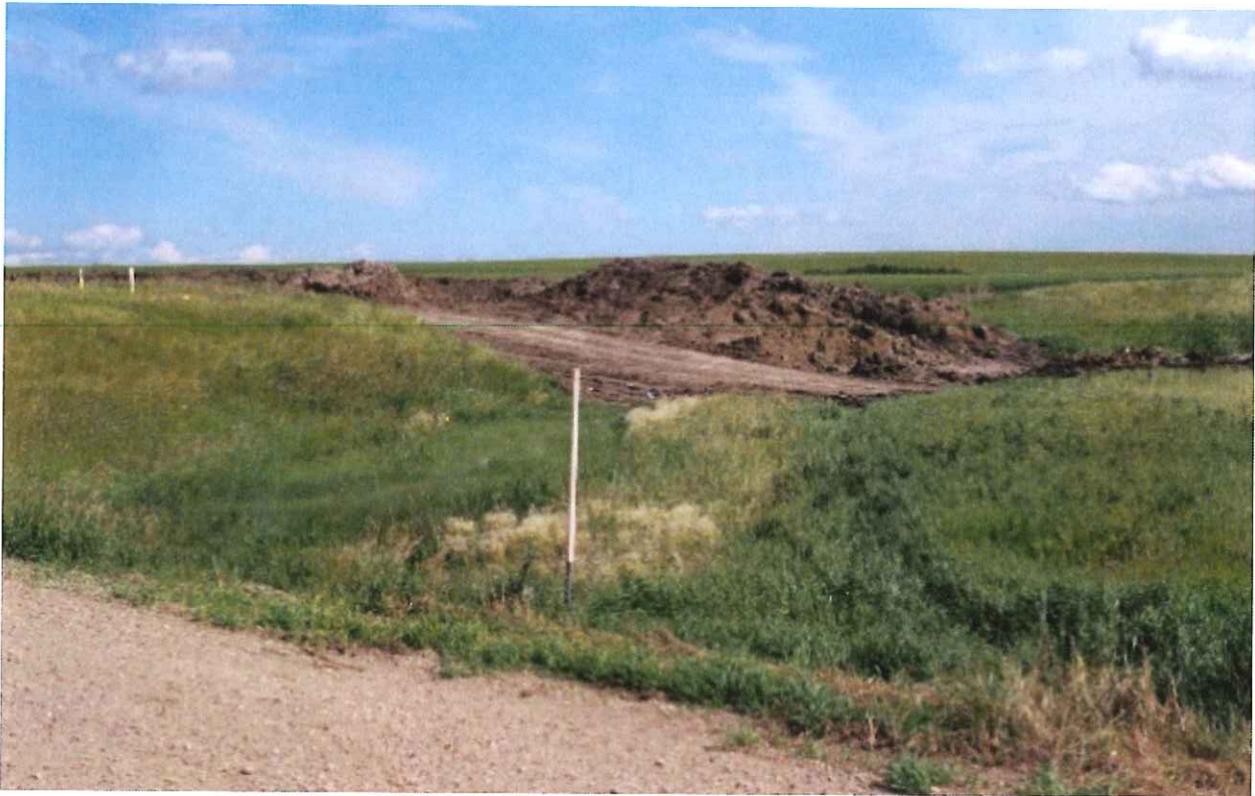
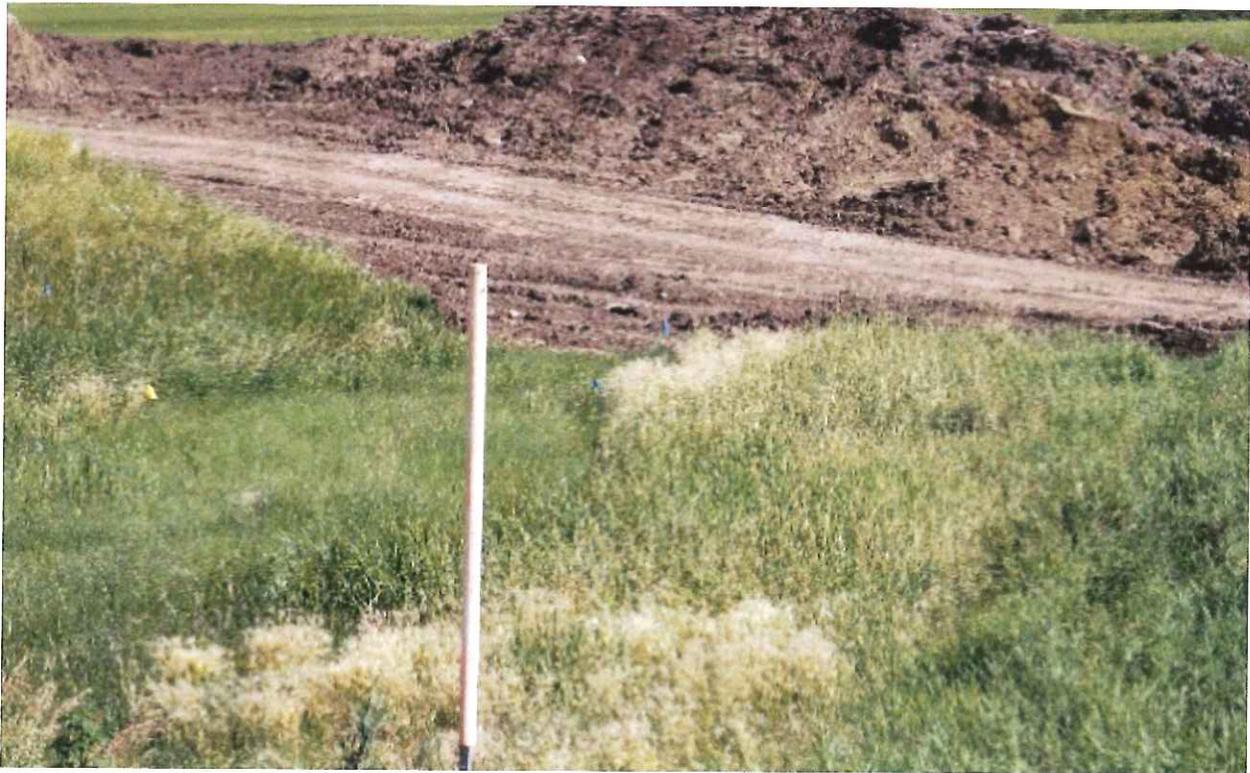
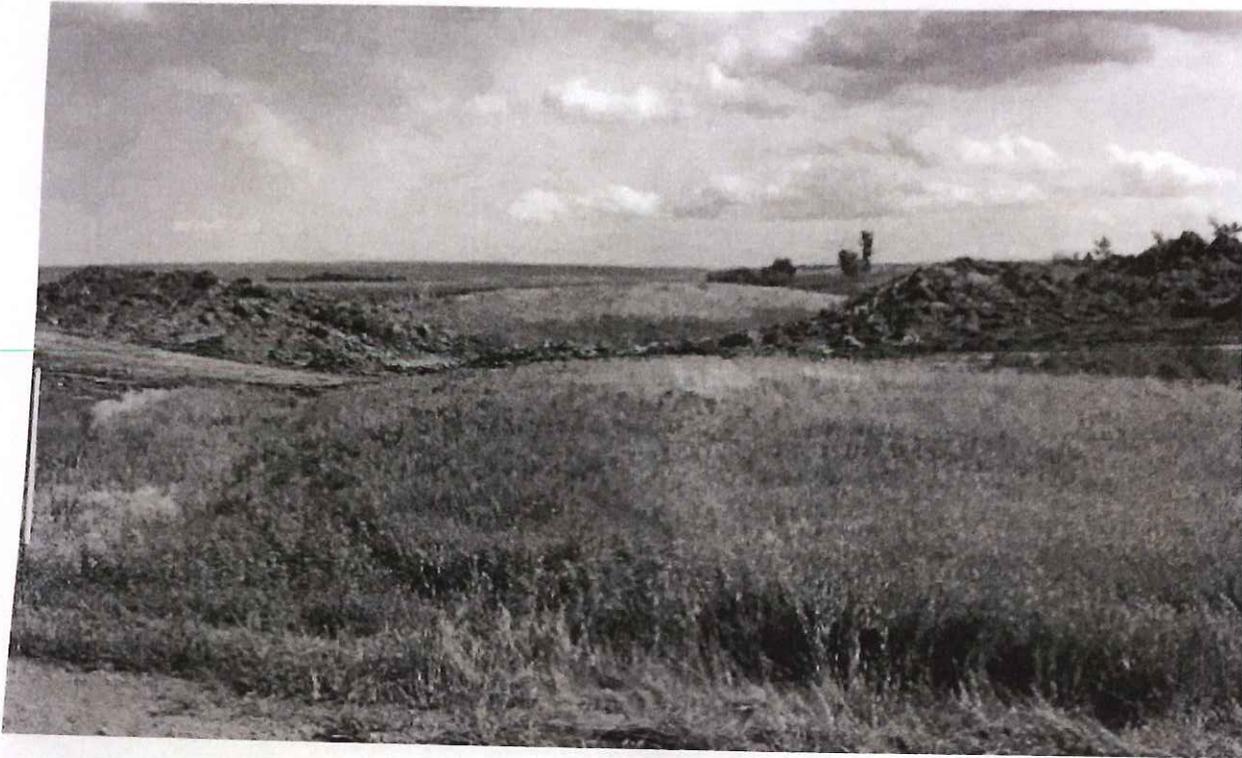
The photos below show locations along the right-of-way where there is clearly no silt fence in place to protect a wetland area. The first photos was taken near 80th Avenue NW north of 59th Street NW; the second two were taken approximately a half-mile west of 87th Avenue NW along an unnamed road north of Newtown; and the remainder were taken about two miles west of 9nd Avenue NW on an unnamed road soth of Newtown.
