2022 Garrison Phase 5 AML Project Summary

Drilling and Grouting Contract Number: AM-864-22

Location: Along McLean County Highway 15 and other infrastructure located less than one mile south of Garrison. Legal Description: Sections 17, 18, T148N, R84W

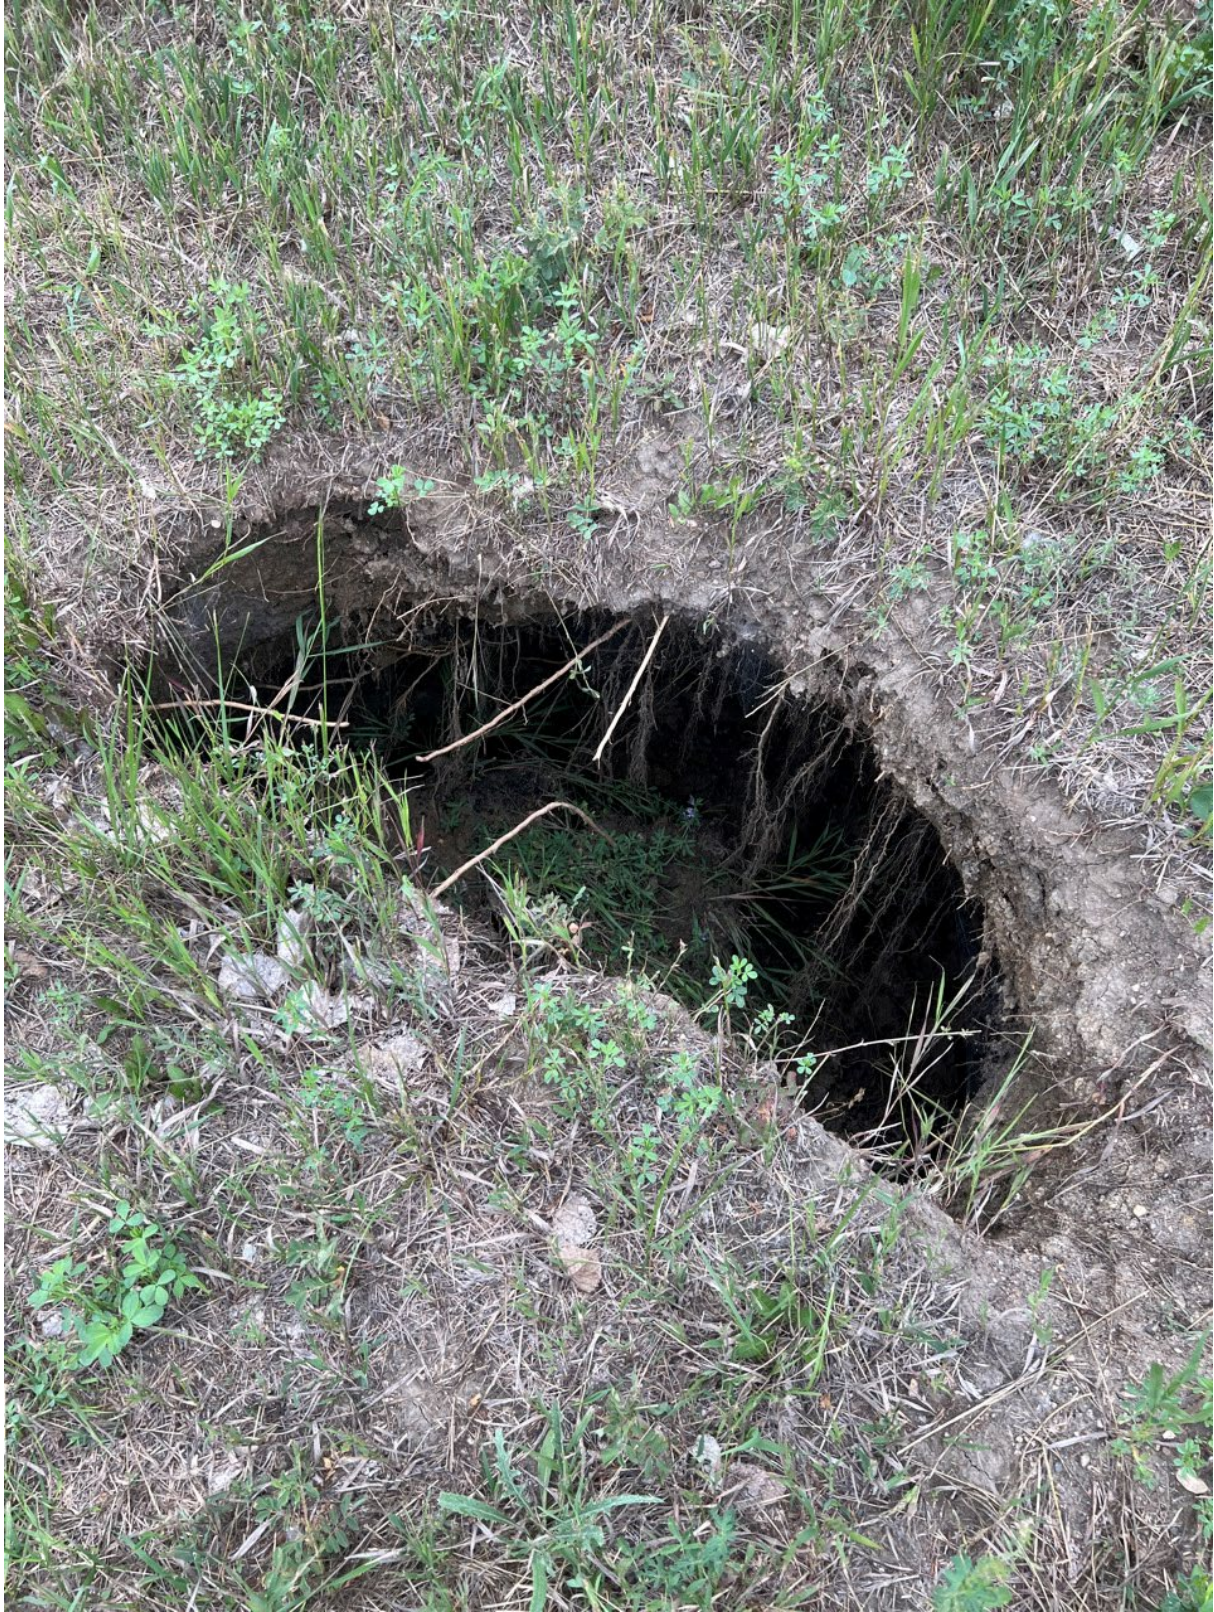
Three known abandoned underground lignite coal mines are located approximately one mile south of Garrison. The Rupp, Kunkel, and Garrison Coal Mines operated in the 1910s and 1920s. However, the Public Service Commission (PSC) Abandoned Mine Lands (AML) Division does not have a mine map of the Garrison Coal Mine. Without accurate mine maps, exploratory drilling is used to characterize and determine the extent of abandoned underground mine workings. The legacy of these mines is exhibited through sinkholes (**Figure 1**).

Figure 1: A sinkhole opened up in the McLean County Highway 15 right of way in the spring of 2022.

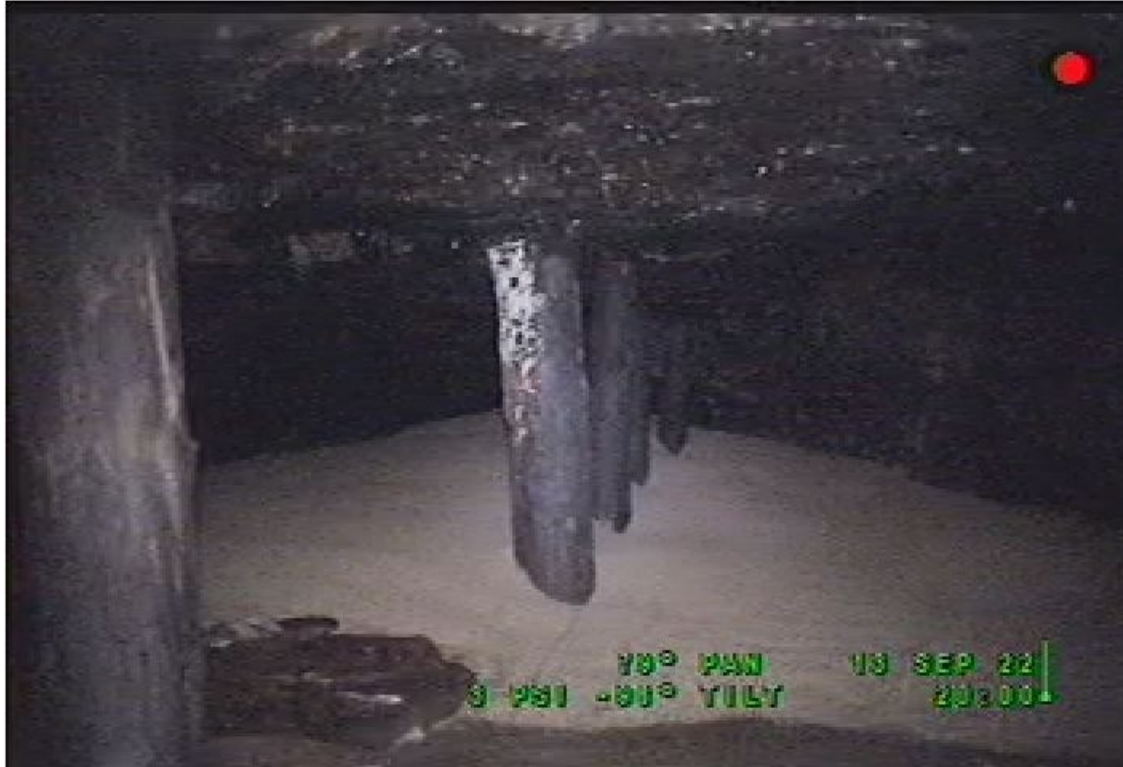
Two months prior to the start of the Garrison Phase 5 AML Project, a 2022 Exploratory Drilling AML Project was conducted. The Garrison portion of the 2022 Exploratory Drilling Project was completed by August 4, 2022. Project totals included 20,072 feet of drilling and 3,765 feet of PVC casing was installed in 108 drill holes encountering mine voids (**Figure 2**). All drilling was done near McLean County Highway 15 and other infrastructure. The drilling in this project revealed the extent of the abandoned underground mines in Garrison were much larger than previously anticipated (**Figure 3**).

Figure 3: A borehole camera image shows timbers in the mine workings. The tan material is grout slowly filling this portion of the mine.

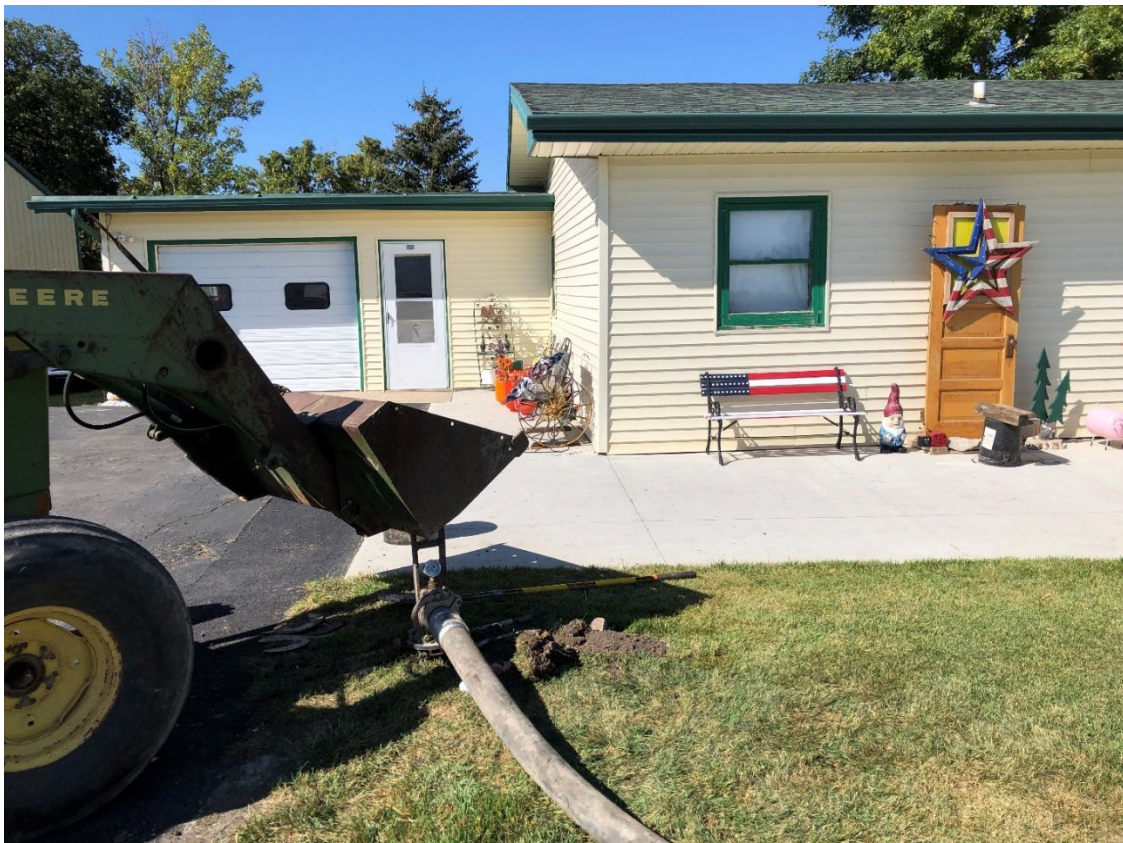
Figure 4: Approximately 60 yards of grout was pumped into this hole.

The bid quantities for this project included 2,000 cubic yards of grout injection, 5,000 feet of drilling, 1,000 feet of casing, and 50 feet of coring. Grout was first pumped near private residences in the South Garrison Subdivision (**Figure 4**). During this time, the contractor continuously monitored the elevations of the buildings using a laser level to detect any changes in building elevations. Grout is tested by the material testing contractor every 50 cubic yards to ensure it meets contract requirements for flowability and strength (**Figure 5**). After pumping near the homes was complete, the grout pump moved to the McLean County Highway 15 right of way until the end of the project (**Figure 6**). A total of 2,139 cubic yards of grout was pumped at the locations shown on the map (**Figure 7**).

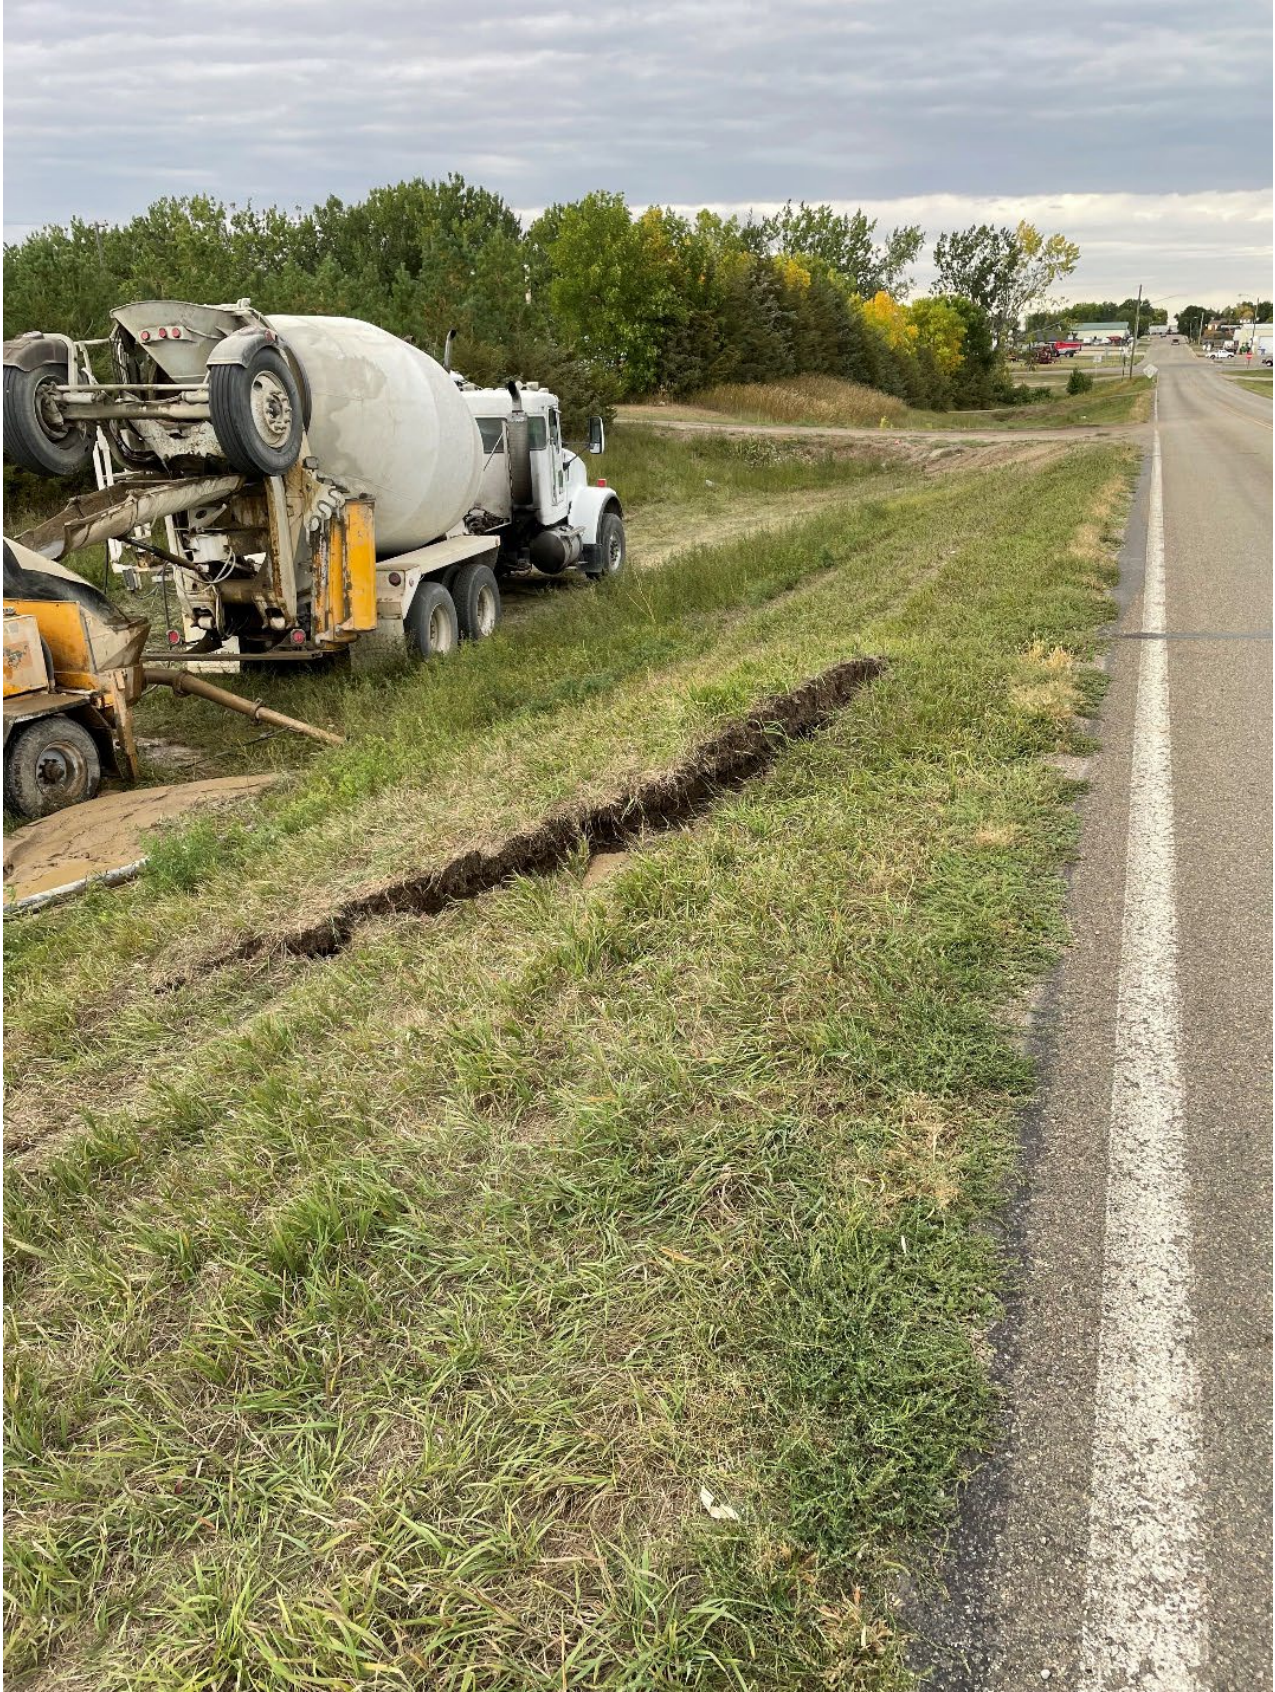
Figure 6: Surface lifting often occurs when a mine void is filled with grout. The grout will find the path of least resistance.

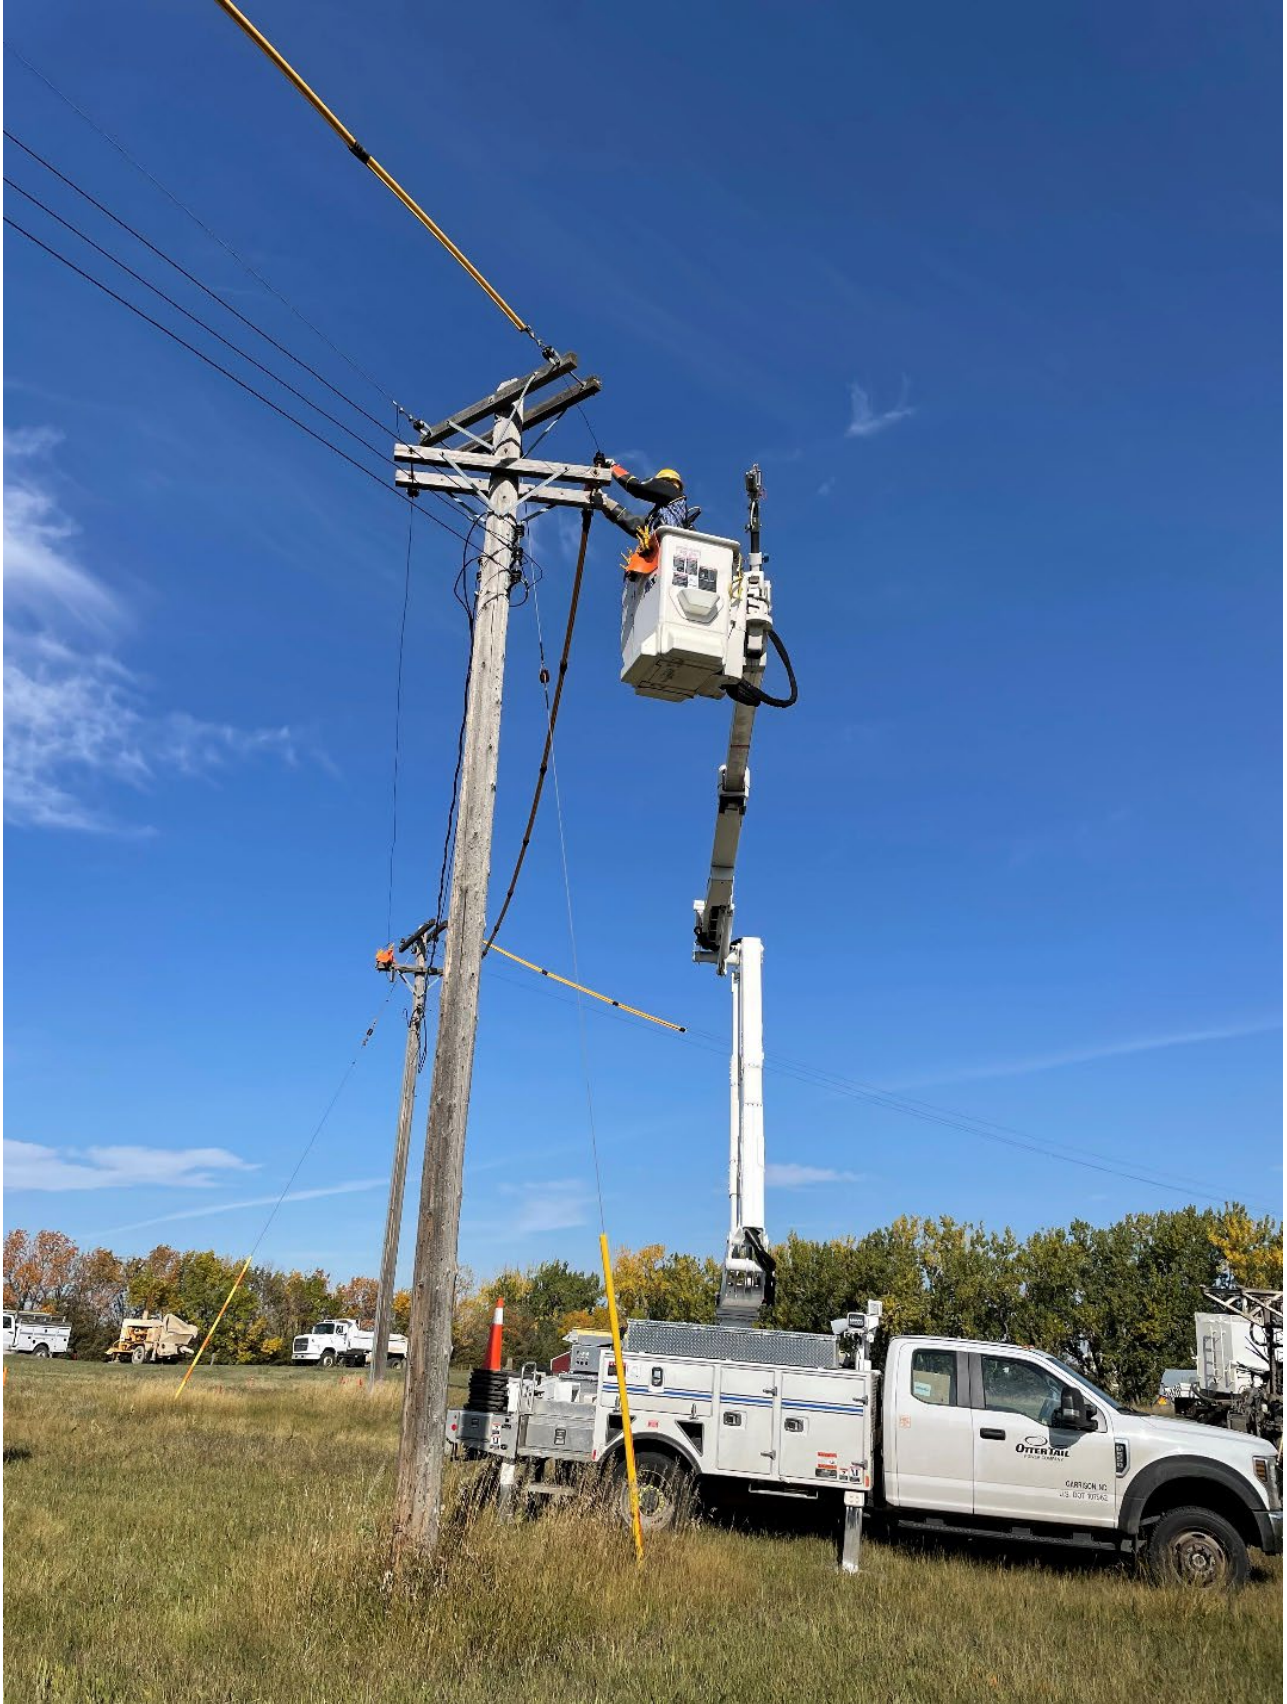
The Garrison Phase 5 AML Project also included drilling in high-priority areas. Previous drilling indicated that some of the power poles in the area are likely undermined. The local power company was able to shield their lines which allowed drilling near the poles (**Figure 8**). Four of the power poles were found to be undermined. Additional drilling in the ditch of McLean County Highway 15 also revealed more voids.

Figure 8: The power company covered the lines to allow safe drilling near these powerlines. Drilling confirmed these poles are undermined.
