2018 AML PROJECT SUMMARY

March 2019

Wilton Phase 4, Shell Lake and Williams County Road 9 Phase 6

Project Type: Abandoned Underground Mine Reclamation

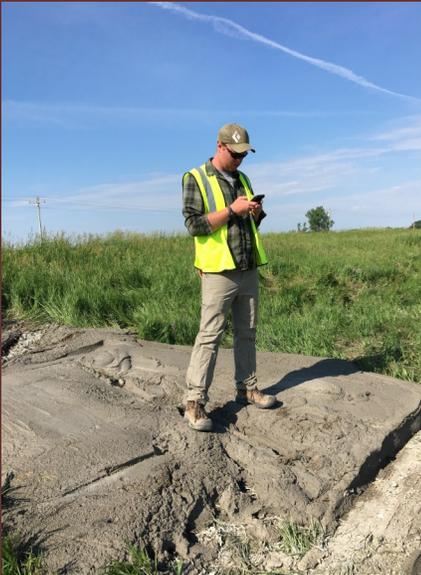
The picture below shows grout on the ground in the north ditch of Highway 36. While pumping, the grout found the least resistant path which led to the surface. We call this a "blowout". At times pumping can

cause the earth to move either by lifting the surface or causing it to crack.

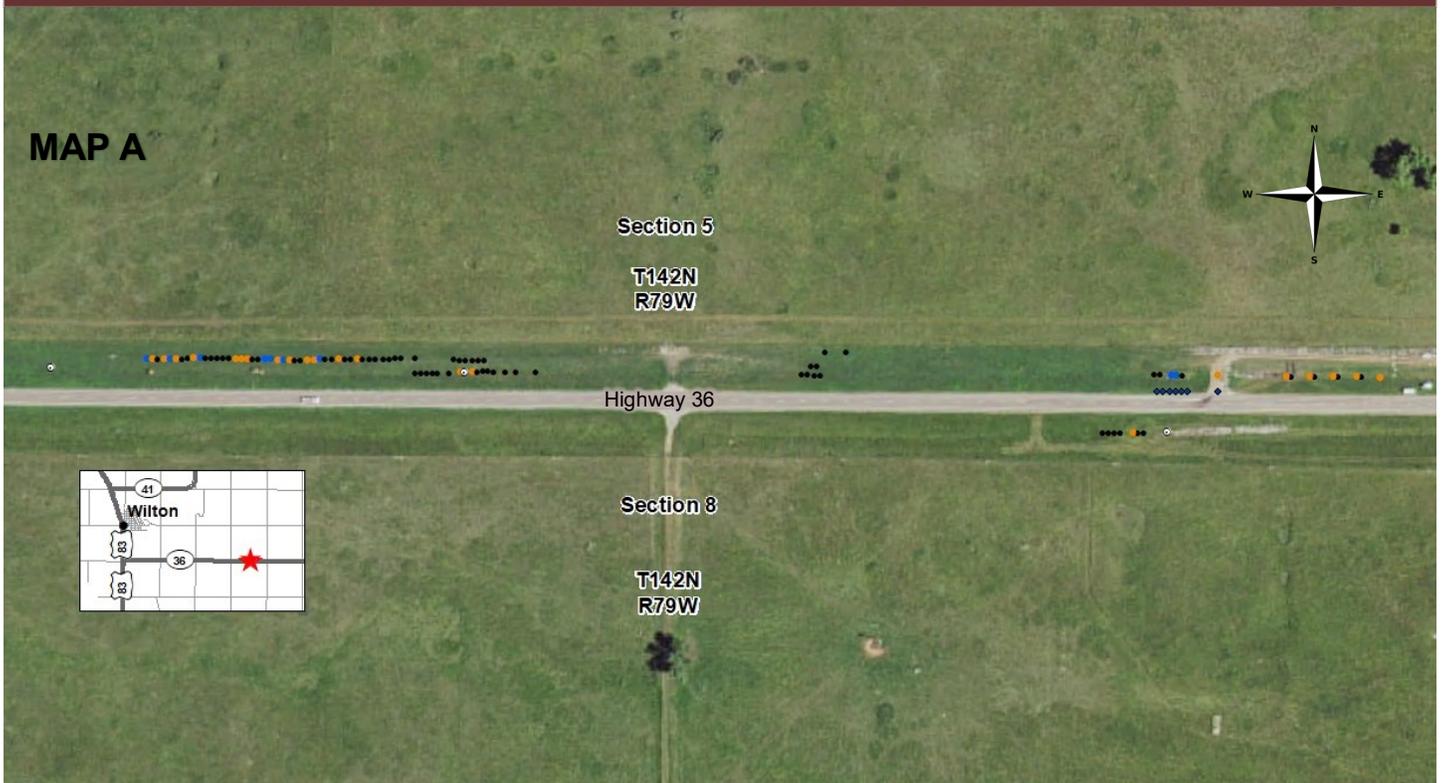
This area took 1,434 cubic yards of grout. Confirmation drilling in both the north and south ditches on the east end of the project area (the east half of Map A) intercepted grout that had been pumped in previous years. Several cores confirmed that grout flowed far beyond the hole that was pumped. During the four phases of drilling and grouting projects 19,434 cubic yards of grout were pumped along 41st Street and in both the north and south ditches of Highway 36 between 41st and 56th Street. The grout will stabilize the highway right-of-way and reduce subsidence hazards. No additional work is planned along Highway 36.

Drilling conducted in the right of way of 26th Street between Highway 36 and 318th Avenue and the north ditch of 318th Avenue west of 26th Street as shown on Map B. No mine workings or grout were encountered along 26th Street. Grout was encountered along 318th Avenue as indicated by the orange dots on Map B. No grout was needed and no additional work is planned for this area.

Maps A & B: North Dakota Highway 36 runs east and west. Each dot represents one drill hole. Drilling encountered solid coal at **black dots**. Grout was pumped into holes at **Blue dots** and **orange dots** are holes filled by pumping grout into a different hole. **White dots** are core holes.

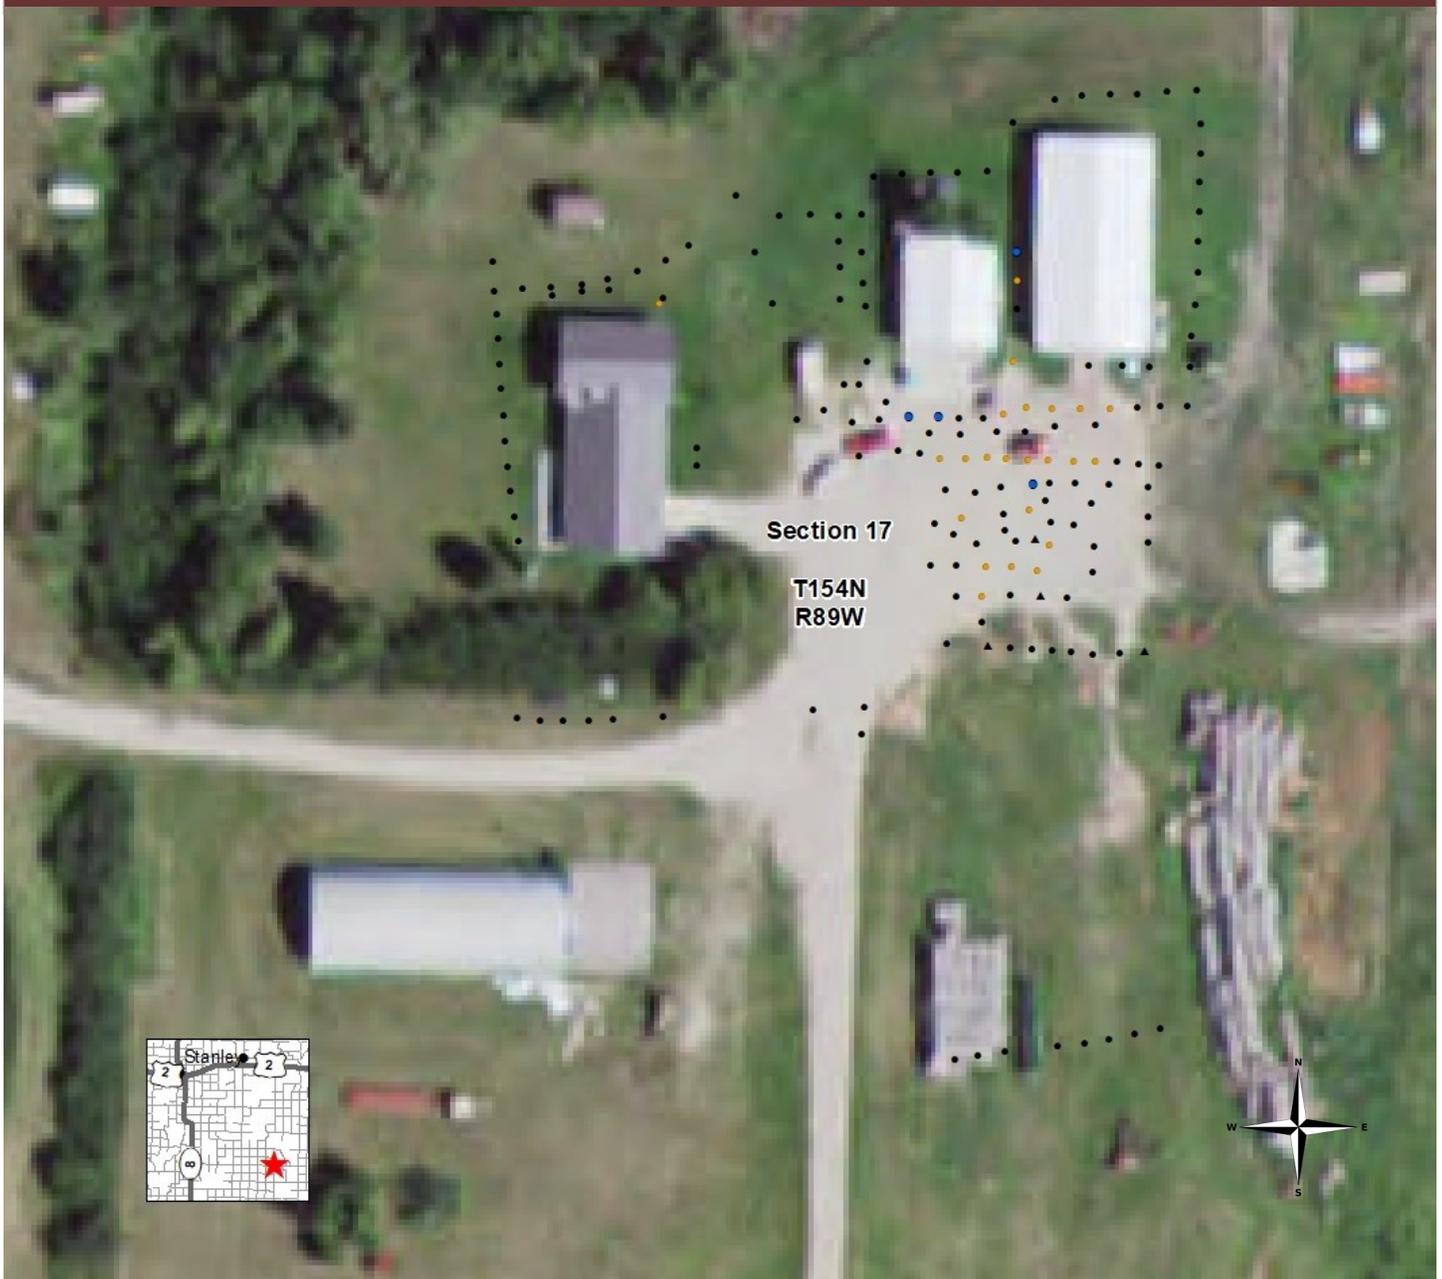
Shell Lake –Wally Lee Farmstead. Each dot represents one drill hole. Drilling encountered solid coal at **black dots** and no coal at **black triangles**. Grout was pumped into holes at **Blue dots** and **orange dots** are holes filled by pumping grout into a different hole.

holes showed upward migration of the voids to within 35 feet of the surface. Without reclamation, the collapsed portion may reach the surface, causing a sinkhole to form. These holes were cased in 2017 for future grouting. In the 2018 Drilling and Grouting project, eleven additional holes were cased in the driveway south of the shops. No true open voids were discovered and it is thought that the mine has collapsed over the years.

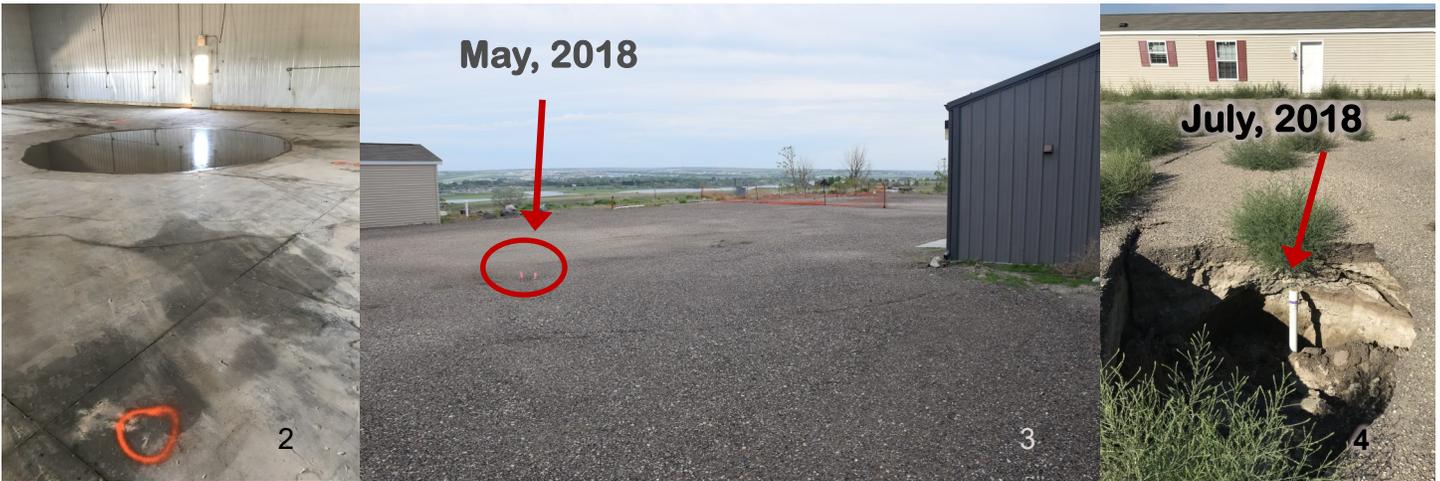
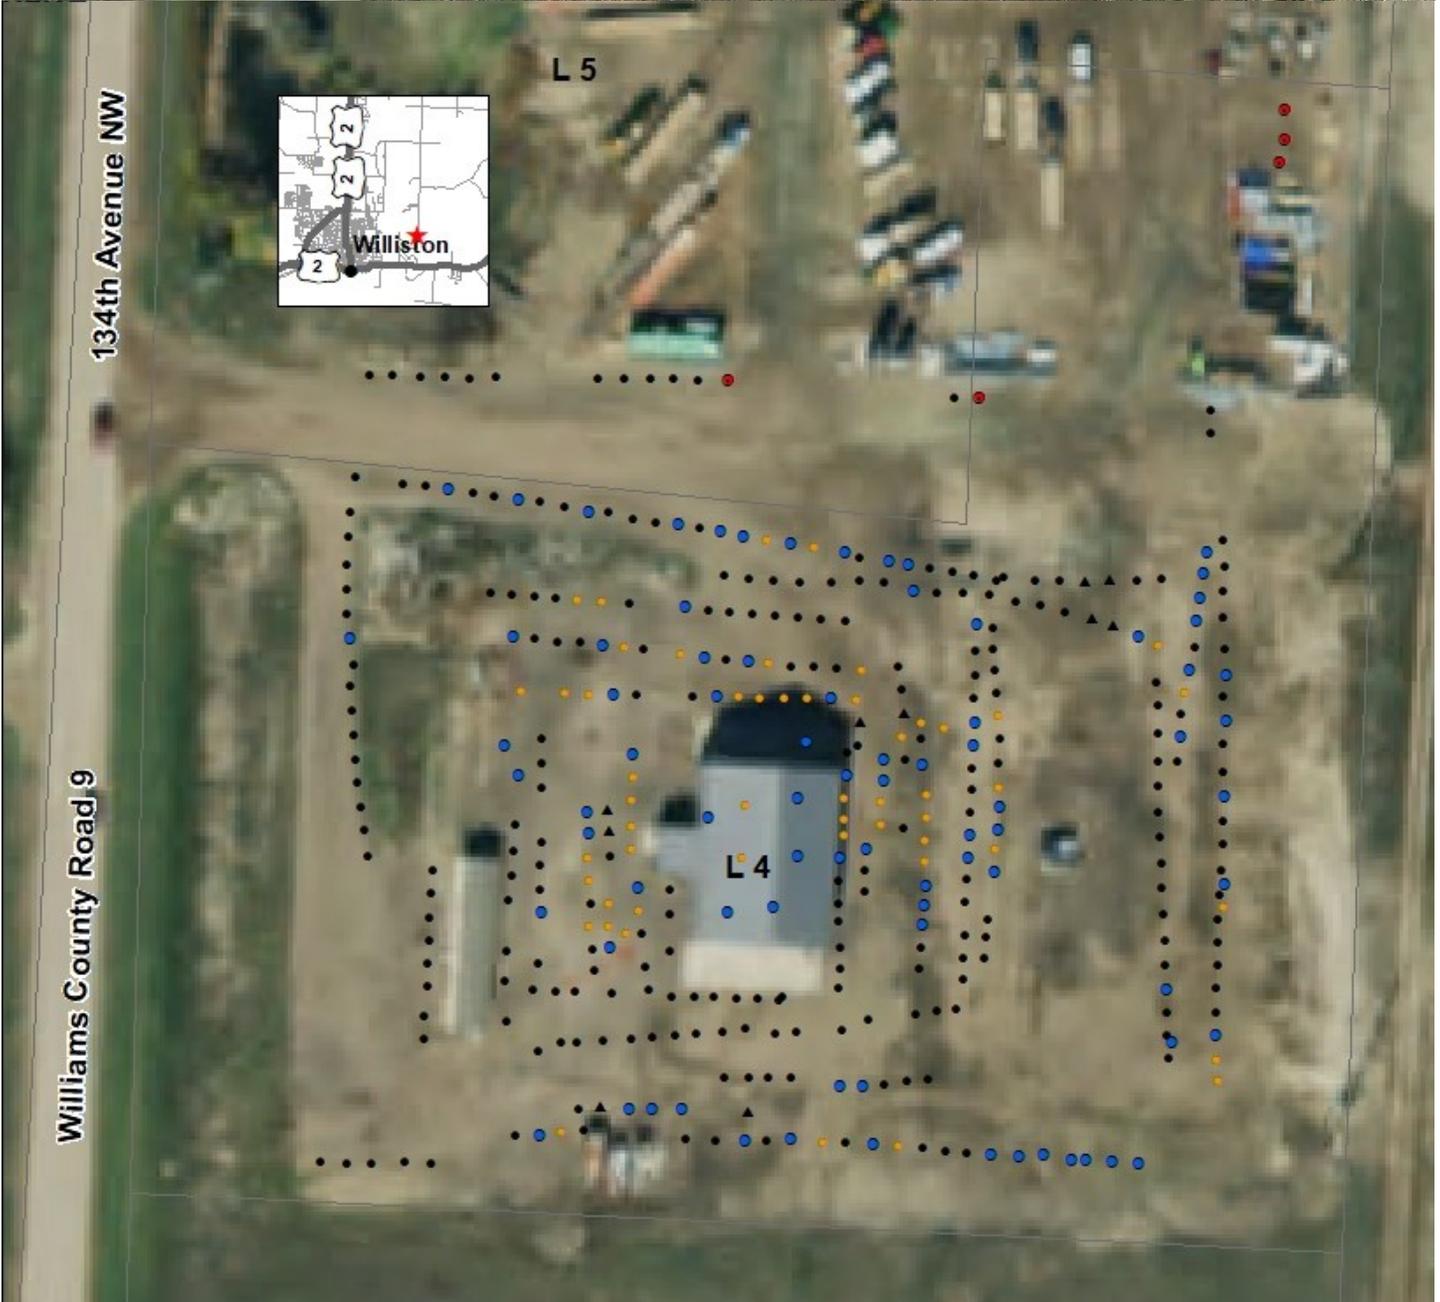
Williams County Road 9, also called 134th Avenue NW, runs north and south. Drilling encountered solid coal at **black dots** and no coal at **black triangles**. Grout was pumped into holes at **Blue dots** and **orange dots** are holes filled by pumping grout into a different hole. **Red dots** show holes that need grout.

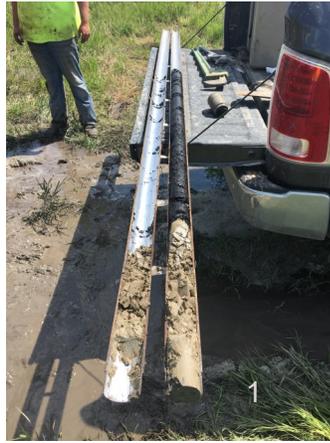
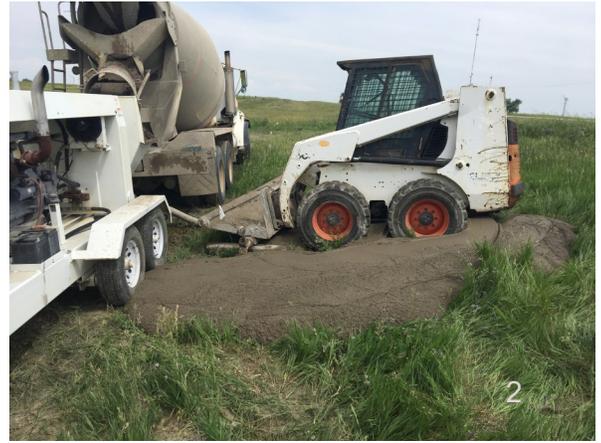
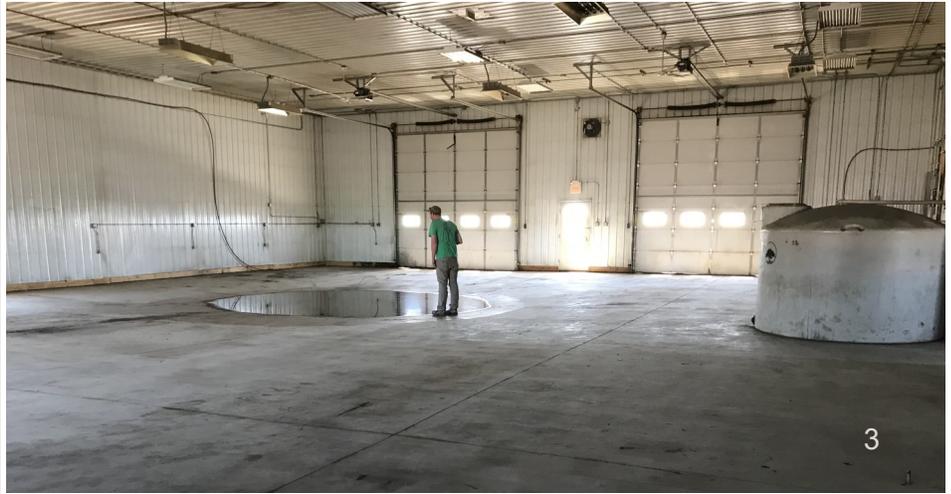
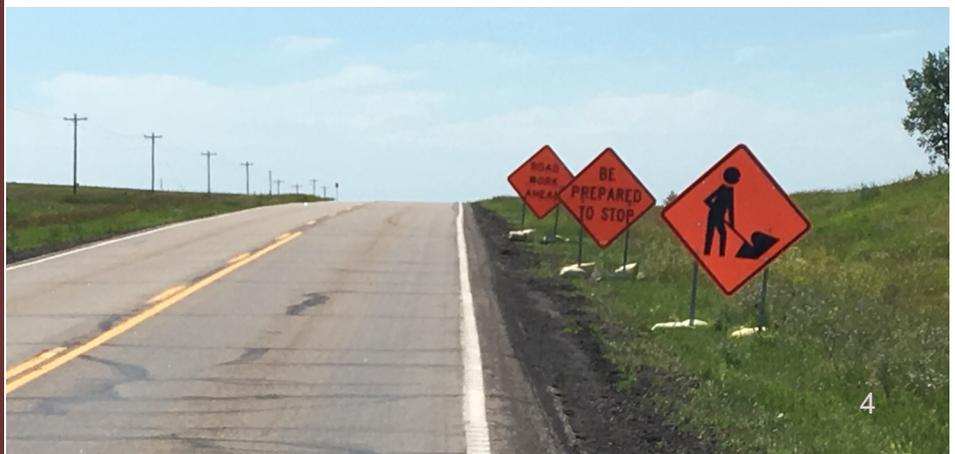
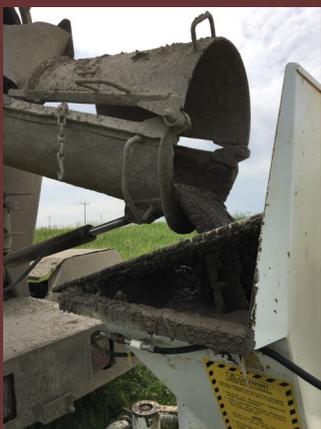
1. A core sample at Wilton. The black is coal. The grey is a grout-clay mix.
2. “Blow out” under the Bobcat. Since we pump grout with pressure, grout finds the path of least resistance. Even after the pump is shut off, grout will continue to flow out of the crack.
3. Inspector Chris Brown near the depression inside the shop at Williston.
4. Safety is always at the forefront of our reclamation projects.
5. & 6. A portable sonic drilling rig was used to drill inside the Williston shop.
7. The material tester set up on the apron on the north side of the shop building in Williston. Two cones mark the sinkhole under the apron as shown on page 12. A drilling rig is set up to the west of the shop.
8. We work until the job is done; sometimes in poor weather. The snow melted by the end of the day.

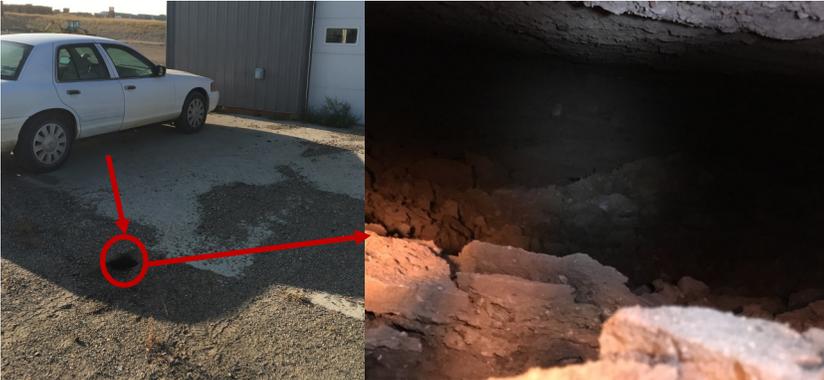
If you live or work near an abandoned underground coal mine, please use caution. The ground can give way without warning. In this photo, workers had been parking on the concrete when they noticed a small hole. Upon looking into the hole, they found a large opening. Over 15 cubic yards were pumped into the hole. Always be aware on an abandoned mine site. A similar event could happen to you.
