2020 PROJECT SUMMARIES

March 2021

2020 Projects

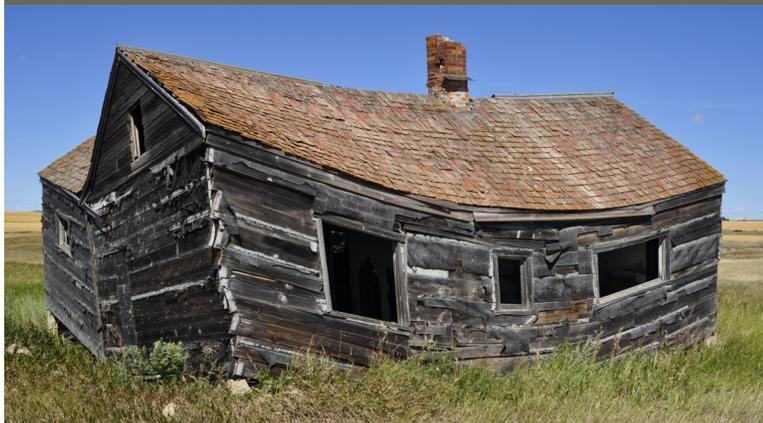
When mines were abandoned, the buildings were also abandoned. Although the foundation has failed, this building at the Albrecht Mine in Hettinger County has managed to hold together.

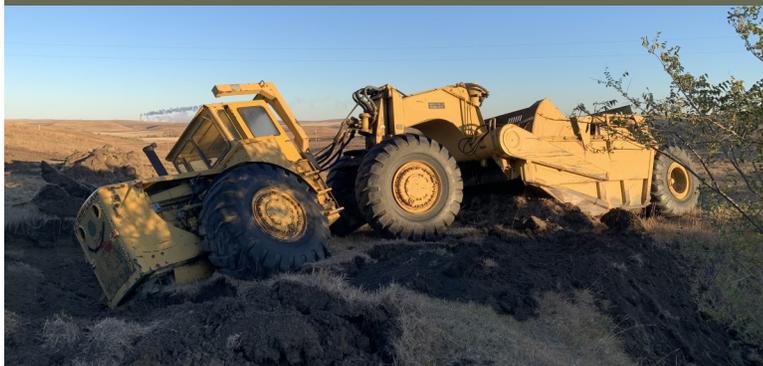
The edge of the sinkhole gave way causing the scraper to become stuck. It took an excavator and truck to tow the scraper out. Please use care when driving near sinkholes.

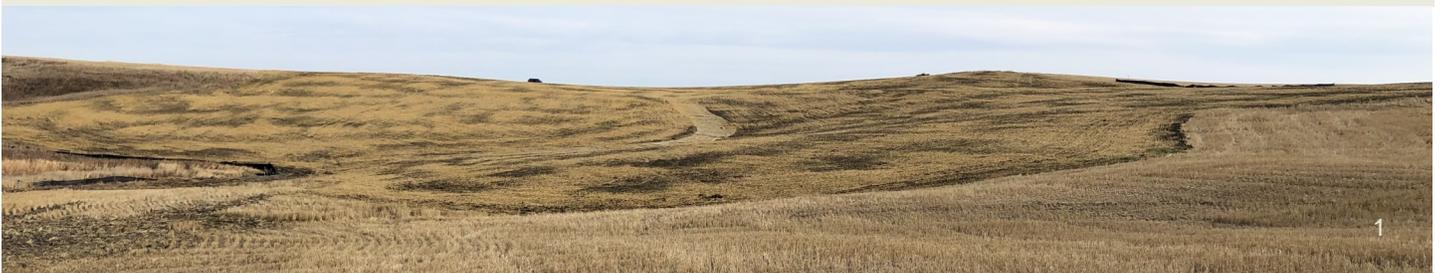
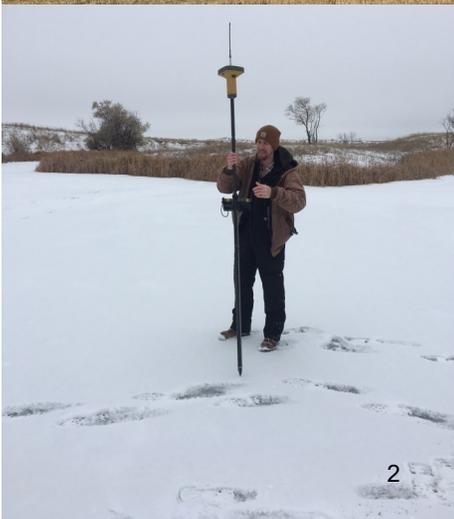
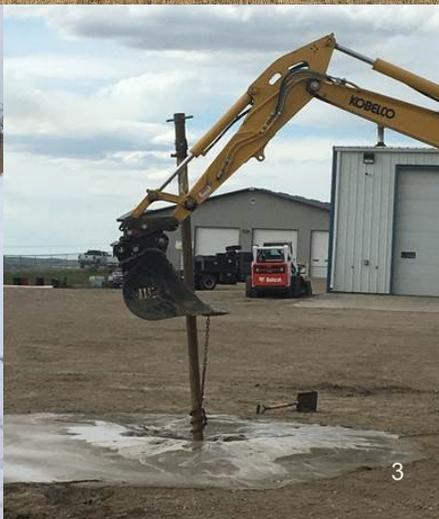
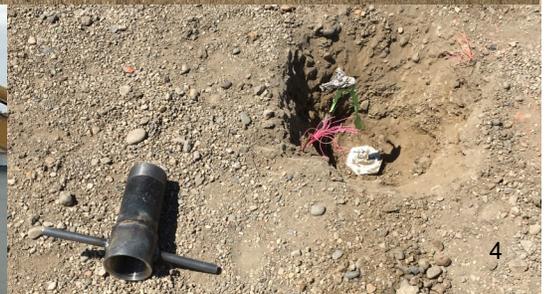
1: Weinandy Site with mulch & erosion blanket.
2: Shawn Nixon, PSC staff, surveys a frozen pit at Regent.
3: Contractor pulling a casing of a grout-filled hole.
Photo 4: A countersunk cased hole with a header pipe.

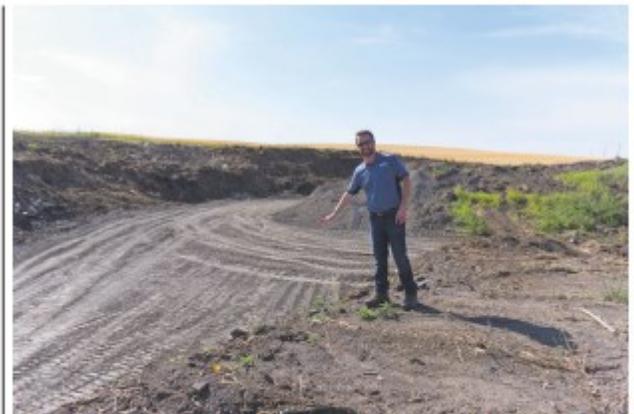
Jonathan Emmer, environmental engineer with the Abandoned Mine Lands Division, demonstrates how deep the pile of trash was at the Buresh coal mine site before his team began its work. Kayla Henson / The Dickinson Press

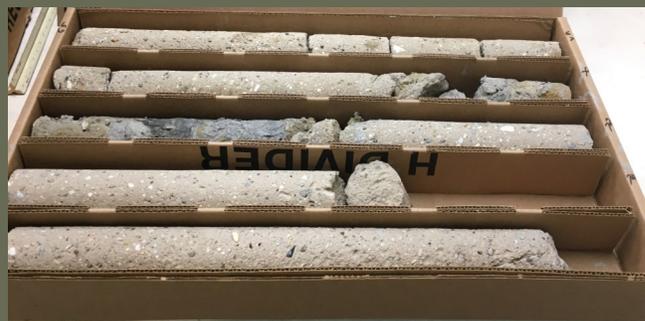
This core was a really good indicator that the void was filled in this area. The grout looks solid and strong.

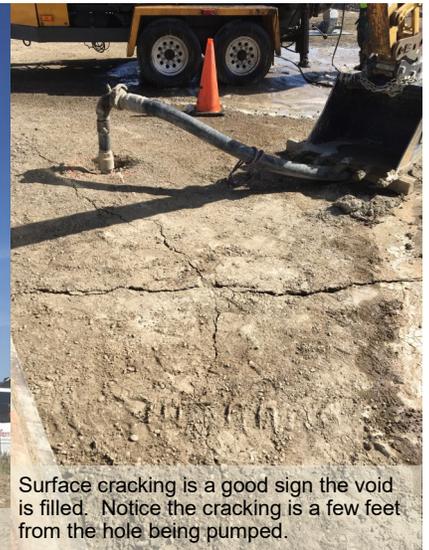
Surface cracking is a good sign the void is filled. Notice the cracking is a few feet from the hole being pumped.

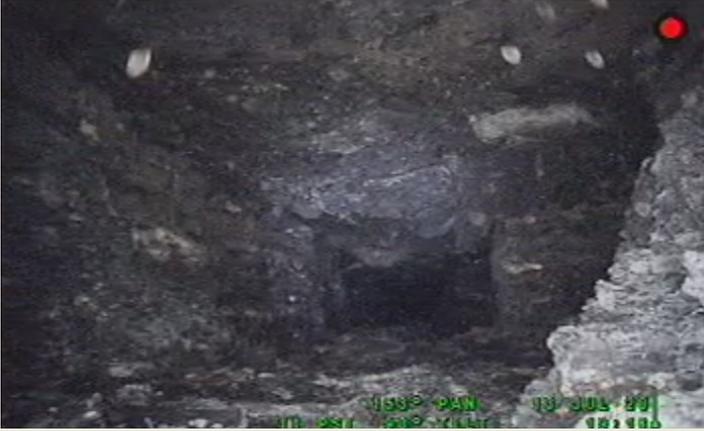
This void hole was on the access road between Drivelines Direct and Pallet Green in Williston. After seeing the large open tunnel, we knew a large amount of grout would be needed. This hole took 1,595 cubic yards.

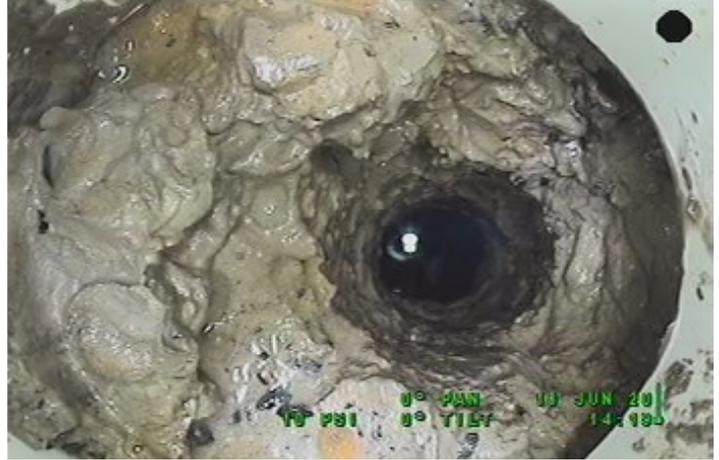
By looking at the muck at the bottom of the casing it seems this hole would not take much grout. However, this hole took 43 cubic yards of grout. You can never be sure until it is pumped!

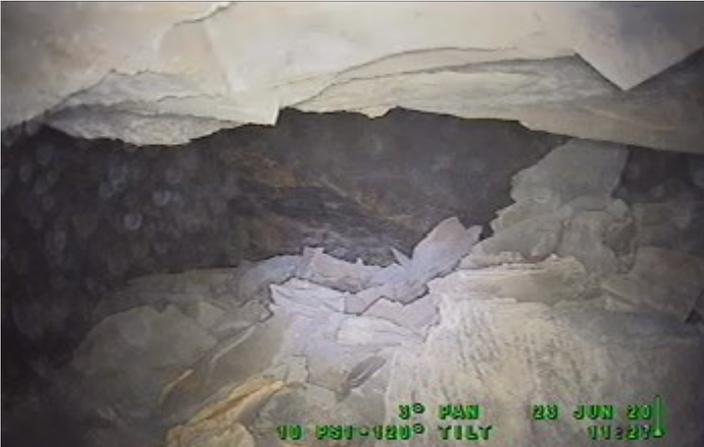
A large void with collapsed rocks and rubble shows another hole that could potentially take a large amount of grout to fill.

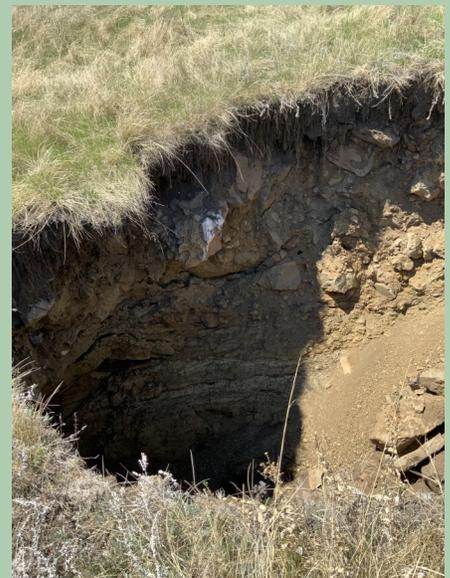
The Haynes sites are approximately 9 miles east of Hettinger. The property owners here included 2 private landowners as well as State Trust Land. The most dangerous sinkholes were found on the State Trust Land where sinkholes are can be deep with steep sides. This is particularly dangerous for livestock. A calf died after falling into a sinkhole at this location in 2020. On the right is an example of a very dangerous sinkhole at the Haynes site.

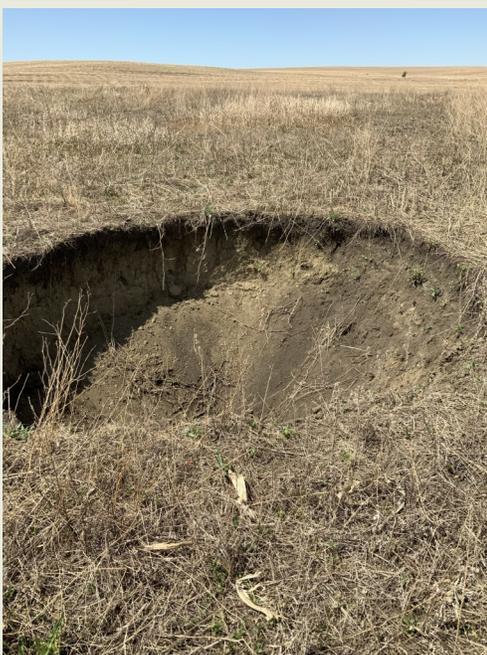
A sinkhole does not need to be large to cause damage to farm equipment or cause an injury. The New Salem sinkhole pictured on the right is in a farmer's field and presents a hazard to farmer and his equipment. Farmers will farm around sinkholes, but they have also been known to accidentally drive equipment into hard to see sinkholes.

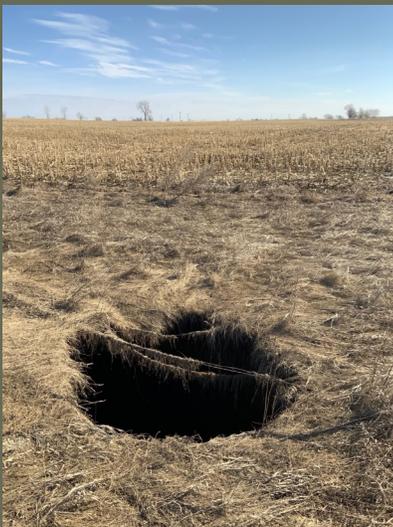
The sinkhole shown on the left was reported by the landowner in March of 2020. This sinkhole was about 20 feet from 26th Street NE. The sinkhole was about 7 feet in diameter at the surface and 13 feet deep. This sinkhole could cause significant damage to vehicles going into the ditch as well as ATVs, and mowers. Additional sinkholes were filled in nearby pastures.

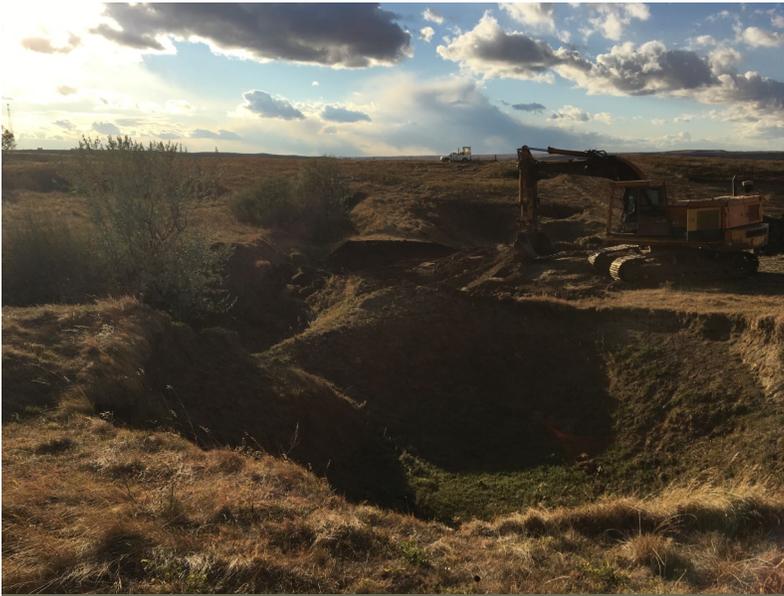
We fill sinkholes based on their perceived hazards. The Beulah area has many large non-hazardous sinkholes like those above. Between these non-hazardous holes was one very dangerous sinkhole.

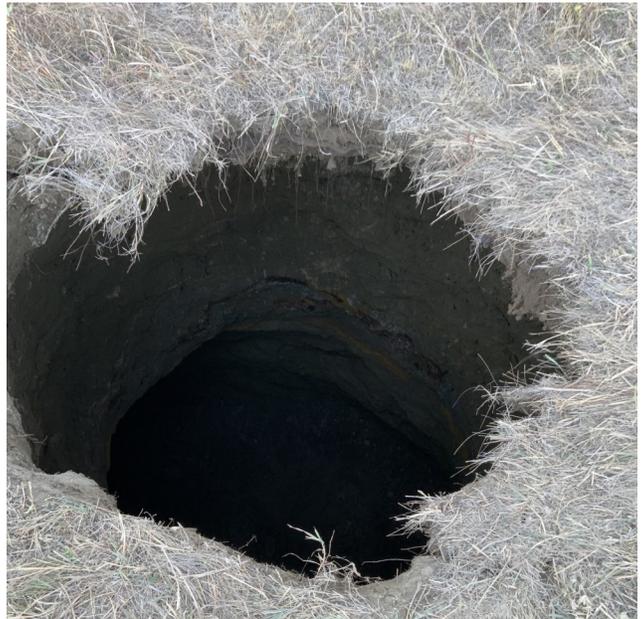
Beulah: This sinkhole opened up after being driven over by heavy equipment. Vibrations along with the high weight of equipment often result in additional sinkholes forming. This hole was then filled along with the other sinkholes.

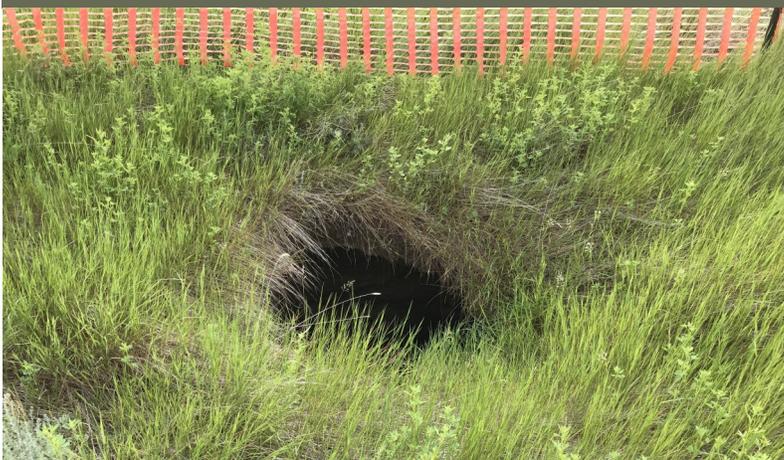
Bowman: When the sinkhole above was reported to the AML Division, it was less than 6 feet in diameter, but over 30 feet deep. Below is the same hole. The contractor is stripping the topsoil around the hole to save for spreading on the top of the filled hole. The hole was enlarged to create a ramp into the hole to allow equipment to compact fill in the bottom of the hole.

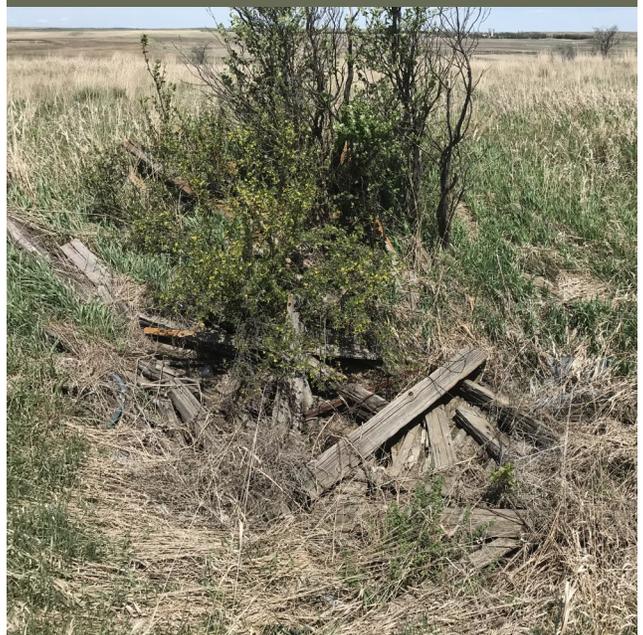
Havelock: Below the bushes and lumber was a very dangerous open shaft that we filled. The sinkhole filling project can address more than just hazardous sinkholes associated with abandoned underground mines.
