## 2025 Buechler Velva Phase 3 AML Project

**Contractor:** Young Gun Construction, LLC.

**Contract Number:** AM-908-25

**Location:** Nine miles southwest of Velva ND, including portions of Section 1, T151N, R81W, and Section 30, T152N, R81W, Ward County

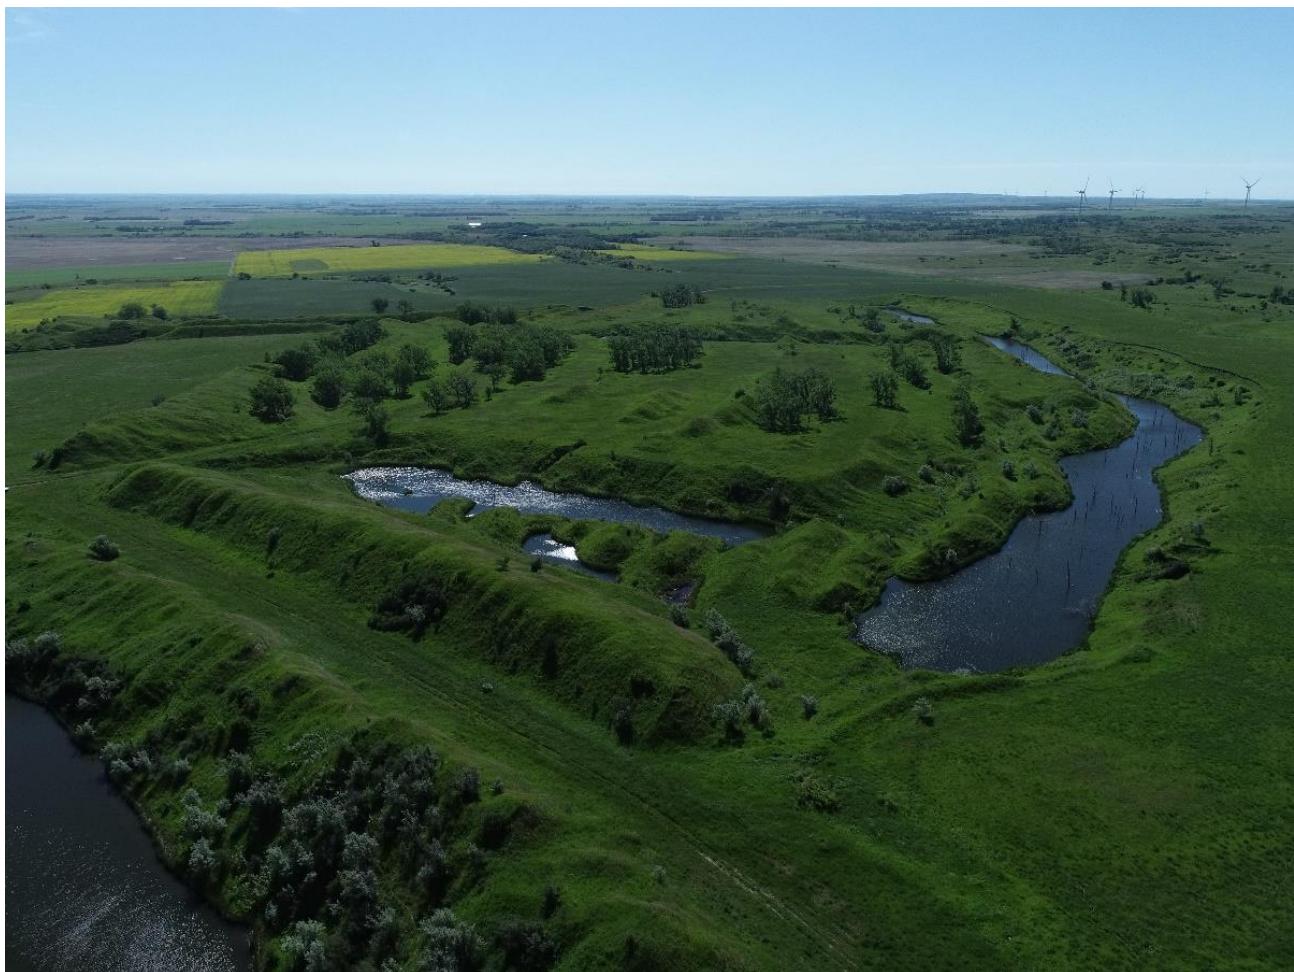
The abandoned surface coal mine (main site) was characterized by a steeply eroding highwall, 40 feet high and 2,900 feet long (**Figures 1 and 2**). Approximately 3,847 feet of silt fence were installed to control erosion and prevent sedimentation downstream (**Figure 3**). The contractor then began segregating topsoil and subsoil into piles. Next, the highwall was backsloped and backfilled with earthen material from adjacent spoil piles. Over 17 inches of rain fell during the construction of the project, creating extremely muddy conditions (**Figures 4 and 5**). A measured 912,022 cubic yards of spoil material were moved to reclaim the surface mine on the main site. Once backfilling and backsloping operations were complete, subsoil was respread. The trees felled in January were shredded, and the wood chips were incorporated and respread between the subsoil and topsoil layers to enhance vegetation (**Figure 6**). Surveys showed 68,386 cubic yards of topsoil and 116,617 cubic yards of subsoil were salvaged and respread (**Figure 7**). Manure was loaded and hauled from the landowners' nearby feedlot and respread over the steepest slopes in the reclaimed areas to help establish vegetation (**Figure 8**). Engineered drainage channels lined with erosion control blankets were installed to direct surface water runoff on the reclaimed area. A rock channel was installed on a steep area to control erosion and act as a drainage channel. A farm trail was re-established, graveled, and a flexible concrete mat was installed as a low-water drainage crossing. The remaining disturbed areas were seeded with locally adapted grass species and mulched. Approximately 1,807 feet of wattles were installed to prevent erosion in the newly disturbed areas (**Figure 9**). Reclamation at the main site was completed on October 22, 2025.

**Figure 2:** The surface mine in Section 1 before reclamation.

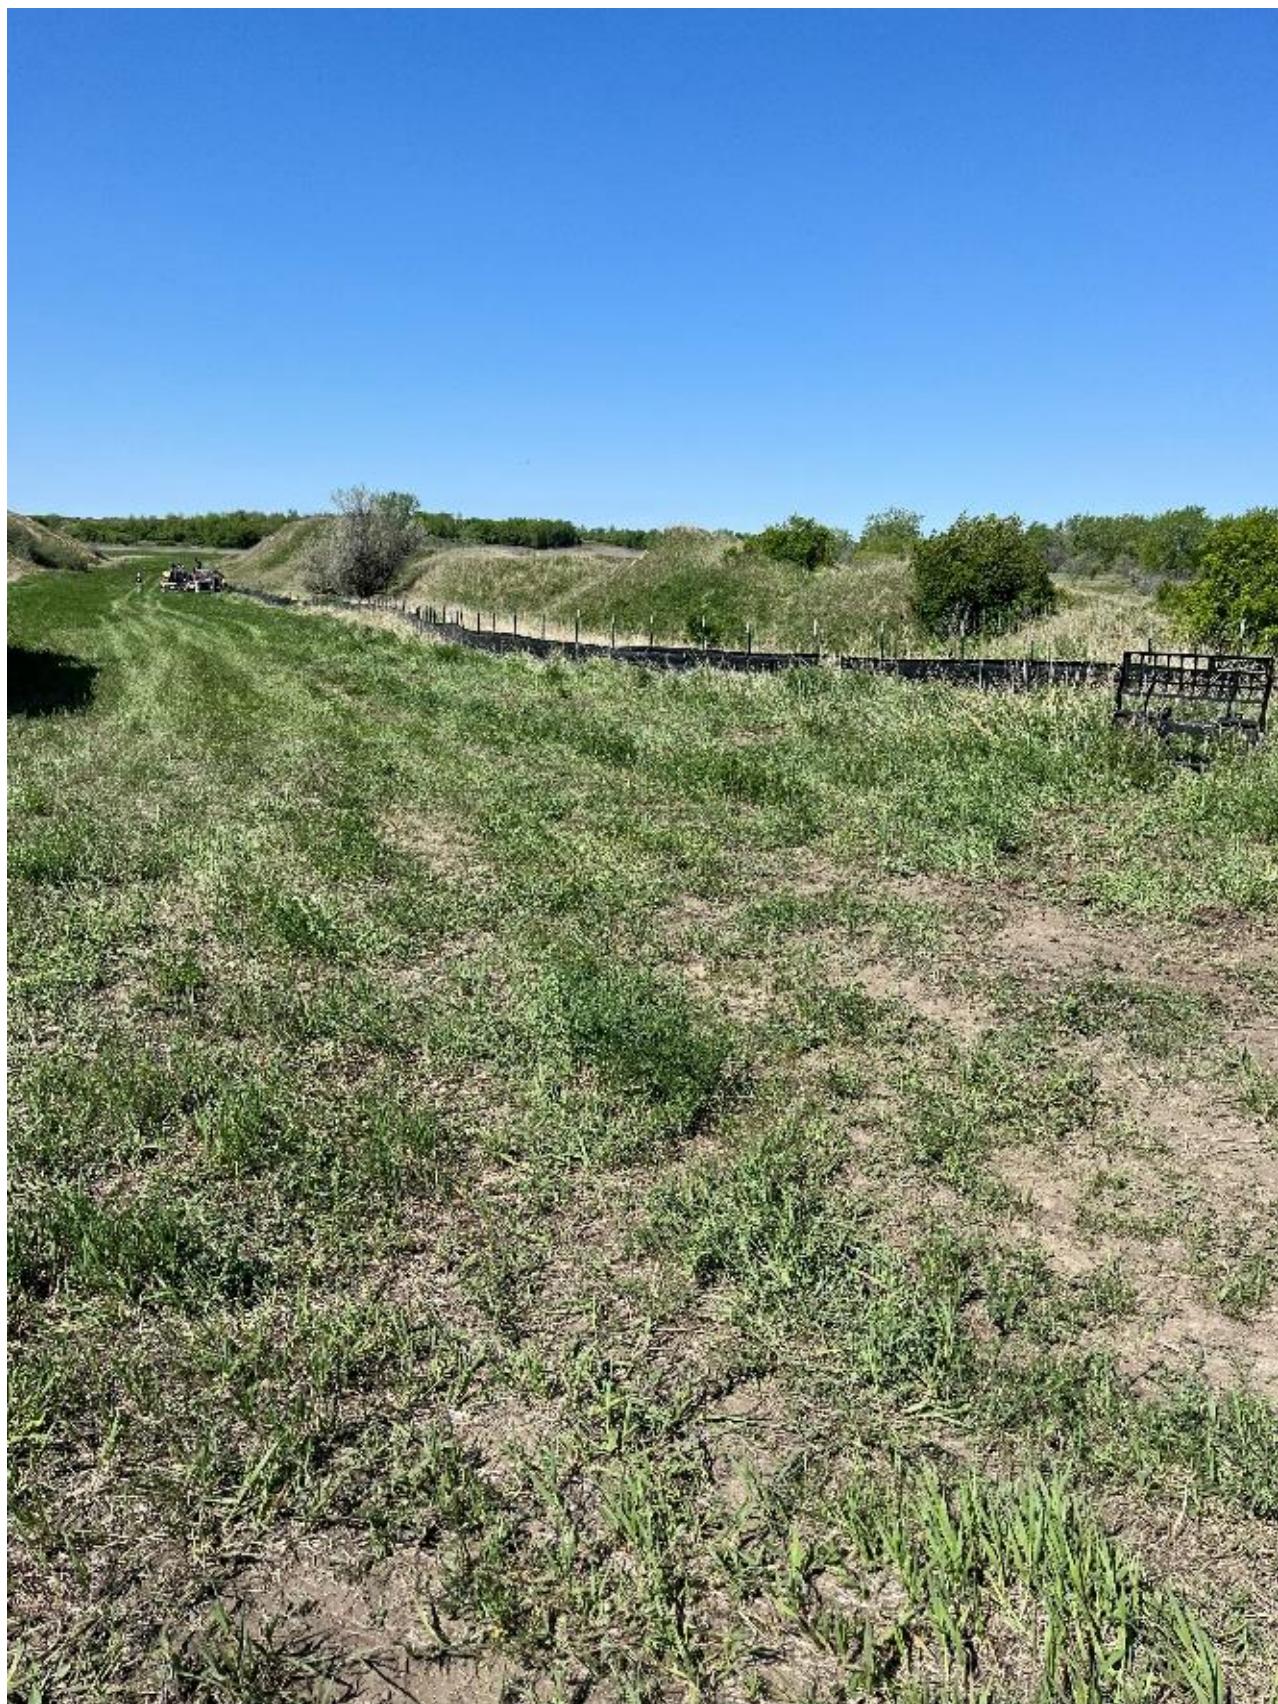
**Figure 3:** Over 3,800 feet of silt fence was installed to control sediment.

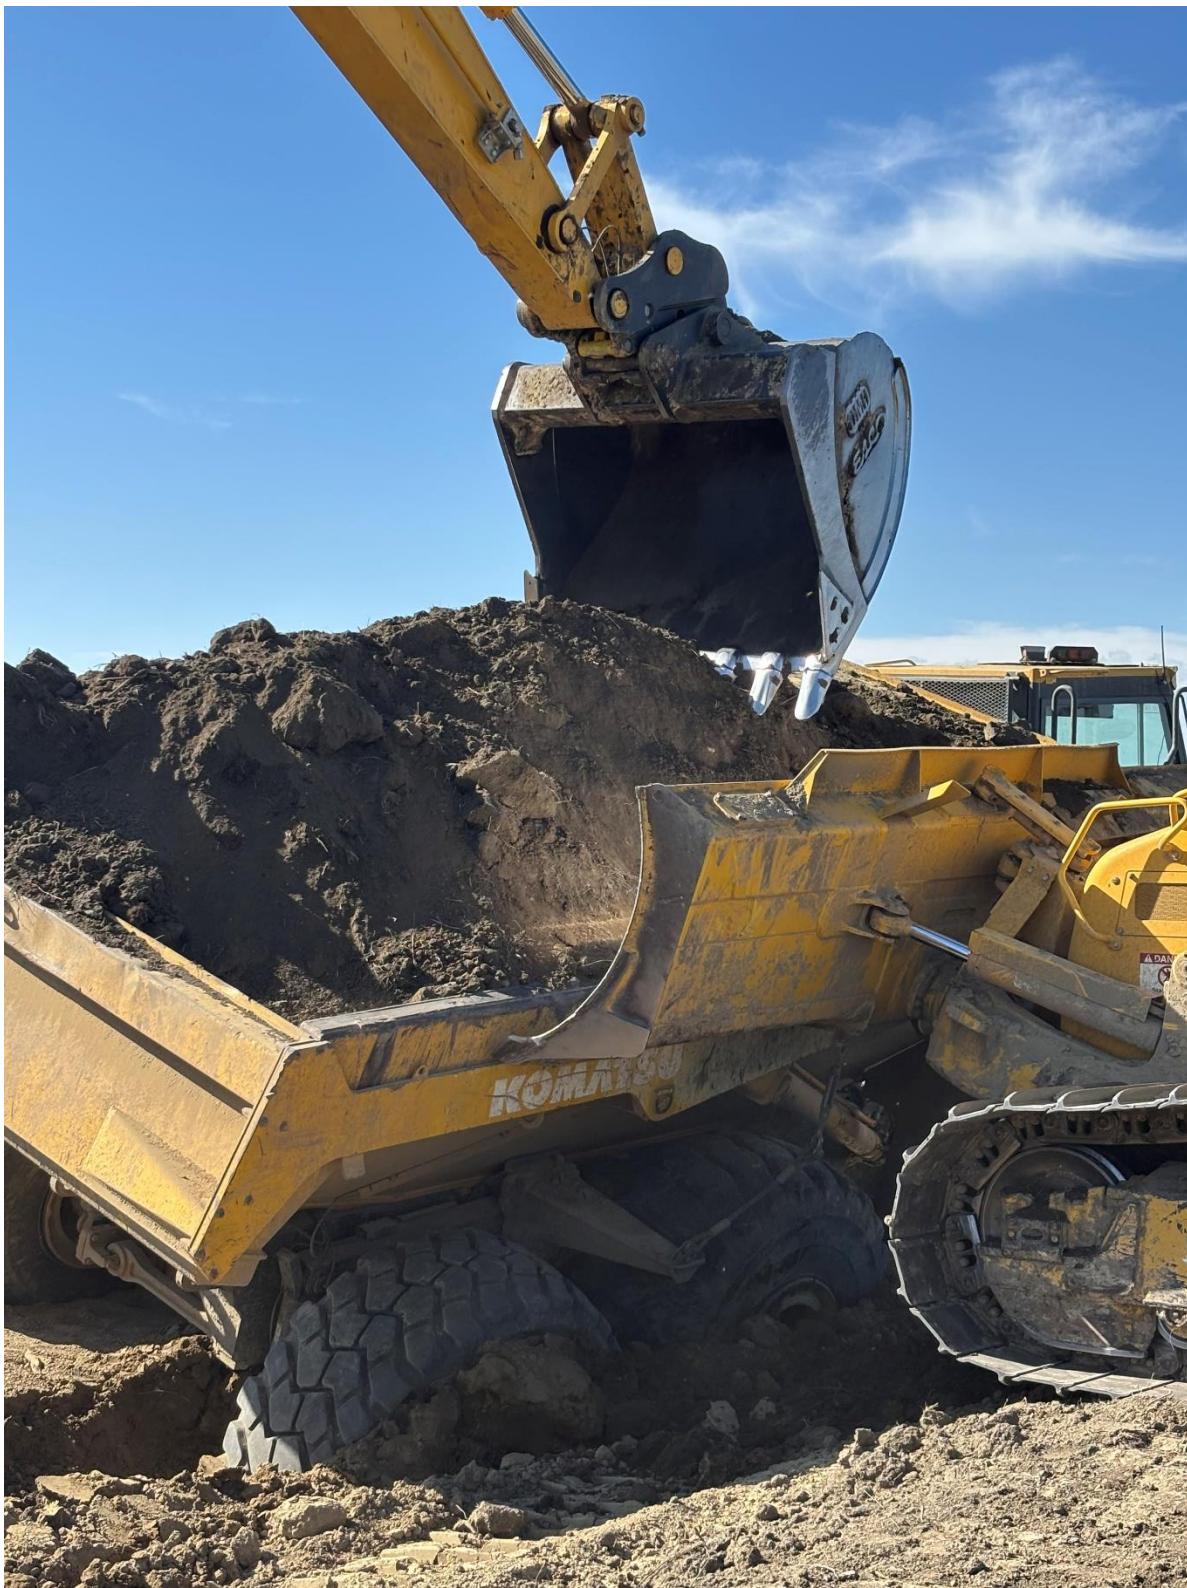
**Figure 4:** Over 17 inches of rain fell during the construction of the project, creating extremely muddy conditions.

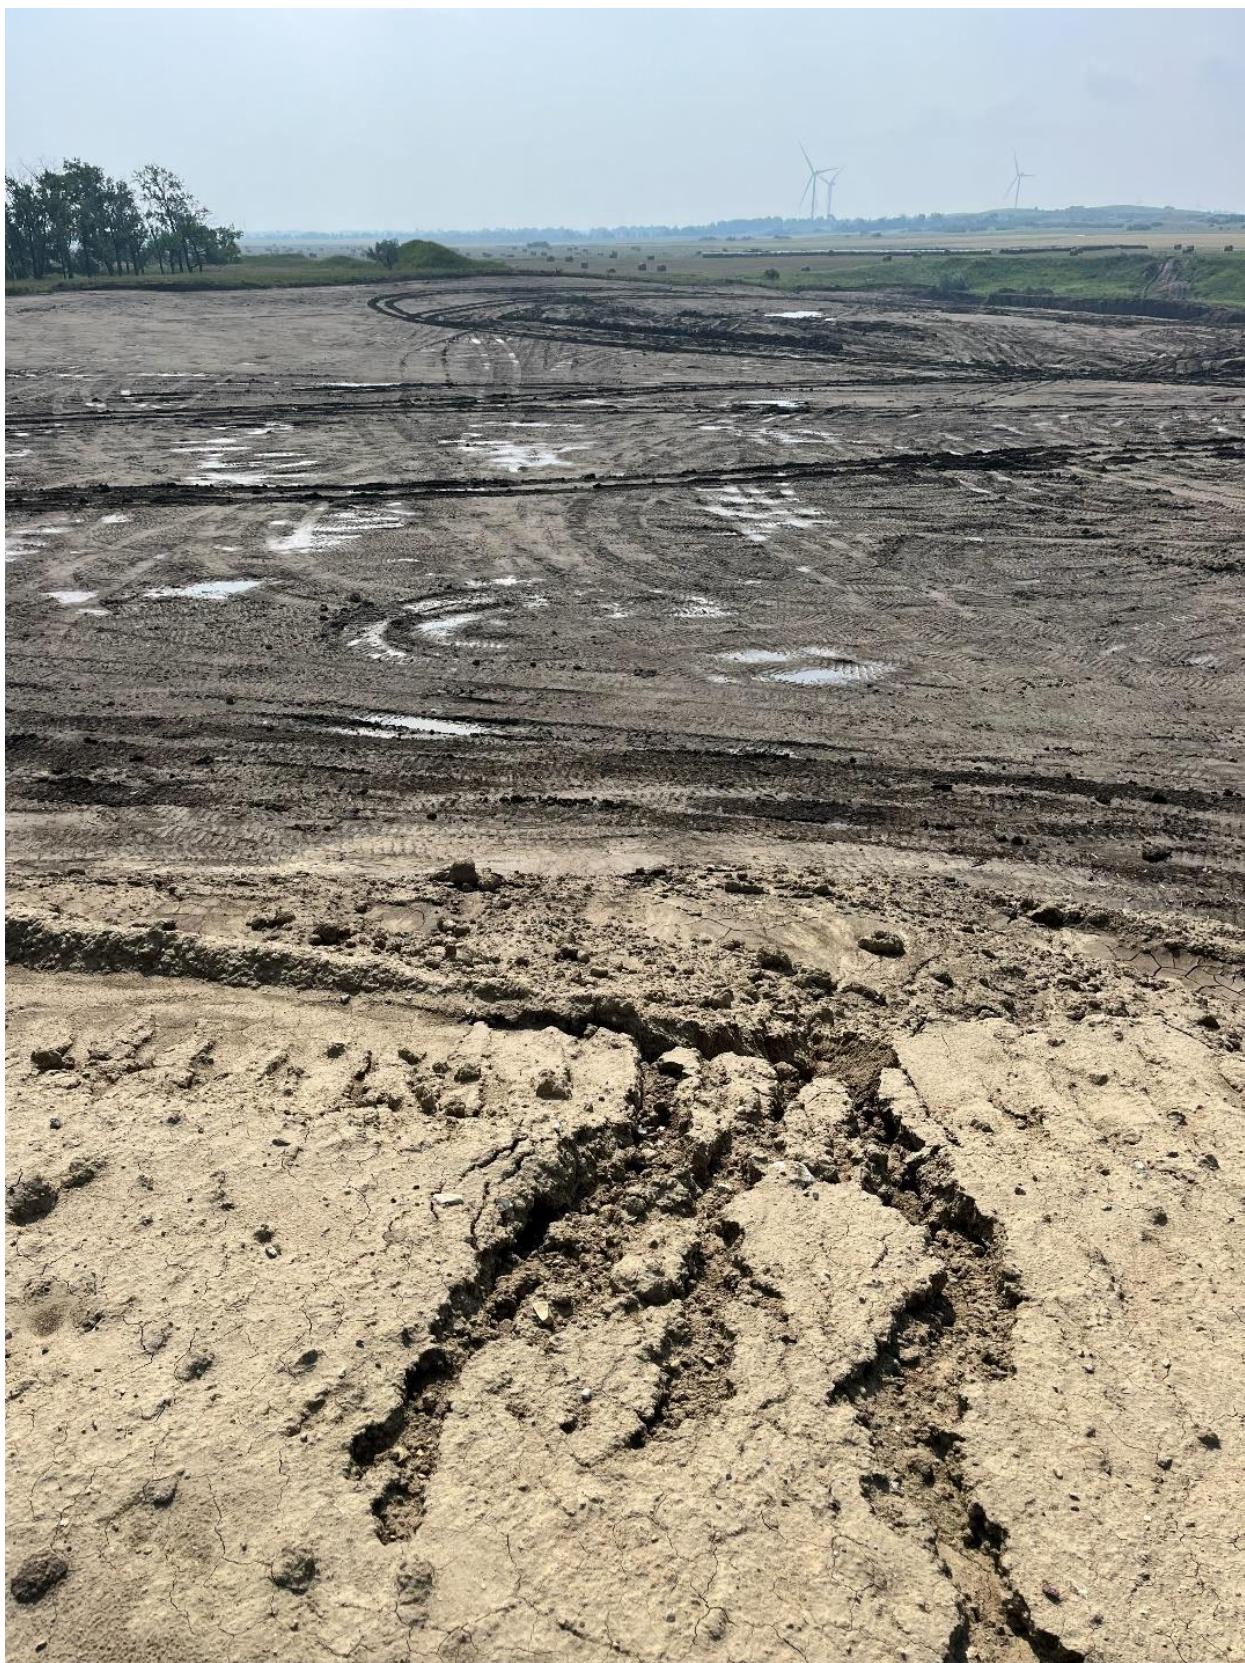
**Figure 5:** Dealing with muddy conditions was a continuous problem during active construction.

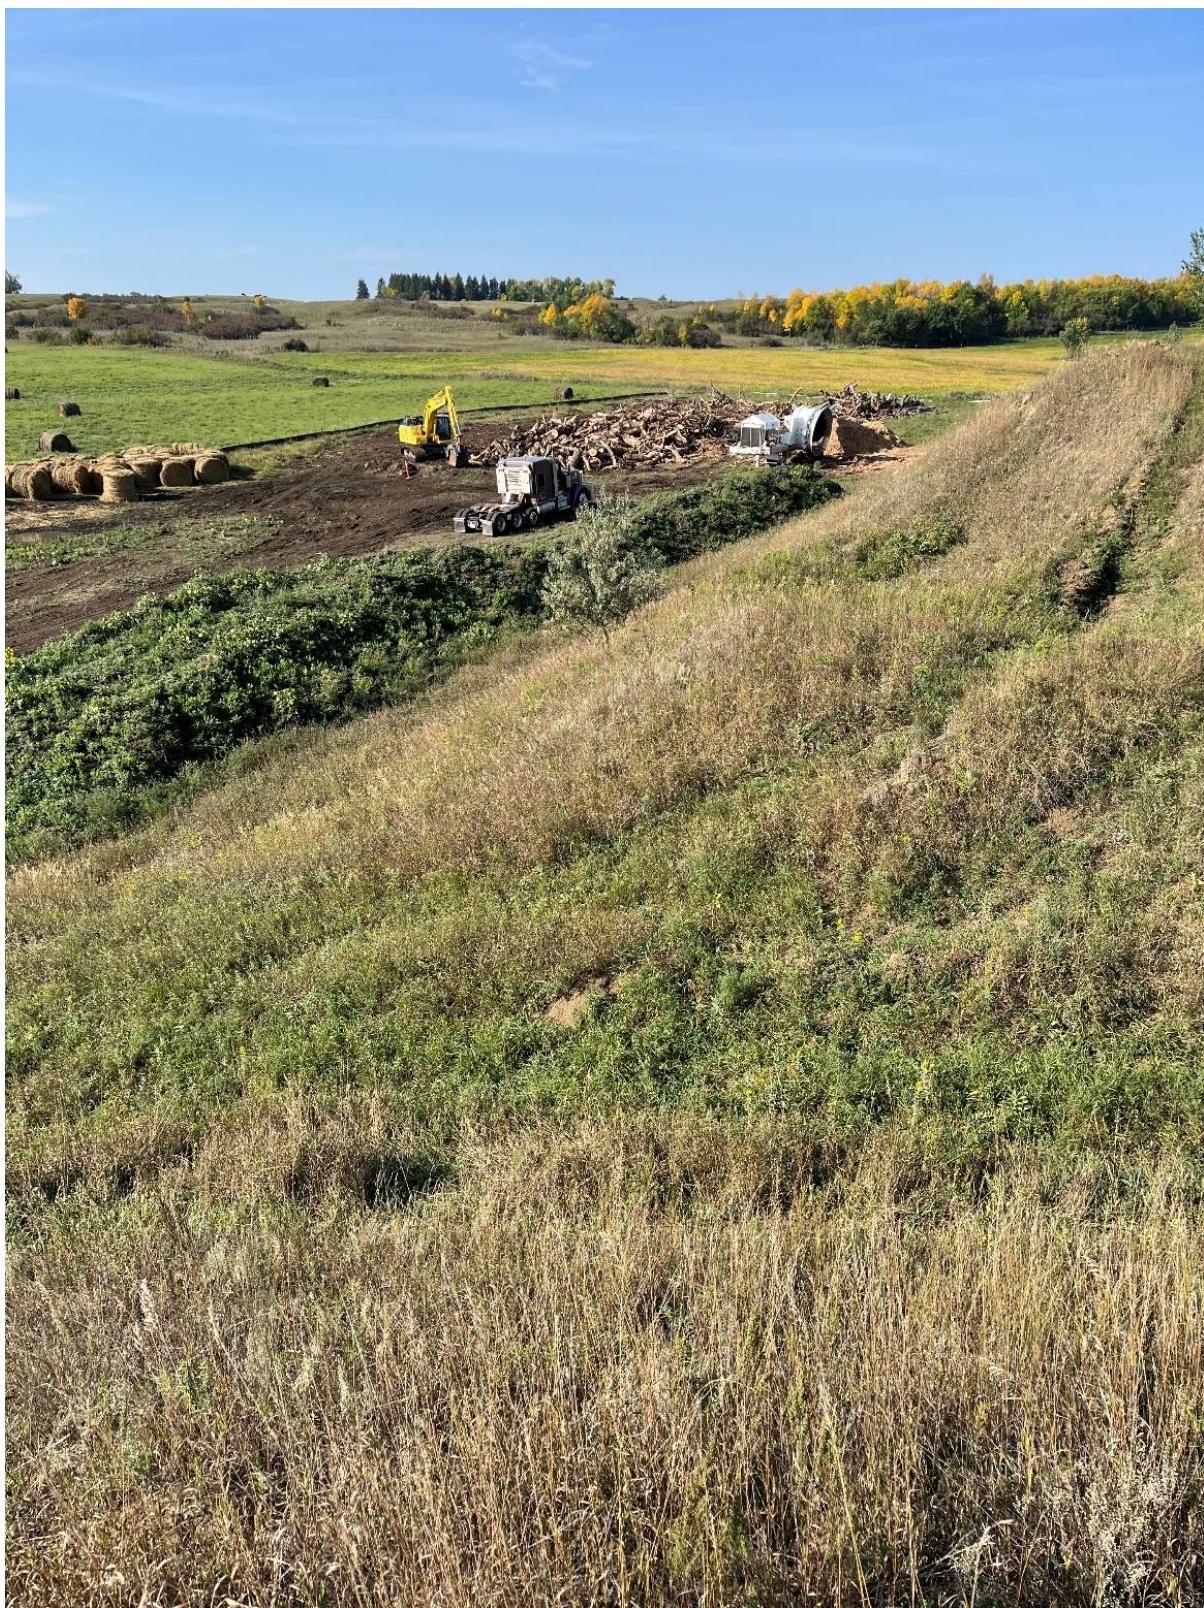
**Figure 6:** Over 600 trees were felled, shredded, and incorporated into the respread soil.

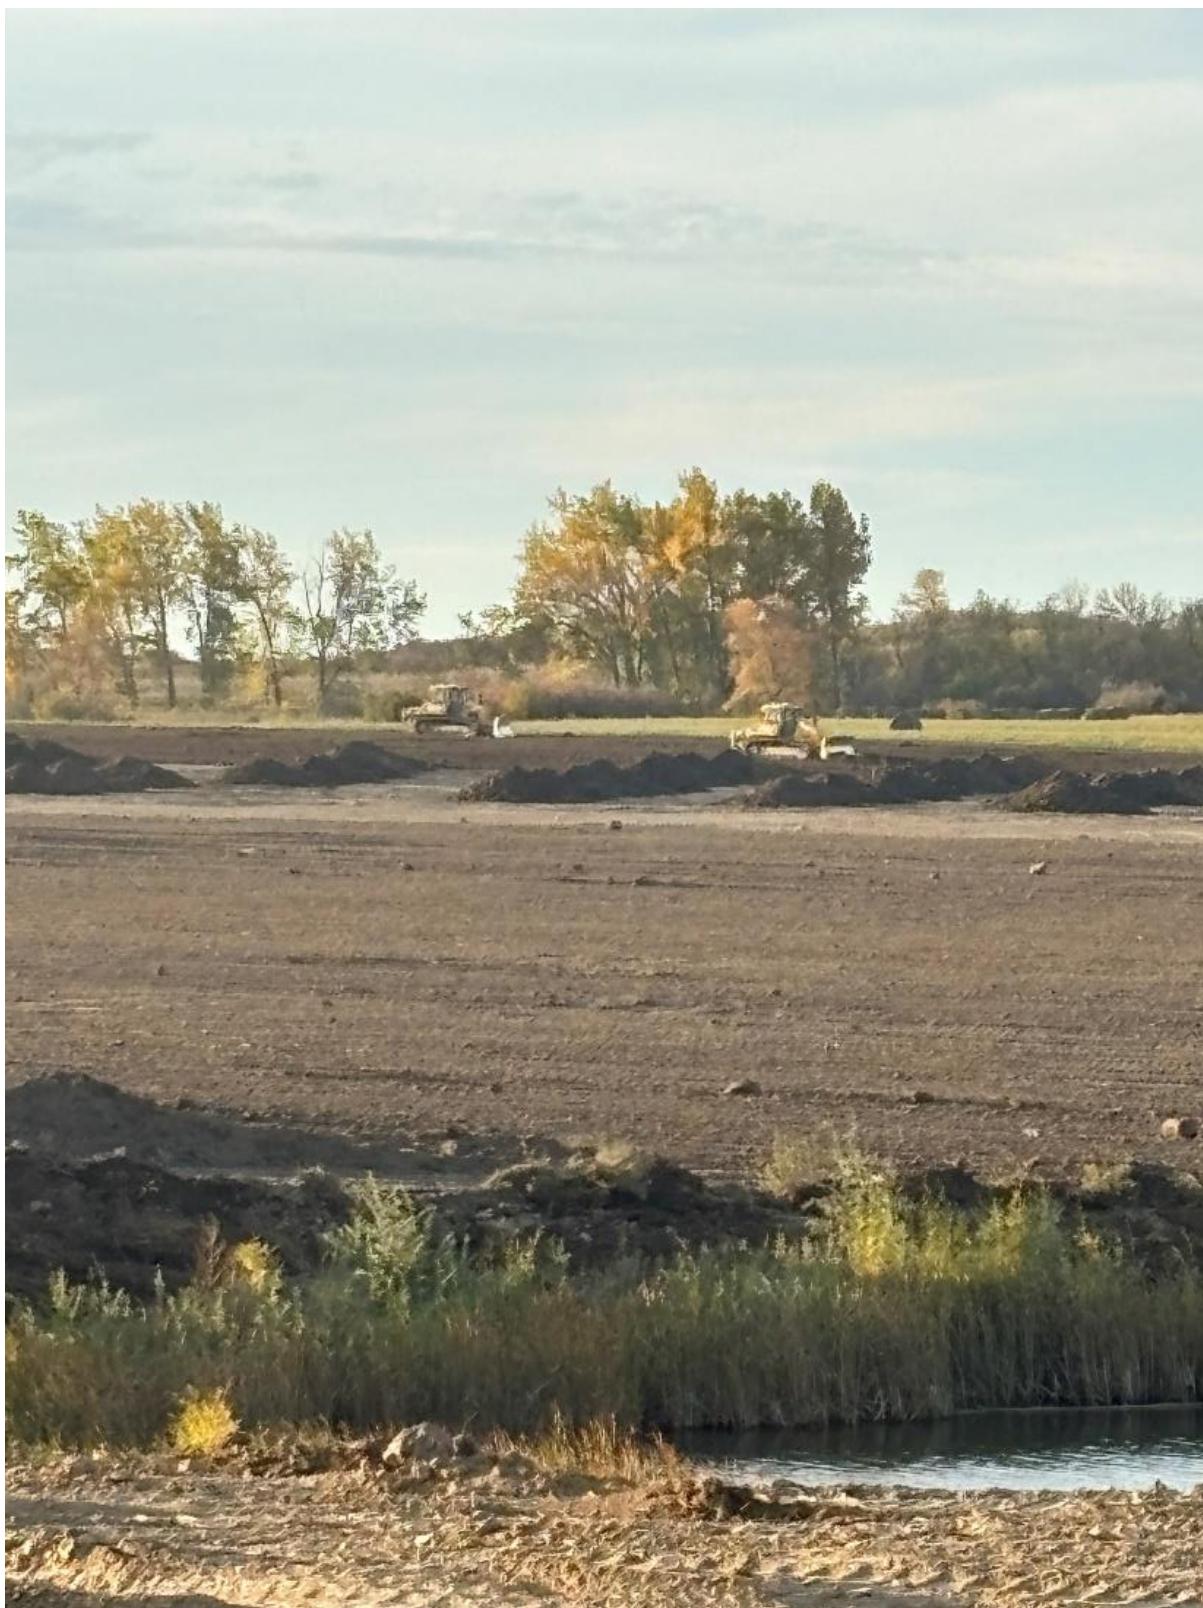
**Figure 7:** Dozers are respreading topsoil.

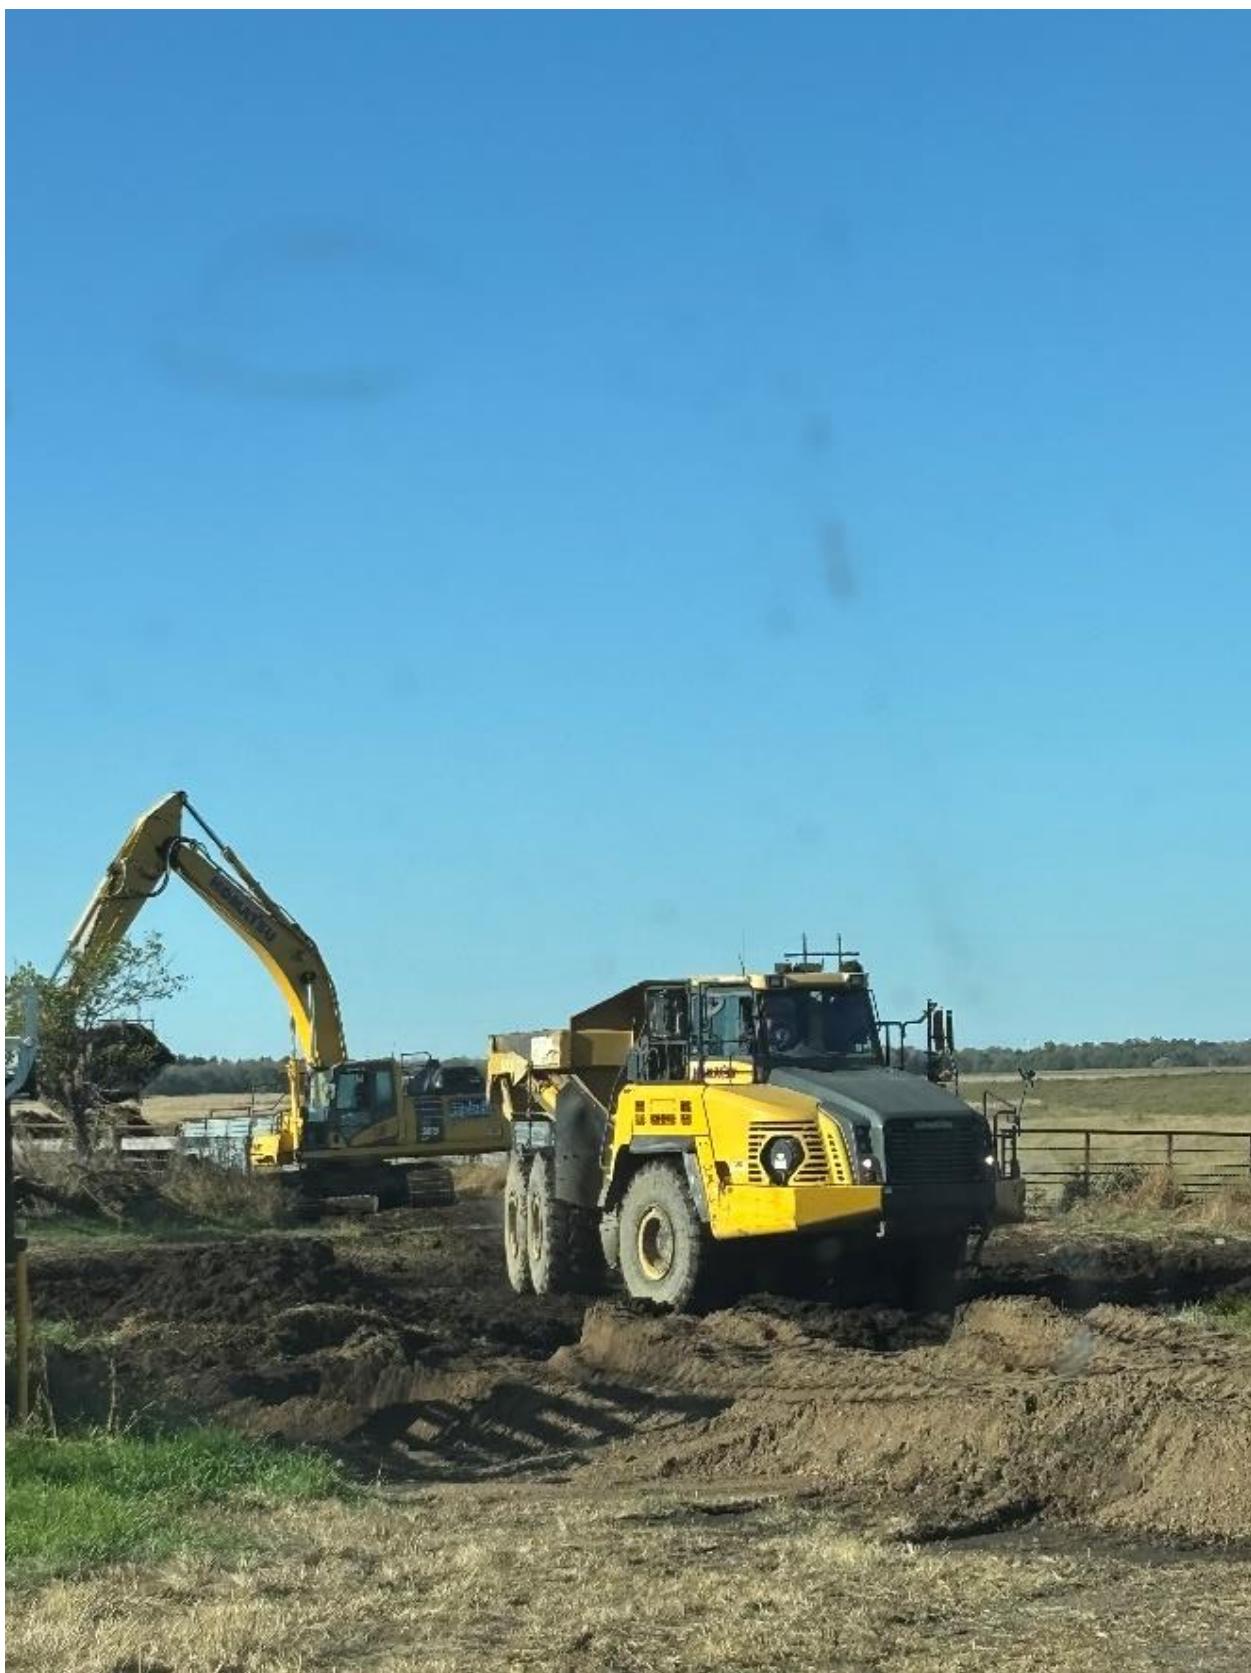
**Figure 8:** Manure is being loaded from the landowner's feedlot.

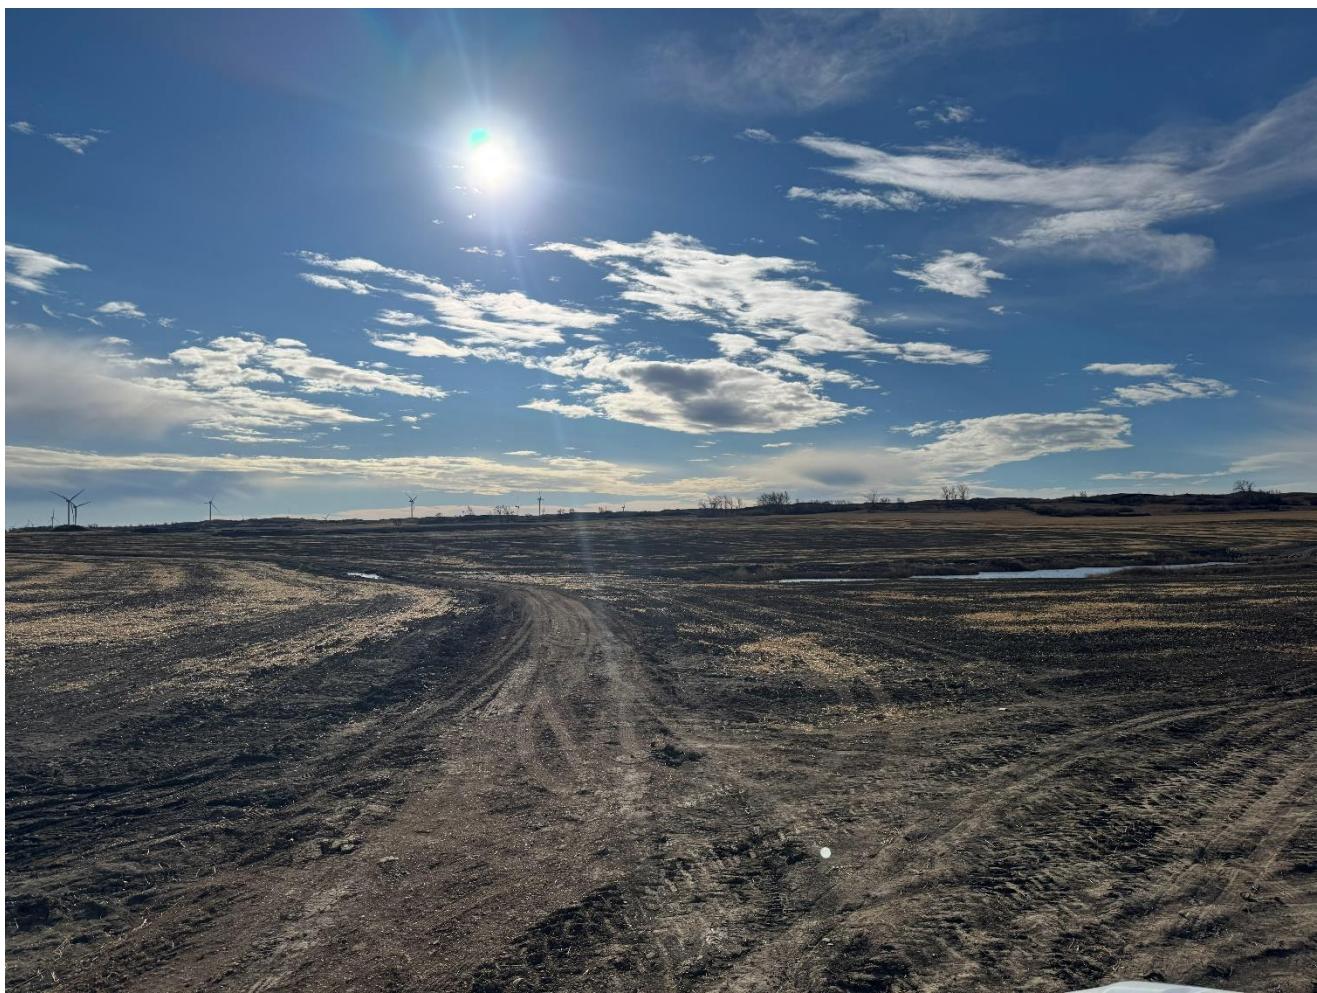
**Figure 9:** The main site in Section 1 after reclamation.

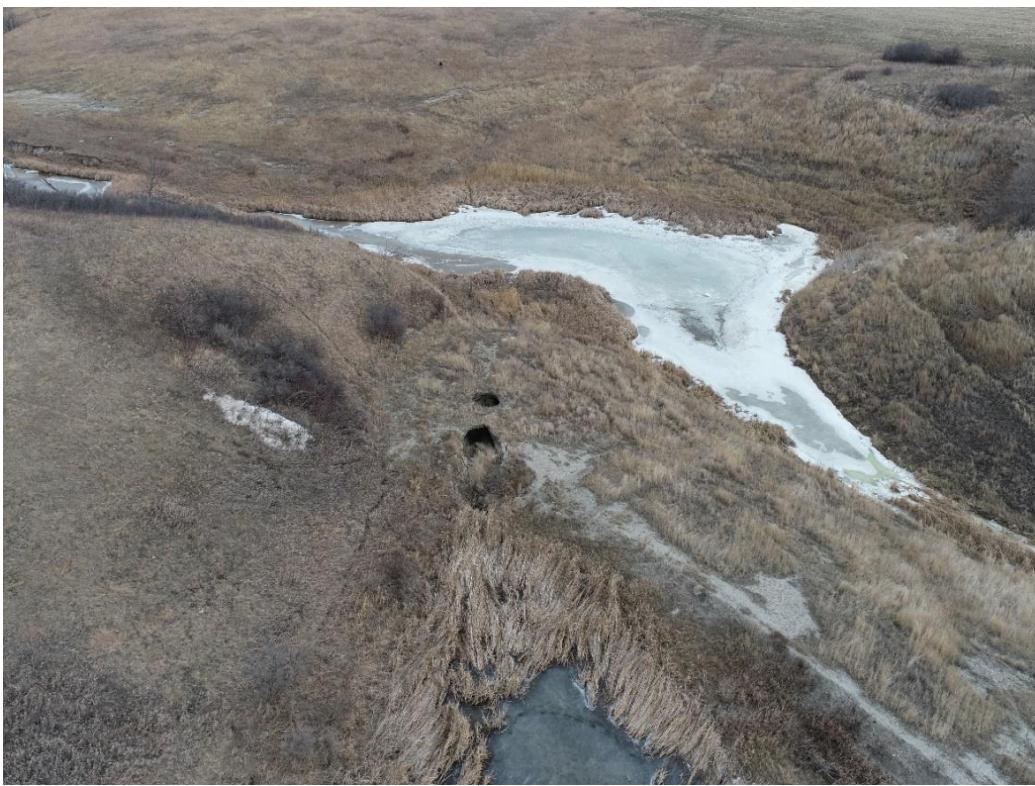
**Figure 11:** Erosional features on the reclaimed surface mine before construction.

This project also included repairing two erosional areas in the 2021 Buechler Velva Phase 2 Project site (**Figure 10**). Repair work consisted of the excavation and disposal of an existing corrugated metal pipe, regrading, and the installation of a rip rap rock channel (**Figures 11 and 12**). The second area repaired was a 150-foot slope failure on a steeply sloped area near the former highwall. Topsoil was incorporated, and the area was regraded. The disturbed area was seeded and mulched (**Figure 13**). Straw wattles were installed to prevent erosion. The project was completed on November 14, 2025.

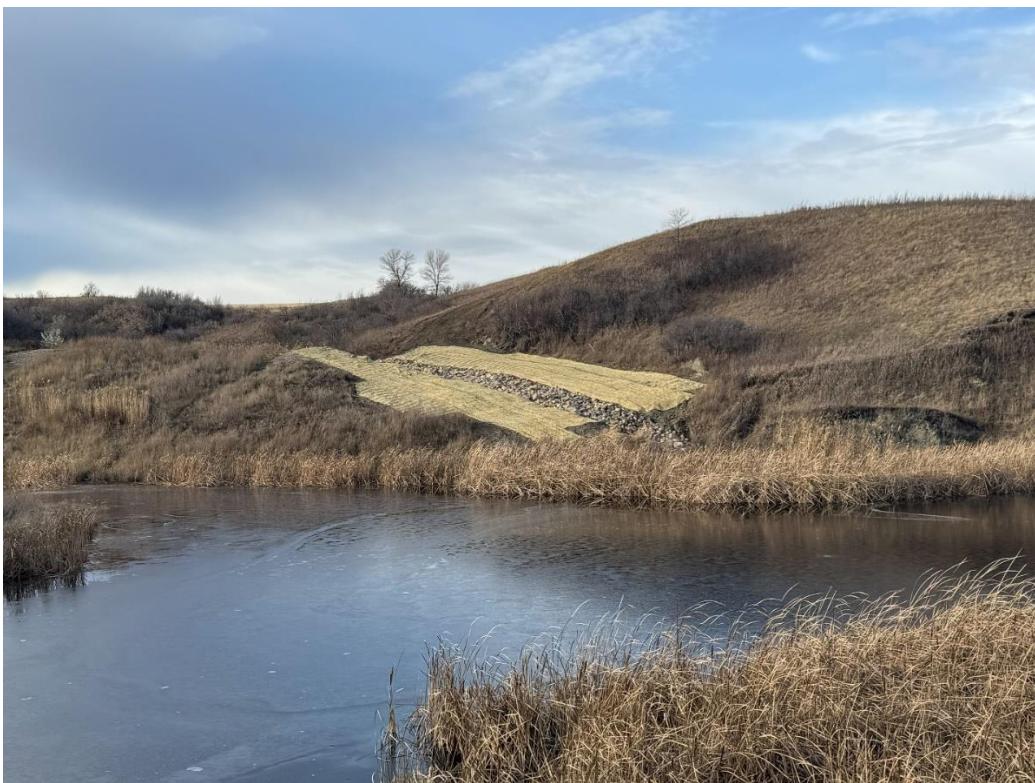
**Figure 12:** A rock channel was installed to replace a culvert with unstable, eroding soil.

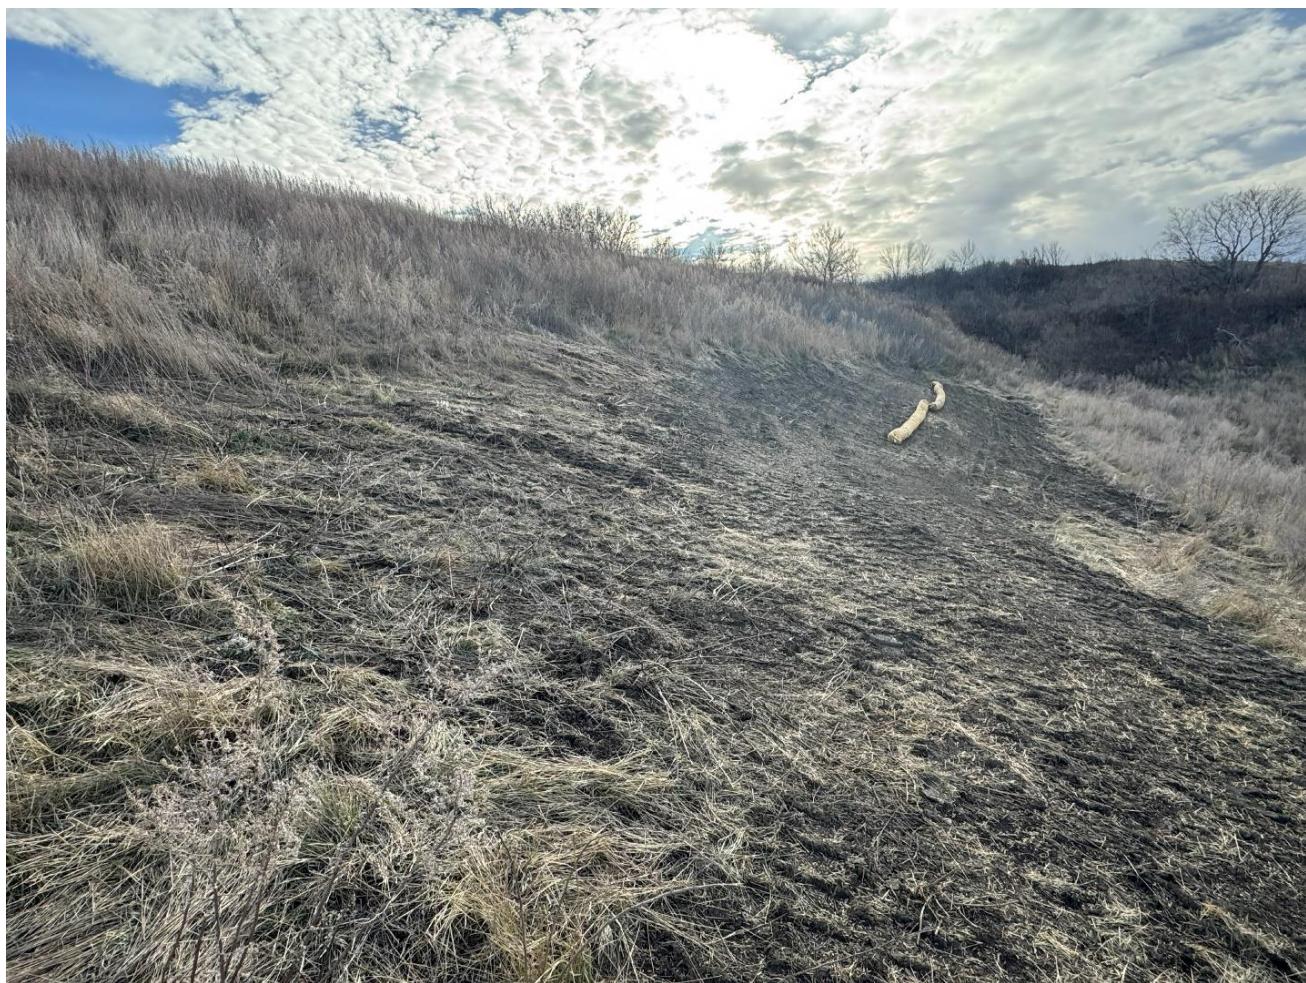
**Figure 13:** Repaired slope stability area after completion.
