PLAINS
PIPELINE, L.P.

Enclosed is a response to the October 29, 2007 post construction inspection of the Plains Pipeline Expansion (Case No. PU-05-184) and Buford Expansion (Case No. PU-05-185).

79 **PU-05-185** Filed: 10/2/2008 Pages: 3
Response to 10-29-07 Post-Construction Inspection

Response to locations that require further monitoring.

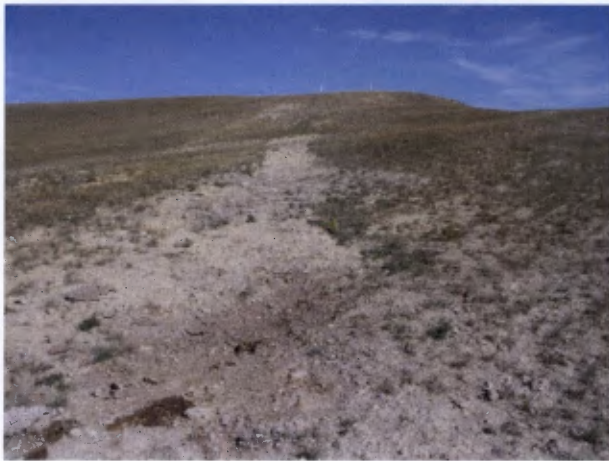
Section 30, T152N R104W, an area of localized scouring and a teardrop settling area were noted as well as thin grass growth.

Looking north from the base of the scoured hill

The scouring was repaired around May, 2008. The teardrop settling area has not been filled to date. The access road to the pasture is through an easement of a third party property owner. The road easement owner will not allow plains pipeline to cross his property to make repairs. The landowner of the affected area has personally made repairs to the scouring with Plains Pipeline paying him for his time, however, Plains Pipeline has not been granted access to repair the settling noted in the report nor plant additional grass seed. The landowner, Mr. Eldridge, is not concerned with the settling that has occurred. The grass has thickened on the right-of-way with the exception of the scour repair area.

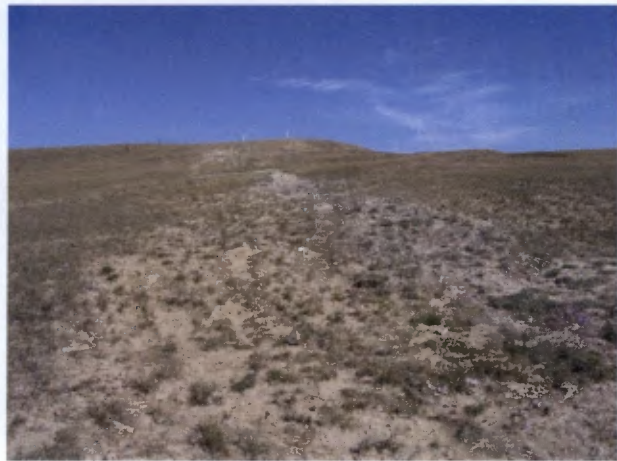
Looking north at the scoured hill from a distance

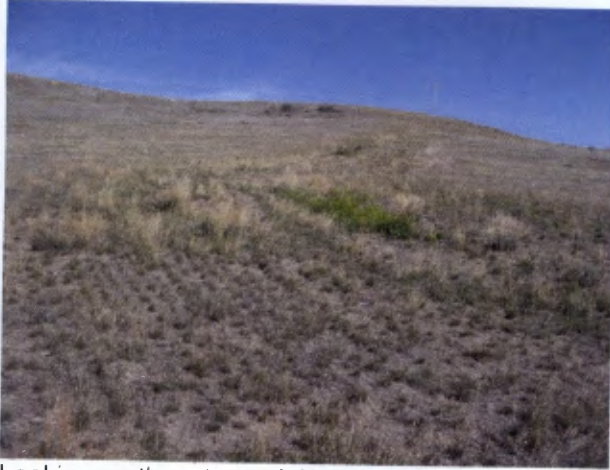
Section 3, T153N R102W, worn water bar and thin grass growth on right-of-way.

Looking north up toward the top of the big hill

The right-of-way was reseeded around June and the worn water bar was built up.

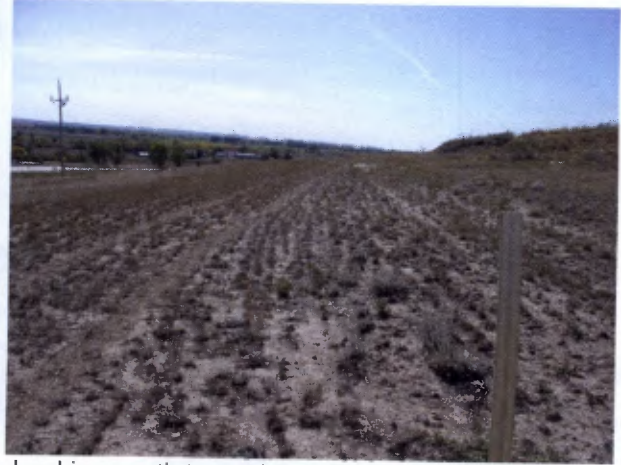
Looking south toward the electrical sub station
