PLAINS
PIPELINE, L.P.

Report of Landowner Complaint Investigation
Regarding
PSC Order No. PU-05-185.

Pictures of Topsoil Segregation

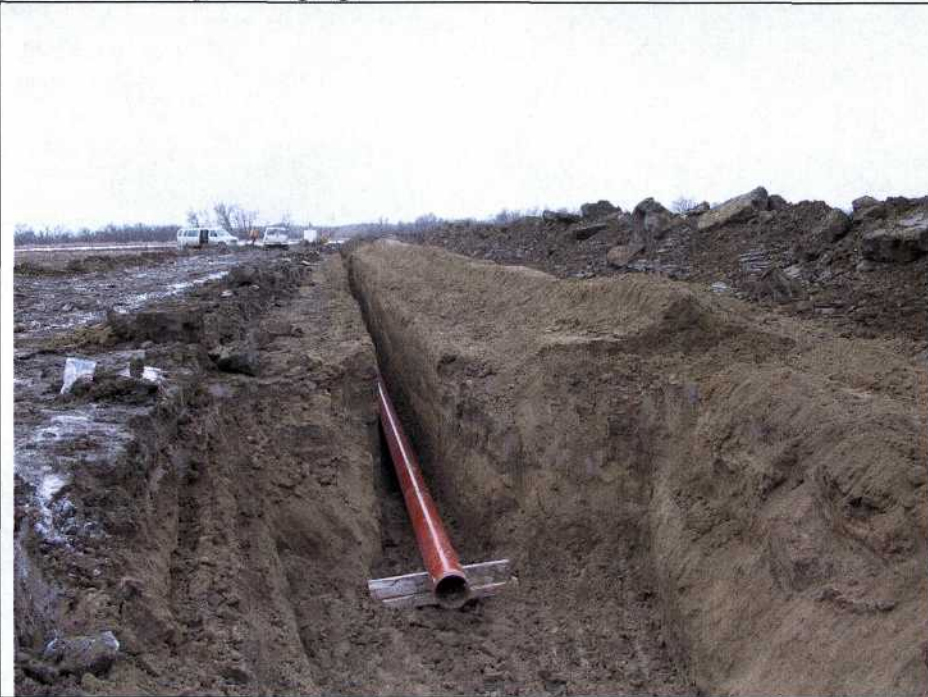
East of the Missouri River, all topsoil was removed to a depth of around 18 inches exposing a layer of river sand. The topsoil was segregated to the side of the Right-of-way and the trench spoil pile was placed on top of the horizontal plane of exposed river sand.

1 S16 east of Missouri River -- east end looking west

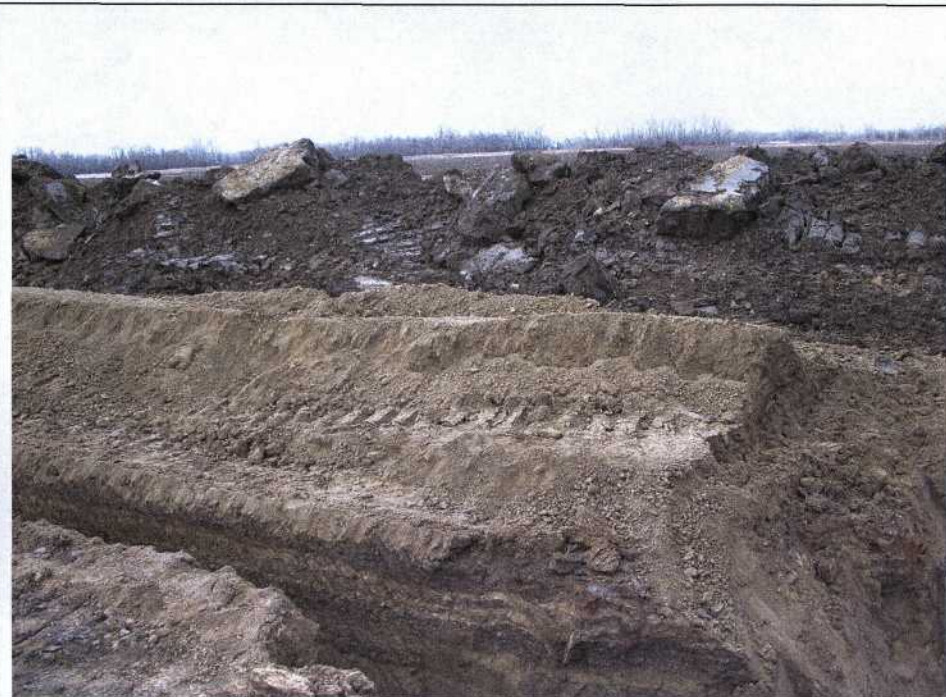
2 S16 east of Missouri River -- east end looking north across ROW

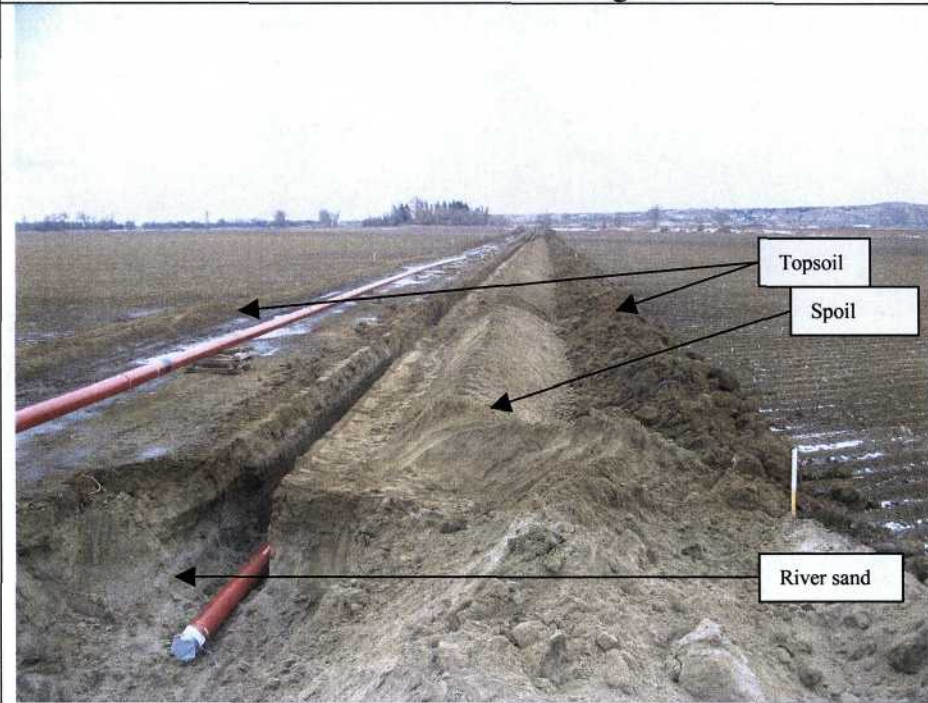
Contractor believes that up to 11-12 inches of topsoil was removed depending on the depth of the observed color change with about 1 in. of soil left over the color change.

#3,4 and 5 are taken from the east end looking west. River sand is observed at about 3.5 feet below the ground surface with topsoil observed from that point to the surface.

3 S20 between Hwy 58 and Missouri River – east end looking west

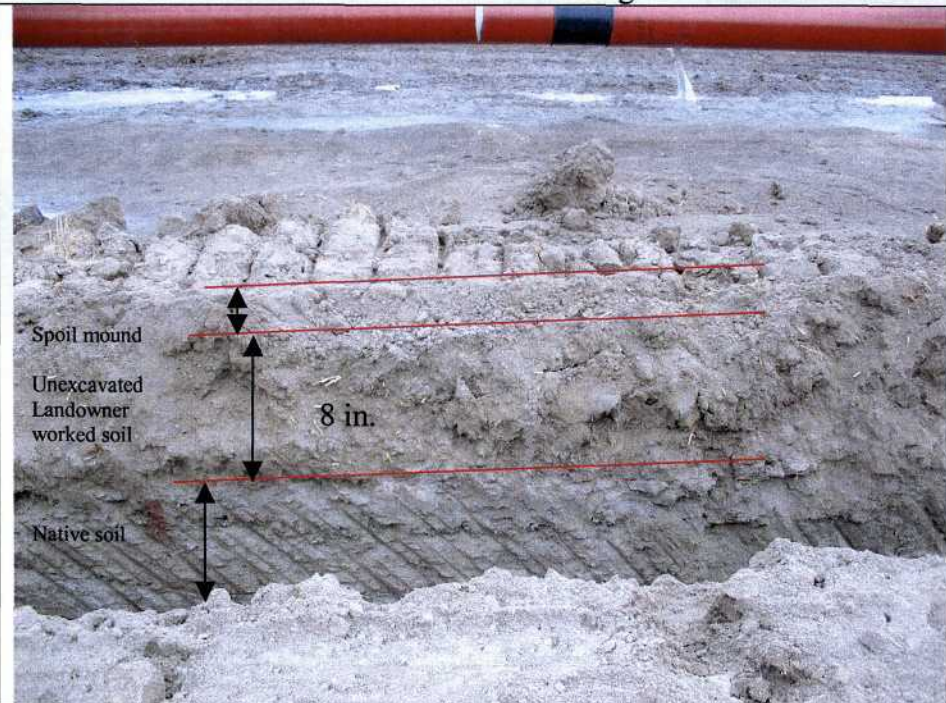
4 S20 between Hwy 58 and Missouri River– east end looking south across cut

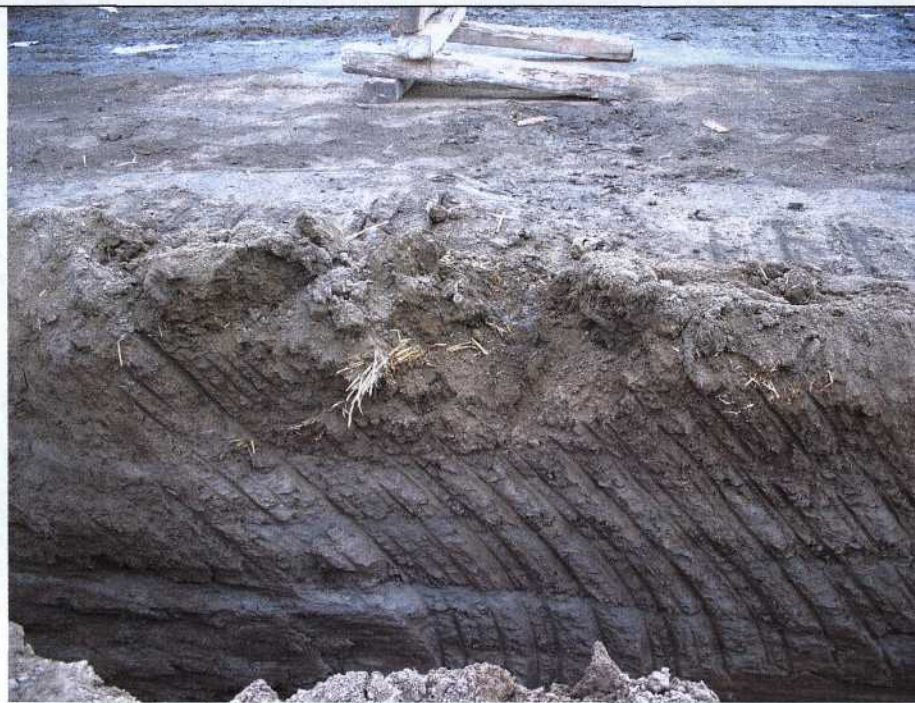
5 S20 between Hwy 58 and Missouri River— east end looking south across cut

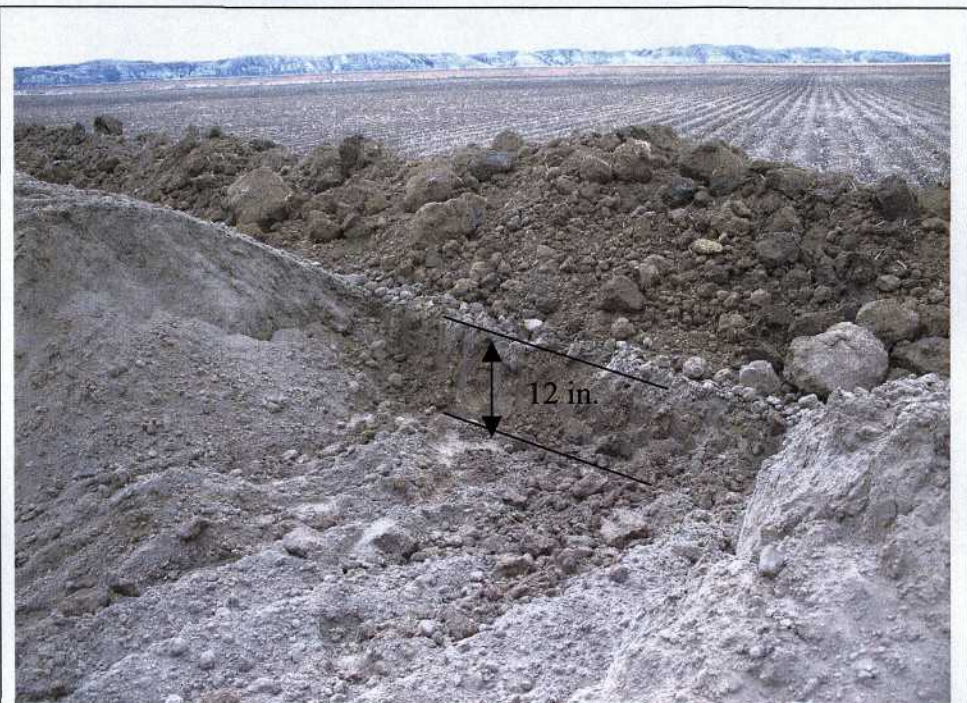
#6 is looking at the north edge of the ROW to show how much surface soil was segregated prior to trenching. This spot is also visible in picture 3 near the topsoil arrow.

6 S20 between Hwy 58 and Missouri River— east end looking north

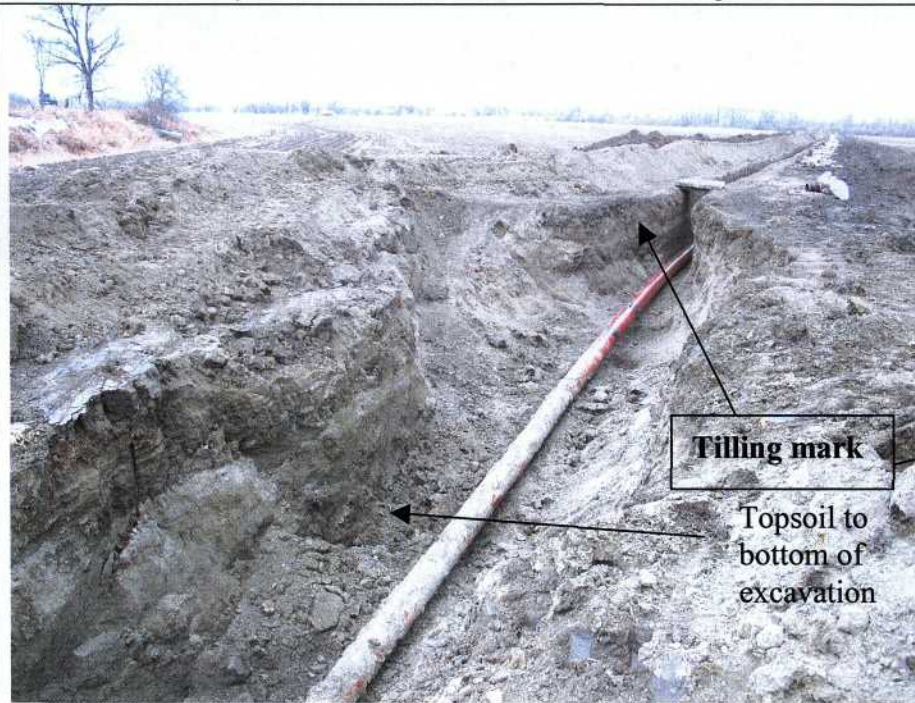
#7 and 8 are taken from the west end looking east. Topsoil is observed to extend to the bottom of the excavation at this point.

7 S20 between Hwy 58 and Missouri River— west end looking east

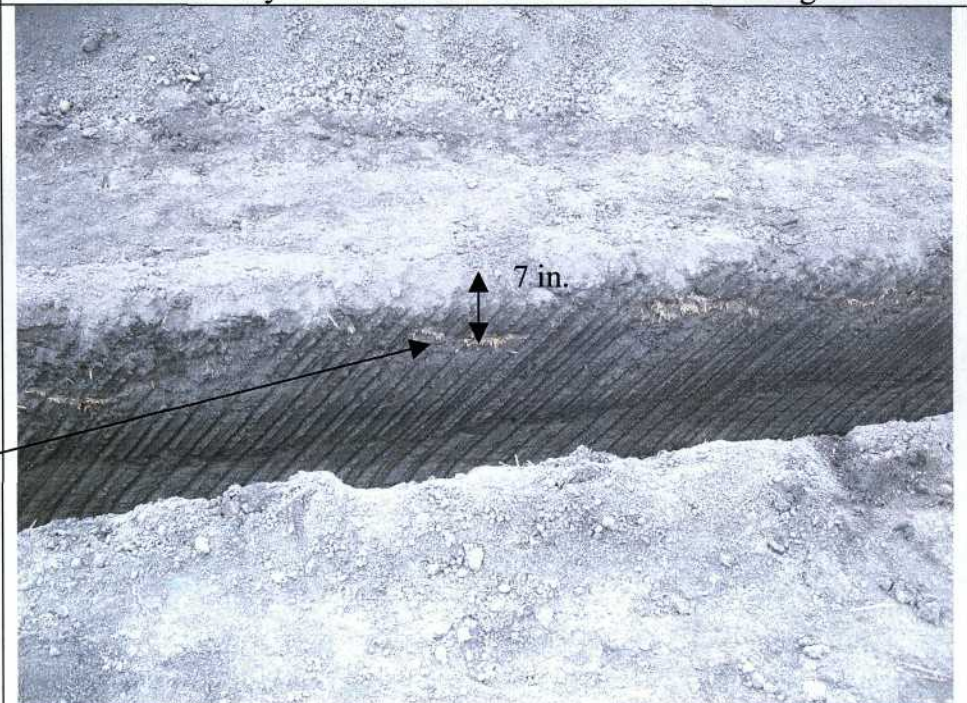
8 S20 between Hwy 58 and Missouri River— west end looking north across cut

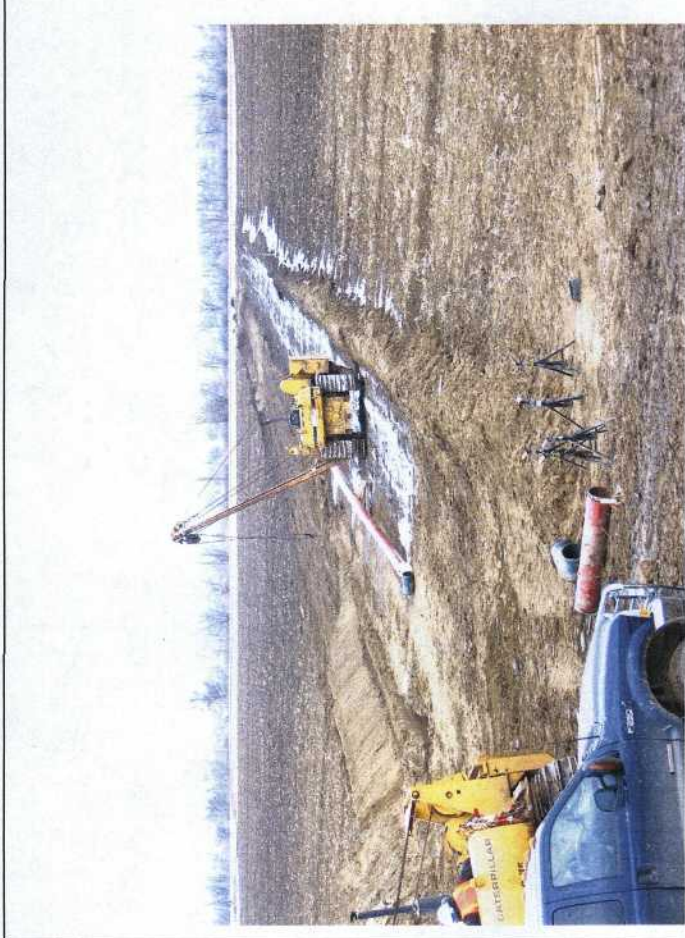
A transit used by the landowner measured a soil elevation difference of 2-3 inches between the outside and the inside of the right-of-way at the location of photograph 9.

(Refer to pictures 9 and 10) Topsoil is observed to extend to the bottom of the trench.

9 S20 between canal and Hwy 58 – south end looking north

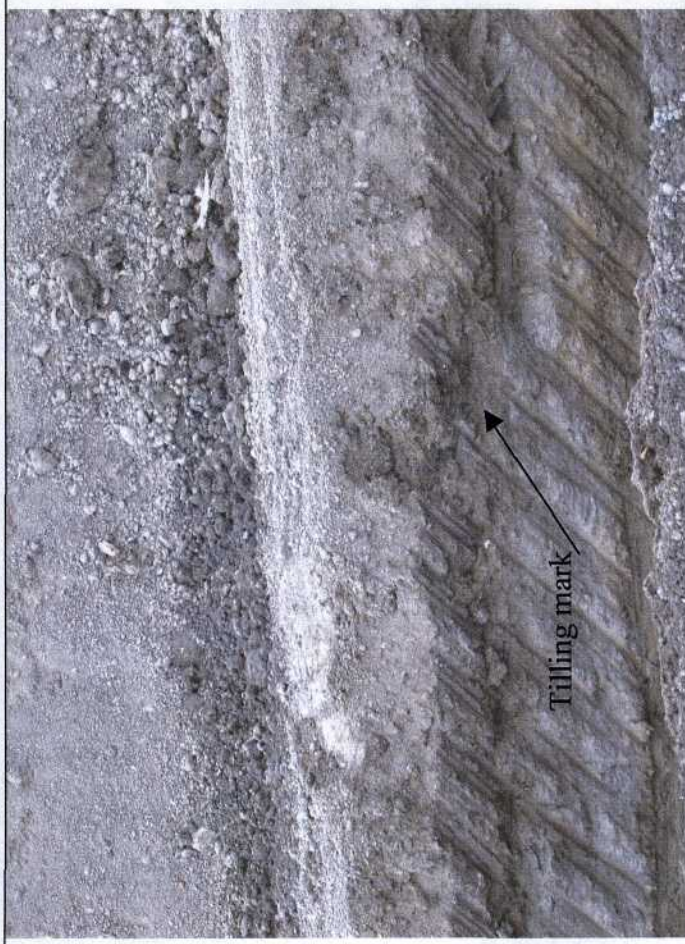
10 S20 between canal and Hwy 58 – south end looking west across cut

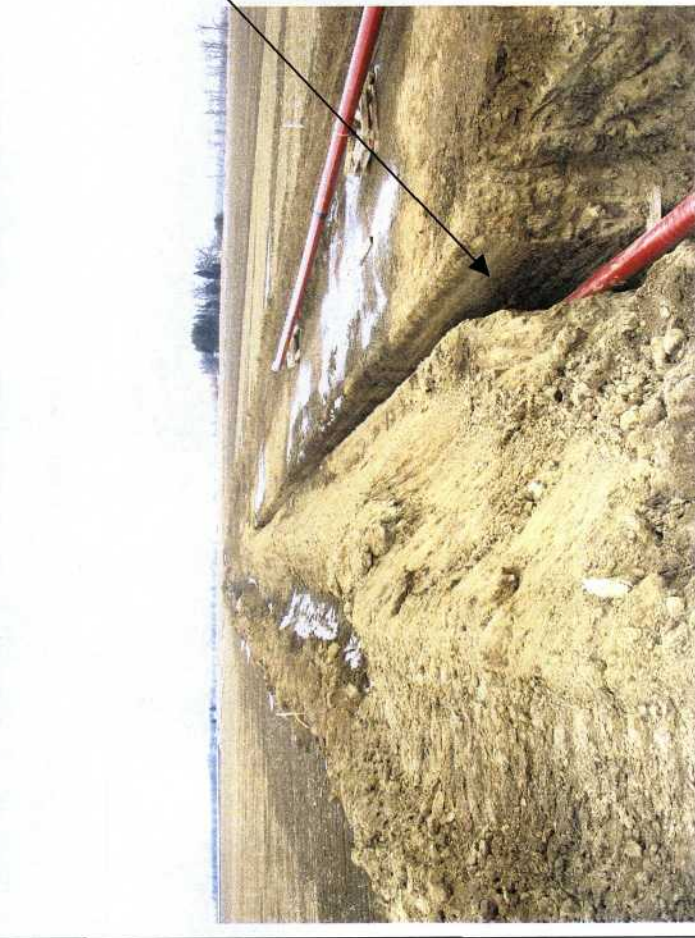
(Refer to pictures 11 and 12 and picture titled "topsoil strata"). Topsoil is observed to extend to the bottom of the trench.

11 S20 between railroad and canal – south end looking north

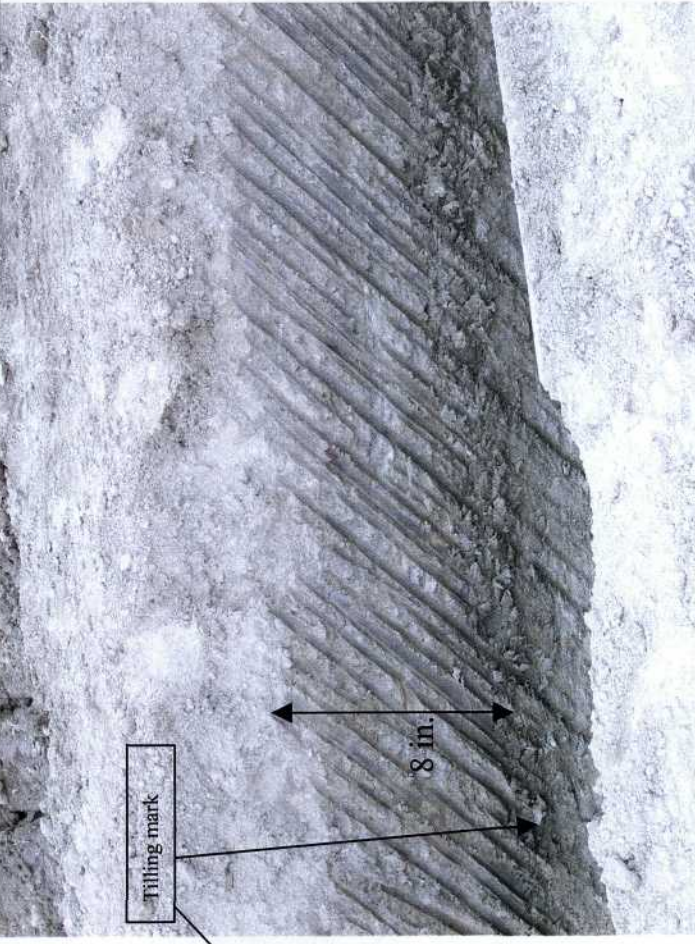
12 S20 between railroad and canal – south end closeup of cut

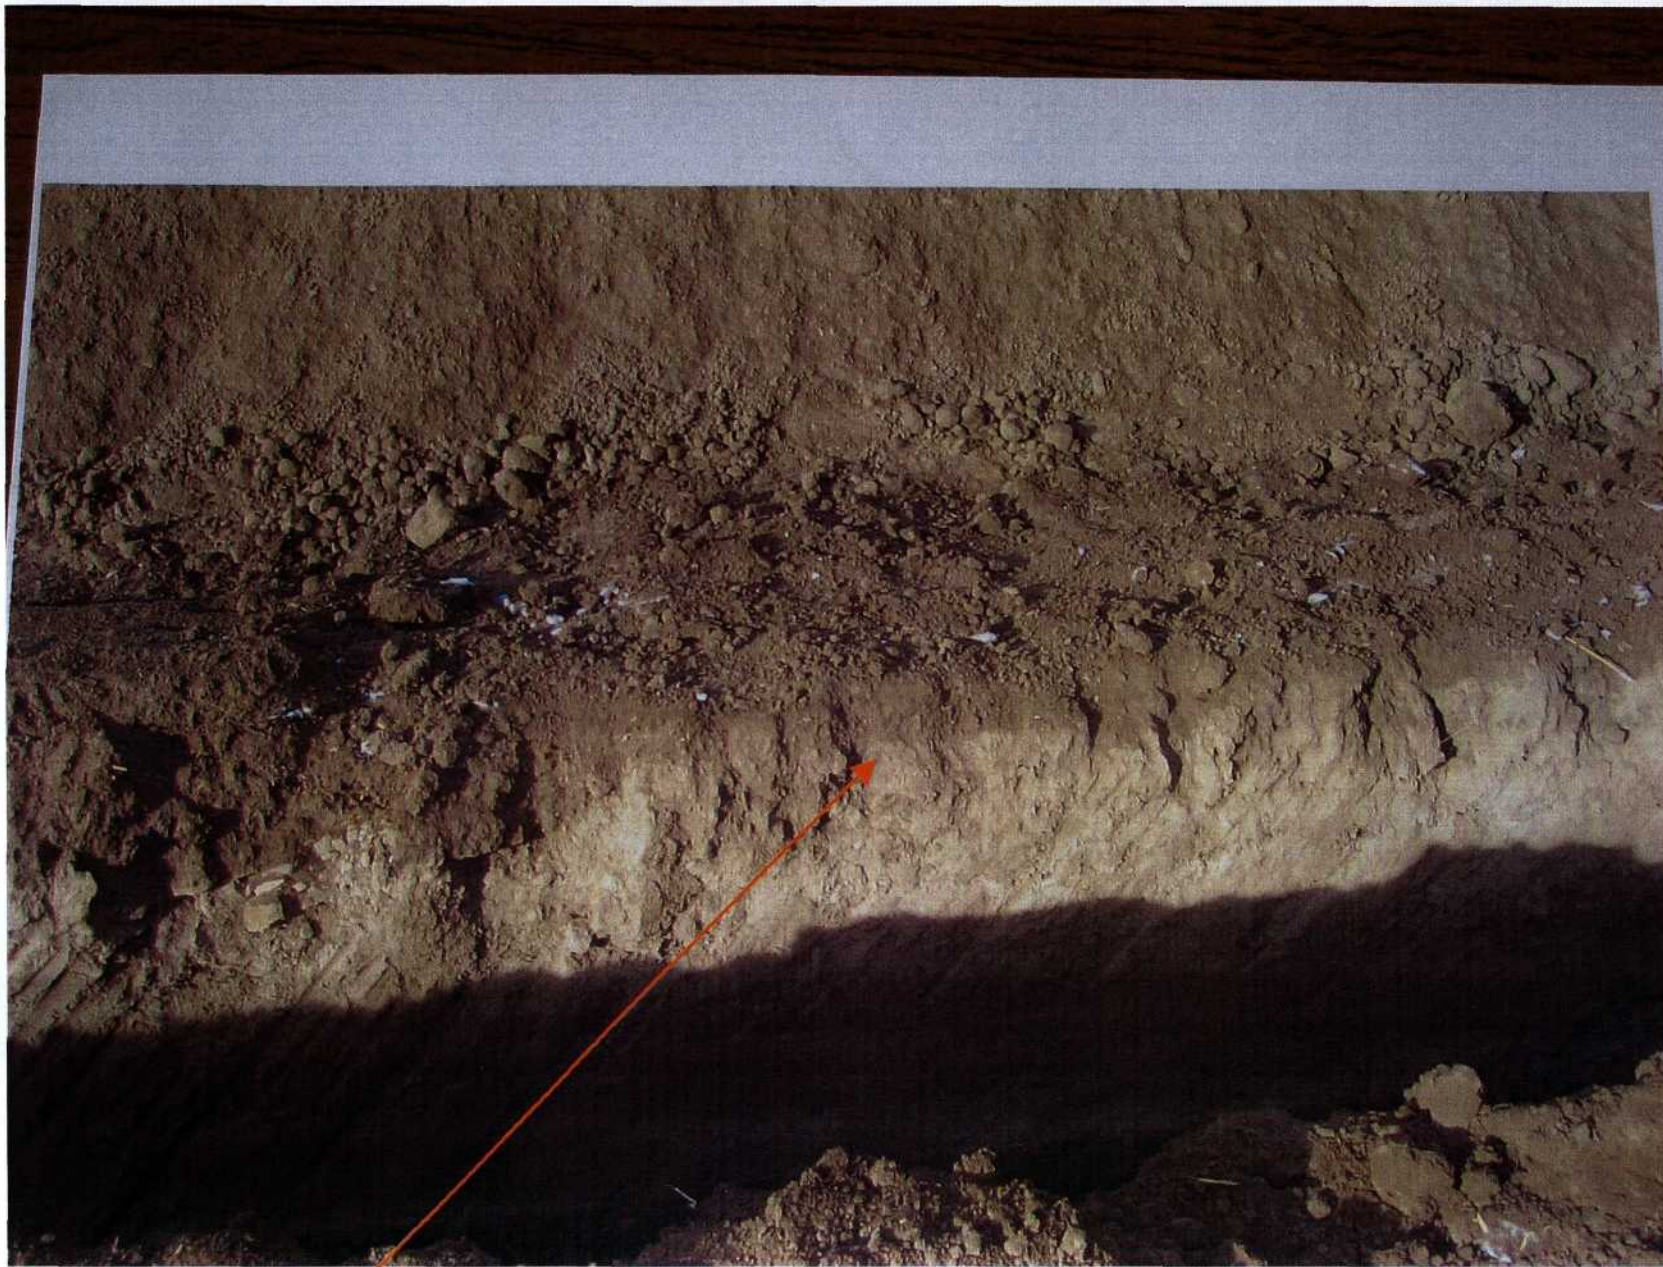
Color Change Picture

The contractor believes that up to 8 inches topsoil was removed depending on the depth of the observed color change with 1-3 in. remaining above color change.

A picture provided by the contractor titled "color change picture" indicates the color change observed in this section at the depth of topsoil segregation.

Color Change

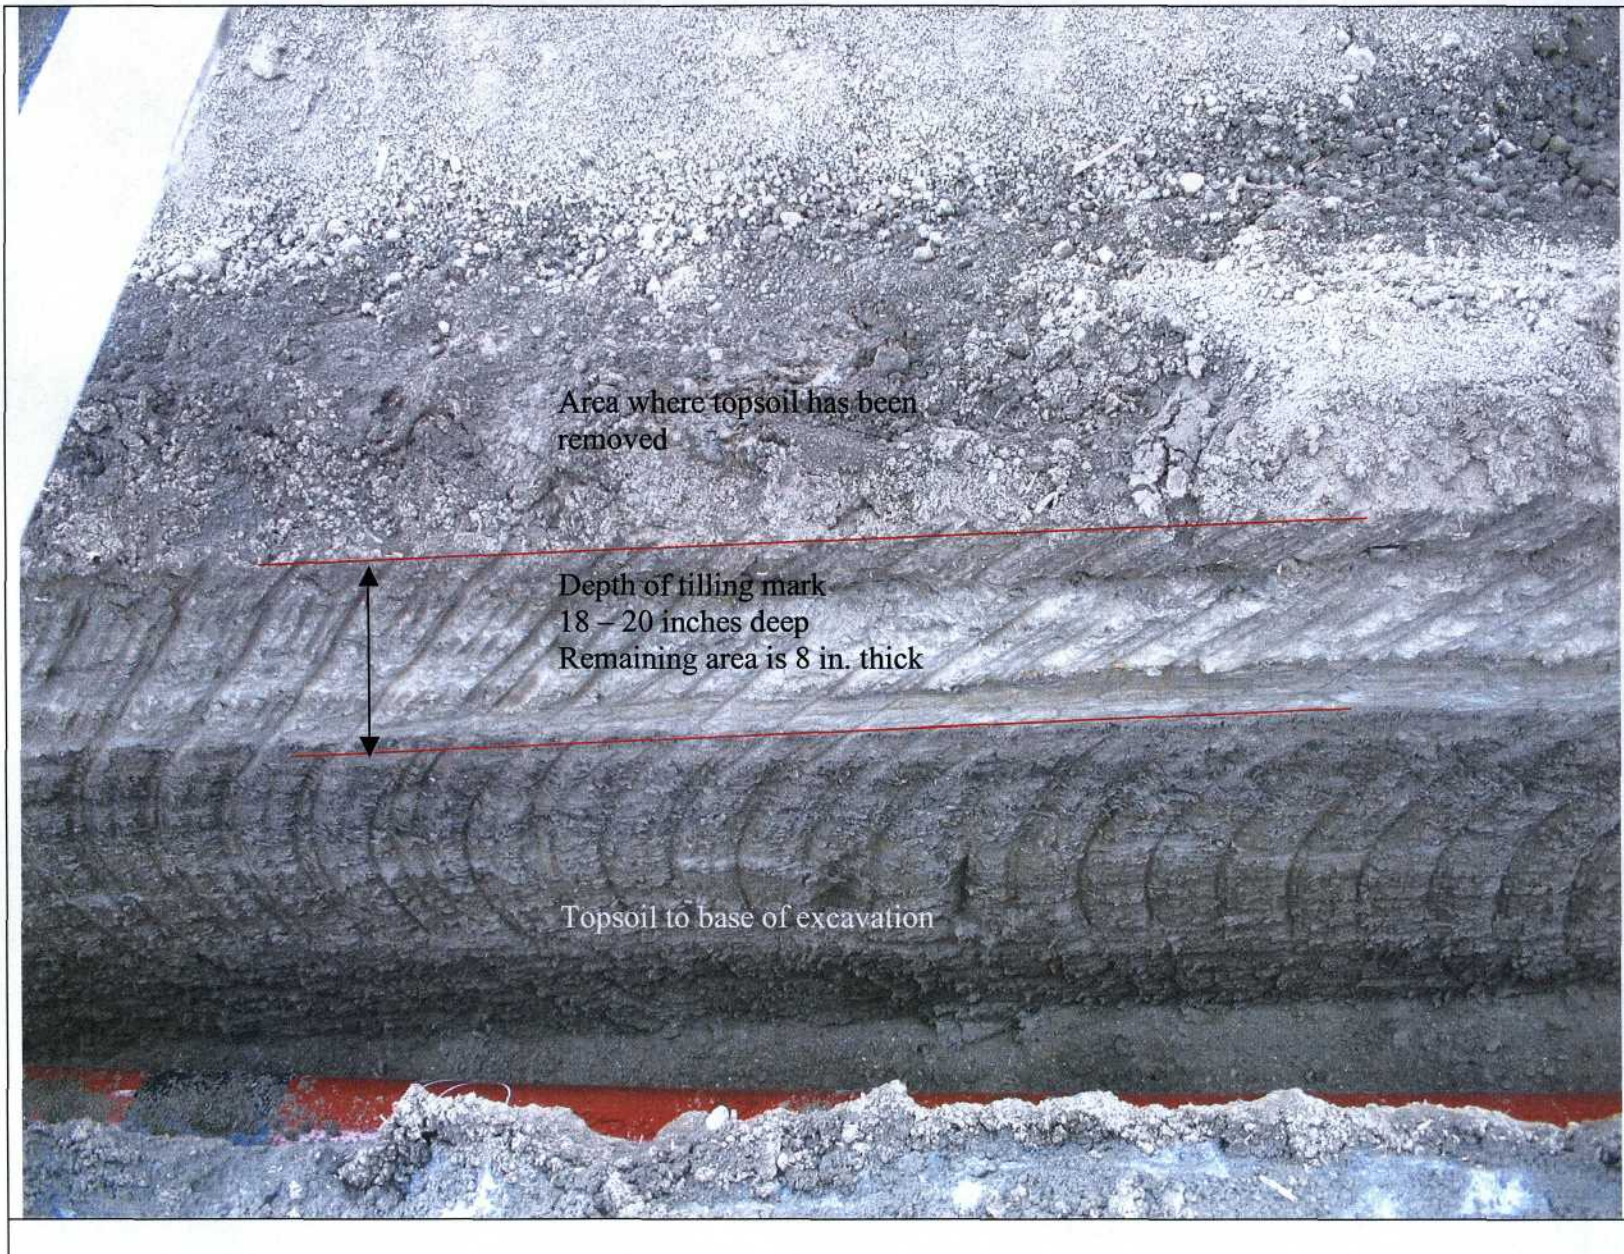
Picture of Topsoil Strata on South end of Section 20 near the railroad tracks
