PSC CASE NUMBER: PU-06-421

DAILY REPORT

Job Site: North SPREAD

Date: January 27, 2009

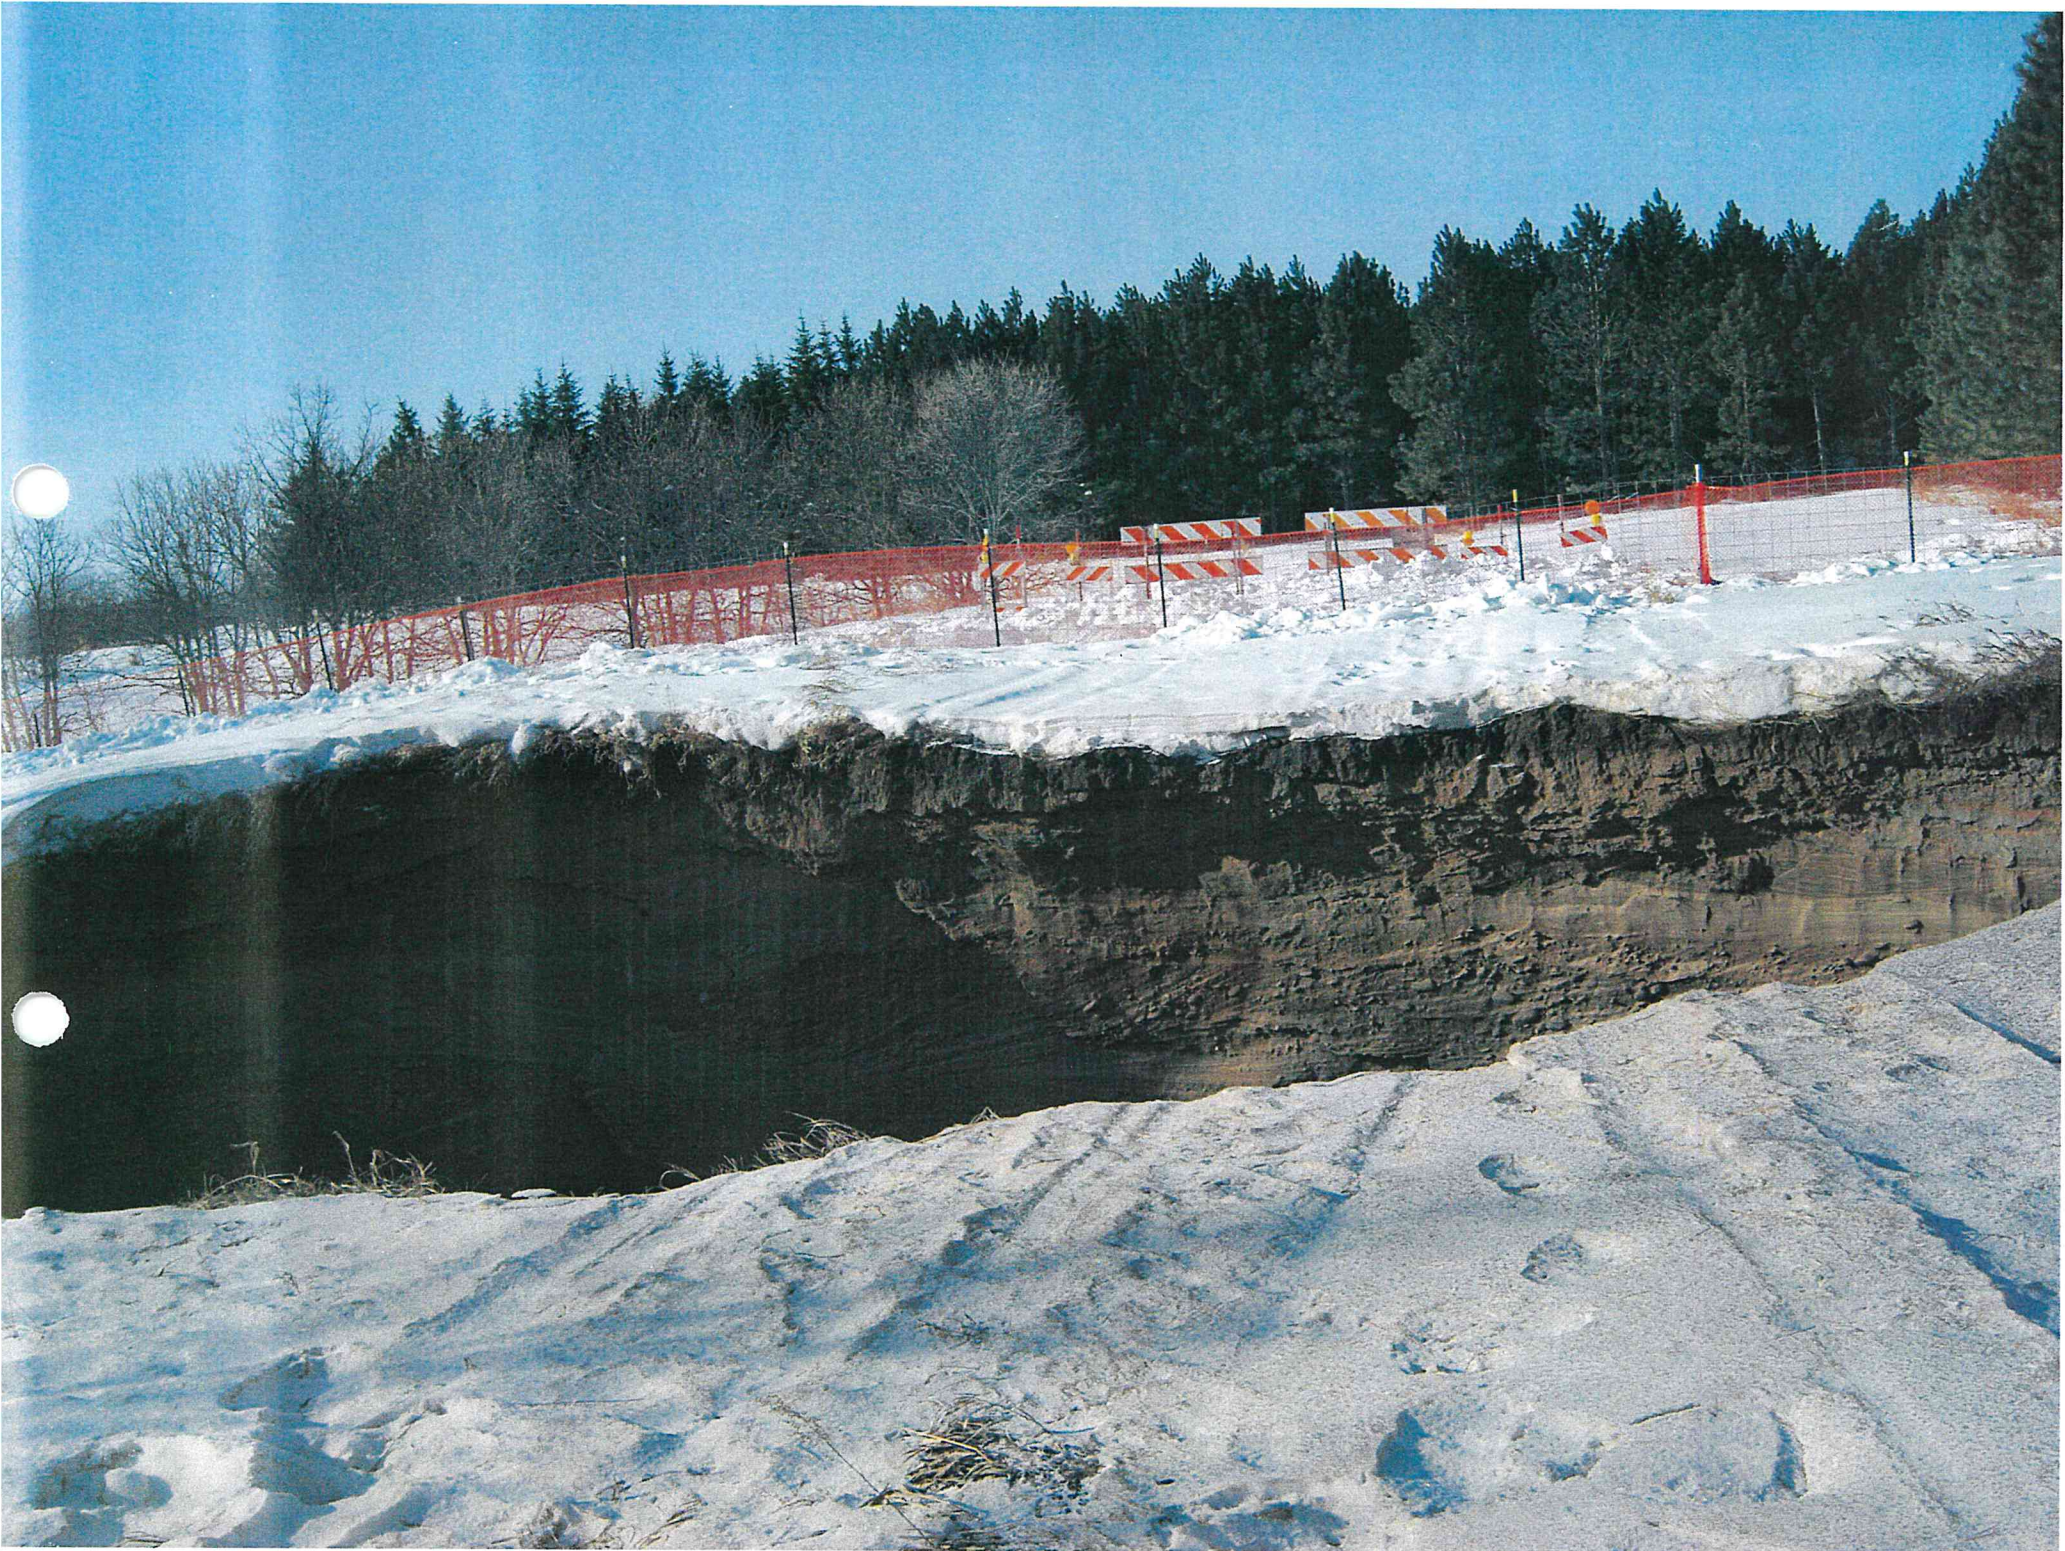
Here are Dennis' reports for 1-27 and 2-2-09. Also attached are 2 pictures of the sink holes that have developed over the pipeline where the bore took place. I will have more pictures that I will put on a CD and send to you.

I revisited the HDD bore site on Mi. 7 of our project, just west of Walhalla in the Pembina Gorge. As you know by reading my previous report, the HDD contractor began pulling the pipe for this bore last Tuesday, Jan 27th. They completed the pull of some 4000+ l.f. of pipe on Friday January 30th. On my Monday visit to the site, (Feb. 2, 2009) I noticed 5 large sink-holes had developed on the North end of this project, directly over the pipeline. They range in size from 20' in diameter to 50' in diameter. The depth of the sink-holes vary from 20' to 30'. One of the sinkholes is directly below a stand of Pine trees in the Tetault State Forest. The trees appear to be standing erect, but the root system is hanging in mid-air for several

of the Pine trees. One of the sinkholes is near a snow-mobile route. The actions taken by the contractor are preventative at this point. They have completely surrounded the holes with orange security fence & posted "road closed" signs at points of intersection with existing road trails. I spoke to Dean Di Thomasso, lead Environmental Inspector for ENSR. He said this all has happened in recent days. Bill Haffoon, Resident Construction Supervisor for Universal Enasco, said the contractor plans to monitor the area this winter, & when they (contractor) return in the spring they will haul in material to back-fill the sink holes. Bill also added that he has been in close touch with Tom of the N. Dak Forest Service & that he has been kept apprised of these occurring events & is satisfied with the counter actions taken by the contractor at this time.

Please note Dennis' suggestion of contacting the ND State Forest Service to verify they are satisfied with the immediate plans the contractor has and their proposal to repair the sink holes in the spring.

In light of these events I think it would be most important to closely monitor this area. If additional cave-ins occur they could be tragic for anyone in the vicinity who may be caught in the ground shift.
