KEYSTONE PIPELINE

**HORIZONTAL DIRECTIONAL DRILL AT PEMBINA RIVER
CROSSING MP 7.1**

**OCCURRENCE OF GROUND SUBSIDENCE (LOCALIZED
SINKHOLES) AT COMPLETION OF DRILLING AND PIPE
INSTALLATION**

**GENERAL DESCRIPTION OF THE
SITUATION AND PLAN FOR
INVESTIGATION AND REPAIRS**

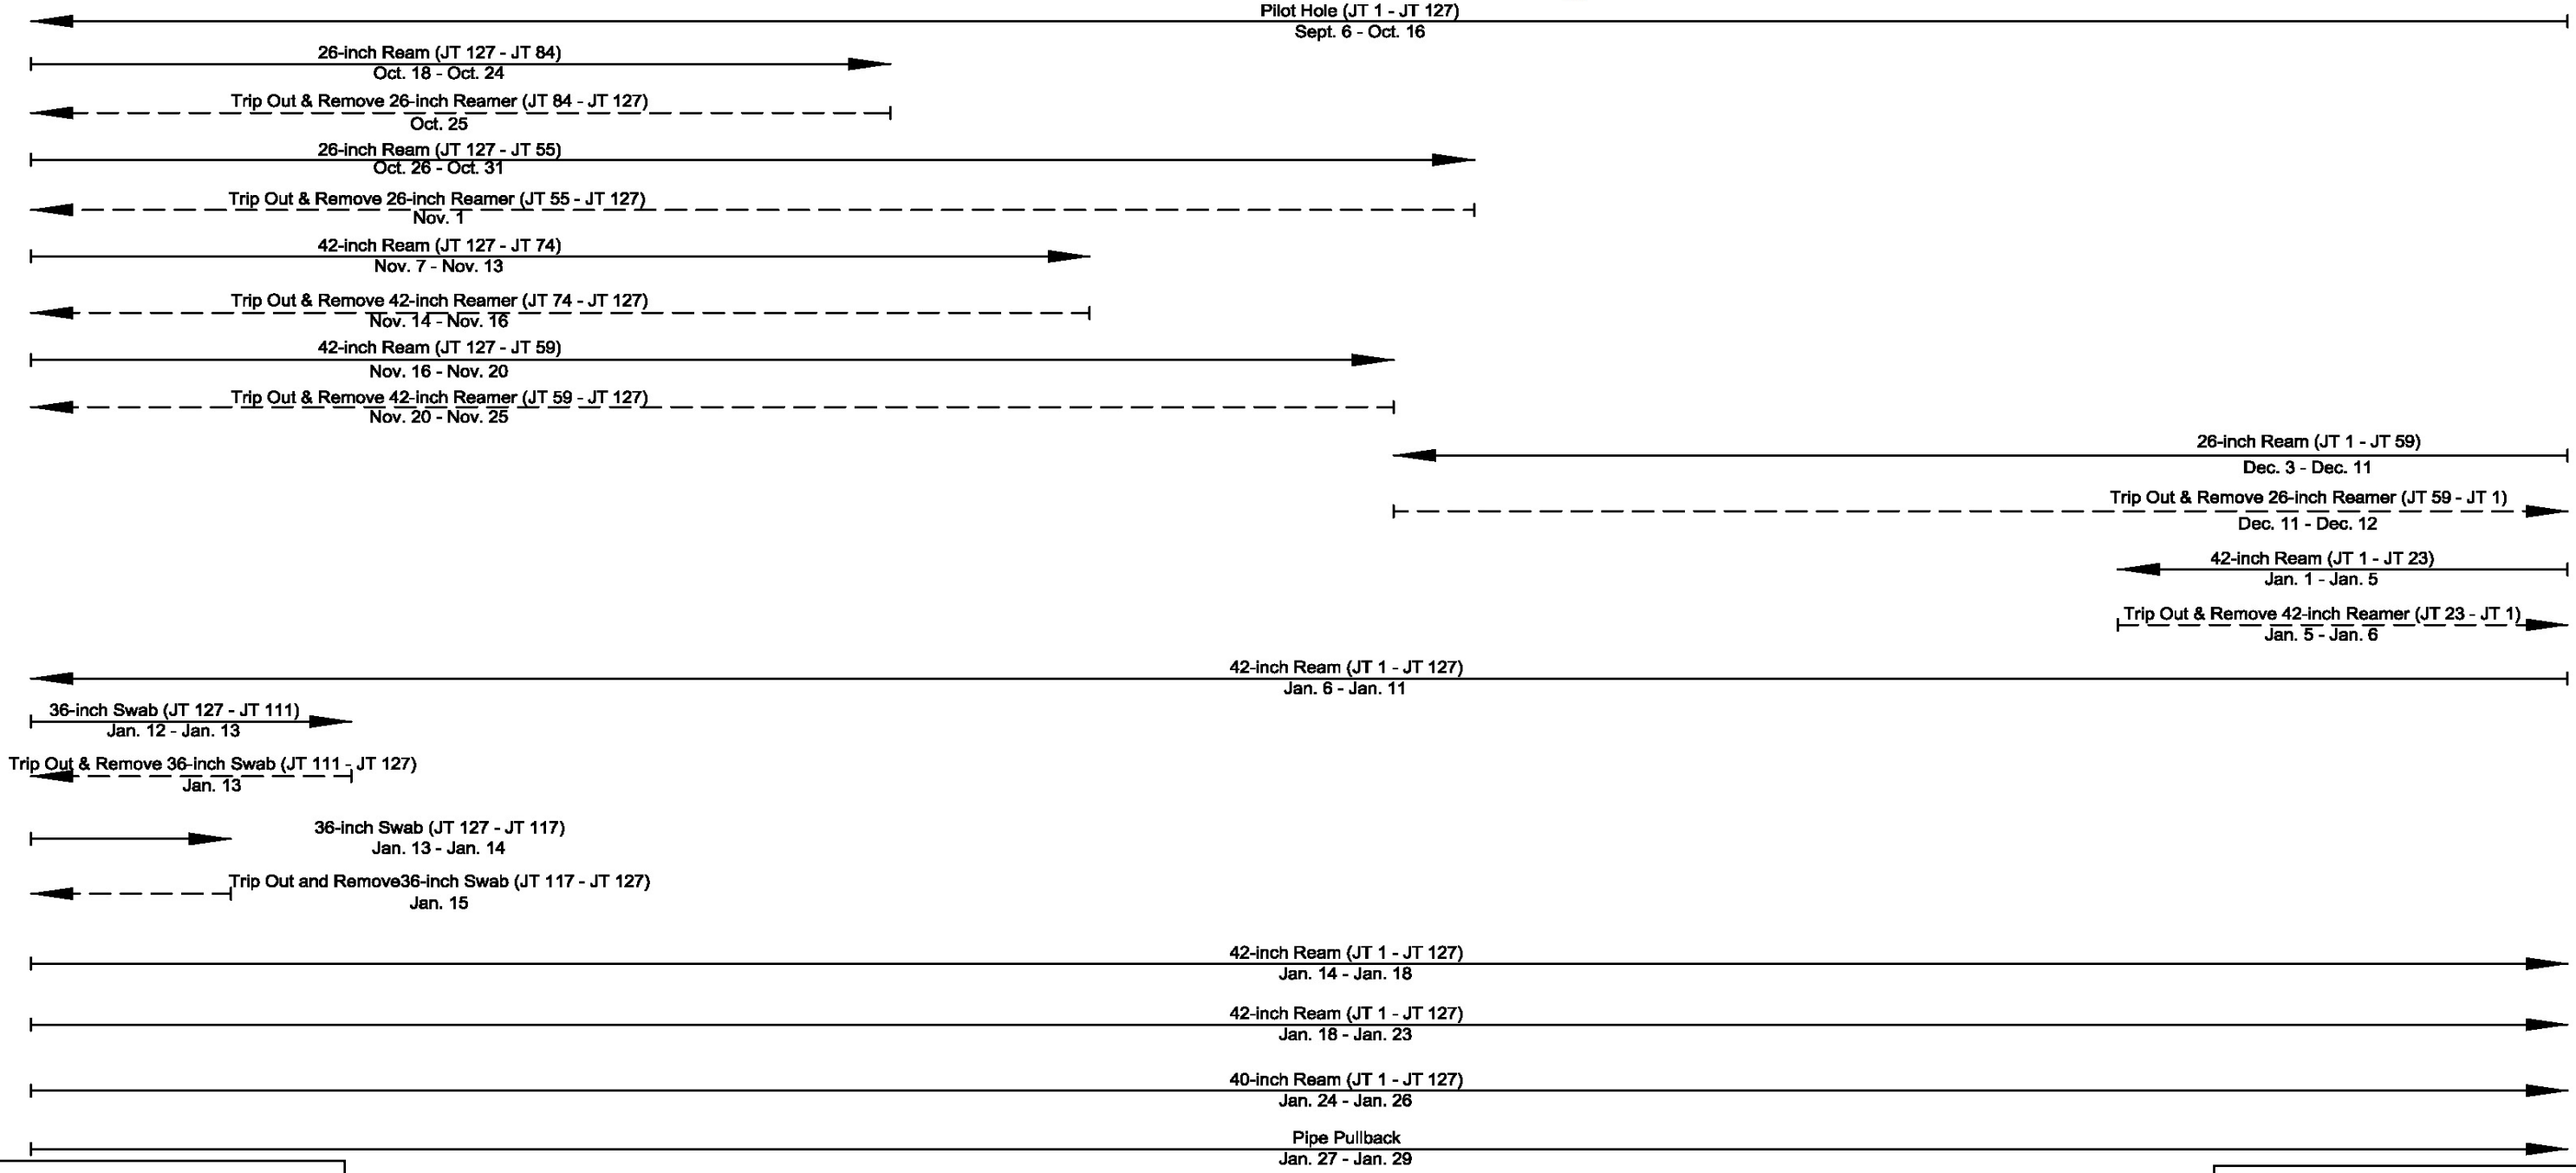
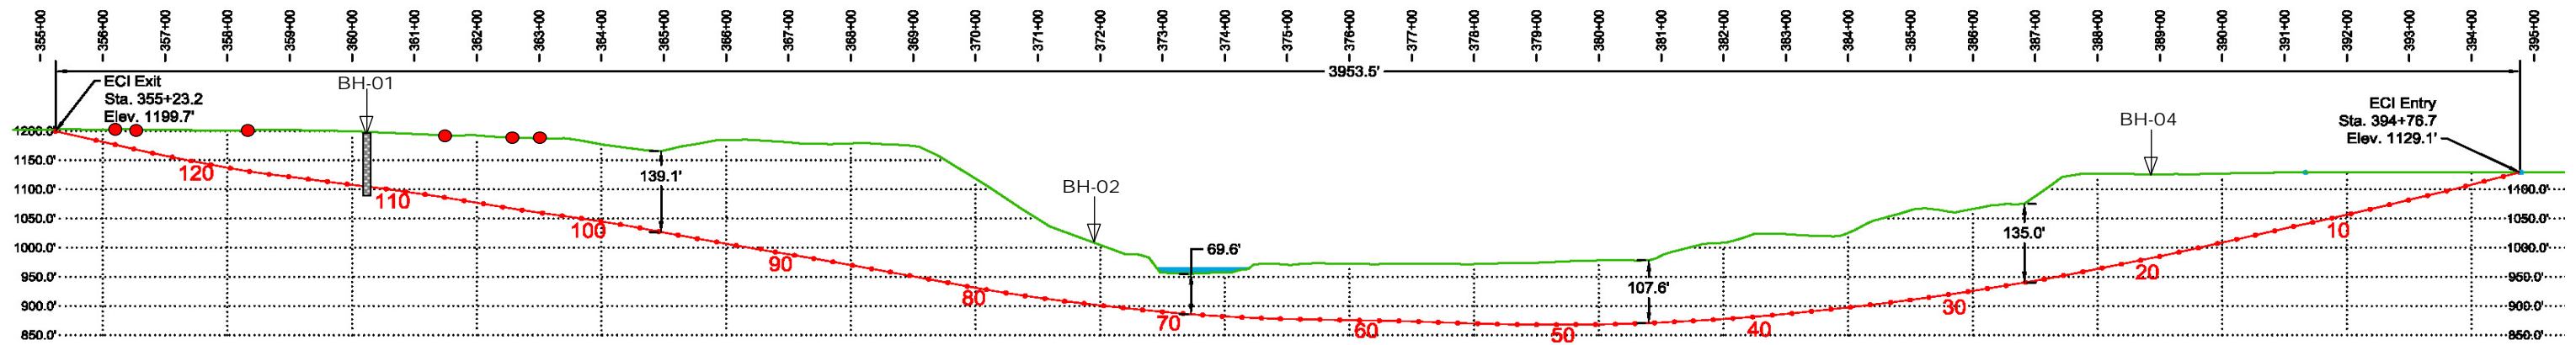
SCALE	DATE	DRAFTER	DRAWING NUMBER	REV.
NTS	2.20.09	DH	FIGURE 1	0

The approximate locations of the sinkholes are at stations: 356+15; 356+50; 358+30; 362+50 and 363+00 feet. The southernmost sinkhole is located approximately 600 feet from the edge of the descent to the river. Locations of the holes are shown in Figure 1 which also depicts the as-built geometry of the installed pipeline.

Details of the actual HDD performed at the Pembina River are provided on Figure 1. The Figure indicates the as built schedule for completion of the pilot hole; successive pre-reaming passes, swabbing attempts and the pipe pull back. The installation involved the completion of an approximately 4000-foot drill reamed to 42-inches. The 30-inch pipeline was constructed on the surface on the north side of the river and pulled into the exit point from the drill rig situated on the south side of the river.

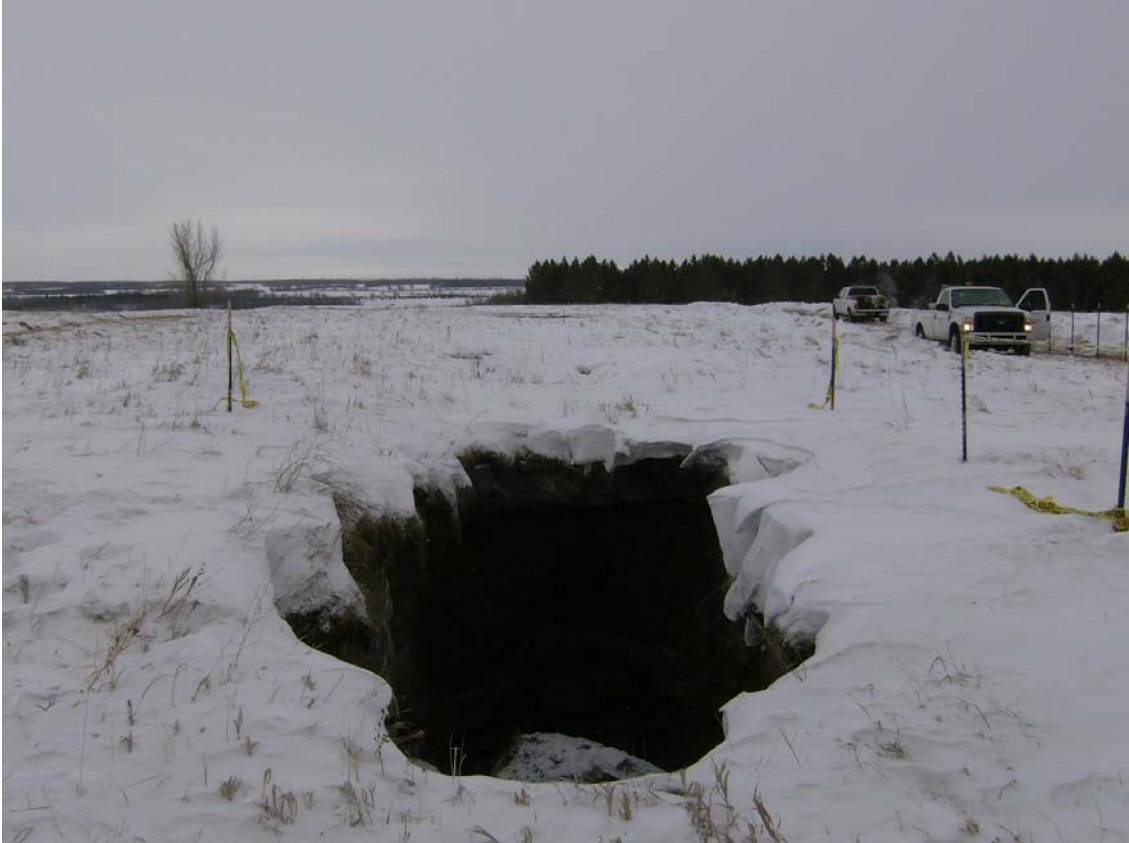
SN 356+15 Sink hole looking south

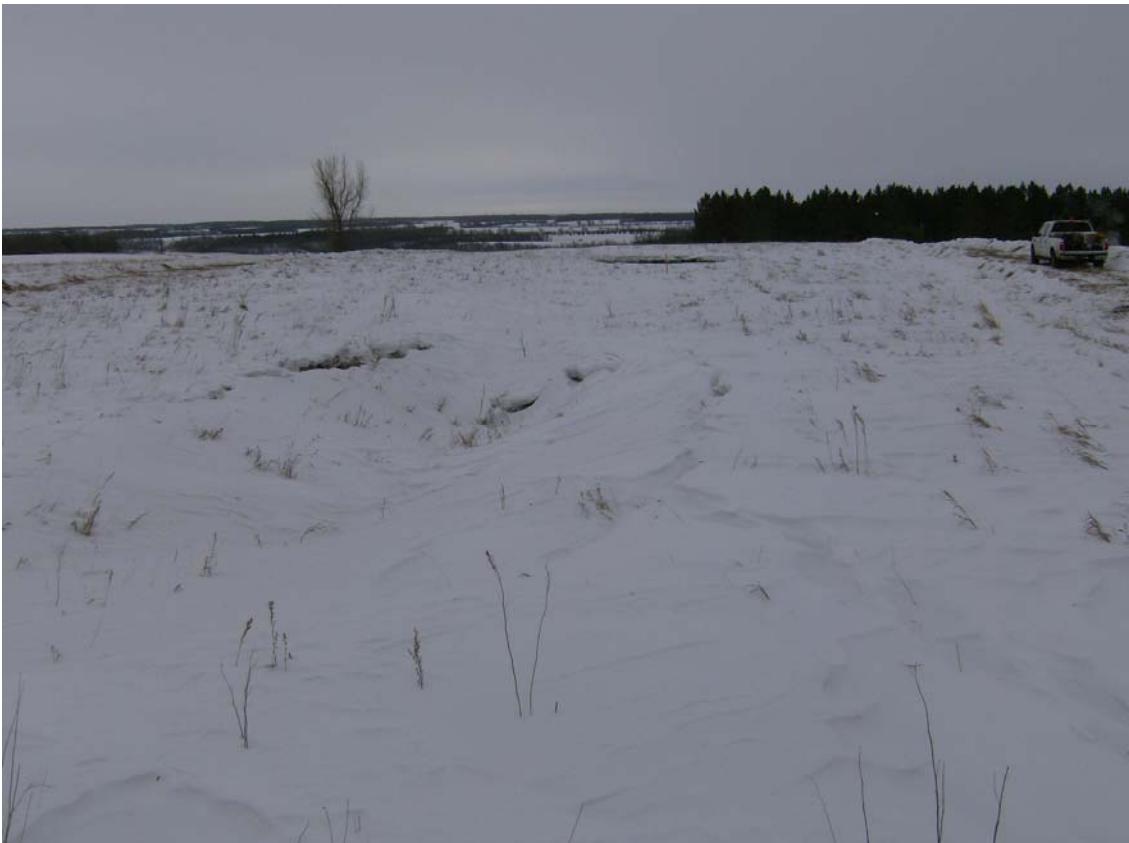
SN 356+50 Subsidence over ditch line looking south

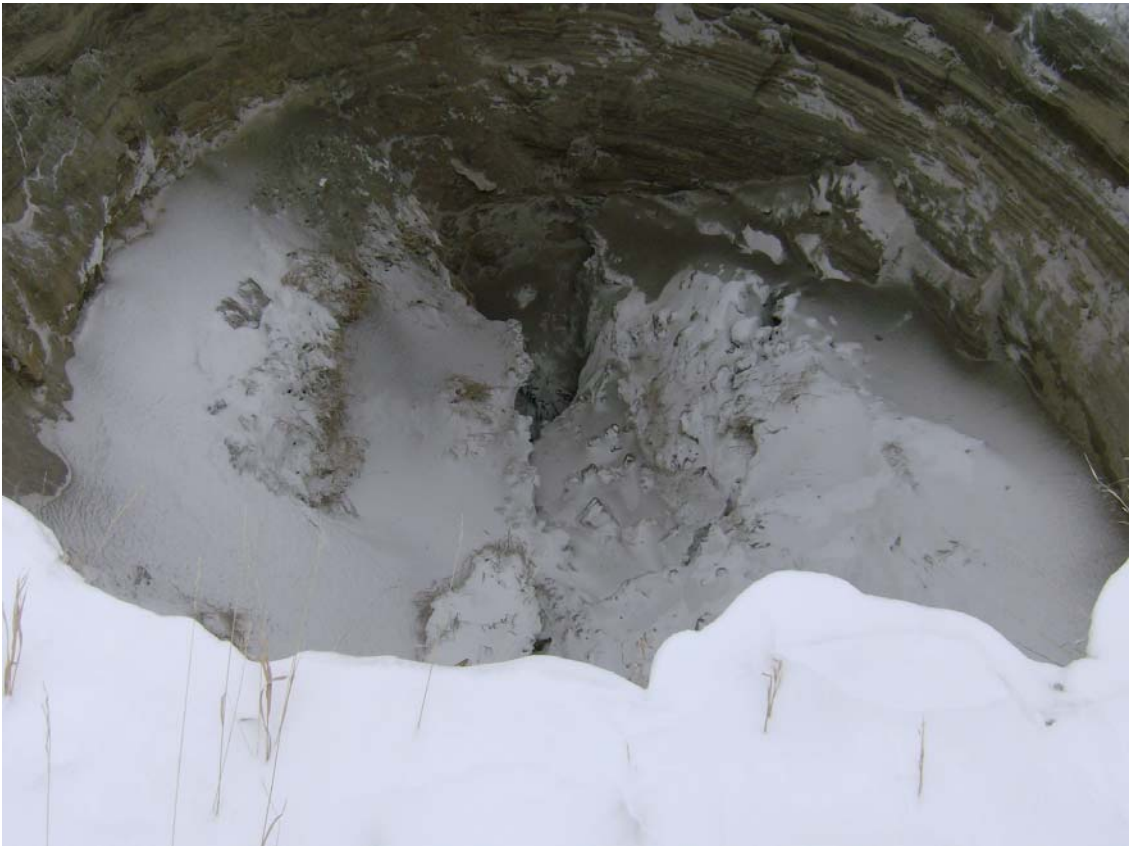
SN 358+30 Sink hole looking into hole

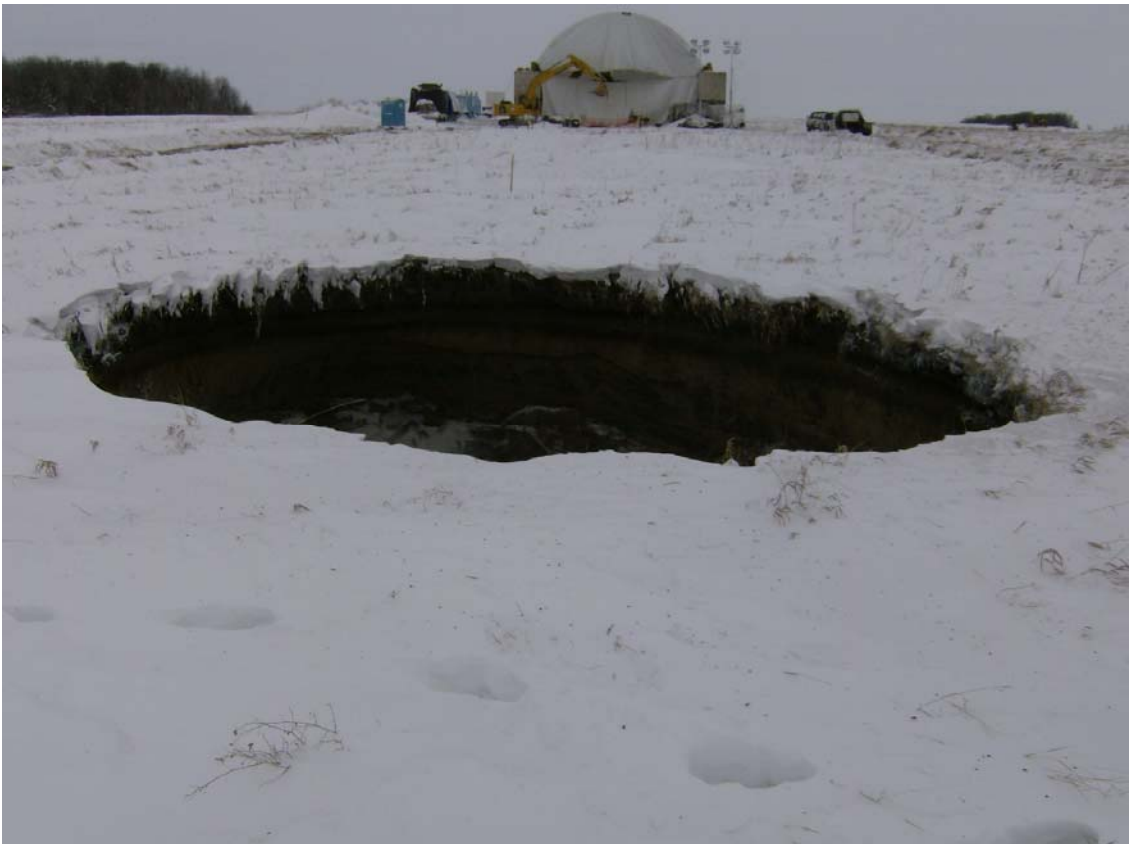
SN 358+30 Sink hole looking north

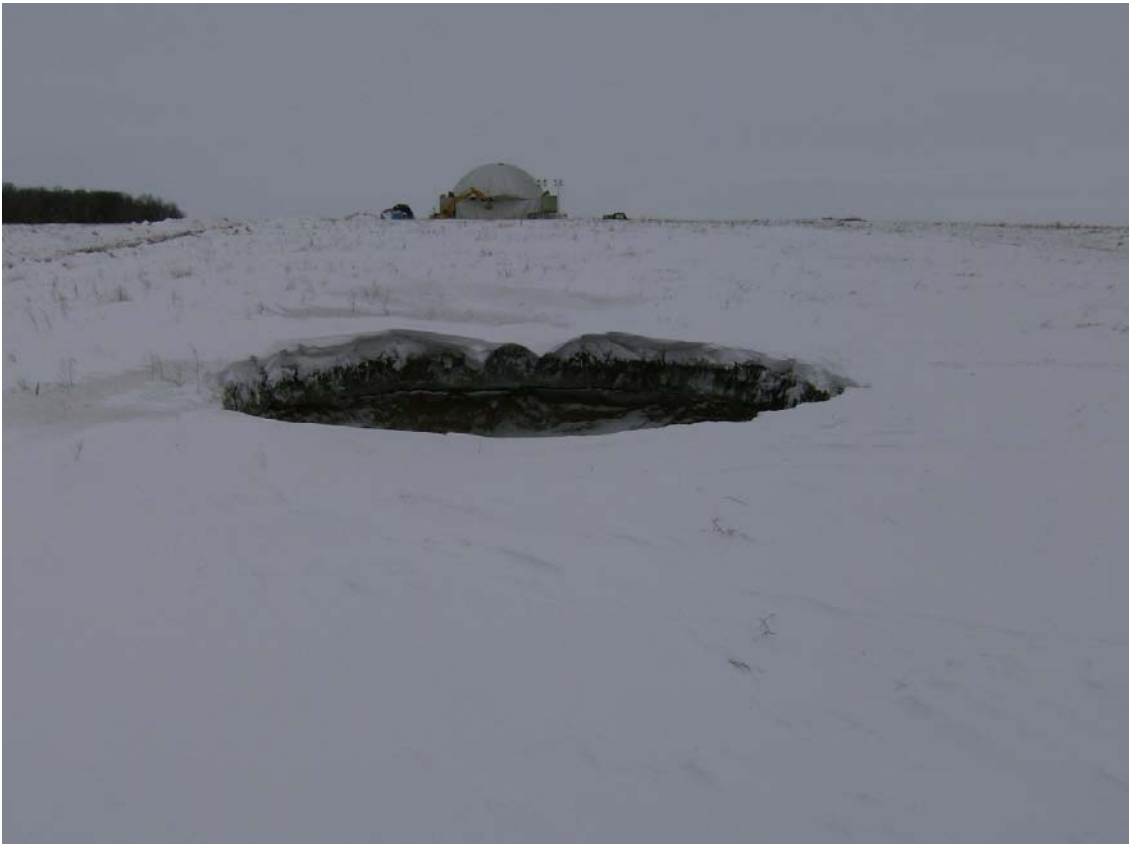
SN 361+50 Sink hole looking north

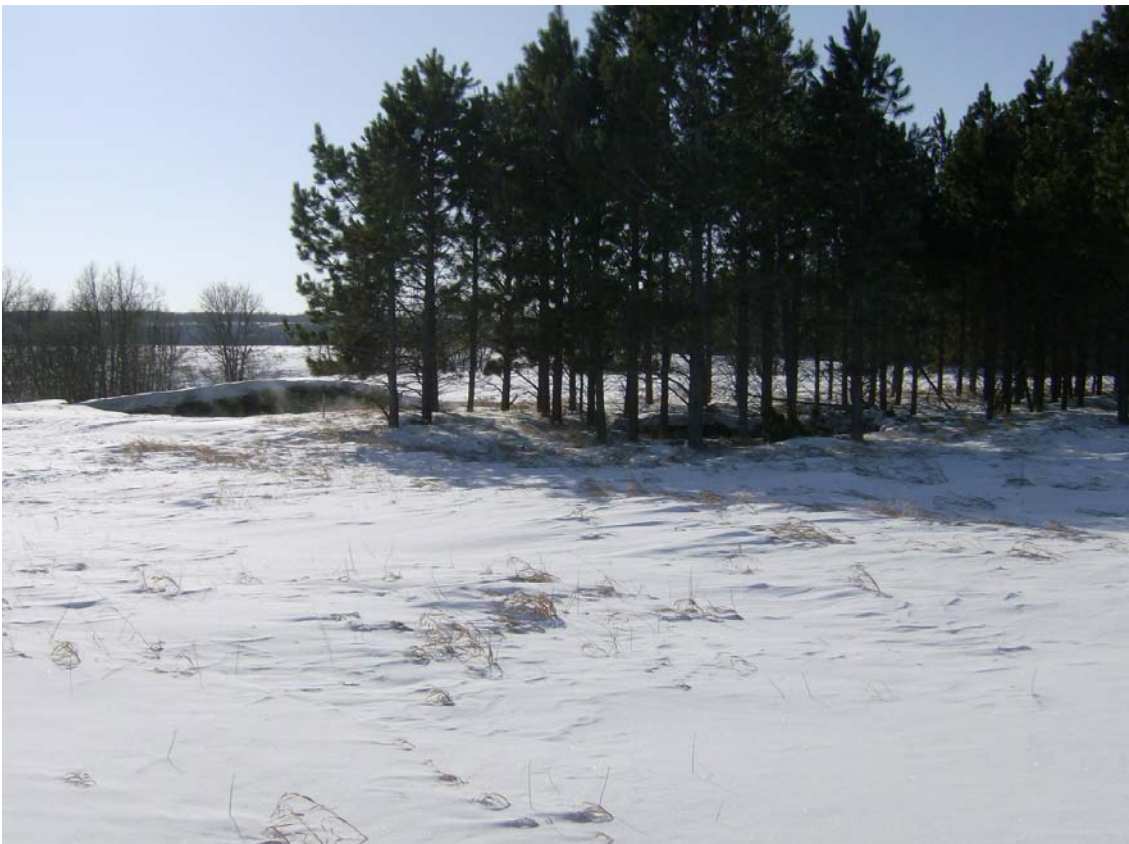
Looking west at both sinkholes within Tetrault SF property 2009-01-29

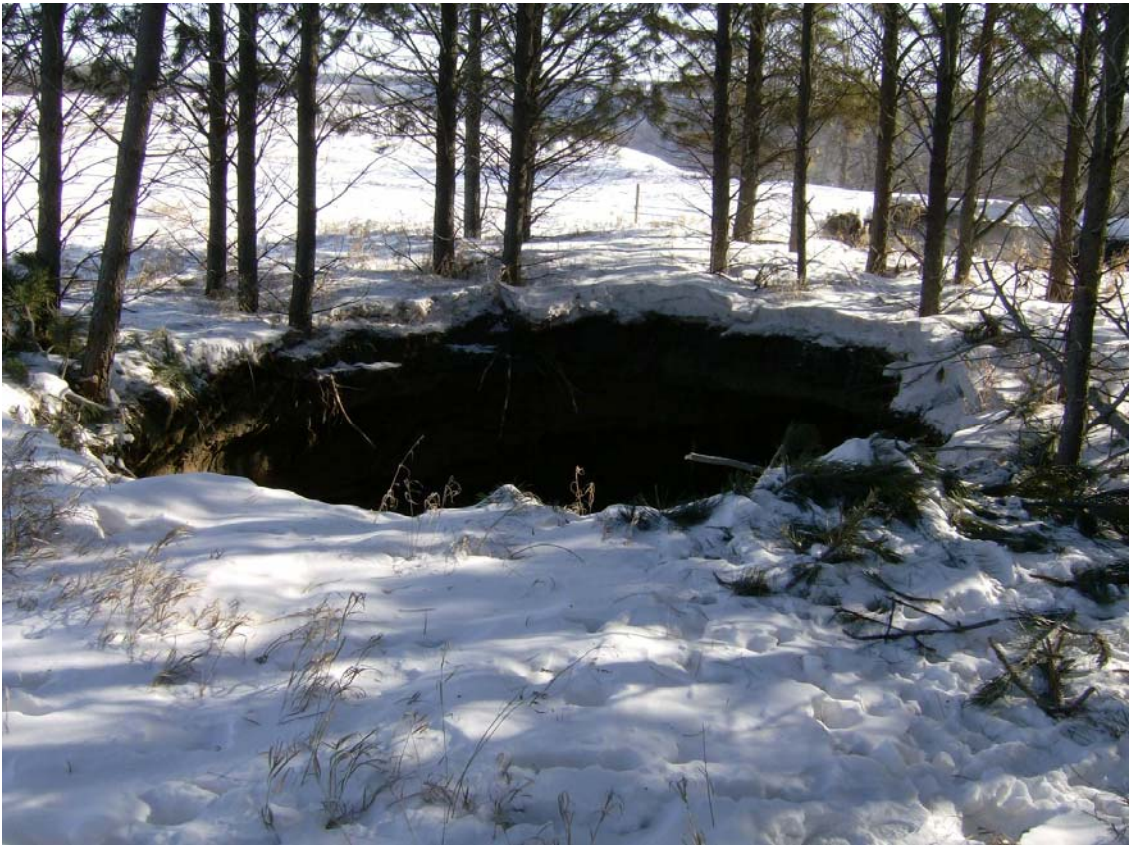
SN 362+50 looking SE, Sinkhole near ROW centerline in pine plantation 2009-01-29

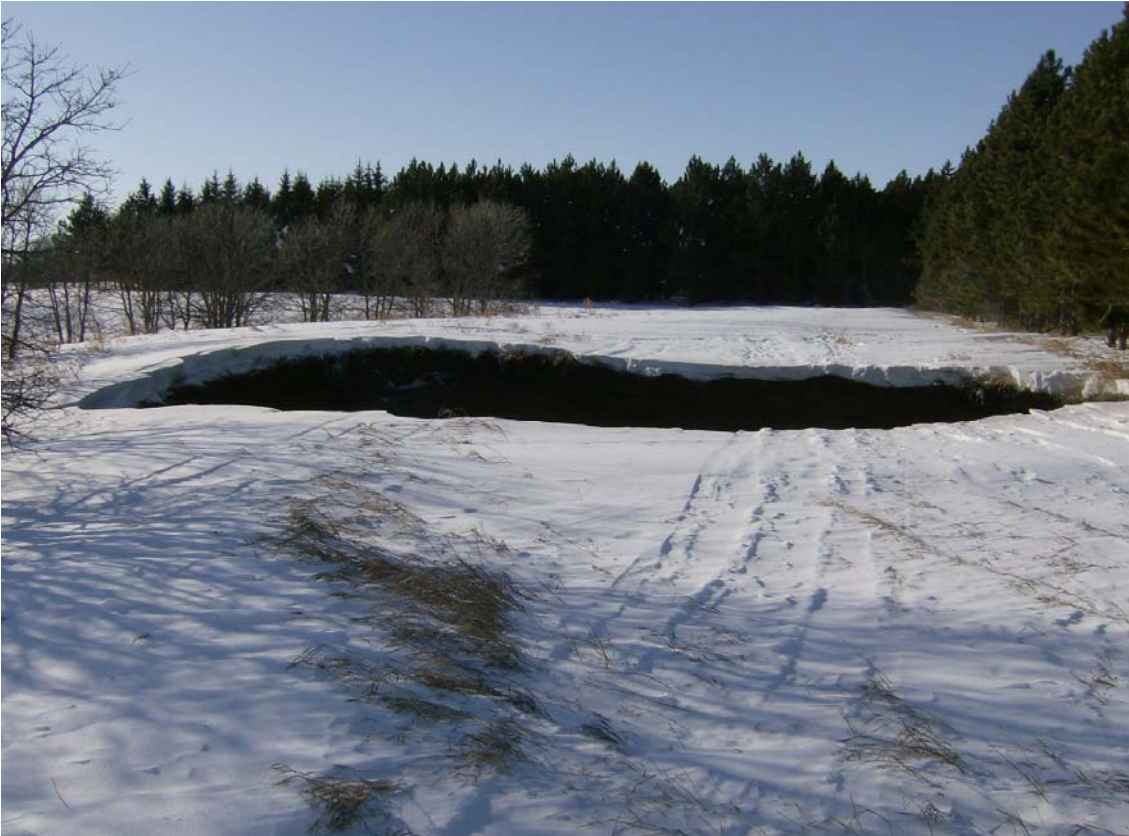
SN 363+00 looking W, Sinkhole near ROW centerline across Tetrault SF overlook road
2009-01-29
