TRANSCANADA KEYSTONE PIPELINE PROJECT

Pembina River Directional Drill Crossing

Sink Hole Remediation Approach DRAFT

Pembina Sinkhole Remediation Plan

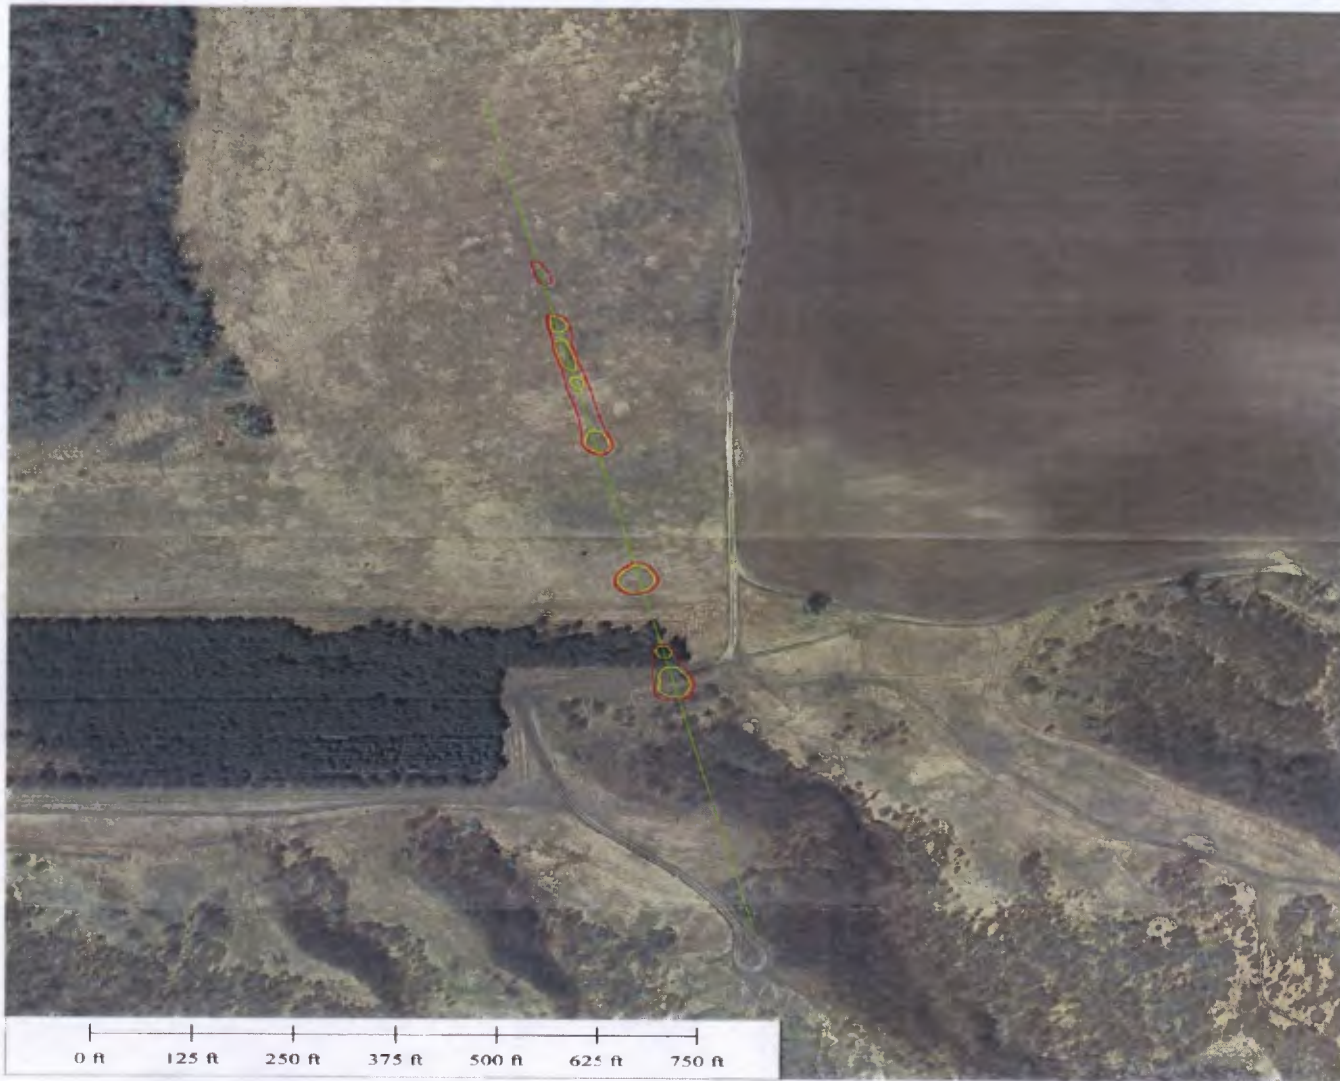
Sinkhole Location

- Subsidence was first noticed at the end of November 2008 while reaming operations were in progress
- Additional sinkholes occurred through February 2009
- Area affected by the sinkholes extends approximately 700-feet south from the drill exit point on the north side of the Pembina River

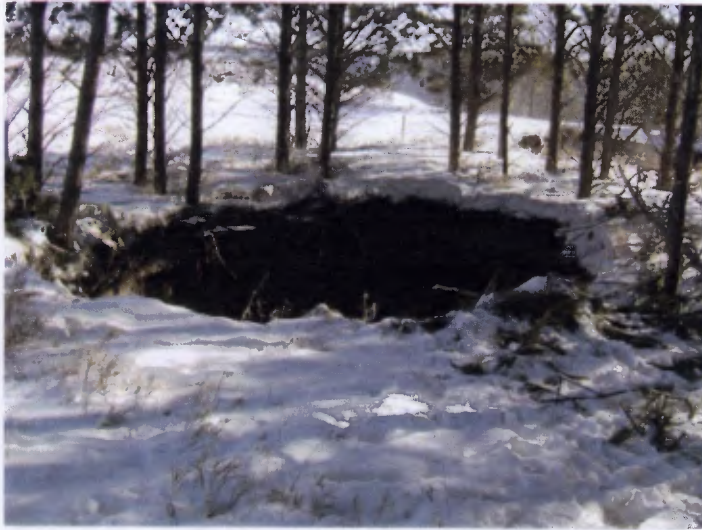
Sinkhole near ROW centerline in pine plantation. View is to the southeast

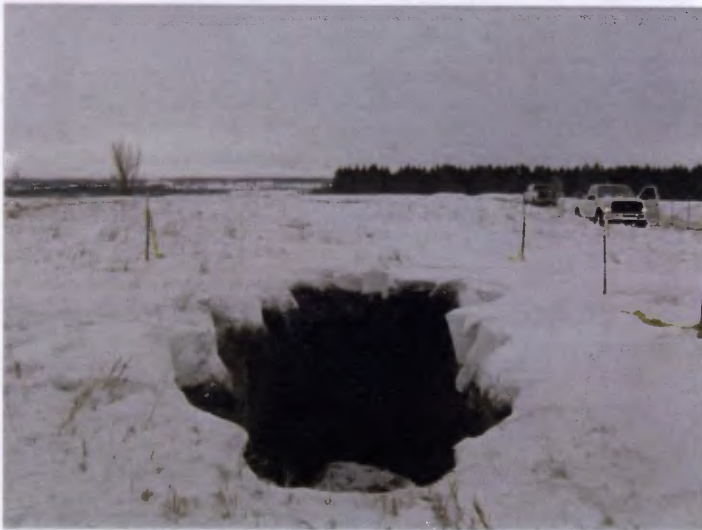
Sinkhole near drill exit point. View is to the south

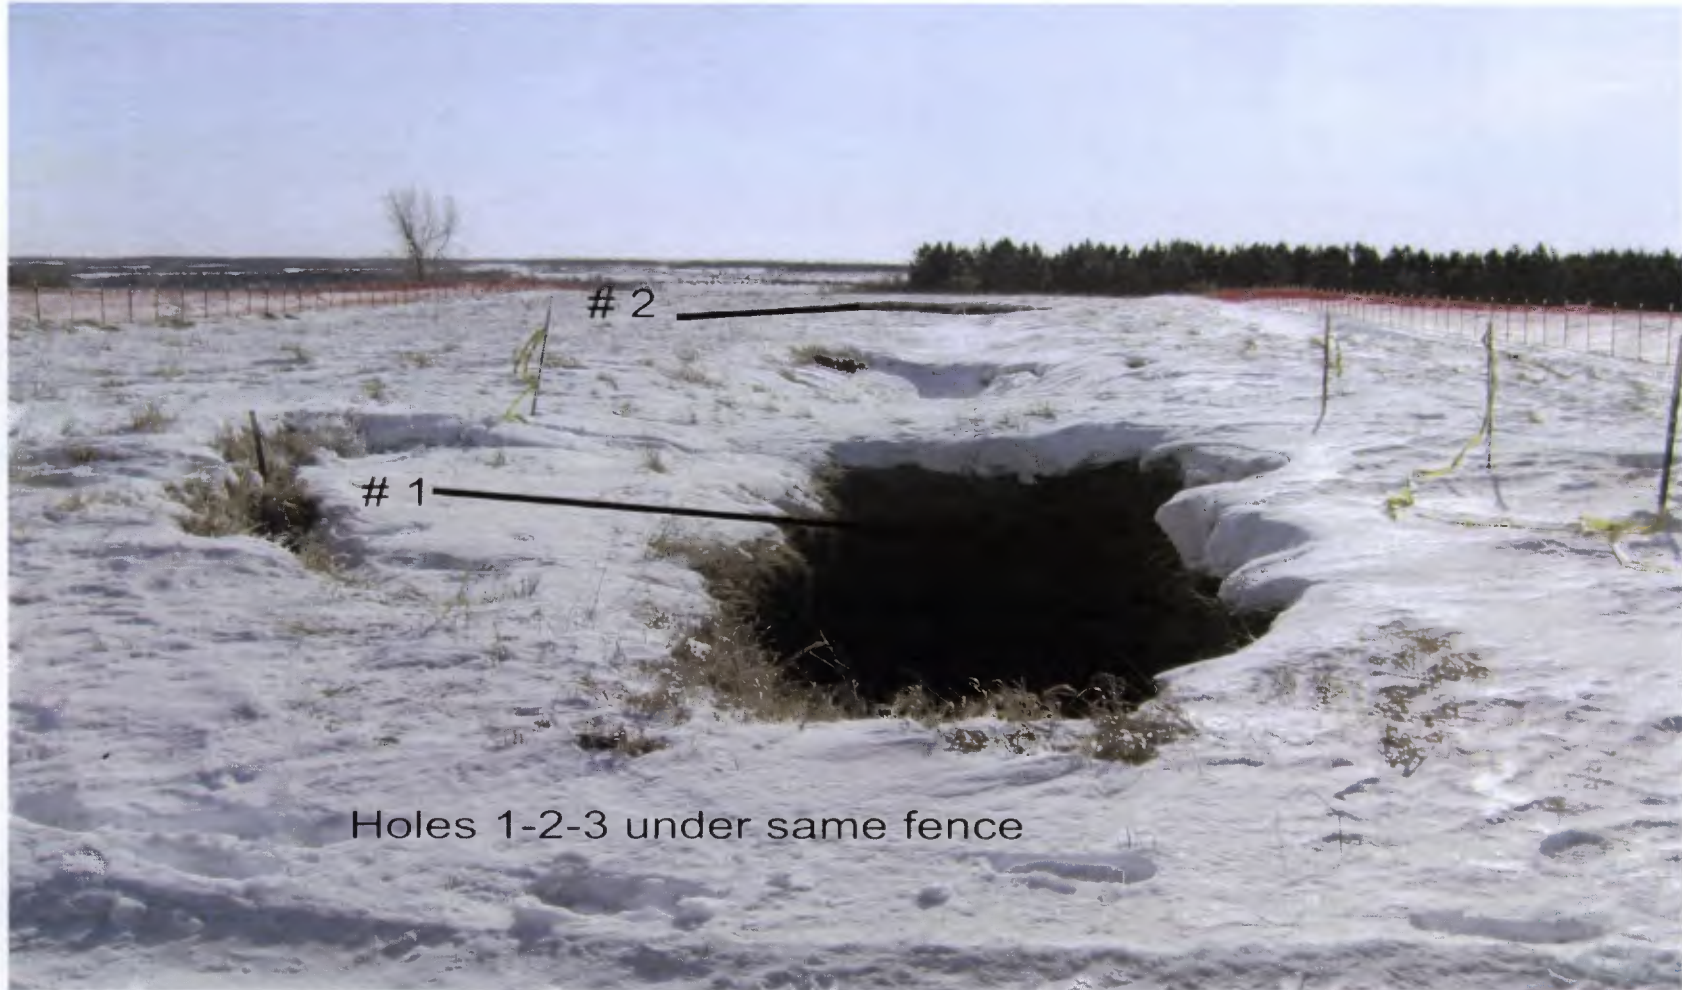
North Sinkholes with Safety Measures

Holes 1-2-3 under same fence

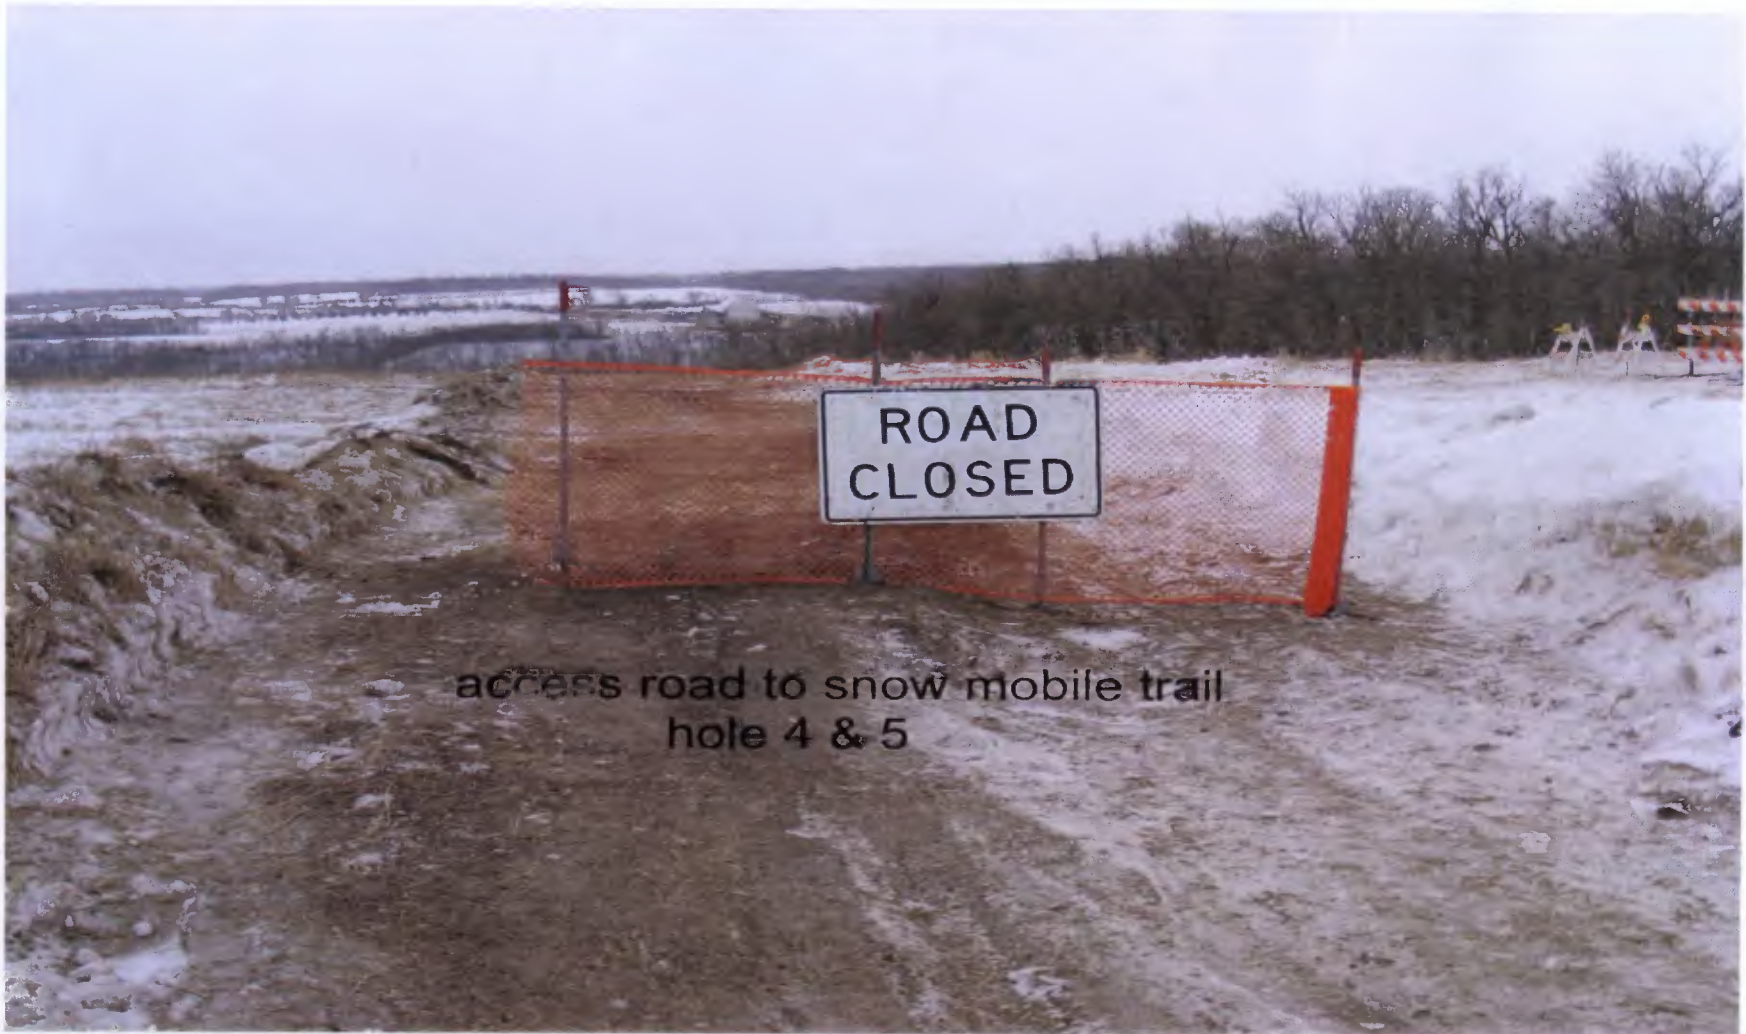
Safety Measures

access road to snow mobile trail
hole 4 & 5
