RE: Pembina River Directional Drill Crossing
Sink Hole Remediation Approach / Remediation Plan Drawings

Pembina Sinkhole Remediation Plan

Pembina River Directional Drill Crossing

**Sink Hole Remediation Approach
DRAFT**

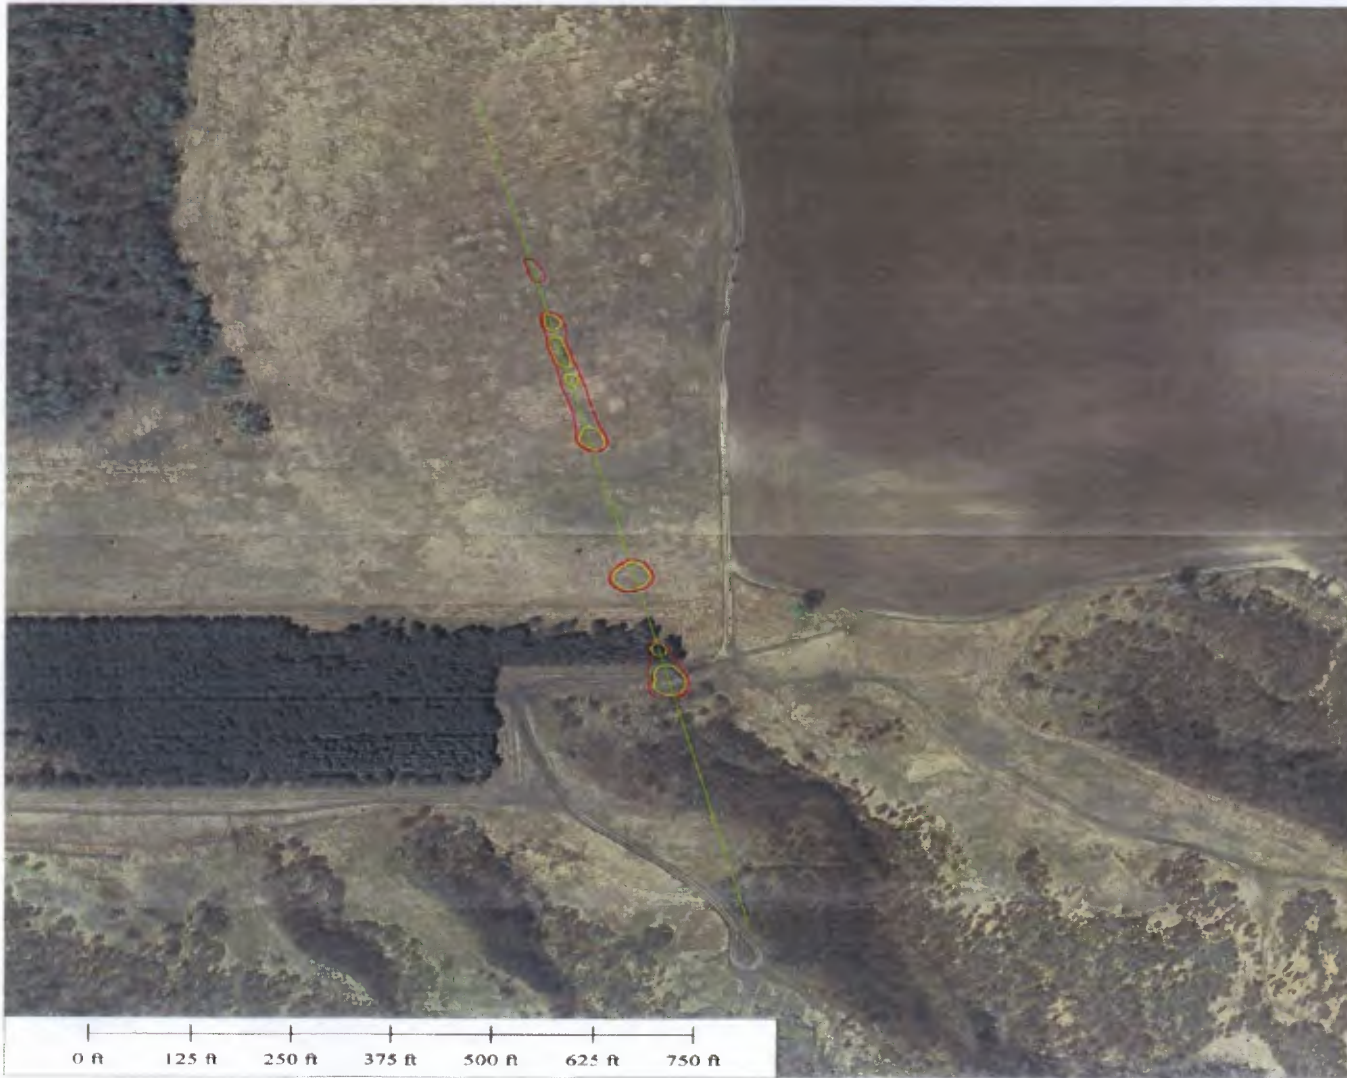
Sinkhole Location

- Subsidence was first noticed at the end of November 2008 while reaming operations were in progress
- Additional sinkholes occurred through February 2009
- Area affected by the sinkholes extends approximately 700-feet south from the drill exit point on the north side of the Pembina River

GREEN = PIPELINE YELLOW = SINKHOLE as of 021309 RED = SINKHOLE as of 032609

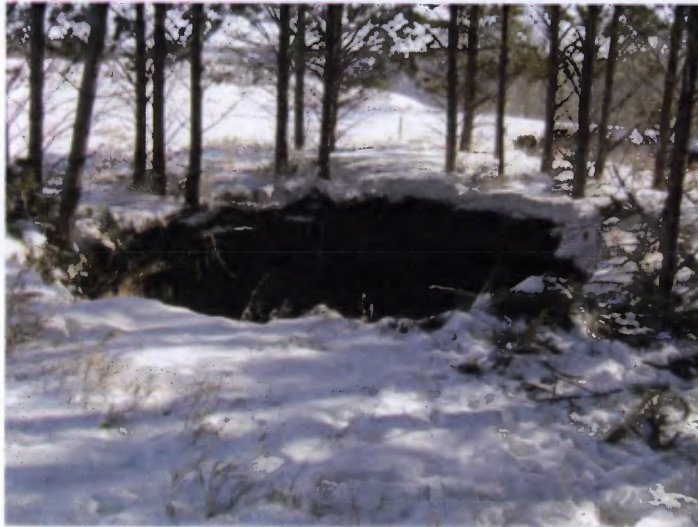
Sinkhole near ROW centerline in pine plantation. View is to the southeast

Some mid size pine trees fell into the two southern-most holes. Their presence may complicate the backfill and may promote localized subsidence as the wood decays over time. This area may be more critical due to the presence of the trail/access road. The trees must be removed prior to placing fill in the sinkholes.

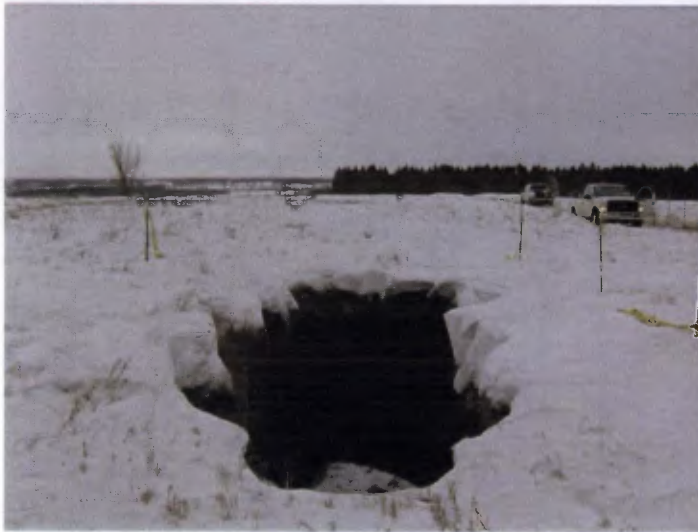
Sinkhole near drill exit point. View is to the south

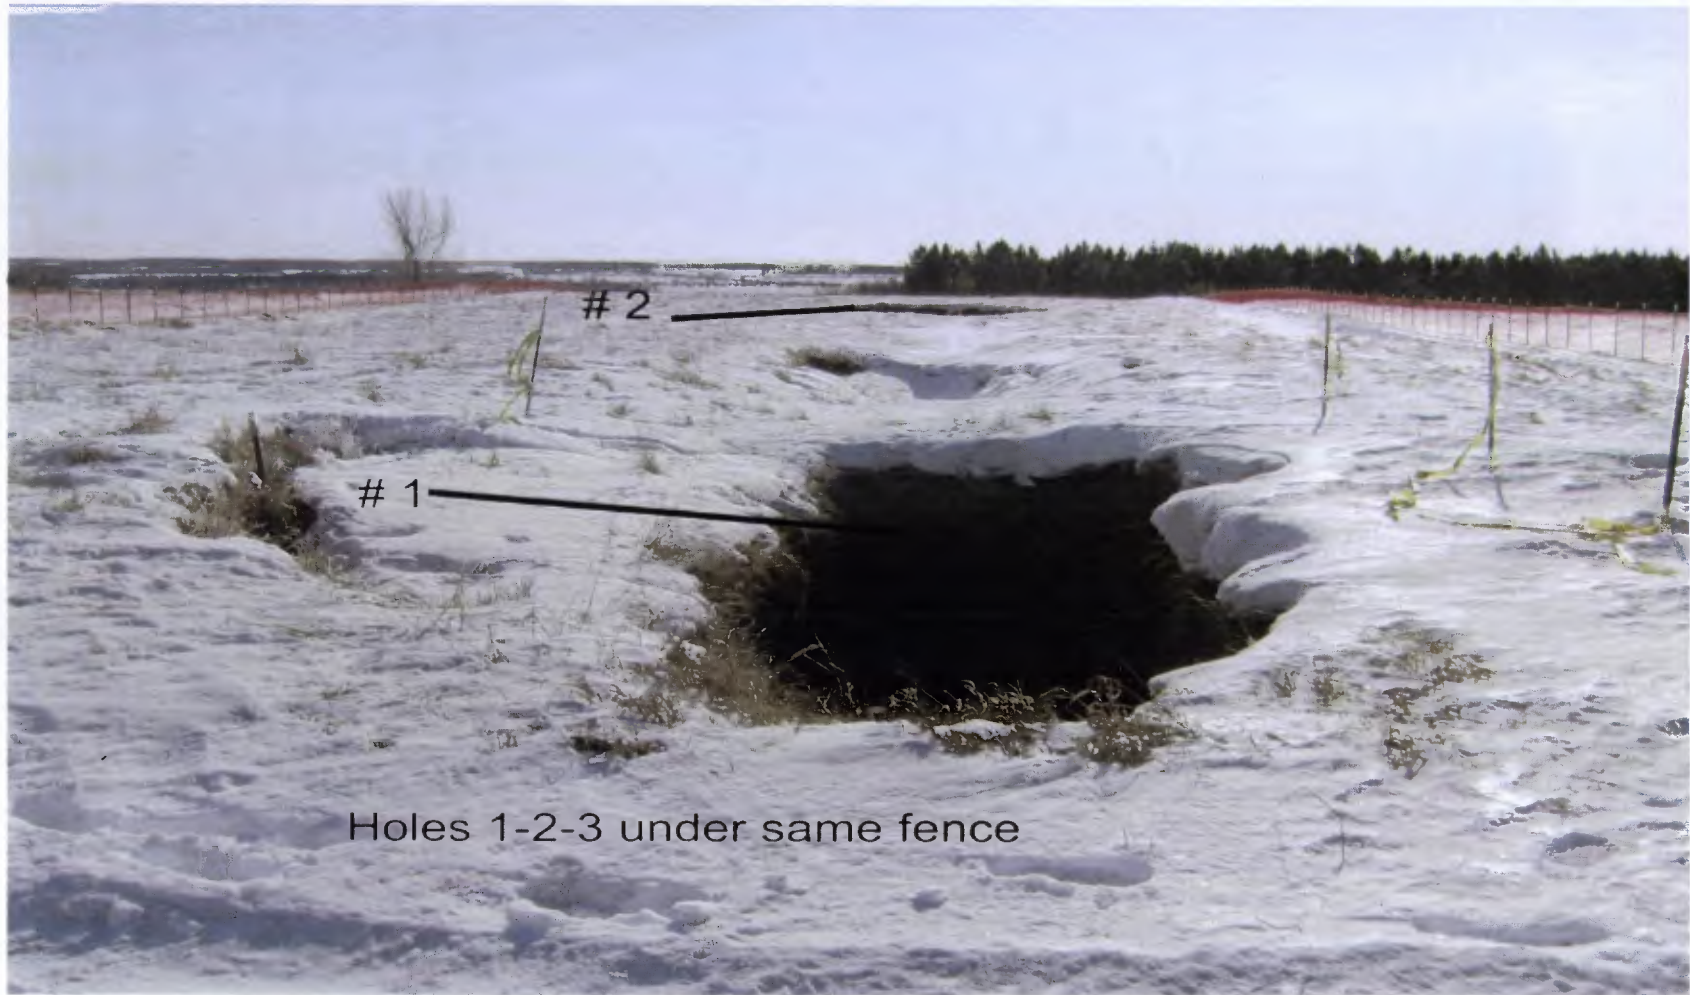
North Sinkholes with Safety Measures

Holes 1-2-3 under same fence

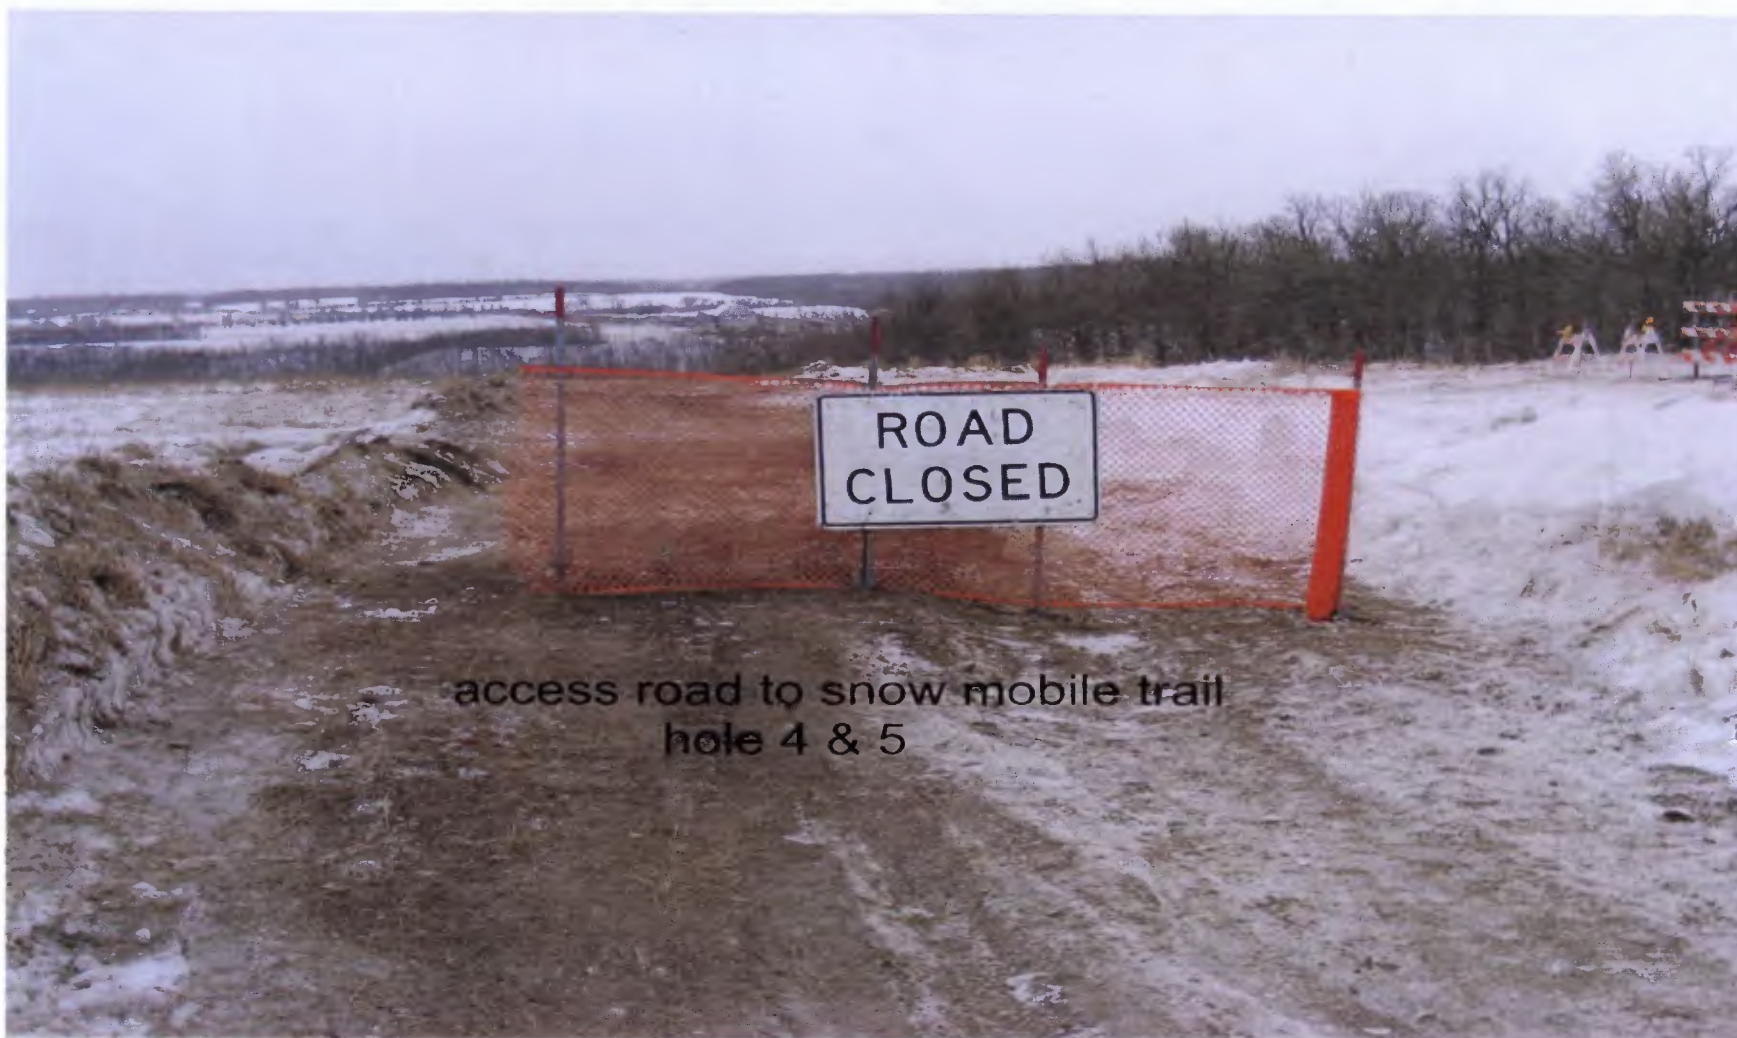
Safety Measures

access road to snow mobile trail
hole 4 & 5
