From: Ken Crowl [ken_crowl@transcanada.com]
Sent: Thursday, June 02, 2011 2:32 PM
To: Fahn, Patrick J.; Jeffcoat-Sacco, Ilona
Cc: Vern Meier; Jim Krause
Subject: Keystone Ludden Pump Station Release
Attachments: 0 Ludden Operations Data Summary 2011 05 11.pdf; Ludden Swage Nipple Failure Investigation.pdf; Ludden Corrective Action and Restart Plan.pdf

Operations Data Summary for Ludden Pump Station

LUDDEN SWAGE NIPPLE FAILURE INVESTIGATION

**LUDDEN SWAGE NIPPLE
CORRECTIVE ACTION and RE-START PLAN**

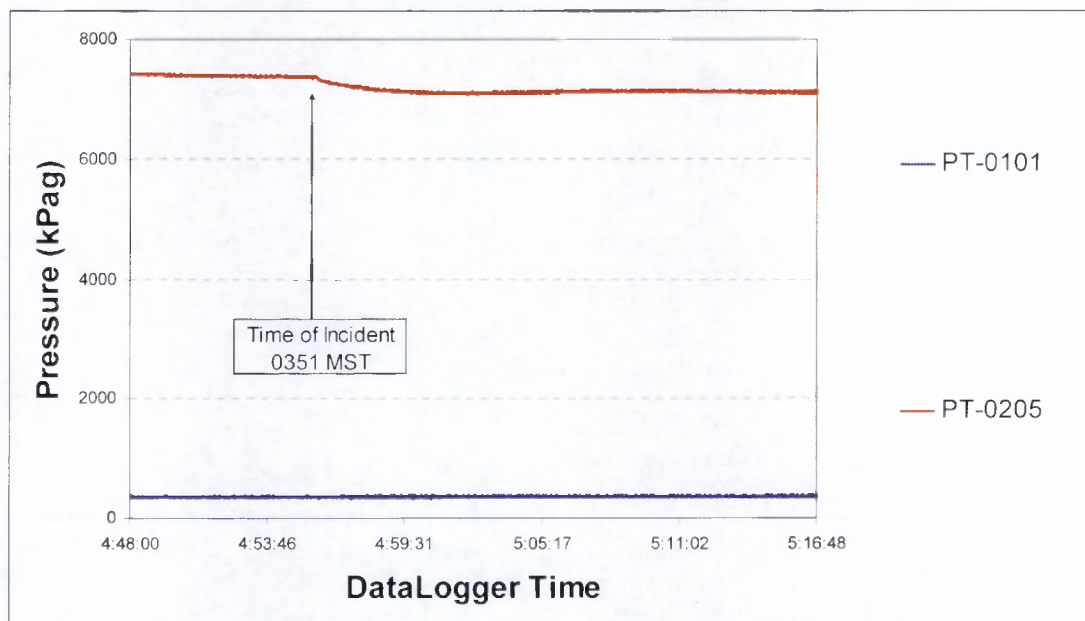
The data from Appendix A is shown graphically below. The Ludden Mainline Suction Pressure (PT-0101) is constant at 350 kPag throughout the time period shown. The Ludden Mainline Discharge Pressure (PT-0205) shows a trending decrease in pressure from approximately 7360 kPag commencing at approximately 0456 MDT May 7, 2011.

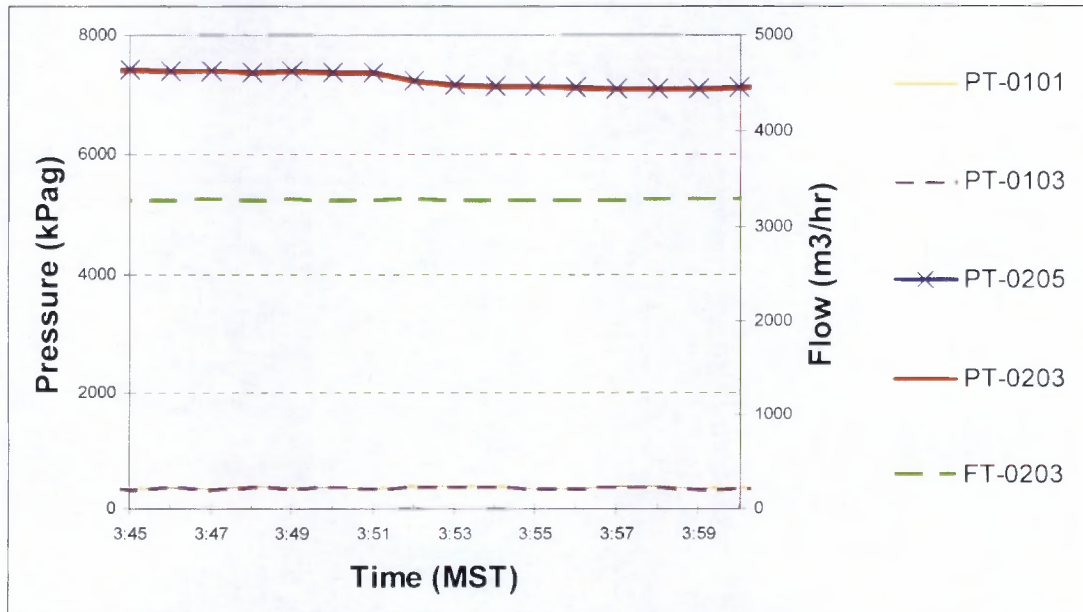
The historical data from Appendix B is also shown graphically below. As shown with the data from the station DataLogger, the Ludden Mainline Suction Pressure (PT-0101) from the historical SCADA data is constant at 350 kPag throughout the time period shown. The Ludden Station and Mainline Discharge Pressure (PT-0203 and PT-0205) show a trending decrease in pressure from approximately 7360 kPag to 7160 kPa commencing at approximately 0351 MST May 7, 2011. The historical SCADA data correlates to the station DataLogger data provided in Section 3 to confirm the commencement of the Ludden incident to be 0351 MST May 7, 2011.

The Ludden Flow Rate provided by Flow transmitter (FT-0203) is constant at approximately 3270 m³/hr throughout the time period shown.

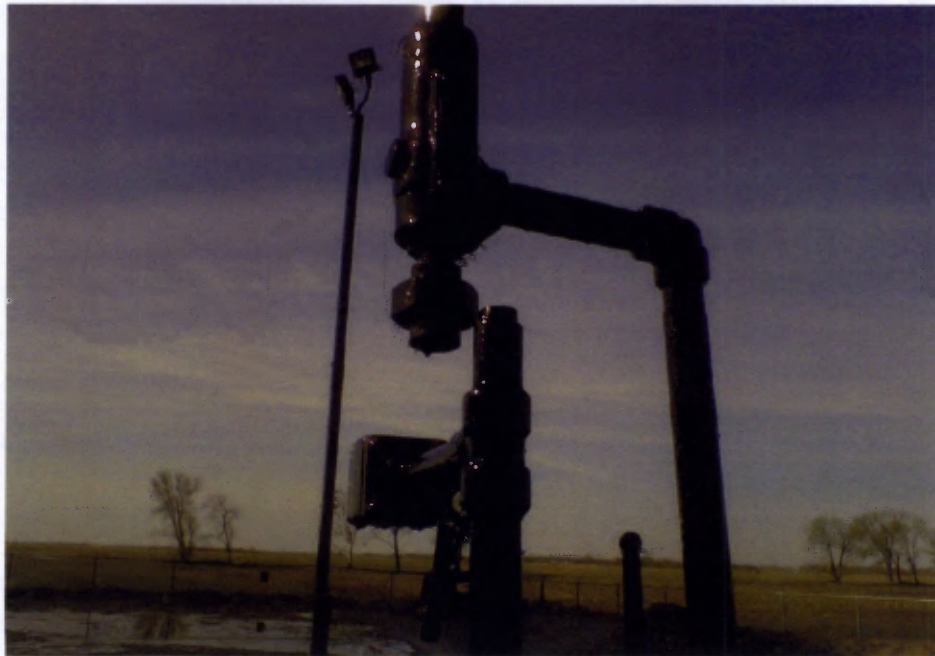
Figure 2 Failed Assembly as Found

The configuration of the piping assembly containing the failed fitting as found at the field site is depicted in Figure 2. The vertical leg of the piping includes the following: NPS 1 weldolet on run pipe, NPS 1 nipple, NPS valve, NPS 1 nipple, NPS 1 tee, NPS 1 x 3/4 swage nipple, NPS 3/4 union, and finally PSV.

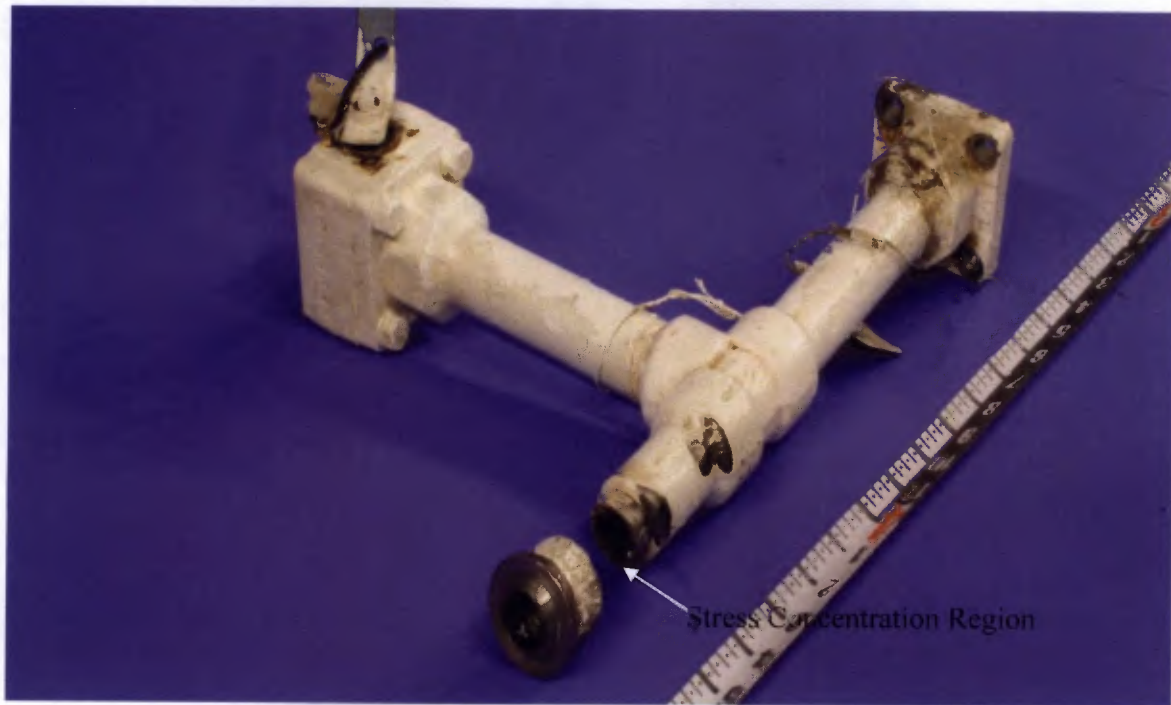
Figure 4: Failed Piping Assembly sent to Lab for Analysis, As-received

The piping assembly containing the failed fitting was shipped to Blade Energy Partners in Houston, who coordinated the testing with the primary laboratory being Anderson & Associates, Inc. The assembly as received by Blade on May 10th is depicted in Figure 4.

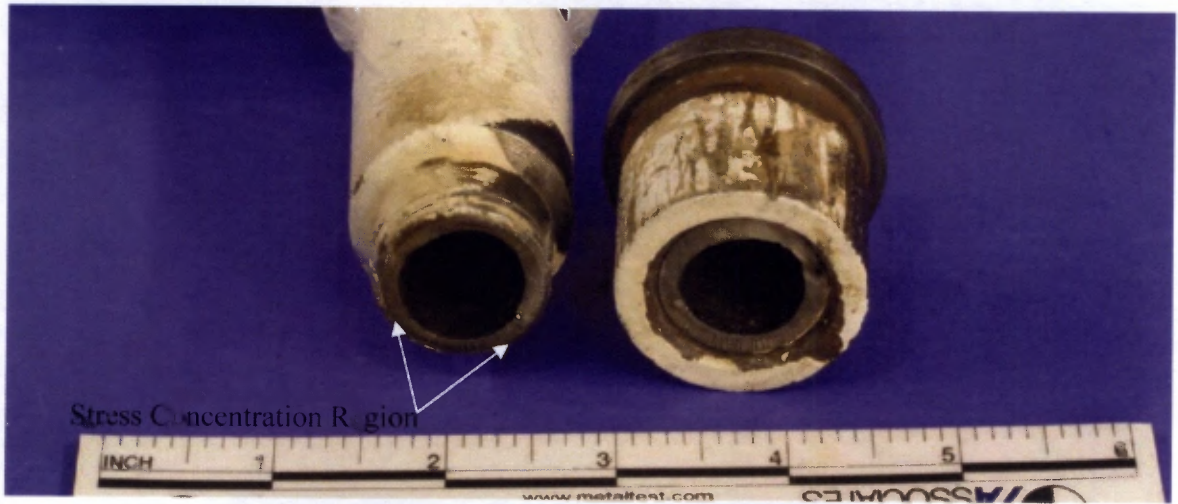
Figure 5: Matching Fracture Surfaces, As-received

The swage nipple had separated at the last thread exposed against the connected union as shown in Figure 5.

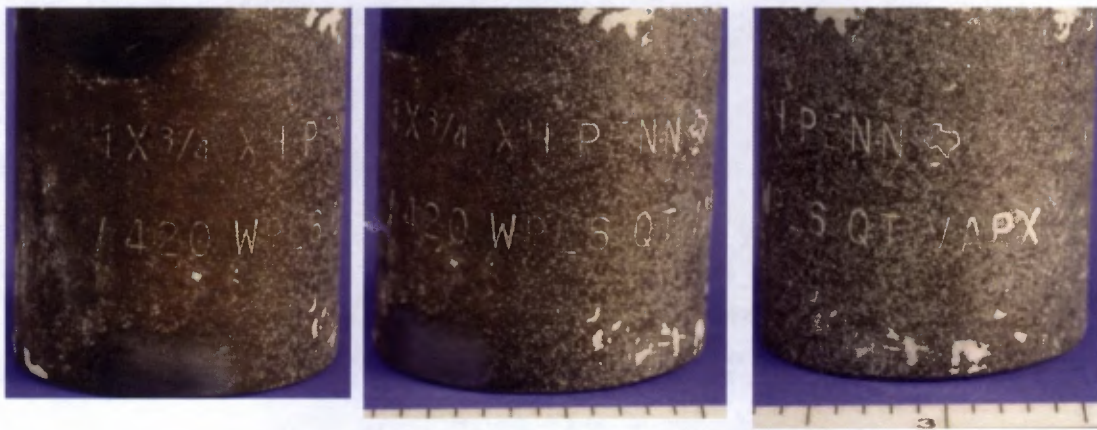
Figure 6: Stamped Markings on Swage Fittings

Figure 6 shows the swage nipple marking information, indicating that the nipple had been produced using ASTM A420 WPL6. ASTM A420, Specification of Piping Fittings for Wrought Carbon Steel and Alloy Steel for Low-Temperature Service,¹ This material specification is correct for this application.

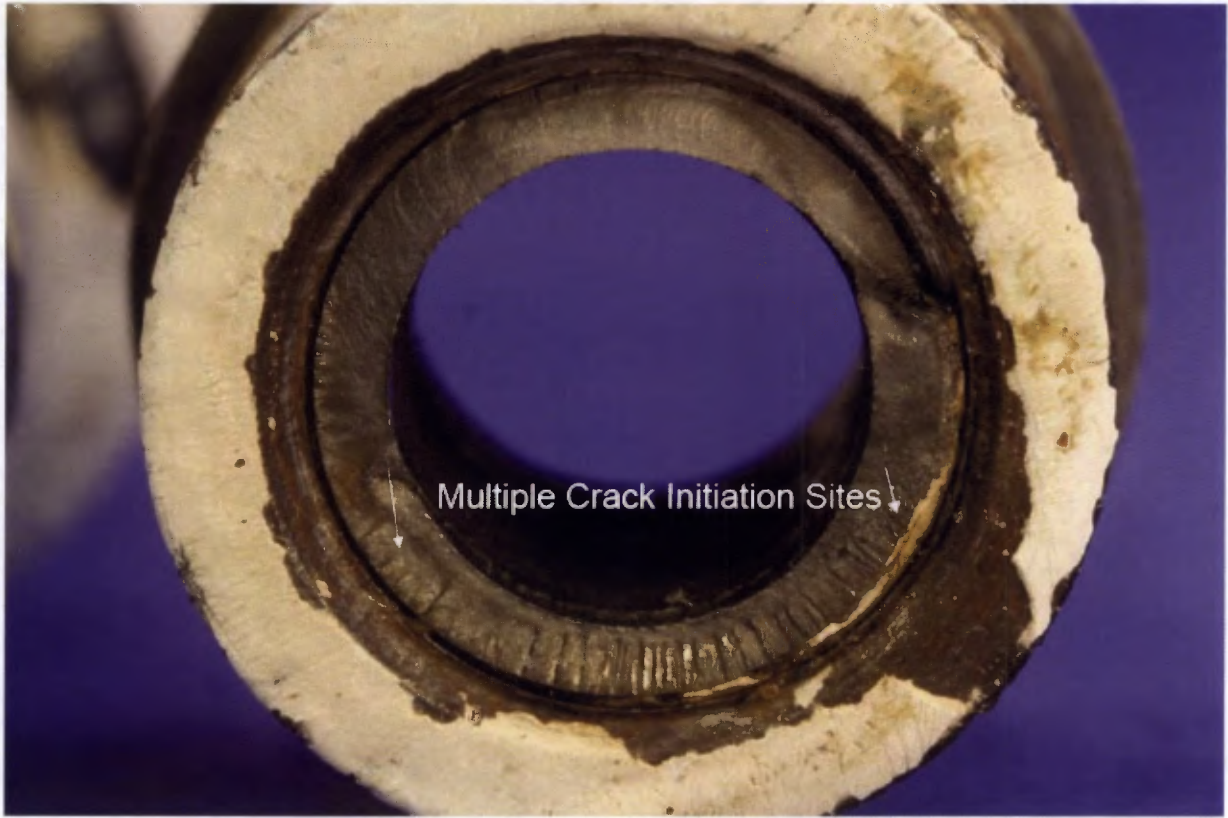
Figure 7: Close-up View of the Failure Surface Defined by Zones 1, 2 &3, As-received

Preliminary examination using a stereo microscope indicated that there were three distinct zones on the fracture surface (see Figure 7), and will be identified as Zones 1, 2, and 3.

Zone 1 represents an area of crack initiation is located around the entire circumference of the first thread visible on the surface with numerous crack initiation sites. Zone 2 extends approximately 150 degrees around the circumference, with crack propagation from the OD towards the ID, characterized with coarse ratchet (radial ridge) marks. The ratchet marks are indicative of fatigue. The remainder of the fracture surface, Zone 3 exhibits a slanted dull gray featureless surface that is typically associated with ductile shear failure.

The observations suggest that fracture had radiated from one side of the threaded connection, thus indicating that bending stresses had contributed to the failure.

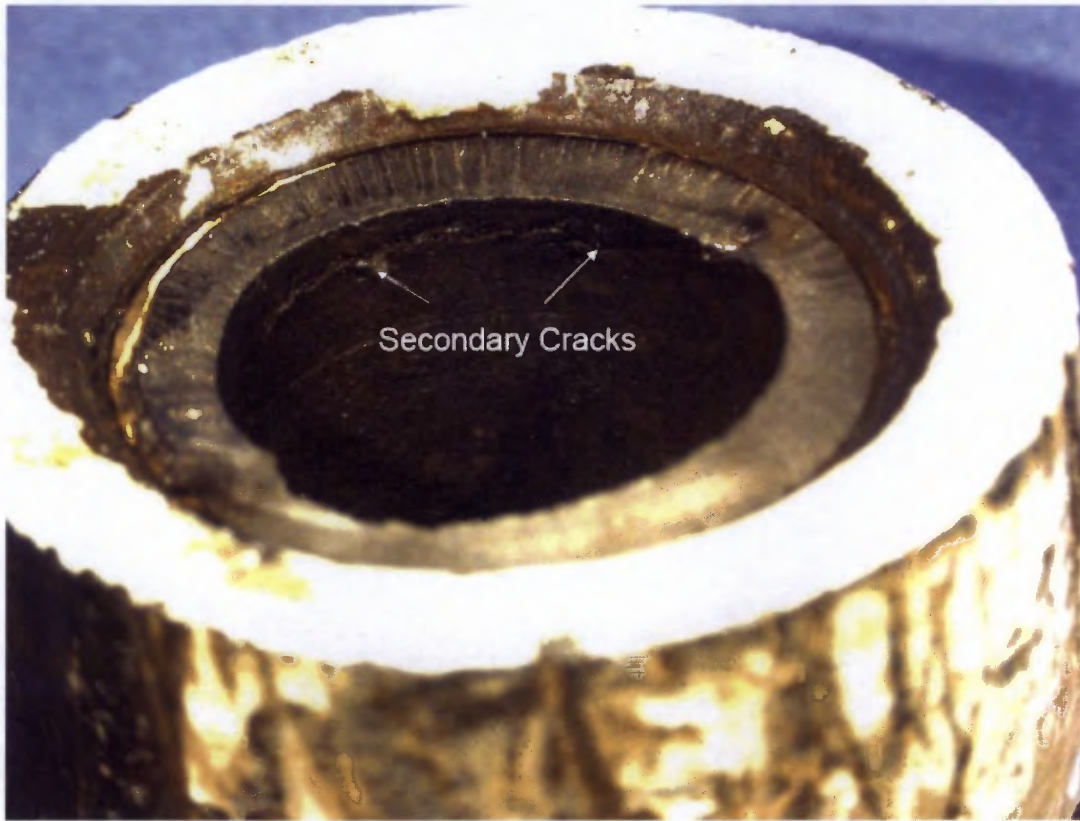
Figure 8: Secondary Cracks on the ID Surface of the Swage Nipple, As-received

The ID surface of the swage nipple (Figure 8) shows some secondary cracking below the fracture surface and indicates that this side of the fitting would have been subjected to high tensile bending stresses.

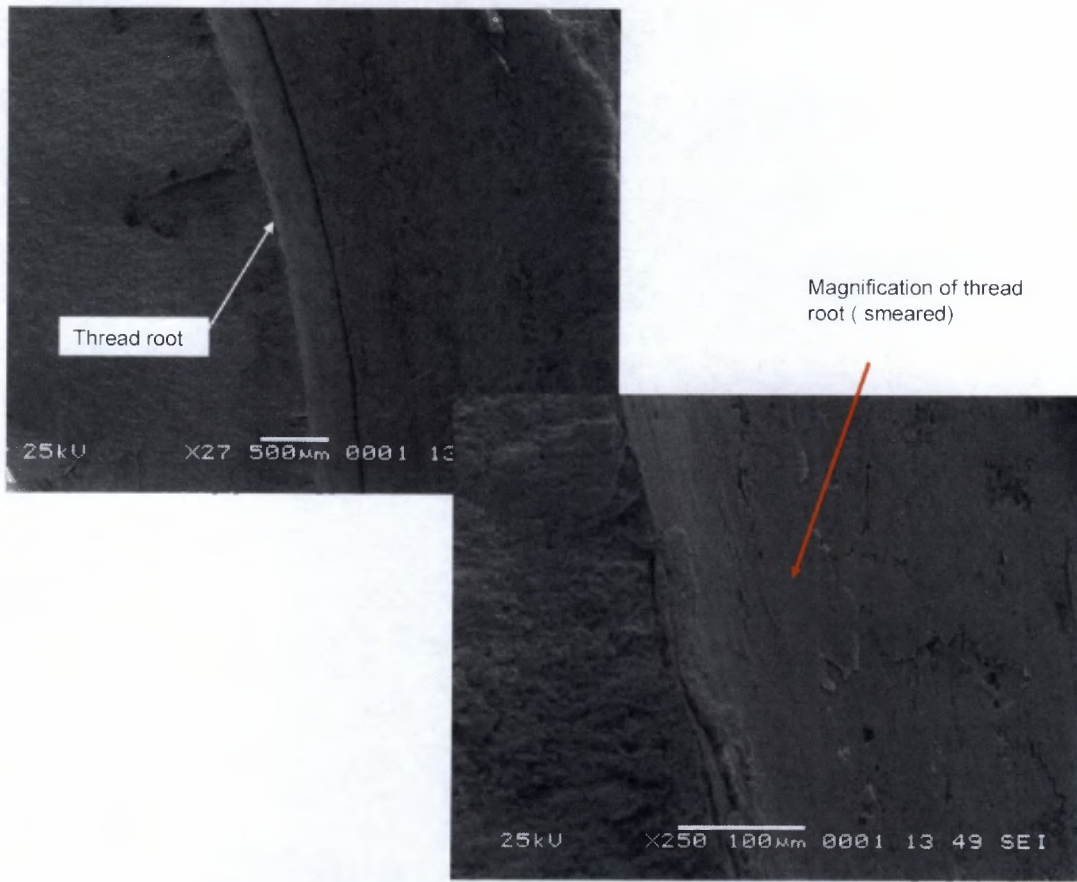
Figure 9: Appearance on the Root of the First Thread

Scanning electron microscopy was used to examine the fracture surfaces, focusing on determining the cause for crack initiation and propagation. Figure 9 shows the plastic deformation on the root of the first thread, which may be due to over torque during installation. At the edge of the 'smeared' root there are numerous shallow cracks that extend towards the ID of the nipple.

The swage nipple failure had initiated from shallow cracks associated with plastic deformation at the root of the thread, likely as a result of over-torque during installation. The cyclic bending stress fatigue due to the vibration propagated the cracks to failure.

- increasing mechanical strength of the swage nipple by replacing it with Schedule 160 nipple (the failed swage nipple was Schedule 80)
- elimination of the thermal relief valve piping vibration by installing proper pipe supports.

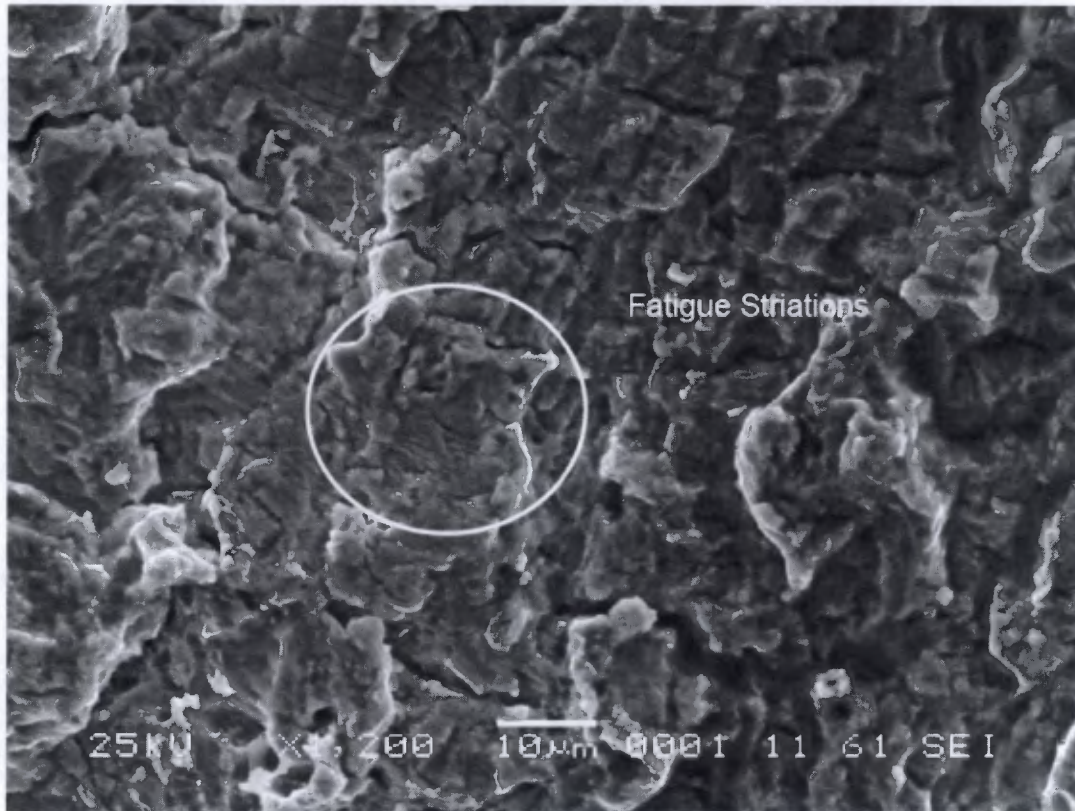
Figure 10: Typical Fatigue Fracture Defined by Striations

Figure 10 shows multiple parallel striations typical of fatigue fracture and commonly associated with cyclic bending stress fatigue. This finding is consistent with the macro examination indicative of fatigue by the ratchet marks.

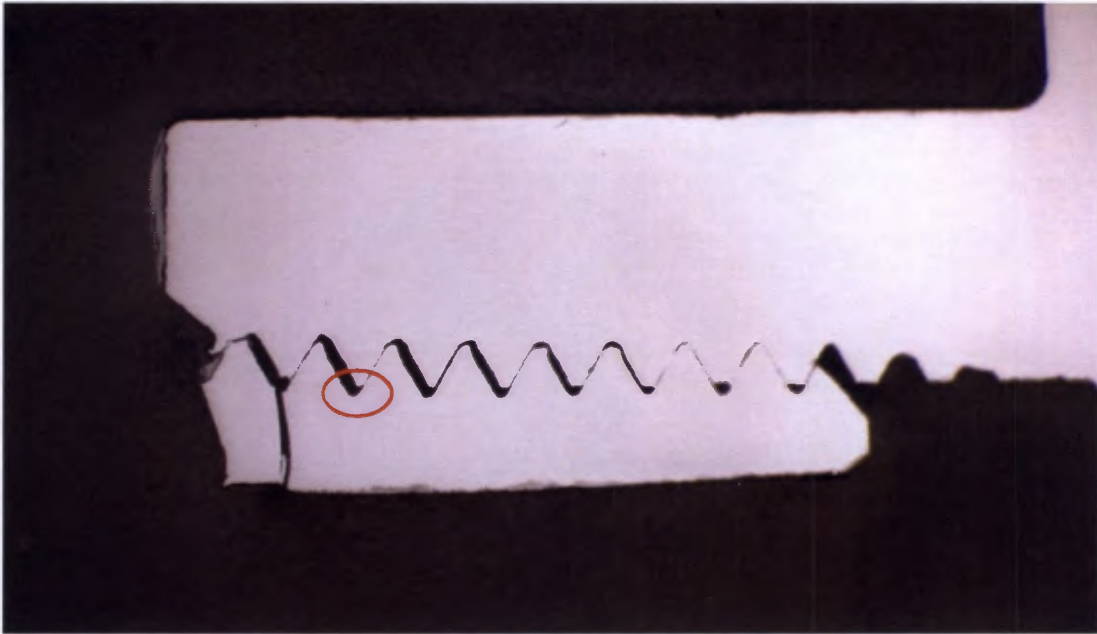
Figure 11: Location and Orientation of Microstructure Sample Highlighting the Root of the Third Thread

Cross-sections of the swage/union were prepared from both parts for microstructural examination, and specifically to confirm the expected microstructures, to examine for evidence of material defects, and to determine if there are any regions of plastic deformation, the latter being indicative of overstressing at the threaded connection. Figure 11 shows the swage union section cracks and engaged threads. Figure 12 shows straight secondary cracks that had initiated at the root of the third thread. Figure 13 is the close-up view of Fig. 12 with an etched sample. The secondary crack is straight and transgranular, which is consistent with cyclic stress fatigue. The root of the thread was heavily deformed, which is consistent with the observation of the smeared surface apparent in Figure 9.
