739 PU-06-421 Filed: 8/26/2011 Pages: 19
**Keystone system restart plan and executive
summary of submittals to PHMSA**

KEYSTONE SYSTEM RESTART PLAN

**- Following Ludden, ND Pump Station Thermal Relief Valve Nipple Failure and Severance,
KS Pump Station Discharge Pressure Transmitter Nipple Failure Incidents**

Executive Summary

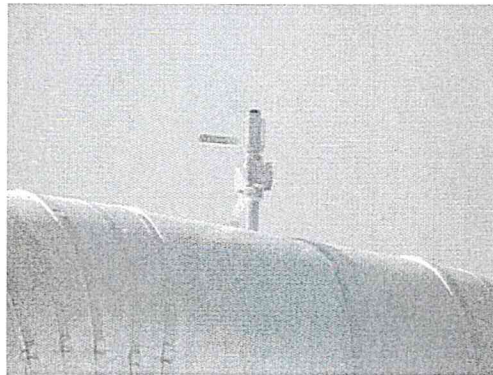
High Point Vents

On June 8th, continuous monitoring points at Severence PS were moved to high point vents to determine the response. The high point vents consist of a 1" nipple welded into the main pipe via a socket welded connection with a weld by threaded ball valve connected to a nipple with a second valve FNPT x FNPT ball valve that was capped with a pipe plug.

High levels of vibration were found when the control valve was pinched >50%. Consistent overall values were found to be up to 5 ips with intermittent spikes up to 16 in/s when PCV's pinched as part of line pressure control.

On report of the high level of vibration, further assessment was completed. The high levels of vibration were assessed in the frequency domain at points corresponding to high levels of overall vibration. The predominant frequency was found to be at approximately 77 Hz which corresponded to the natural frequency of the attachment.

The vibration amplitude was assessed against EDI/SWRI screen criteria and found to be at a level that required remedial action. To increase the natural frequency of the attachment and remove areas of high levels of stress at threaded connections, all high point vents were removed from all fixed speed sites and as an added precaution, at variable speed sites as well.

Vibration testing after the modification showed vibration within limits when the PCV was open and vibration spikes during start up and shutdown of the station where the PCV opens and closes. Vibration was assessed in the frequency domain at one of the spikes in overall vibration where it was found that the

predominant frequency was approximately 132 hz. The vibration amplitude was assessed against EDI/SWRI screening criteria and found to be within limits.
