770 **PU-06-421** Filed: 1/28/2013 Pages: 19
**Summary of Oct., Nov., Dec., 2012 monthly report
submitted to PHMSA**

TransCanada Keystone Pipeline, LP

CPF No. 3-2011-5006H – Keystone Pipeline Corrective Action Order
October 2012 Monthly Report

CPF No. 3-2011-5006H – Keystone Pipeline Corrective Action Order
November 2012 Monthly Report

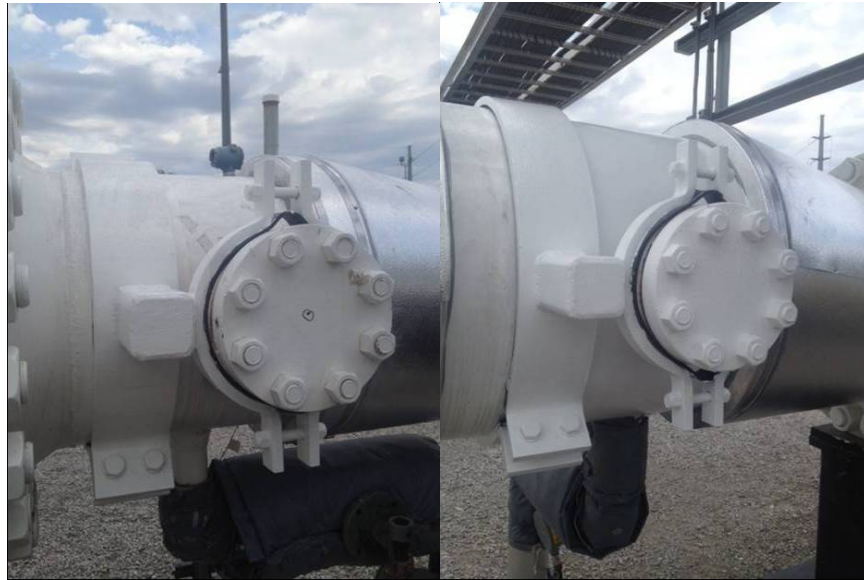
Unit discharge MOV bypass nozzles are located upstream and downstream from the pump discharge motor operated valve (MOV). Based on the recent strain test results the nozzles on pump #4 at all eight fixed speed stations were braced as shown in Figure 1. Effectiveness of the bracing was verified through a strain test at Severance pump station. The test results were provided in the September 2012 monthly report. In addition, all the MOV bypass nozzles, which prior to bracing showed vibration higher than the screening value of 1 in/s when energy dissipation across the station PCV was at 3000 kW level, were re-tested after bracing. Vibration of all the braced nozzles was below the screening value of 1 in/s, except for the downstream nozzle at Freeman fixed speed station which was measured to be 1.19 in/s. This nozzle will be further evaluated to determine acceptability.

Figure 1: Examples of braced pump #4 discharge MOV bypass nozzles at the fixed speed stations: upstream from MOV (left) and downstream from MOV (right).

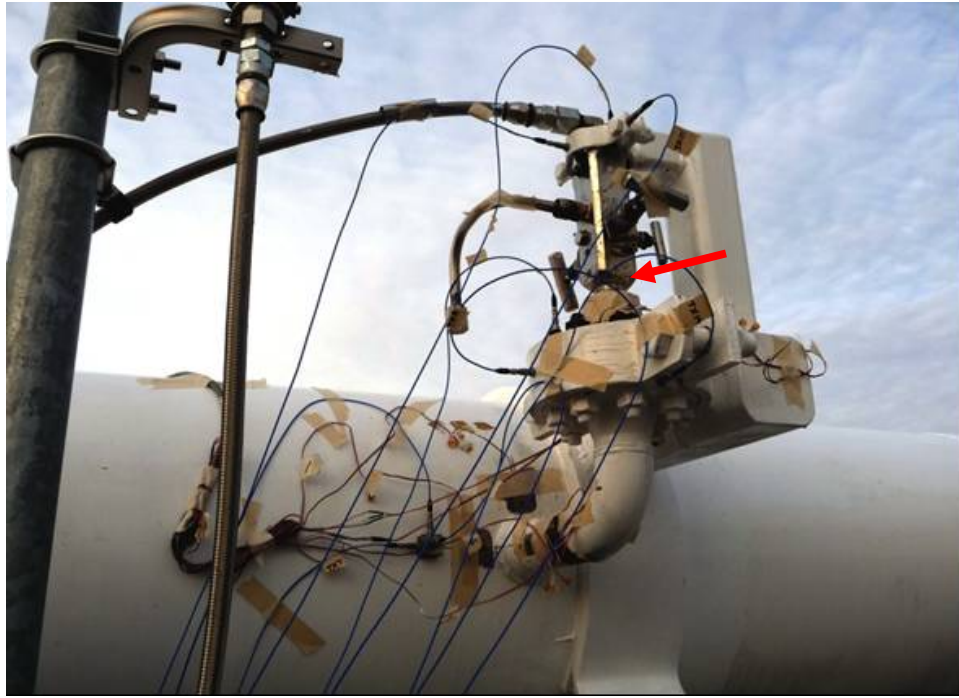
As reported in the September 2012 monthly report, vibration levels of PT201 manifolds at Steele City, Tina, Salisbury and Pierron VFD stations and PT203 at Pierron exceeded the screening value of 1 in/s. These manifolds were braced as shown in Figures 2 and 3. Effectiveness of the bracing was verified through vibration tests at all four stations. In addition, strain test of the PT201 manifold was completed at Steele City VFD station at 2000 kW energy dissipation across the PCV. This manifold was selected for the strain test because it can be exposed to higher levels of vibratory excitation than PT manifolds at other VFD stations (due to higher energy dissipation levels across the PCV occurring at Steele City). All vibration readings of the braced PT manifolds at Tina, Salisbury and Pierron were below the screening value of 1 in/s. Although vibration of the braced PT201 manifold at Steele City exceeded the screening value of 1 in/s, all the strain levels in the critical area shown in Figure 2 were below the screening value of 100 $\mu\epsilon$. Bracing of the PT201/ and PT203 manifolds was therefore effective in reducing the strains to acceptable levels.

Figure 2: Braced PT201 manifold at Steele City VFD station

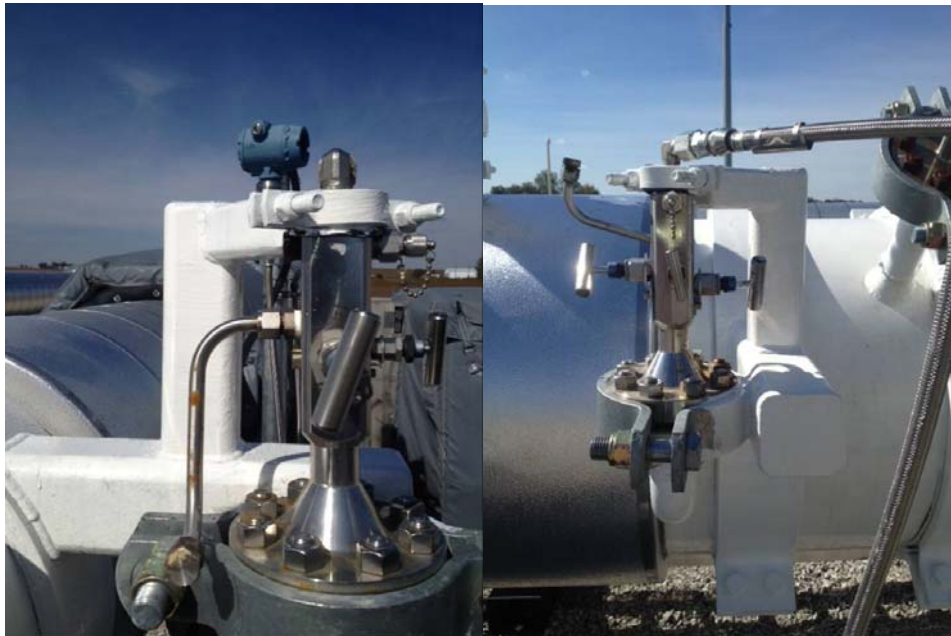
Figure 3: Braced PT201 (left) and PT203 (right) manifolds at Pierron VFD station

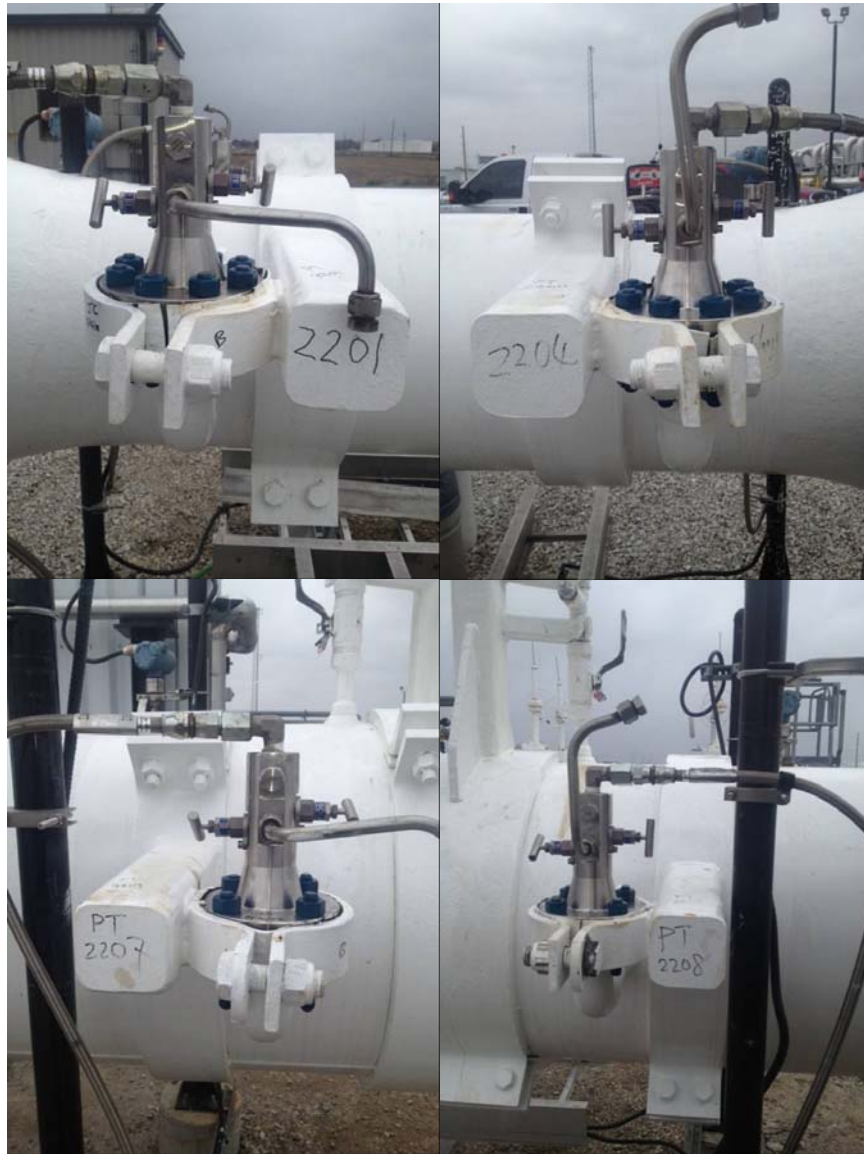
Figure 4: New PT2201, PT2204, PT2207 and PT2208 manifolds at Hartford Delivery Terminal

- PT manifolds PT2201, PT2204, PT2207 and PT2208 upstream and downstream from the PCV were replaced with manifolds not sensitive to vibration, as shown in Figure 4.
- The terminal drain and water injection connection downstream from the PCV were abandoned by removing the valves and closing the nozzles with blind flanges. Before and after configurations are shown in Figure 5.
- PSV2205 and PSV2206 bracing was improved to minimize vibration of the PSV assemblies.

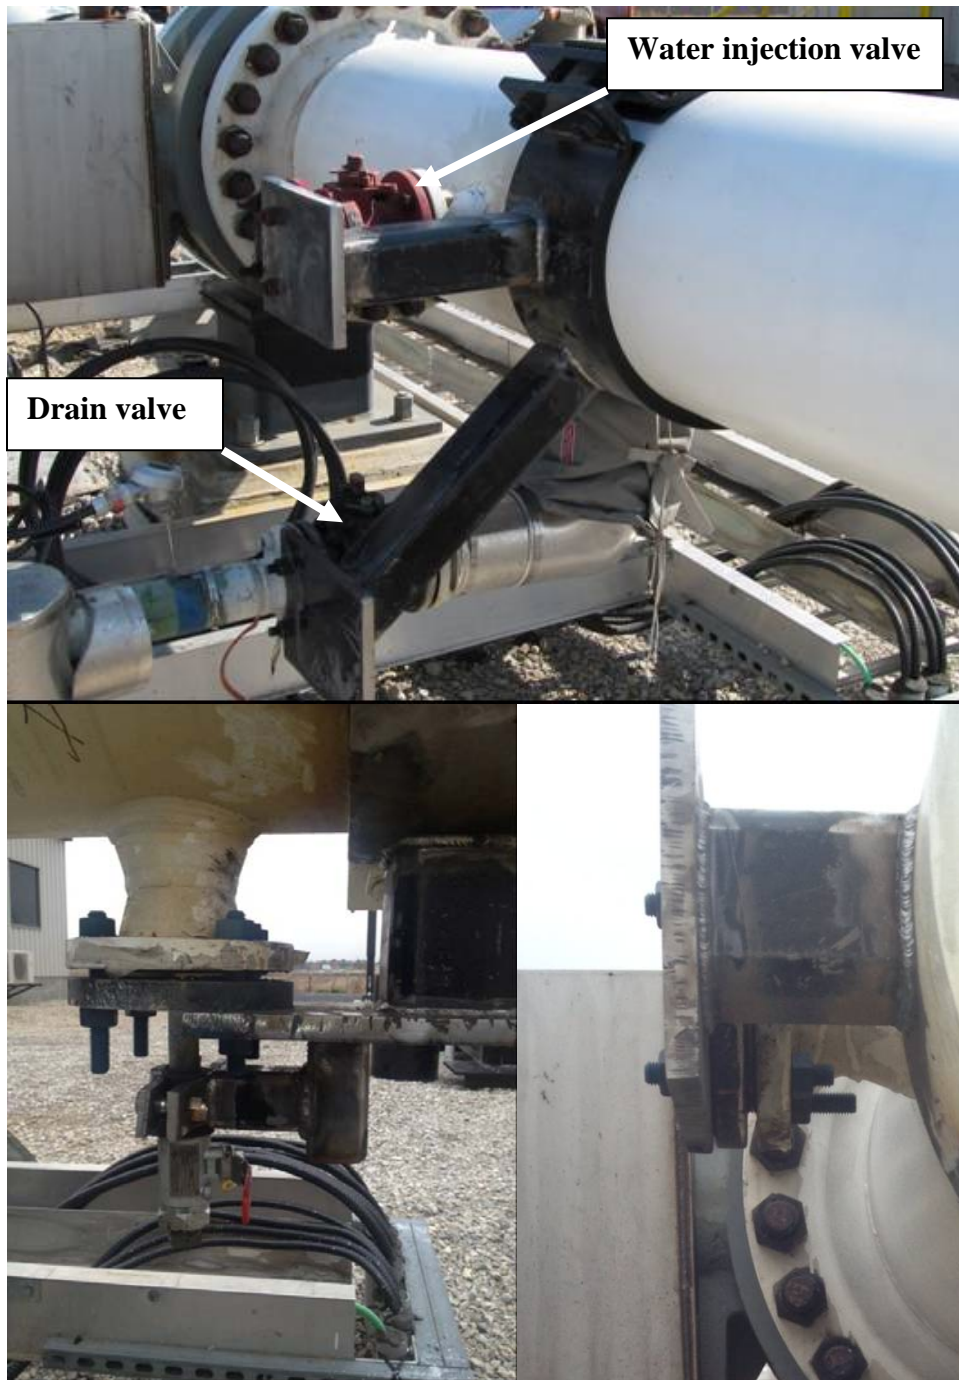
Figure 5: Hartford Delivery Terminal – drain and water injection branch connections: original configuration (top), abandoned drain (bottom left) and abandoned water injection (bottom right)

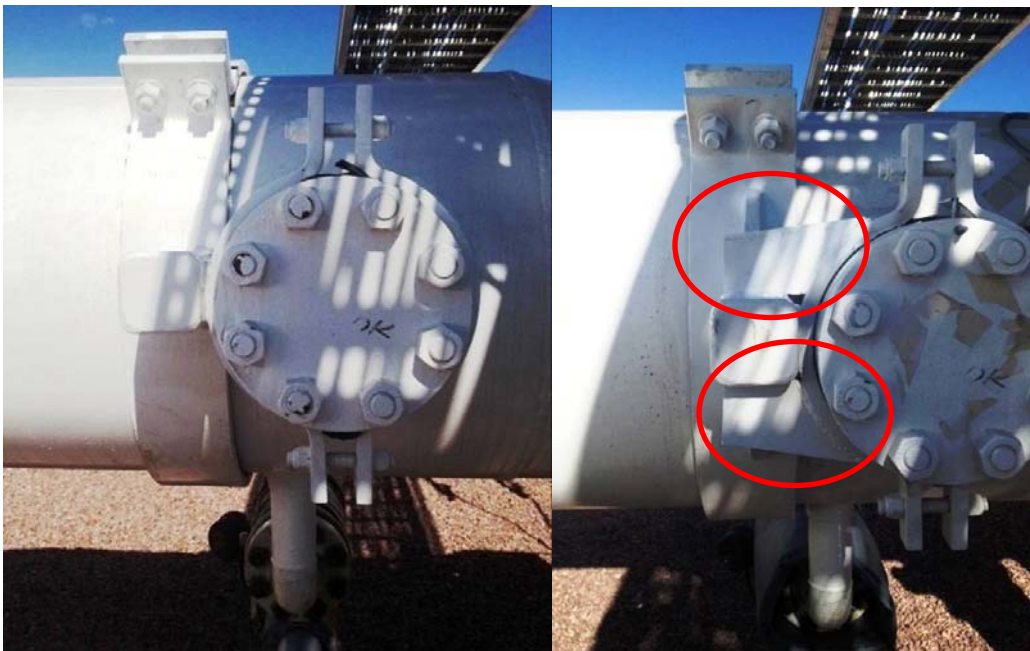
Unit discharge MOV bypass nozzles are located upstream and downstream from the pump discharge motor operated valve (MOV). As reported in the October 2012 monthly report, the nozzles on pump #4 at all eight fixed speed stations were braced and the effectiveness of the bracing was verified through vibration tests at all the stations. Vibration of all the braced nozzles was below the screening value of 1 in/s, except for the downstream nozzle at Freeman fixed speed station which was measured to be 1.19 in/s. The bracing of this nozzle was further reinforced to improve the nozzle long term integrity. Figure 1 shows the original (left) and reinforced (right) bracing. A validation strain and vibration test of the improved bracing was completed at 3000 kW energy dissipation across the station PCV. All vibration levels were below the screening value of 1 in/s and the peak strain was 139 $\mu\epsilon$. A 3D FEA was used to determine strain amplification between the strain gauge location and the adjacent weld toe. The analysis determined the strain amplification factor to be 3.17, as shown in Figure 2. The resulting peak strain at the weld toe was 441 $\mu\epsilon$ and the resulting factor of safety for the nozzle was 1.96, based on the material endurance limit of 866 $\mu\epsilon$. The bracing improvement was effective in reducing the nozzle vibration and strains to acceptable levels.

Figure 1: Braced pump #4 discharge MOV bypass nozzle at Freeman fixed speed station: original brace (left) and reinforced brace (right).

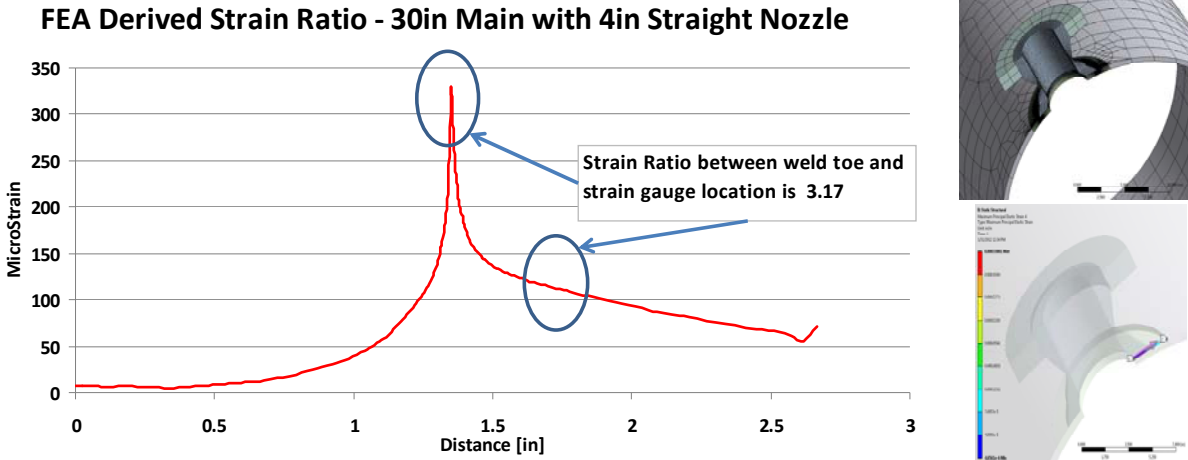
Figure 2: Results of FEA for pump discharge MOV bypass nozzle

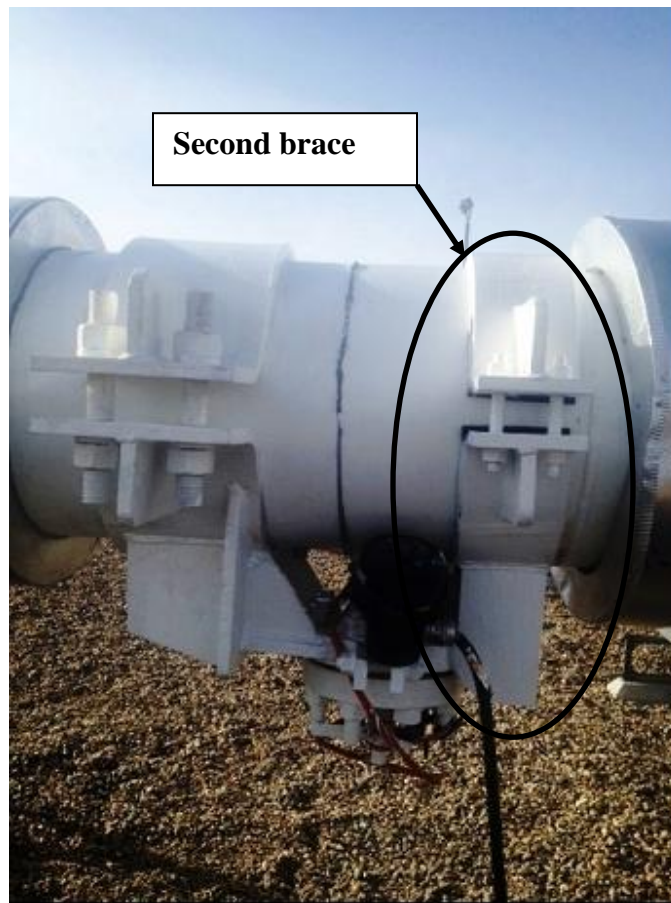
The long term integrity of Fort Ransom station drain nozzle located upstream from the PCV was improved by the addition of a second brace as shown in Figure 1. The effectiveness of the double brace was validated through a vibration and strain test at 3500 kW energy dissipation across the PCV. The maximum vibration of the drain nozzle was 1.04 in/s and maximum piping strain was 112 $\mu\epsilon$. A 3D FEA was used to determine strain amplification between the strain gauge location and the adjacent weld toe. The analysis determined the strain amplification factor to be 2.7, as shown in Figure 2. The resulting peak strain at the weld toe was 302 $\mu\epsilon$ and the resulting factor of safety for the nozzle was 2.86, based on the material endurance limit of 866 $\mu\epsilon$. The bracing improvement was effective in reducing the nozzle vibration and strains to acceptable levels.

Figure 1: Fort Ransom drain nozzle upstream from the PCV with double bracing

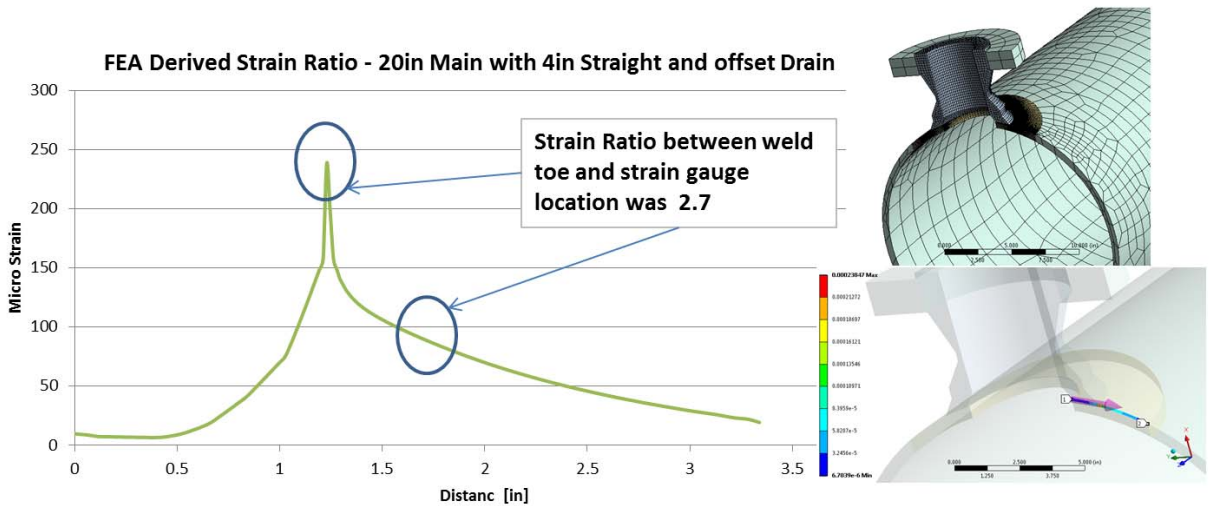
Figure 2: Results of FEA for 4” drain nozzle from 20” header
