Langdon I Wind Energy Center Construction Inspection Report

*NextEra Energy Resources LLC
Langdon Wind LLC*

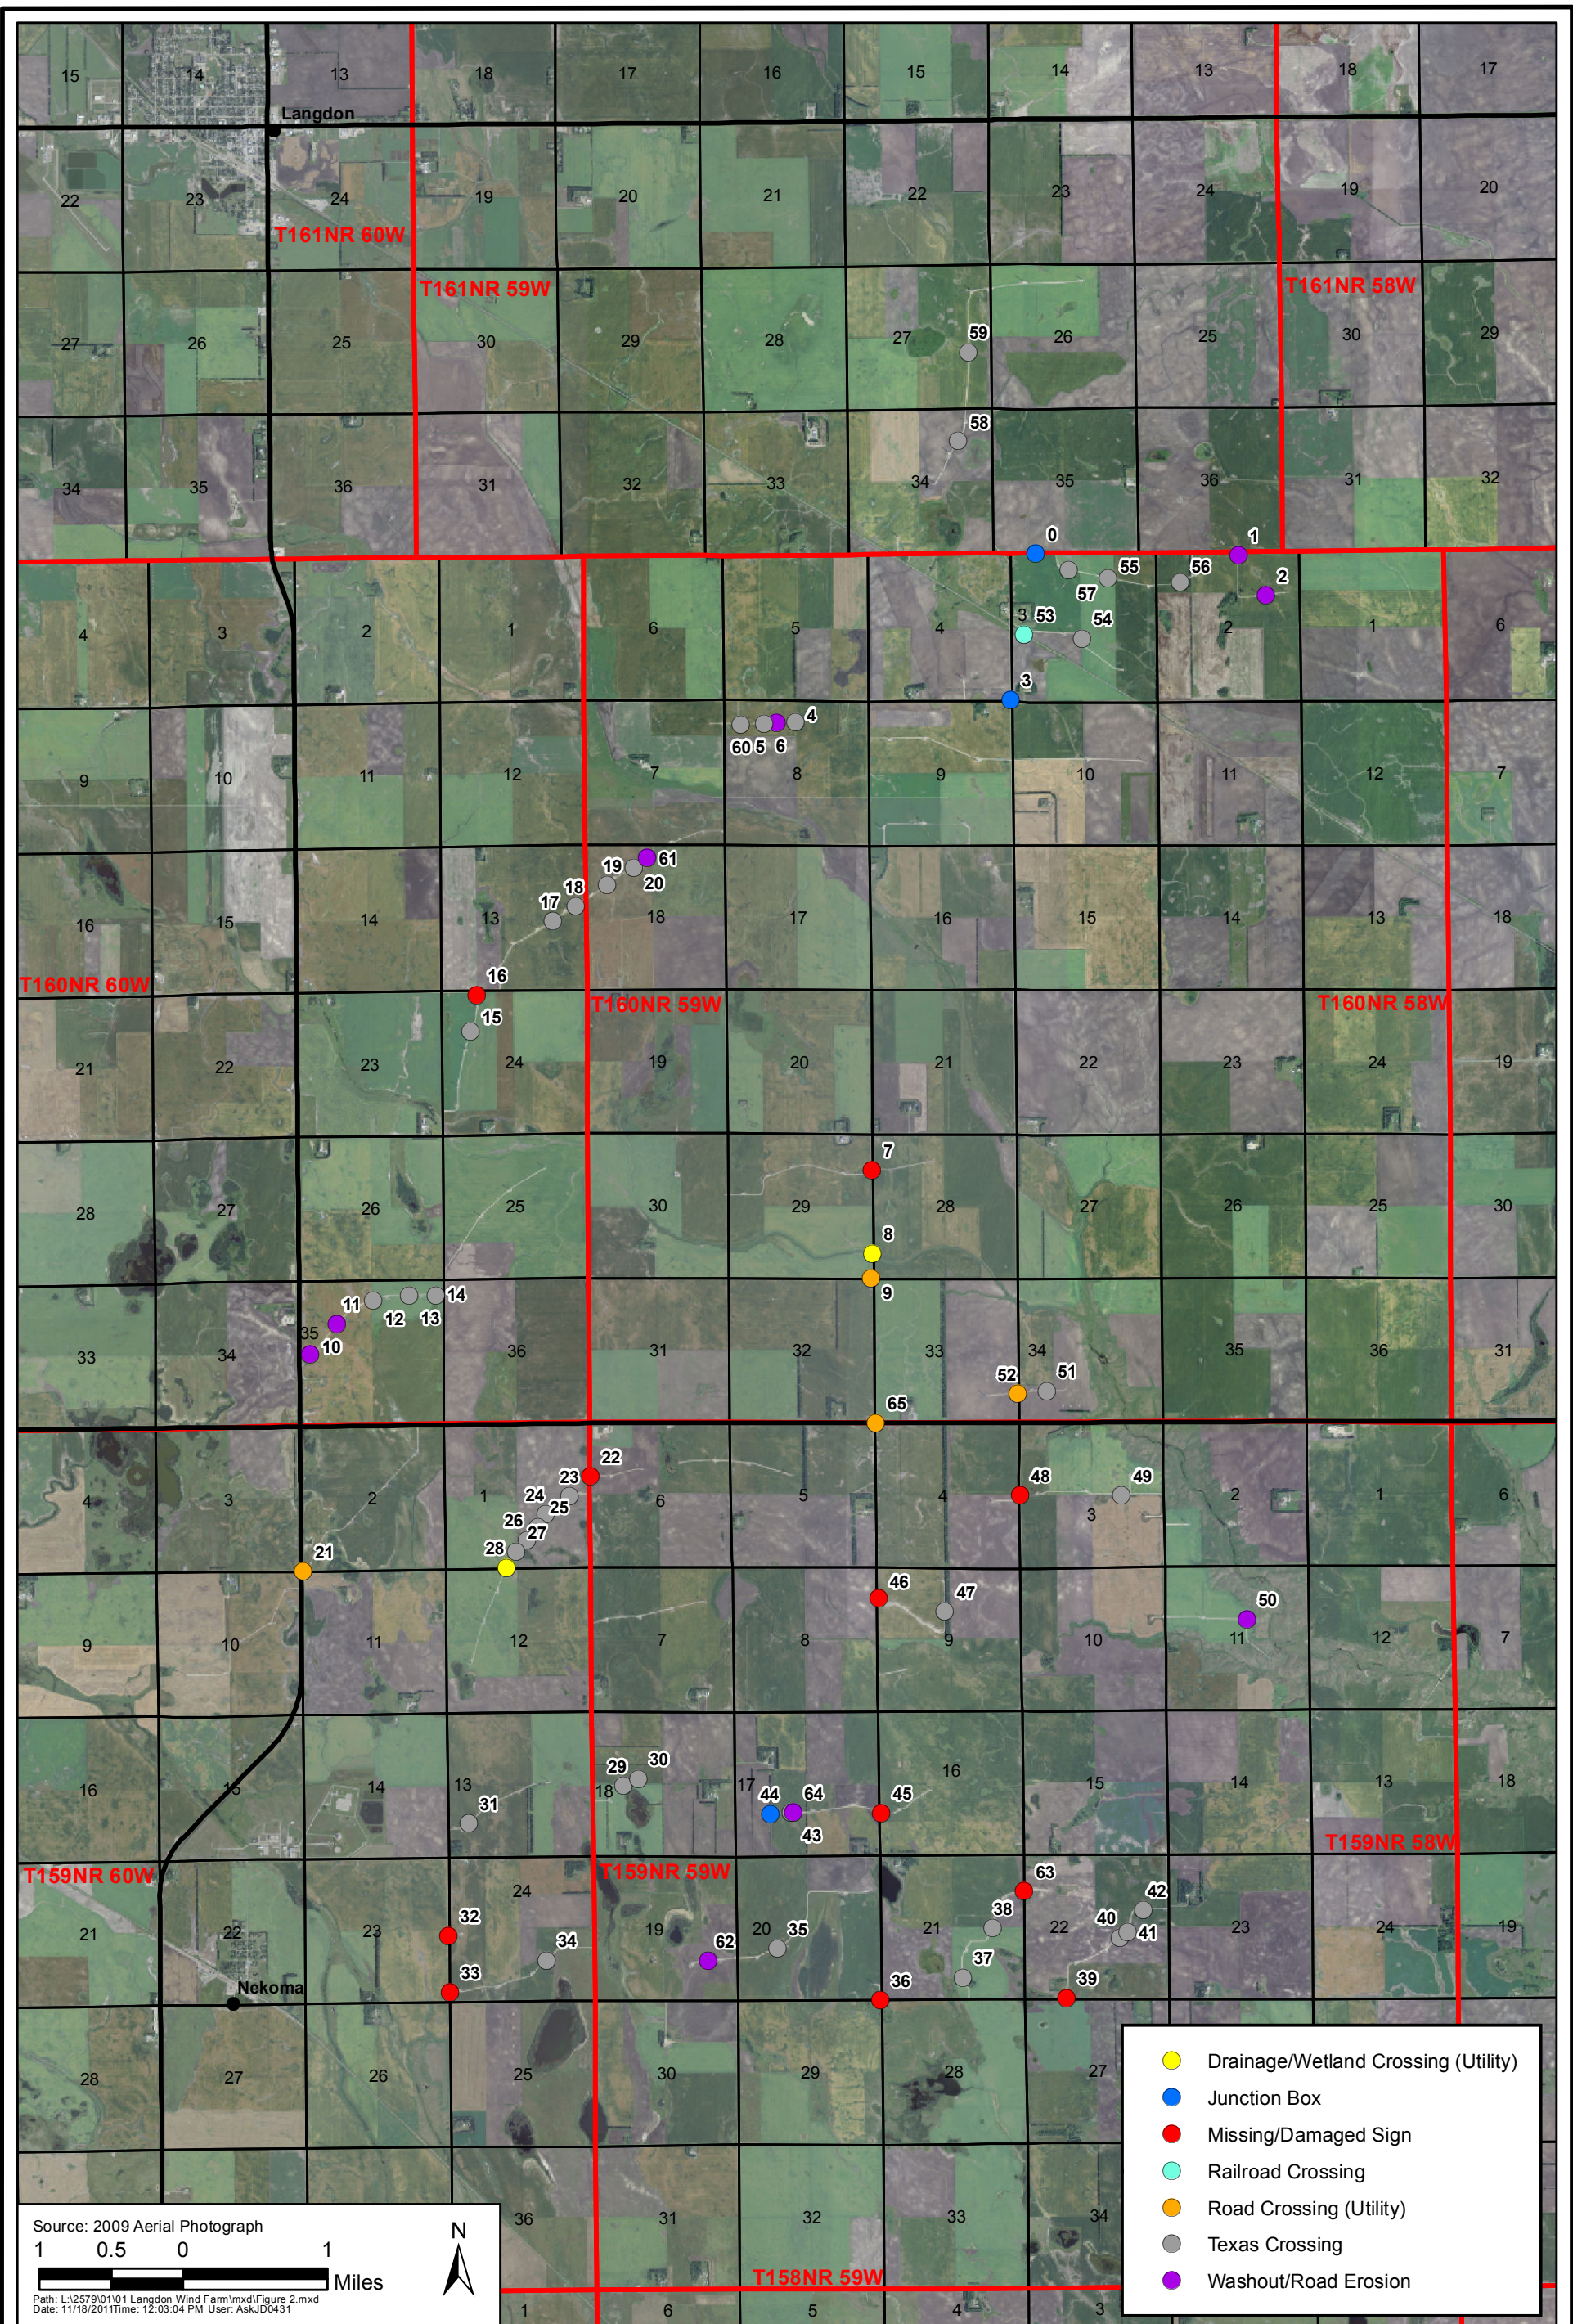
Source: 2009 Aerial Photograph
 1 0.5 0 1 Miles
 Path: L:\2579\0101 Langdon Wind Farm\mxd\Figure 2.mxd
 Date: 11/18/2011 Time: 12:03:04 PM User: AskJD0431

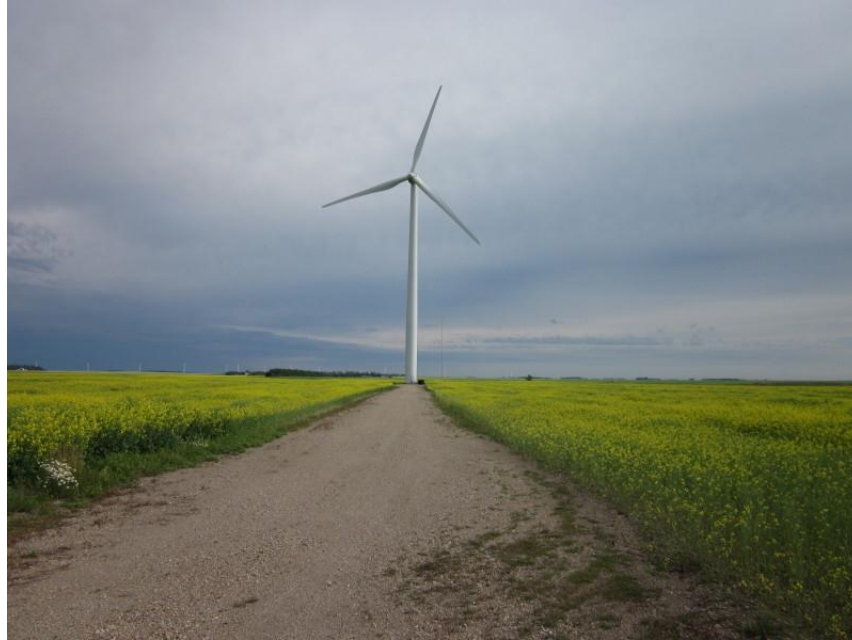
Photo 1. Direction: North. Tower L2-18 on the east-central side of the project area was an example of a typical tower and access road, surrounded by cropland with the crop planted immediately adjacent to the edge of roadway.

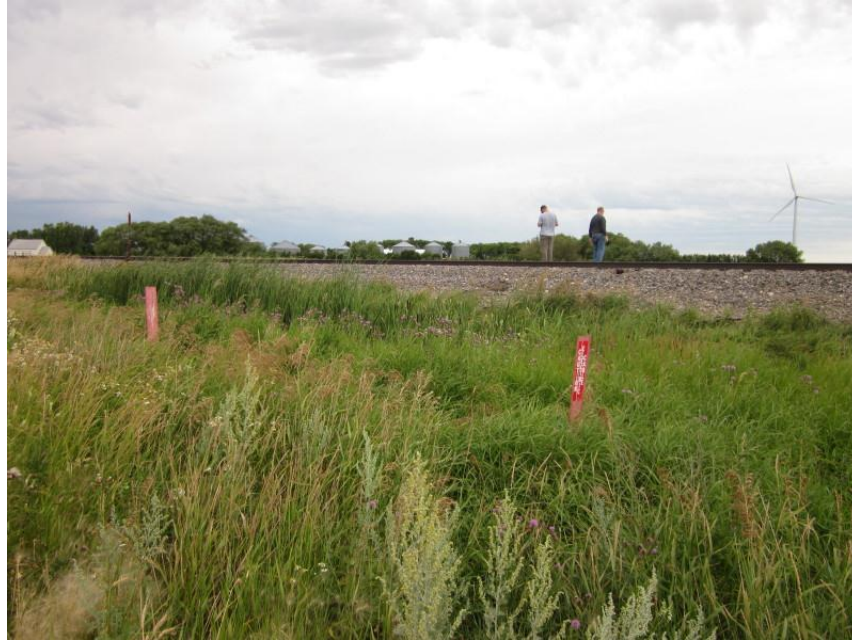
Photo 5. Direction: Northwest. Red markers indicate directional bore for utility line crossing underneath railroad tracks. The bore actually began and ended further out beyond the ditches in the adjacent fields. The railroad is a historical site (32CV121) and disturbance was avoided by boring. The vegetation in the ditches were typical wetland/mesic grassland vegetation that did not appear to have been disturbed, including reed canarygrass (*Phalaris arundinacea*), cattail (*Typha* sp.), Canada thistle (*Cirsium arvense*), smooth brome (*Bromus inermis*), reedtop (*Agrostis stolonifera*), and Kentucky bluegrass (*Poa pratensis*).

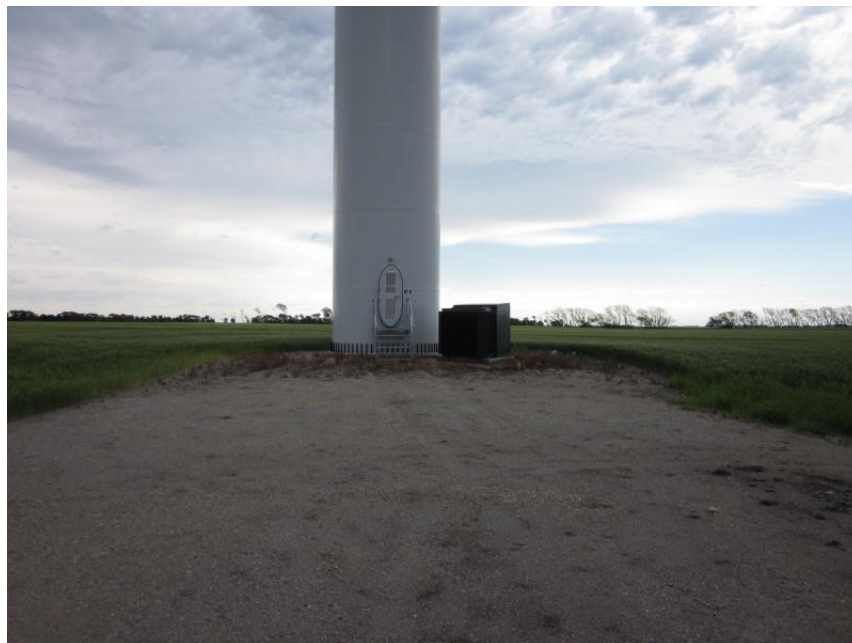
Photo 6. Direction: Northeast. Base of tower OT-17, showing an example of proper seasonal maintenance with annual weeds sprayed on the gravel pad. Note the surrounding crop was planted as close to the edge of the pad as possible by the landowner.

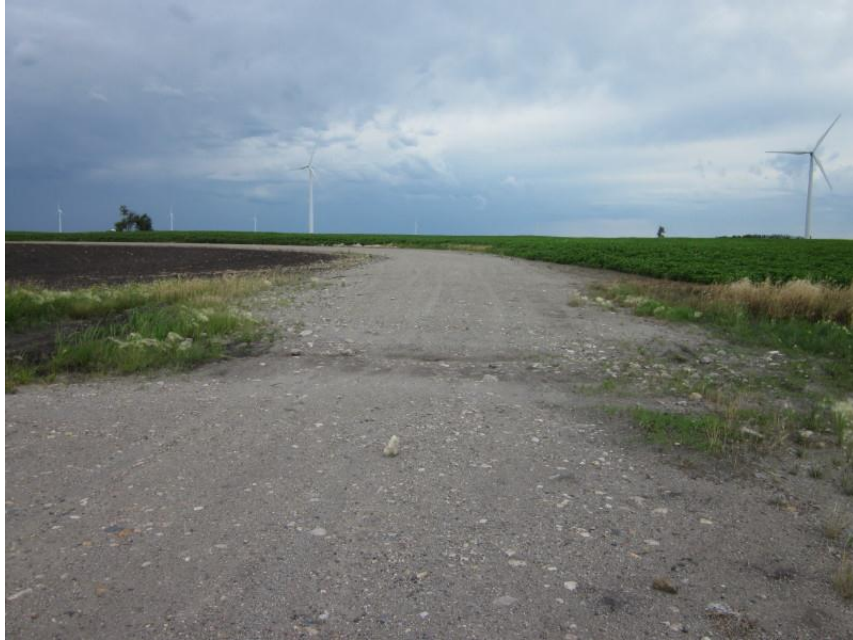
Photo 7. Direction: North. Texas crossing between towers OT-17 and OT-16. This crossing was in good condition, with rocks still in place for drainage.

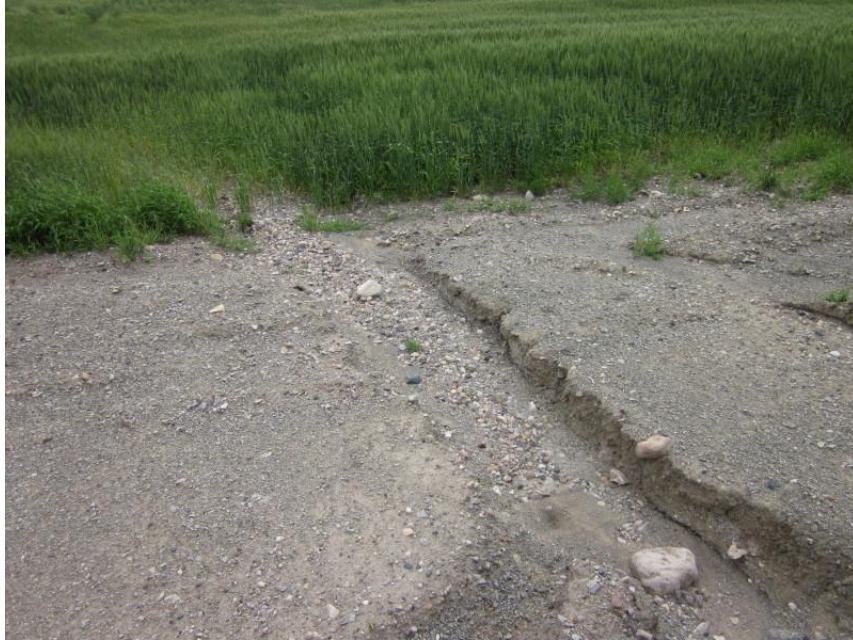
Photo 13. Direction: Southeast. Close-up of erosion on roadway, showing gravel being washed into adjacent field. NextEra stated that this problem has already been noted and will be repaired.

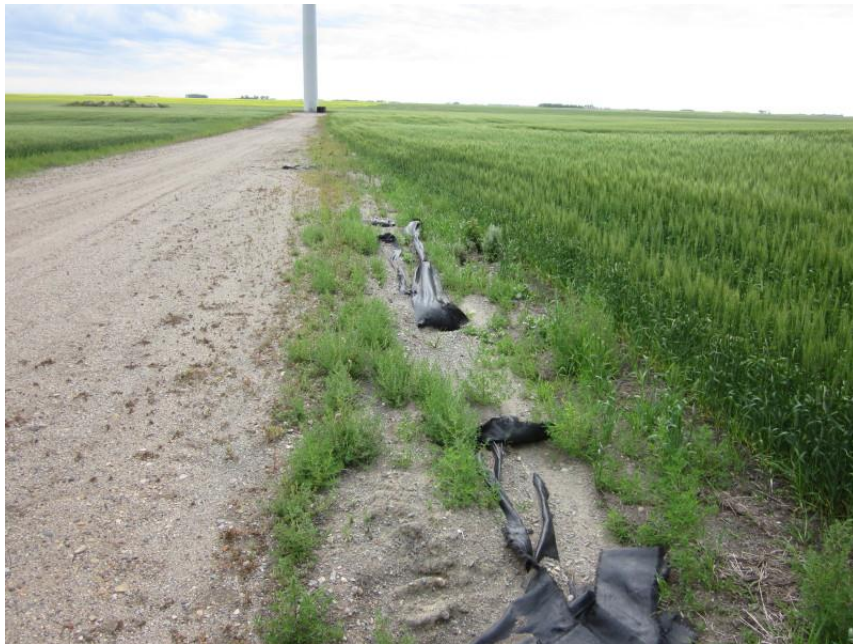
Photo 14. Direction: East. Erosion on edge of roadway between towers OT-14 and OT-15. The Geotech fabric was washed out on both sides of the road and the erosion extended partially across the roadway with sedimentation into adjacent fields.

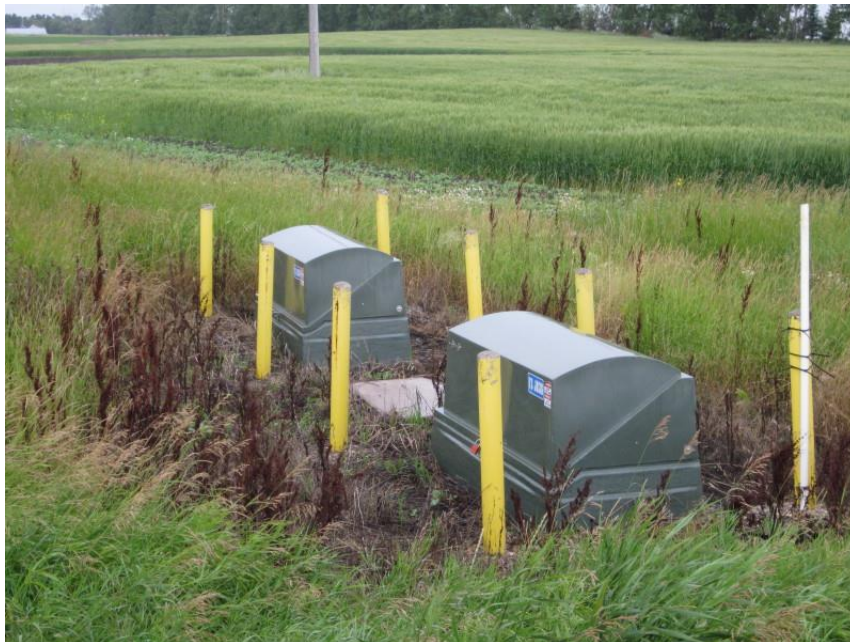
Photo 16. Direction: Northwest. Two junction boxes (F3-JB36 and F2-JB24) at intersection straight east of tower OT-18. The site was in good condition with no signs of settlement or erosion around the boxes or bollards.

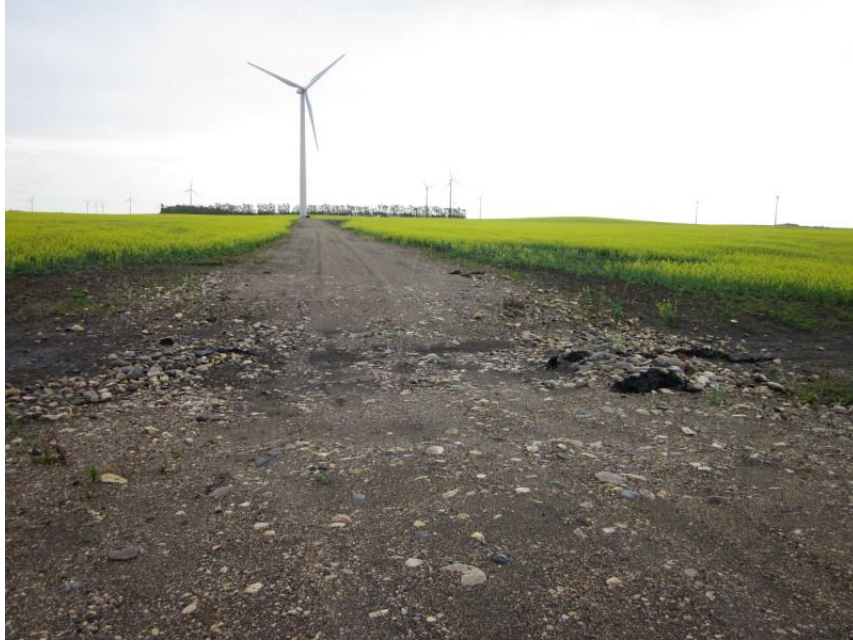
Photo 17. Direction: East. Texas crossing east of tower L2-11 between towers L2-11 and L2-12 (in distance). The crossing had been eroded to a deep and rough washout. A culvert would likely be better suited for the drainage at this particular crossing.

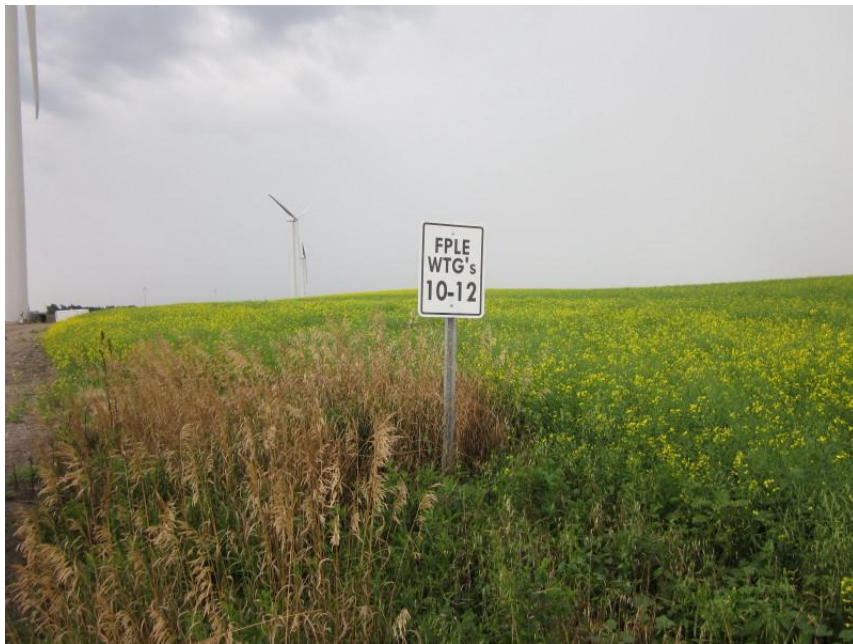
Photo 28. Direction: South. “No trespassing” sign was missing from post at entrance of access road to towers LD-10 to LD-12.

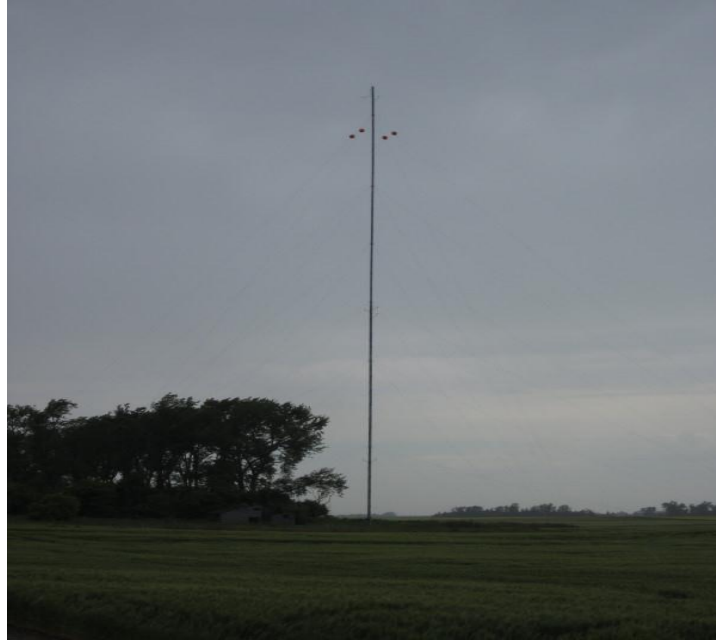
Photo 29. Direction: Northwest. Meteorological tower 5 at the northwest side of project area. Note the large orange spheres at the top of the guywires which is a birdsafe design feature.

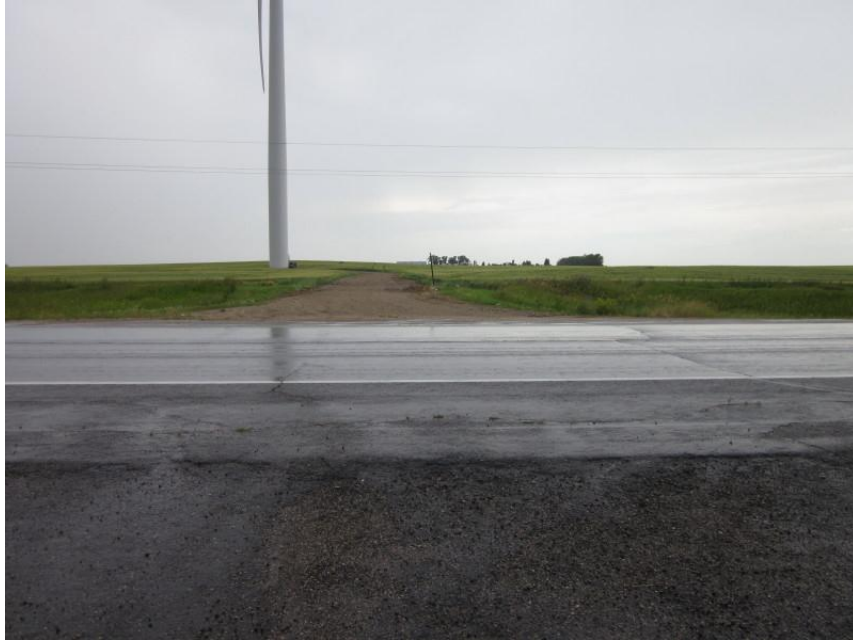
Photo 31. Direction: West. Location of directional bore underneath Highway 66 for utility lines. Red markers were present but are not visible in the photo. Note the signs were missing at the entrance to the access road for towers L-1 to L-5.

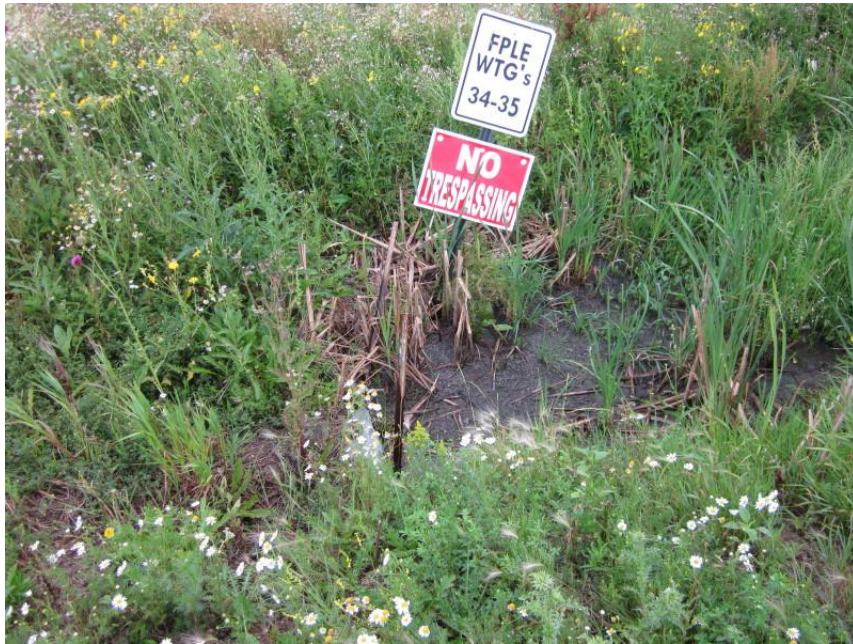
Photo 32. Sign at entrance to access road for towers LD-34 and LD-35 was being washed out by nearby culvert.

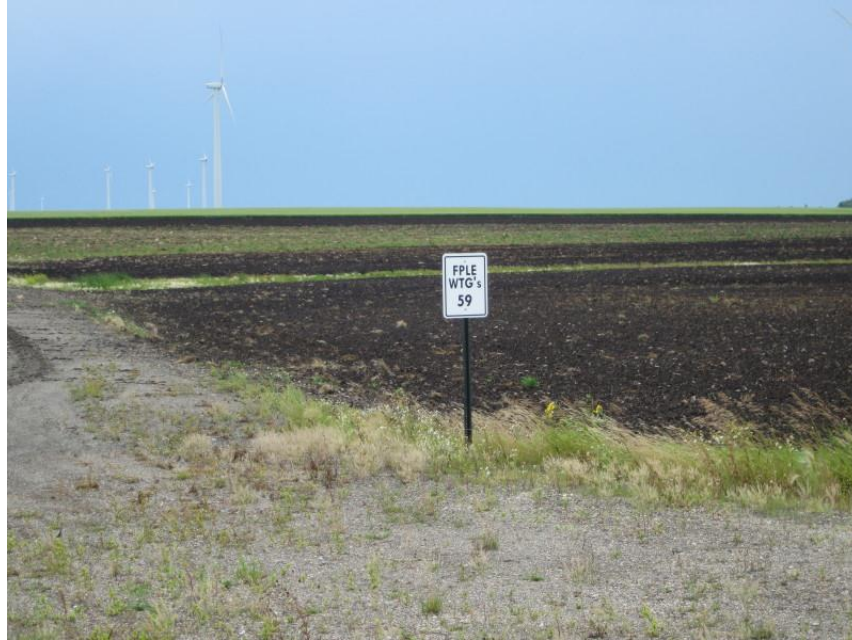
Photo 35. Direction: East. “No trespassing” sign was missing from post at entrance of access road to tower LD-59.

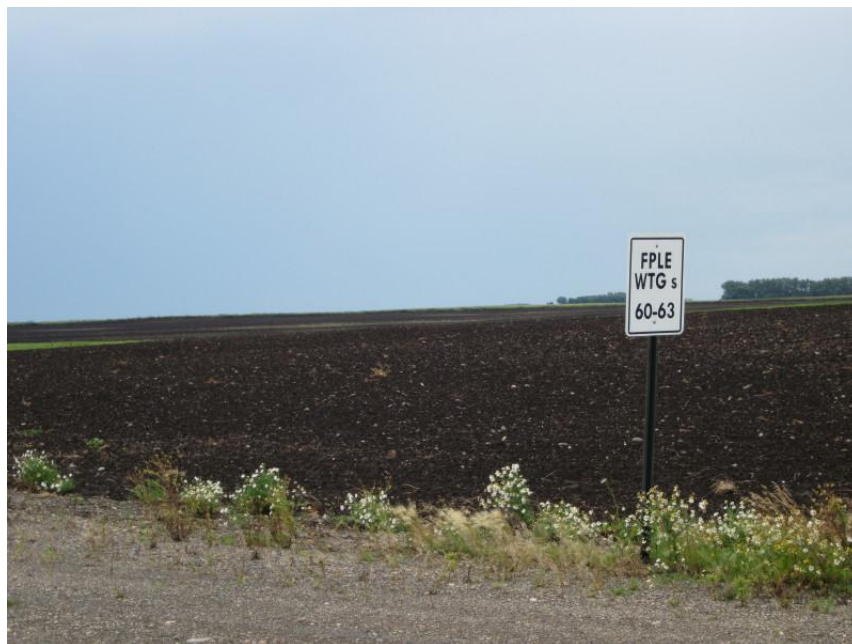
Photo 36. Direction: Southeast. “No trespassing” sign was missing from post at entrance of access road to towers LD-60 to LD-63.

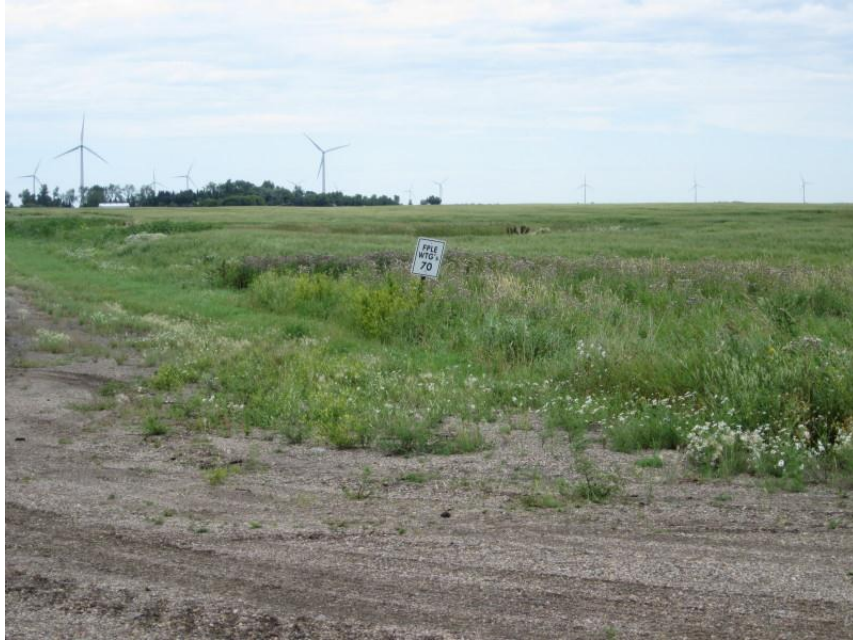
Photo 39. Direction: North. “No trespassing” sign was missing from post at entrance of access road to tower LD-70.

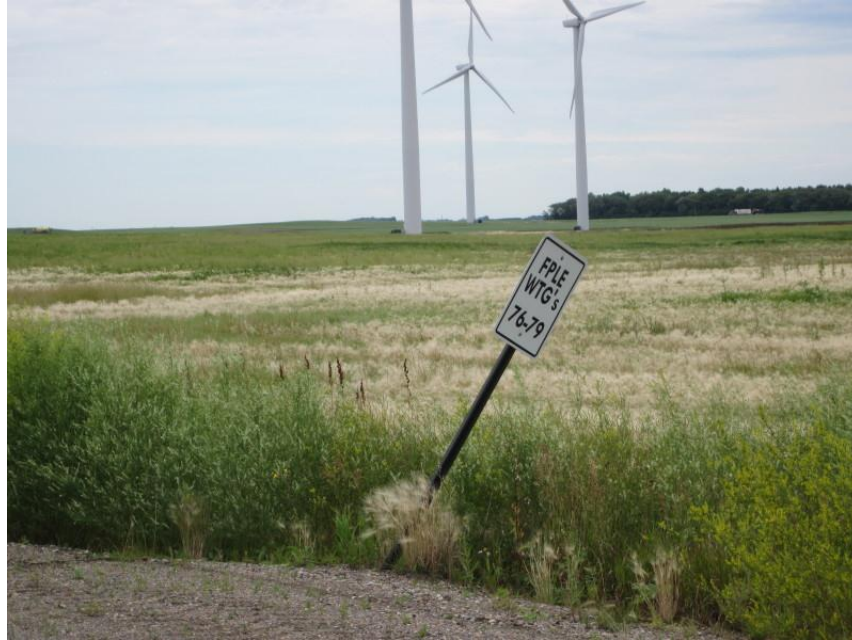
Photo 41. “No trespassing” sign was missing from post at entrance of access road to towers LD-76 to LD-79.

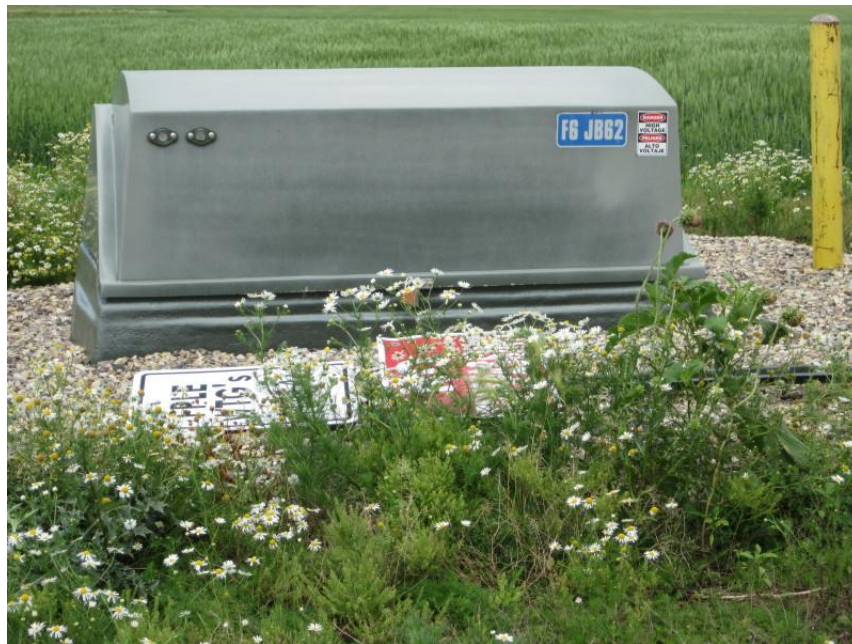
Photo 46. Direction: North. A signpost had been broken off and was placed beside junction box F6-JB62.

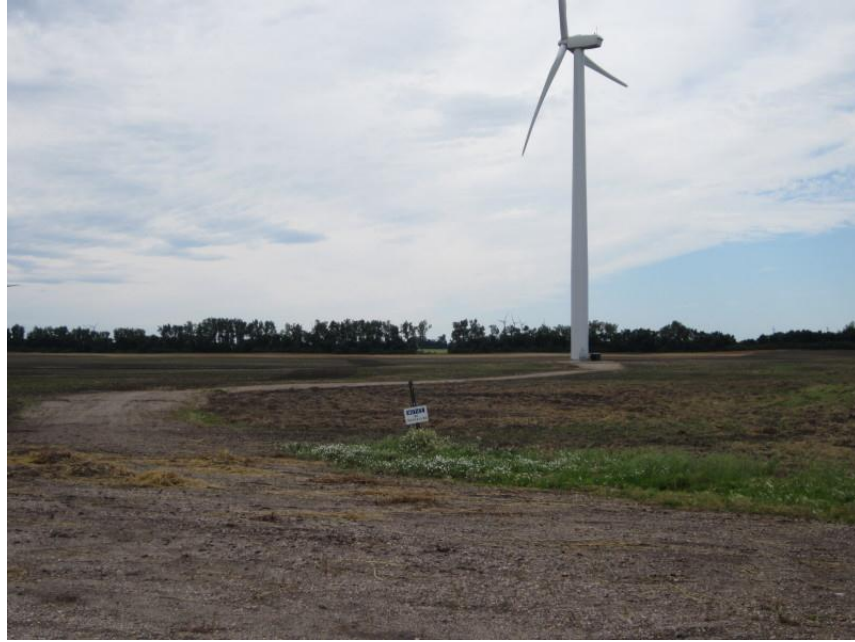
Photo 47. Direction: West. Sign missing on the entrance to the access road for tower L2-15.

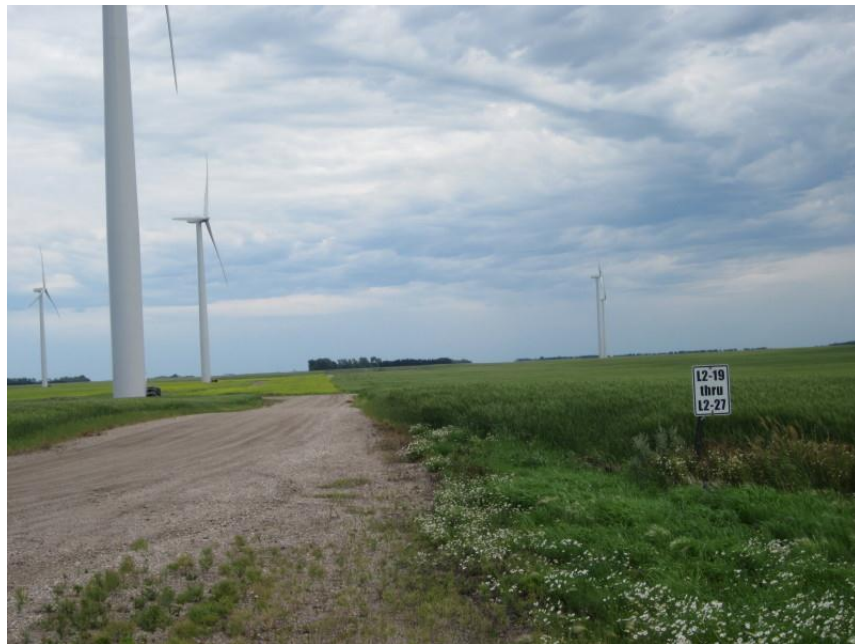
Photo 48. Direction: East. “No trespassing” sign missing from entrance to access road for towers L2-19 through L2-17.

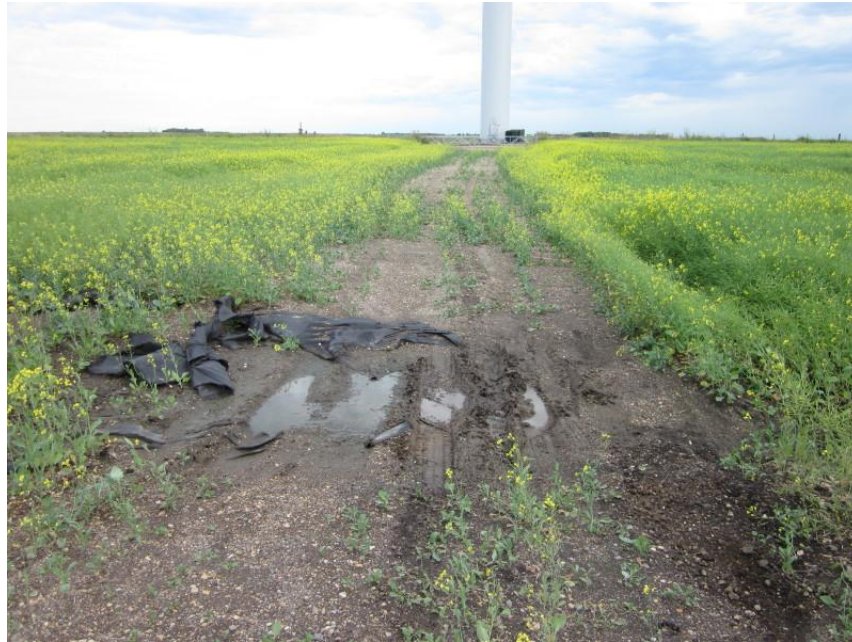
Photo 49. Direction: East. Access road to tower L2-26 was washed out with deep ruts and exposed Geotech fabric. Note the crops had been seeded across the roadway.
