# *LSr Pipeline* **Construction Inspection Report**

*Enbridge Energy Co., Inc.*

December 2011

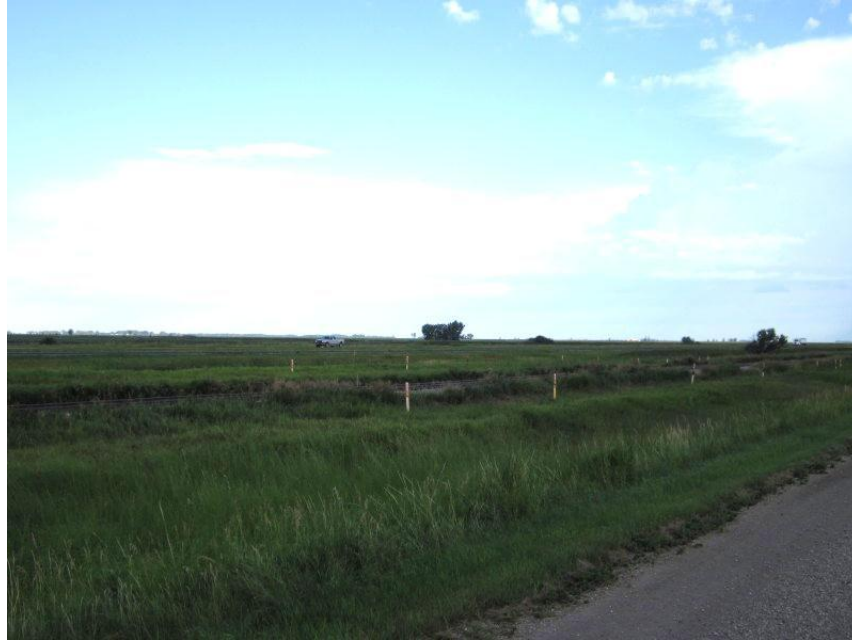
**Photo 1.** Direction: Northwest. Pipeline markers from left of photo denote Alberta Clipper and LSR pipelines to the east of Mile 795 of the pipeline route. Interstate 29 in the distance (on which pickup is located), Burlington Northern Railroad in mid-ground, the gravel frontage road in foreground, and a wetland on the west side of Interstate 29 (not visible) were all crossed underneath using one large horizontal drilling bore to avoid impacts to all these features. The railroad was cultural site 32PB0173.

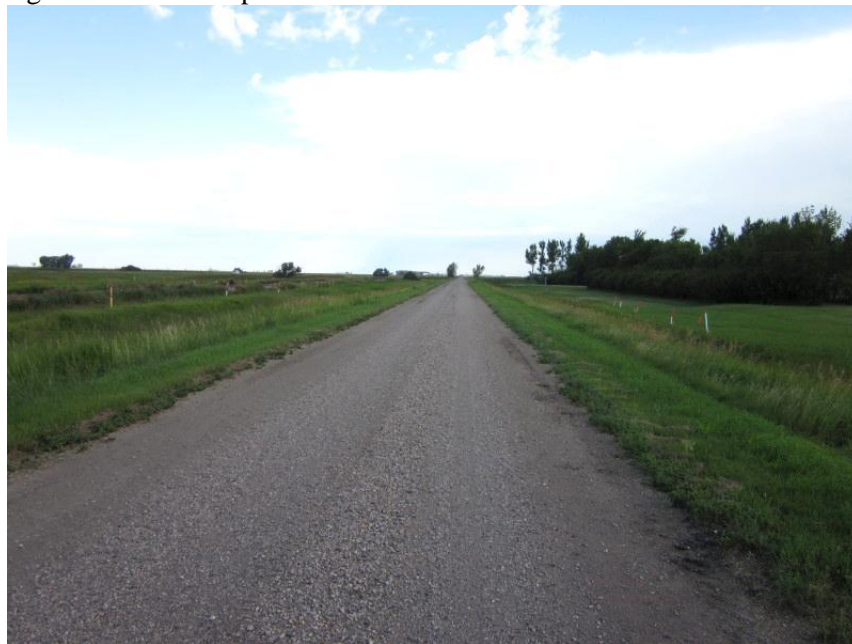
**Photo 2.** Direction: Northwest. Frontage road (Old Highway 44) to the east of Interstate 29 crossed underneath by the pipelines. All markers were in place and it appeared no vegetation had been disturbed in the ditches.

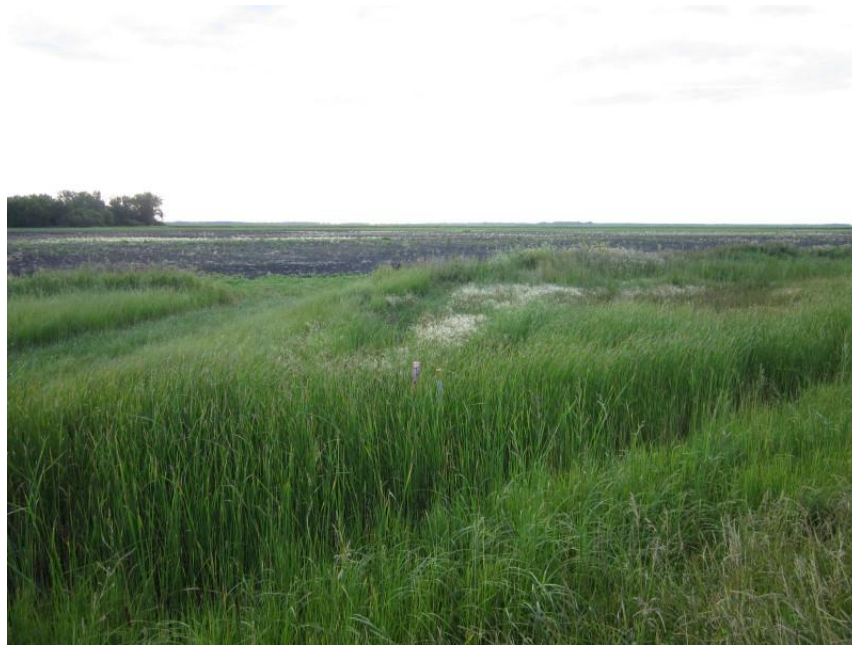
**Photo 3.** Direction: Southeast. Ditch and field to the southeast of gravel frontage road at Mile 795.2. Markers denote pipeline routes, which were barely visible in wetland vegetation. The bore would have ended within the field in the distance. There was no settling observed in the field along the route.

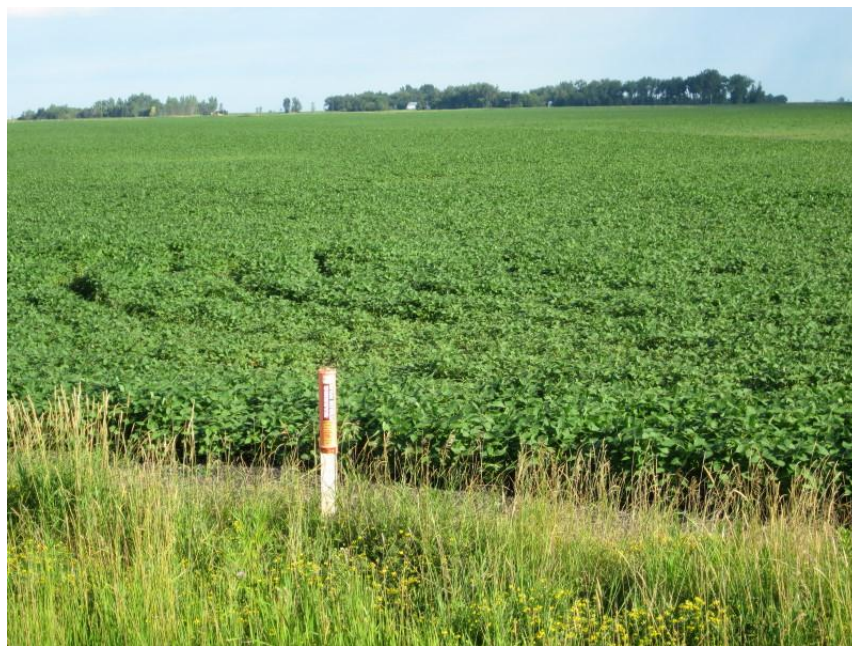
for one location which showed minor stunting (**Appendix A, Photo 4**). This was a good indication that topsoil had been segregated appropriately.

**Photo 4.** Direction: Northwest. Ditch and field to the northwest of 93<sup>rd</sup> Street NE at Mile 796.4. The road had been directionally bored underneath, denoted by pipeline marker in foreground. There appeared to be a slight depression and stunted, slightly yellowed crop at the end of the bore in the field.

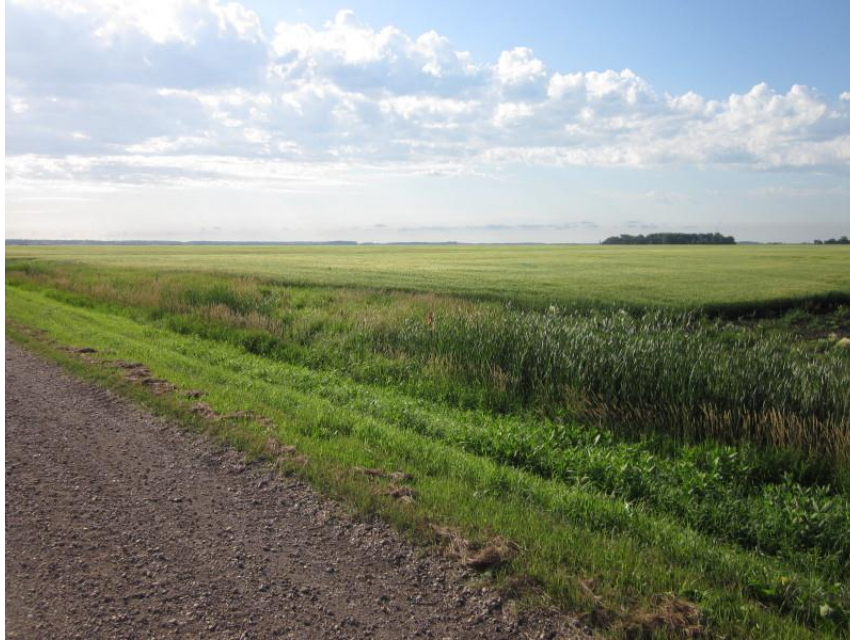
**Photo 5.** Direction: Southeast. South side of 93<sup>rd</sup> Street NE crossing. Right-of-way appeared to be in good condition. Vegetation in ditch and crop appeared to have no impacts.

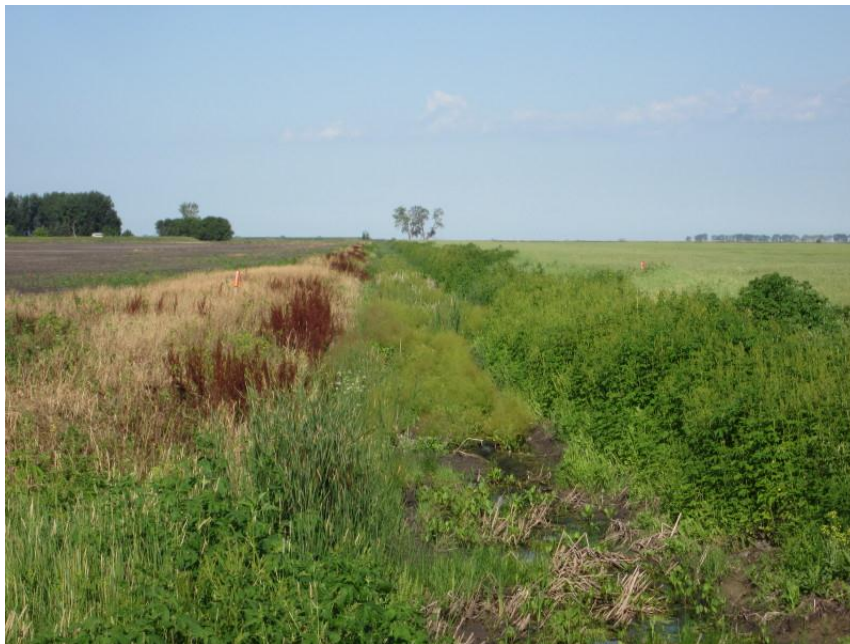
**Photo 6.** Direction: West. Irrigation ditch crossed by open cut to the southeast of Mile 797 and to the west of 161<sup>st</sup> Ave NE between fields. Orange markers indicate pipeline right-of-way. The vegetation was in good condition and was indistinguishable from surrounding vegetation. Dominant species included giant ragweed (*Ambrosia trifida*), cattails (*Typha* sp.), and curly dock (*Rumex crispus*).

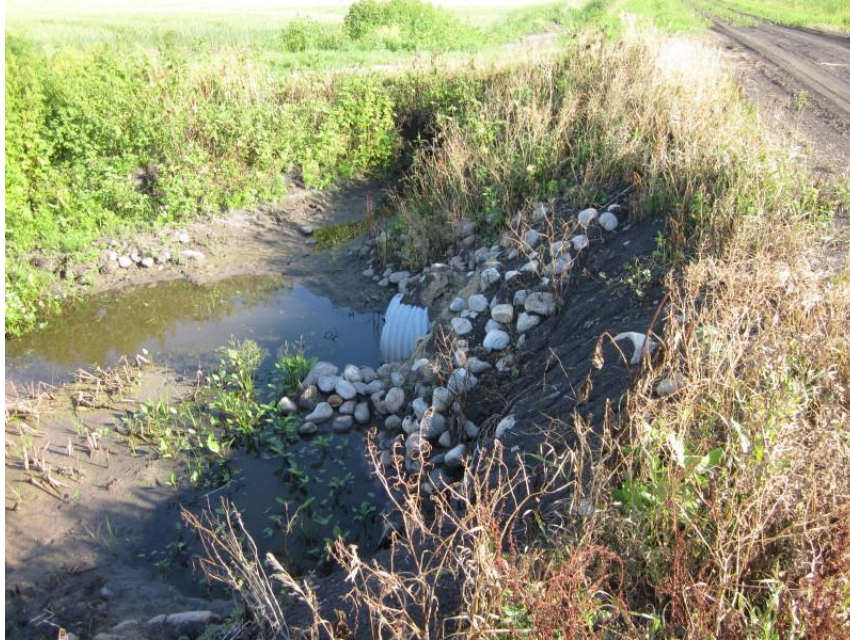
**Photo 7.** Direction: Northeast. Culvert installed at crossing of 161<sup>st</sup> Ave NE, to the southeast of Mile 797. There were no signs of settling or erosion around the culvert. It appeared to be in good condition.

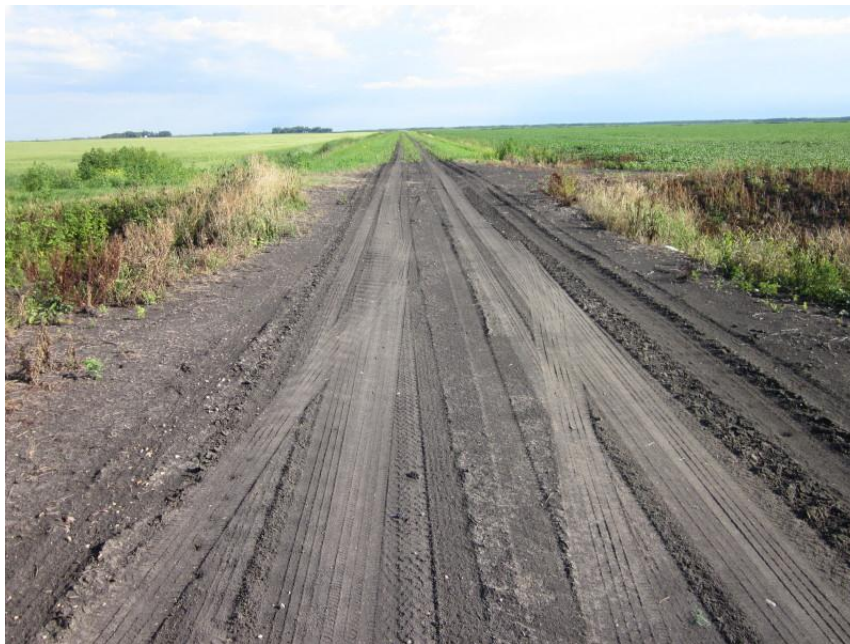
**Photo 8.** Direction: North. Minimum maintenance section line road was restored (161<sup>st</sup> Ave NE) and showed no signs of construction. This was to the southeast of Mile 797.

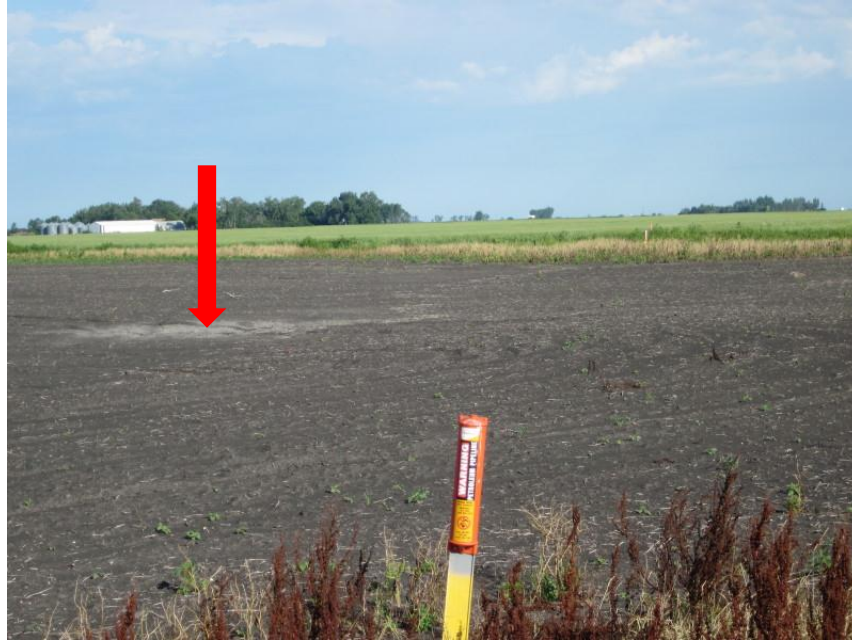
**Photo 9.** Direction: Northwest. View of field to the northwest of crossing of 161<sup>st</sup> Ave NE. There was a depression in the field within the construction right-of-way but off the pipeline route which may be due to settling or improper topsoil replacement (red arrow), though it may also be a natural depression. Pipeline markers were in place along 161<sup>st</sup> Ave NE (foreground).

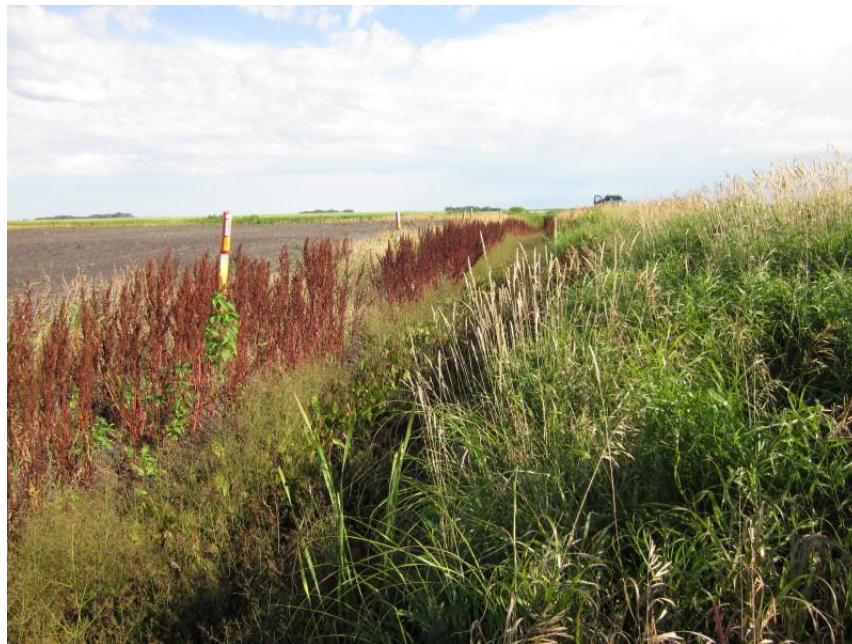
**Photo 10.** Direction: North. West ditch of 161<sup>st</sup> Ave NE which was open cut. Pipeline markers are visible on edge of field. Revegetation of the ditch appeared to be successful. Dominant species included smooth brome (*Bromus inermis*), reed canarygrass (*Phalaris arundinacea*), curly dock (*Rumex crispus*), and arrowhead (*Sagittaria cuneata*). The crop to the southeast of this crossing showed no impacts.

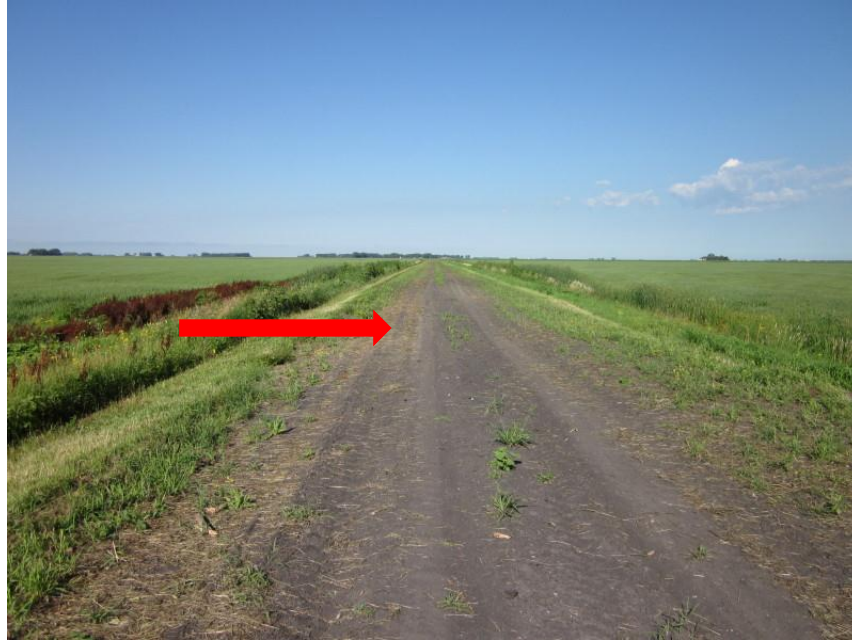
- 36). These depressions did not impair traffic and there was no erosion, but they should be monitored; if the dips worsen as soil continues to settle repair may be necessary.

**Photo 11.** Direction: West. Southeast of Mile 799 at crossing of 91<sup>st</sup> St NE. There was a slight depression in the road where the pipeline crossed (red arrow). The dip was not problematic and there was no erosion, but the location should be monitored. The vegetation in the ditch and the crops adjacent to this area appeared to have no impacts.

traffic. However, because these areas have potential to erode or settle further, Wenck recommends these locations be monitored to ensure they do not worsen over time.

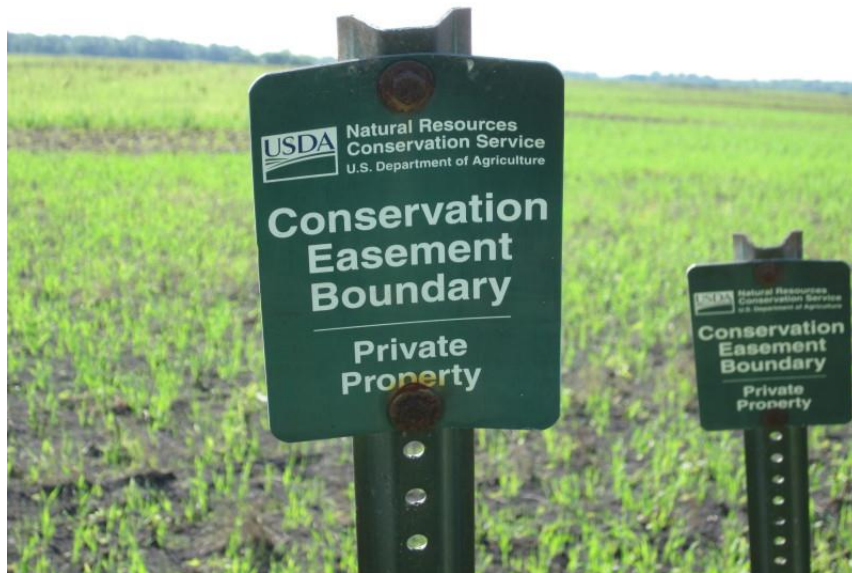
**Photo 12.** Direction: Southeast. Conservation Easement boundary markers along 163<sup>rd</sup> Ave NE, just to the southeast of Mile 800. The pipeline right-of-way through the field was planted to a wheatgrass (*Agropyron* sp.) or small grain crop, whereas the adjacent field was not tilled and had annual weeds. It was unclear why there was a difference in treatment and why the conservation easement had been tilled, since these are typically uncultivated grassland areas.

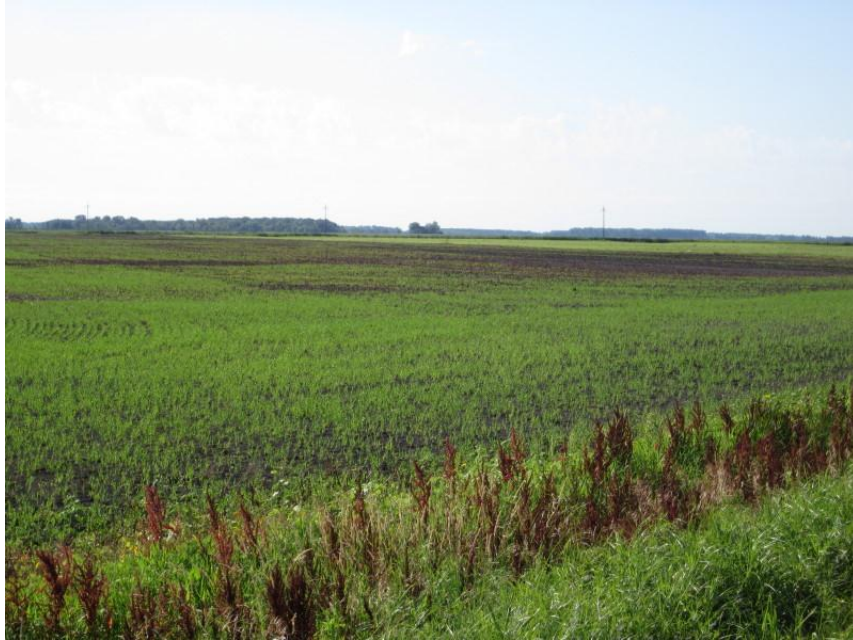
**Photo 13.** Direction: Southeast. View of pipeline right-of-way marked as conservation easement, showing the wheatgrass or crop that was planted.

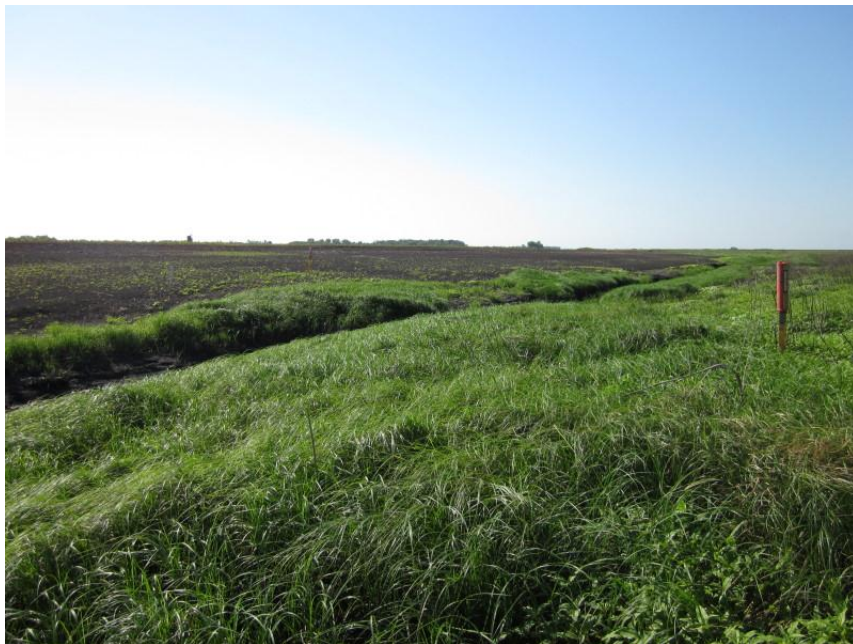
**Photo 14.** Direction: South. View of County Ditch 66-1 to the south, which diverges from the Red River within 0.5 miles north of this point. The crossing of the pipeline is indicated by the marker posts on either bank, and is just to the northwest of Mile 801. This crossing was directionally drilled underneath the ditch. There were no indications of vegetation disturbance or erosion problems.

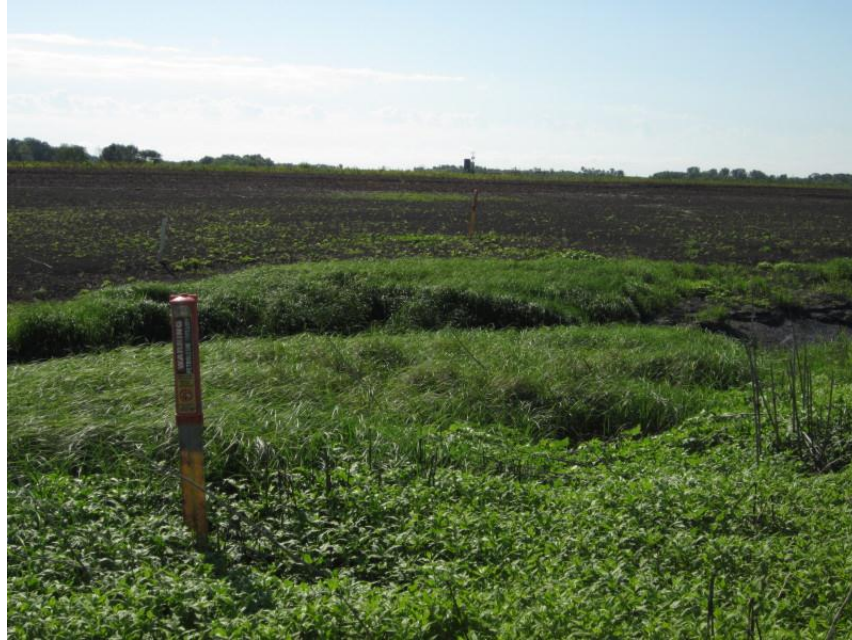
**Photo 15.** Direction: Southeast. Another view of the County Ditch 66-1 crossing, indicated by the pipeline markers on either side. In the distance slightly right of center the above-ground Mainline Valve site is visible. The trees in the distance indicate the woodland on the east side of the Red River, which marks the end of the pipeline in North Dakota. The Red River and cultural site 32PB0161, which were scattered materials on the west bank, were avoided by a directional drill underneath them.

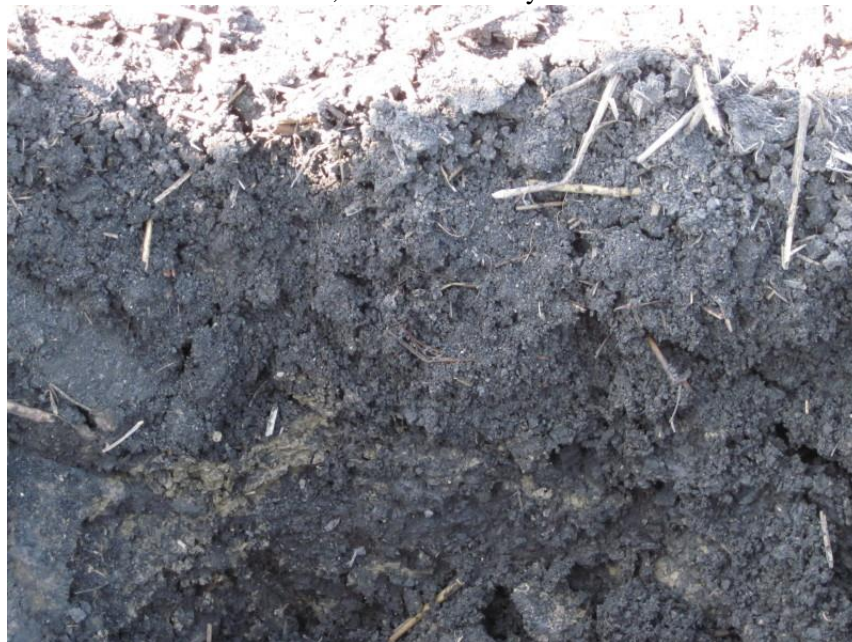
**Photo 16.** Topsoil exploration pit in an agricultural field south of 90<sup>th</sup> St SE within the pipeline right-of-way (at approximately Mile 800.6). Topsoil was very dark brown to a depth of 10-inches, underlain by light brown mixed clays in the subsoil layer.

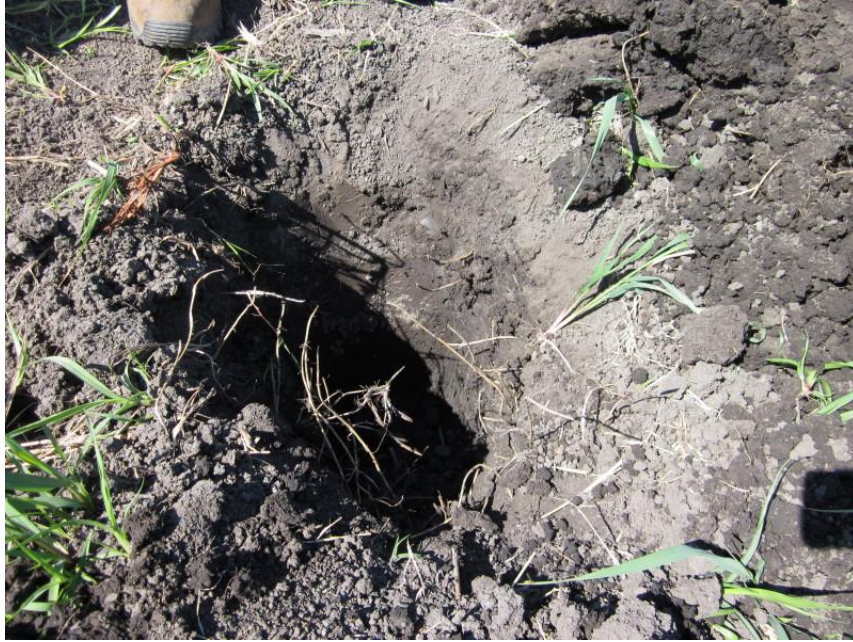
- *Topsoil Replacement 12in Depth or Depth of Cultivation.* The Environmental Mitigation Plan in the Application described topsoil segregation methods and depth of stripping at a minimum 12in. The PSC requirement is at least 12in or to the depth of cultivation, whichever is greater. Wenck observed that all topsoil appeared to have been removed and replaced to the required depth. Cropland that was disturbed during construction appeared the same as adjacent undisturbed cropland (**Appendix A, Photos 5, 22, 25, 26, and 34**), except for one location which showed minor stunting (**Appendix A, Photo 4**). This was a good indication that topsoil had been replaced to the appropriate depth. Wenck also excavated soil pits in cropland in two locations within the pipeline right-of-way. The first location was in a field south of 90<sup>th</sup> St SE at approximately Mile 800.6. The topsoil layer was very dark brown in color and went to a depth of 10 in. It had been plowed. Below this, light brown clays were mixed in and formed the subsoil (**Appendix A, Photo 16**). The second pit was to the east of Neche, ND along 109<sup>th</sup> St NE on the north side of the road, at approximately Mile 774.5. The topsoil, also plowed, was measured to at least 20 inches (**Appendix A, Photo 17**). The clays of the subsoil could not be detected.

**Photo 17.** Topsoil exploration pit in an agricultural field north of 109<sup>th</sup> St NE within the pipeline right-of-way (at approximately Mile 774.5). Topsoil went to a depth of greater than 20-inches. Subsoil could not be distinguished.

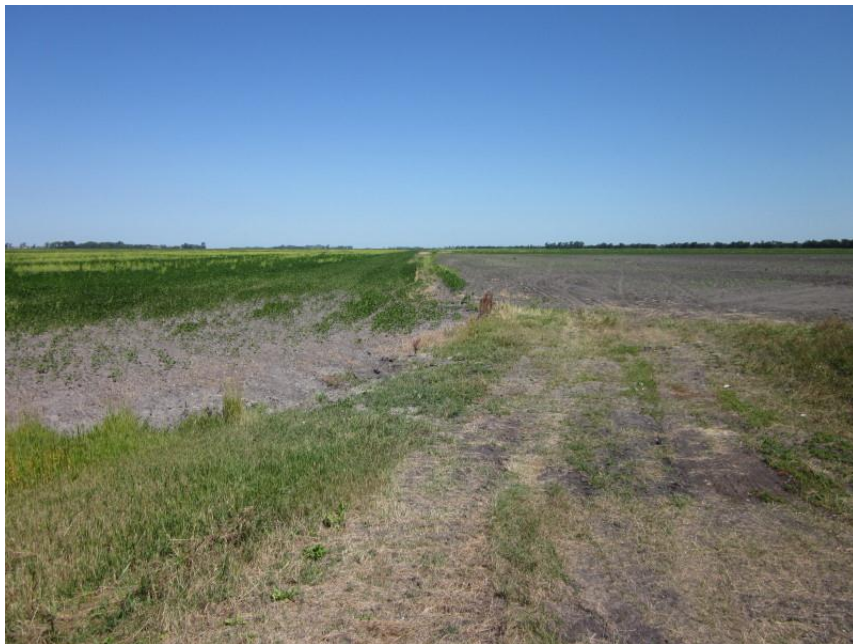
**Photo 18.** Direction: North. Location of temporary access road, going straight north from 109<sup>th</sup> St NE to approximately Mile 773.9 on the pipeline route. There was no indication of the access road. The cropland and road ditches of 109<sup>th</sup> St NE had been completely restored to prior condition.

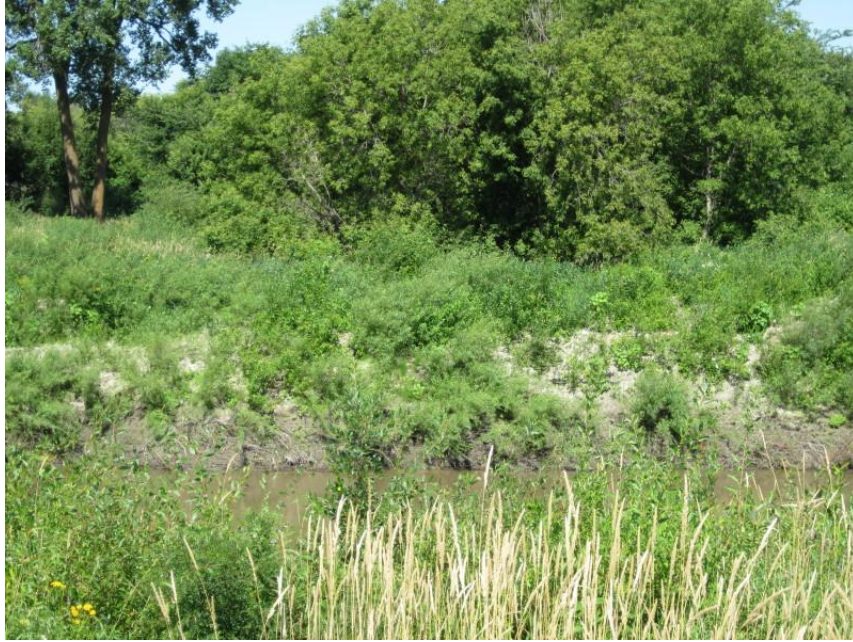
**Photo 19.** Direction: Northwest. Pembina River crossing. View from south bank across to north bank. No pipeline markers were visible on north side of river, though they could have been obscured by tall vegetation. The river had been avoided by horizontally drilling underneath. There was no indication of soil or vegetation disturbance along the banks that would have been caused by pipeline installation.

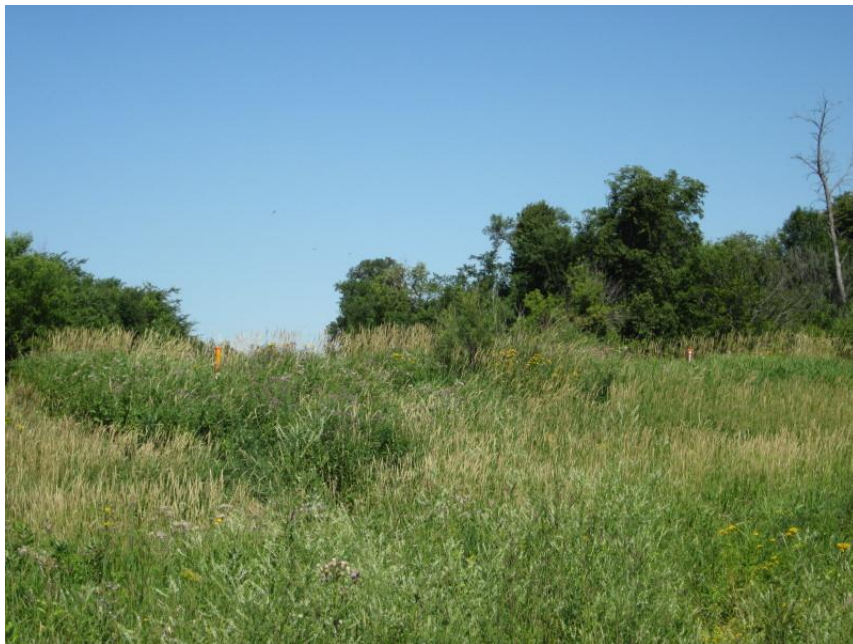
**Photo 20.** Direction: Northwest. Pembina River crossing. View of south bank, showing orange pipeline markers amidst the tall grasses, at approximately Mile 775.6. The river had been avoided by horizontally drilling underneath.

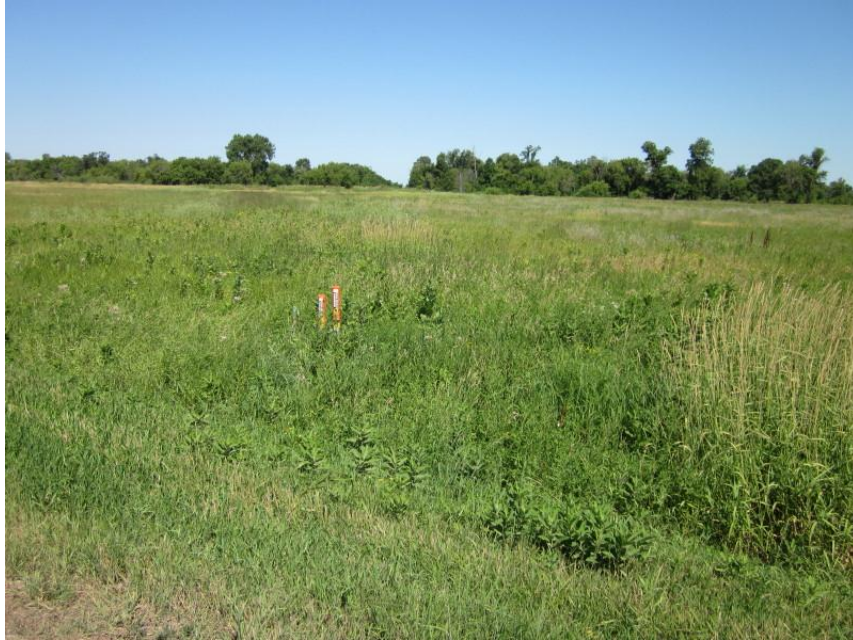
**Photo 21.** Direction: Northwest. View of WMA between the south bank of the Pembina River (trees in distance) to 108<sup>th</sup> St NE (ditch in foreground). This area and the road were avoided along with the river via one long directional bore that ended in a field on the south side of the road.

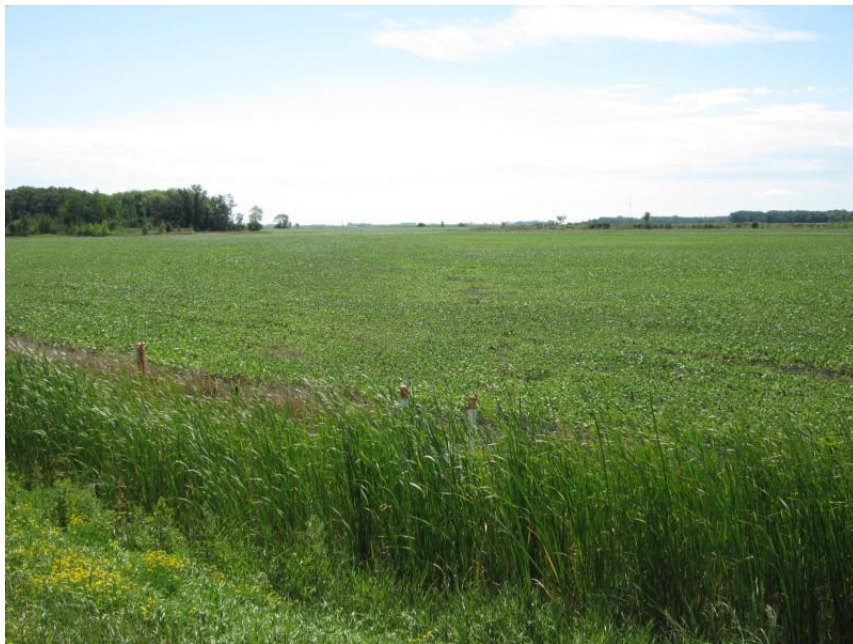
**Photo 22.** Direction: Southeast. Field to the south of 108<sup>th</sup> St NE along the pipeline route. There was a slight depression within the pipeline right-of-way which could have been subsidence after pipeline installation.

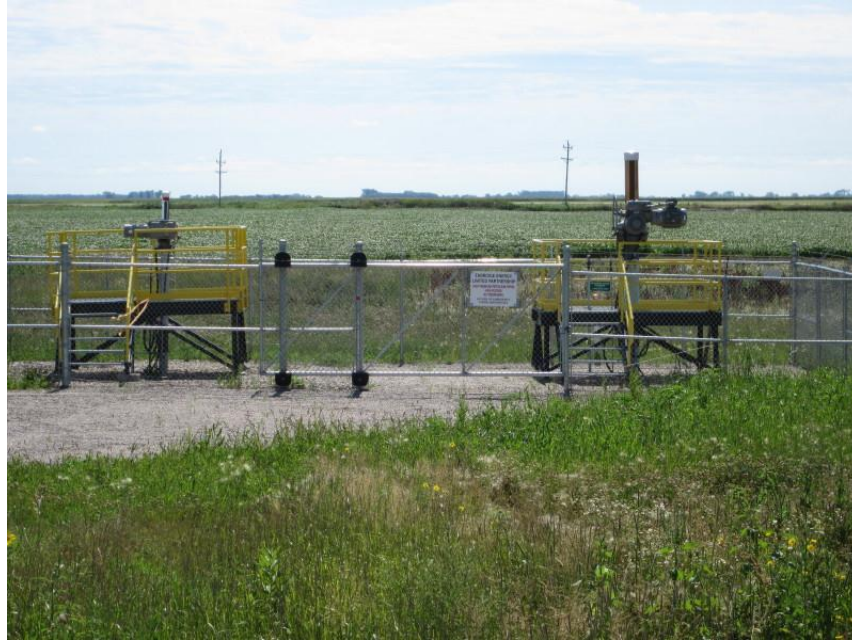
**Photo 23.** Direction: Southeast. Pipeline valve system to the northeast of the intersection of 147<sup>th</sup> Ave NE and 107<sup>th</sup> St NE (County Hwy 55), near Mile 777. The LSr valve is on the left and the Alberta Clipper valve is on the right.

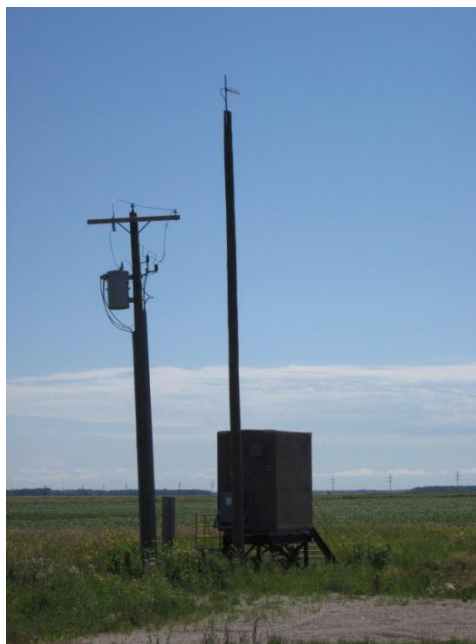
**Photo 24.** Direction: Southeast. Densitometer next to the valve system, which measures the density of the oil flowing through the pipeline. Information on the line served was not available at the time of the survey.

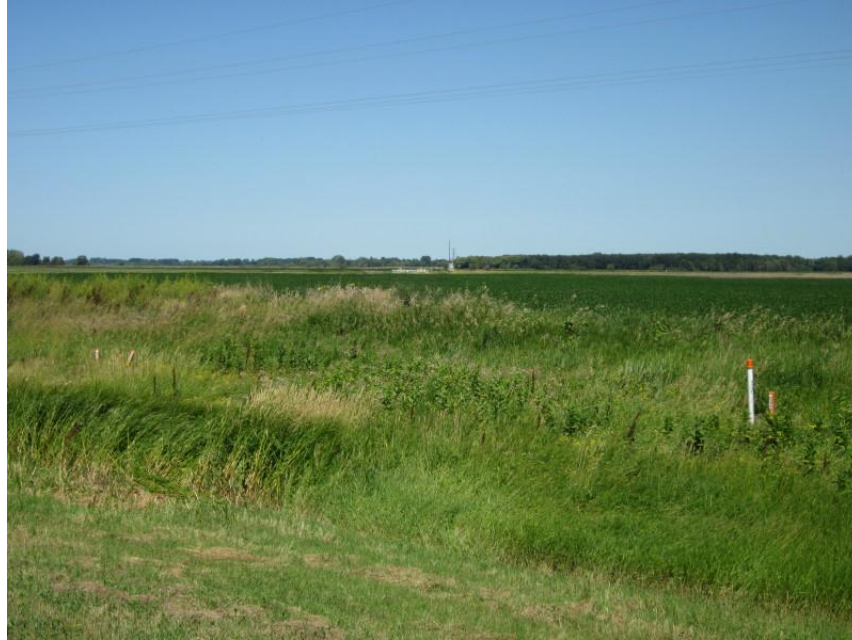
**Photo 25.** Direction: Northwest. Looking back across field to valves in the distance, with the road ditch of 107<sup>th</sup> St NE (County Hwy 55) in the foreground. This road had been bored underneath. The crop appeared to be in good condition.

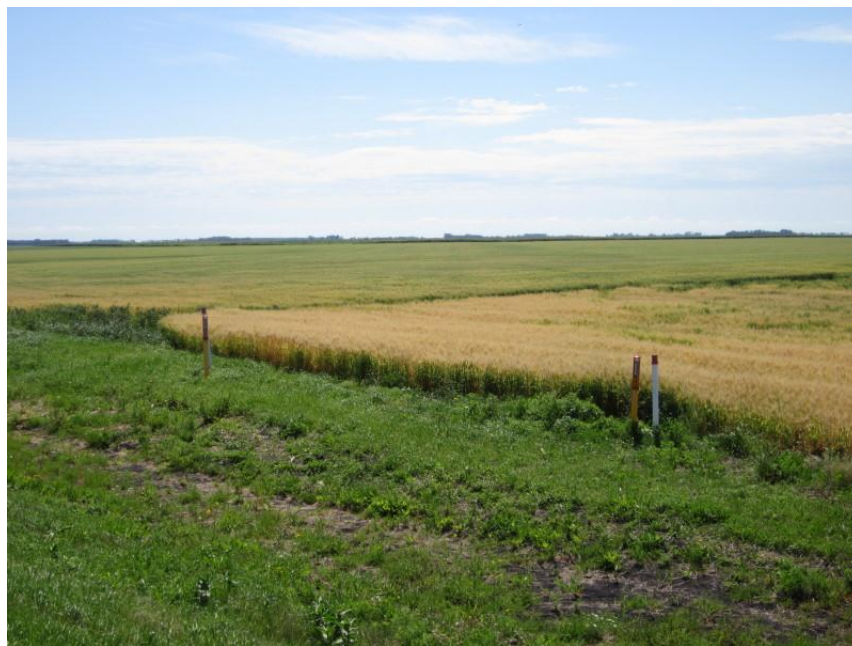
**Photo 26.** Direction: Southeast. To the southeast of 107<sup>th</sup> St NE (County Hwy 55) along the pipeline route. The crops appeared to be in good condition, with no differences within versus outside the pipeline route. Markers were in place in the ditch.

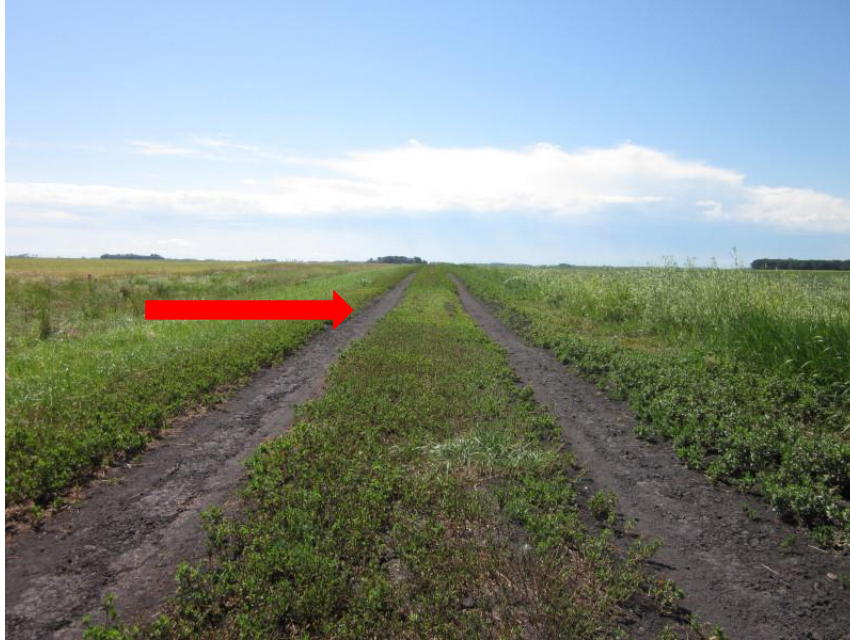
**Photo 27.** Direction: South. 148<sup>th</sup> Ave NE just to the southeast of Mile 778. This road had been open cut and there was a slight depression where the pipeline route crossed (red arrow). It was not problematic for driving and there was no erosion, but the location should be monitored. The vegetation in the ditch had regrown completely and the crops adjacent to this area appeared to have no impacts.

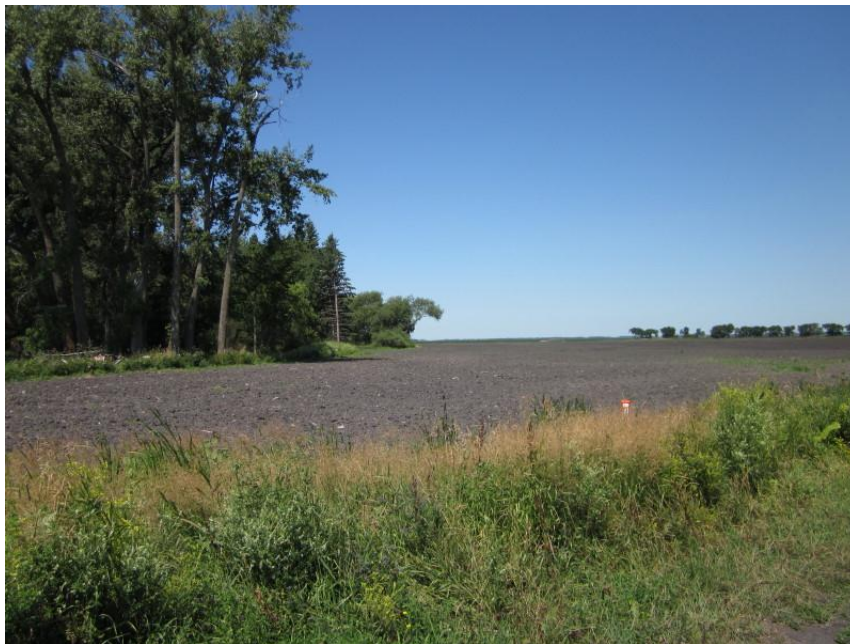
**Photo 28.** Direction: Northwest. To the southeast of Mile 781 along 150<sup>th</sup> Ave NE showing view looking across field toward end of tree rows surrounding a farmyard. The workspace width was reduced to less than 50ft to minimize the number of trees removed. The back row of trees was totally avoided, whereas the front rows had to have some trees removed at the end.

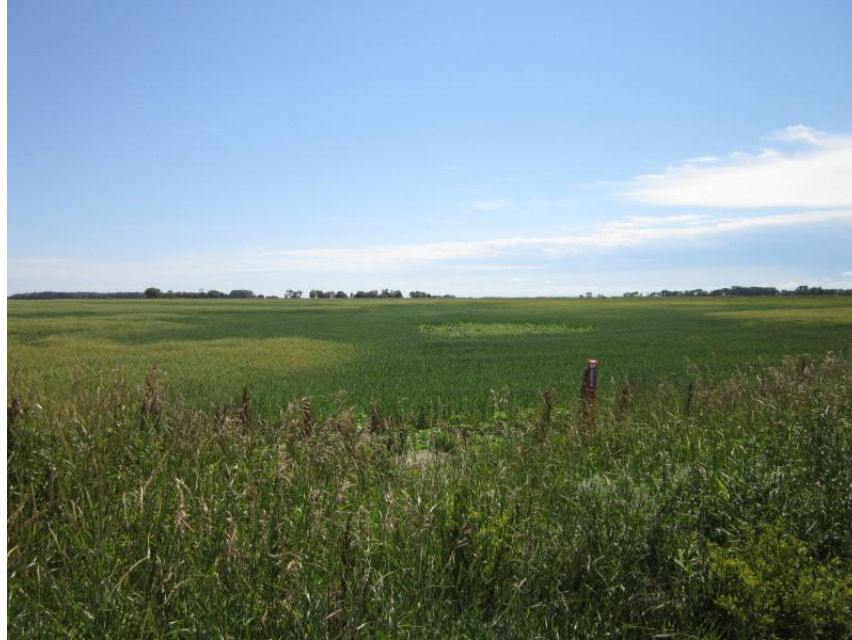
**Photo 29.** Direction: Southeast. On 150<sup>th</sup> Ave NE across the road from the trees showing a restored wetland depression within a field along the pipeline route. The wetland depression appeared to have been in the field before construction, according to aerial imagery. The wetland was currently naturally revegetated and was not supporting crops well, though this was due to wetland conditions and not the pipeline construction.

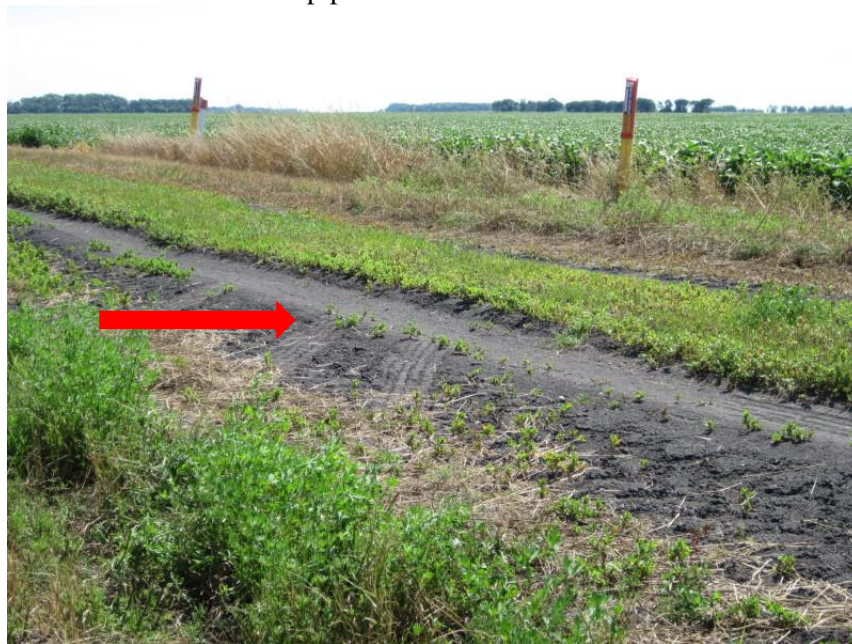
**Photo 30.** Direction: Southeast. Minimum maintenance portion of 104<sup>th</sup> St NE to the southeast of Mile 781. The ditch vegetation and crops looked fine on either side, but there was a slight depression on the road from where the pipeline crossed (red arrow), which is difficult to see with this photo angle.

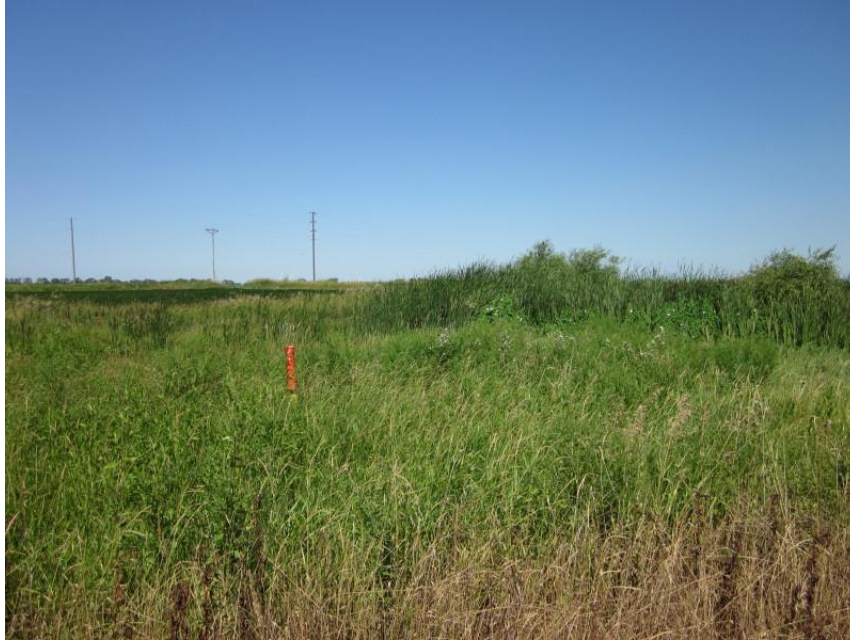
**Photo 31.** Direction: Northwest. Pipeline route across a tributary to the Tongue River (County Ditch 33) between Miles 782 and 783, just to the southeast of the intersection of 151<sup>st</sup> Ave NE and 103<sup>rd</sup> St NE. Records indicate the waterway and the two roads were bored underneath. Markers were in place and vegetation was intact, including cattails (*Typha* sp.), reed canarygrass (*Phalaris arundinacea*), smooth brome (*Bromus inermis*), panicked aster (*Aster simplex*), and curly dock (*Rumex crispus*).

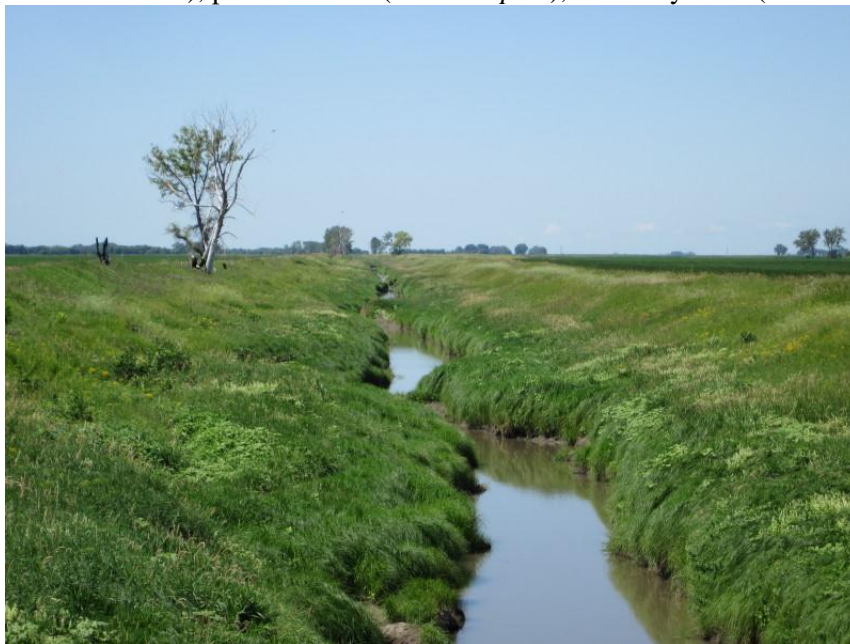
**Photo 32.** Direction: West. Tongue River cutoff ditch which had been open cut. The crossing of the pipeline is in the distance (though markers are not visible on photo). There were no revegetation or erosion problems.

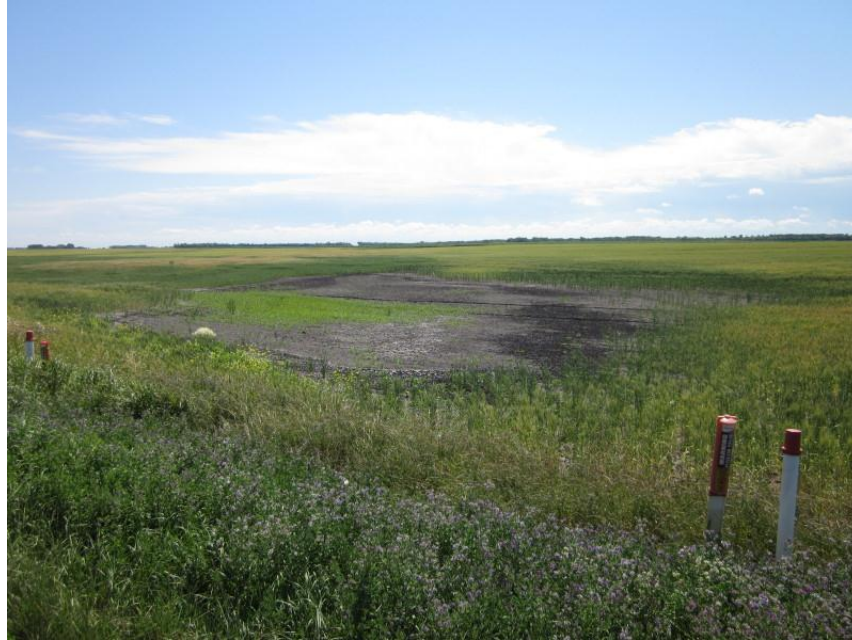
**Photo 33.** Direction: Southeast. Field southeast of 102<sup>nd</sup> St NE at Mile 784 had a restored wetland depression (based on aerial imagery) within the pipeline route. Road had been bored underneath and all markers were in place.

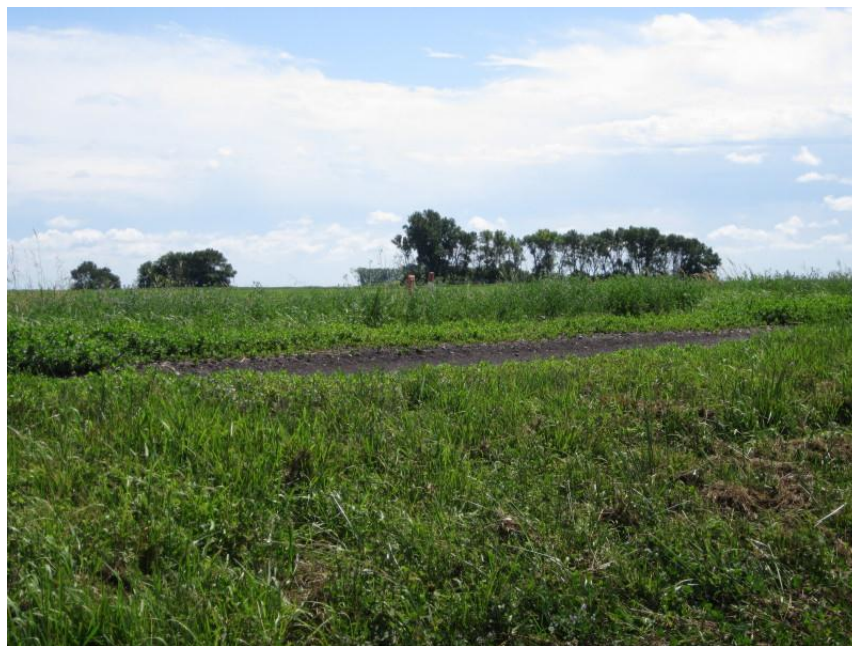
**Photo 34.** Direction: Southeast. Looking across a minimum maintenance portion of 154<sup>th</sup> Ave NE at Mile 787 with ditch in the foreground and field in the distance. Crops, soils, and ditch vegetation were in good condition. The road had a slight depression from being open cut along the pipeline route.

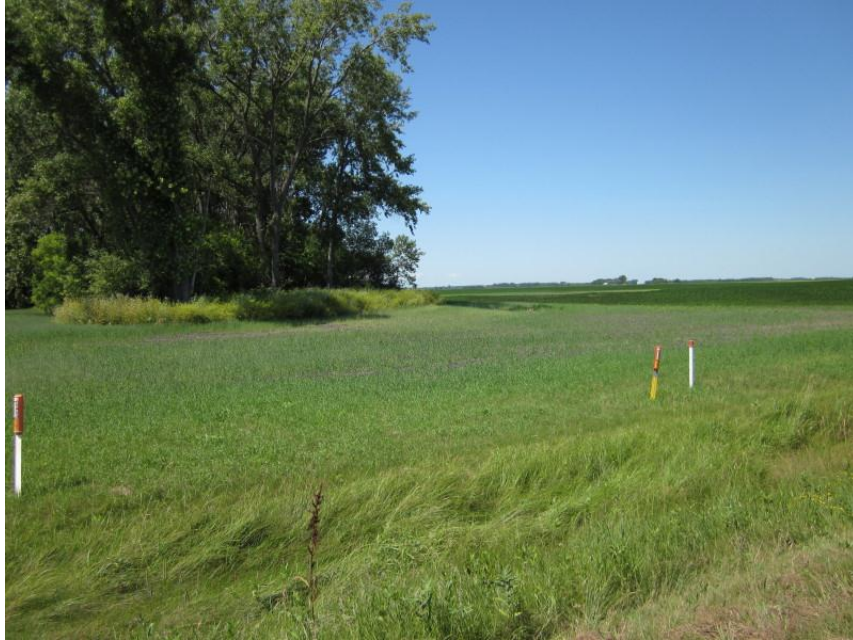
**Photo 35.** Direction: Northwest. Along 155<sup>th</sup> Ave NE between Miles 788 and 789, showing route of pipeline where the workspace width was reduced to less than 50ft to minimize the number of trees removed from tree rows surrounding another farmyard.
