# *LSr Pipeline* **Construction Inspection Report**

*Enbridge Energy Co., Inc.*

December 2011

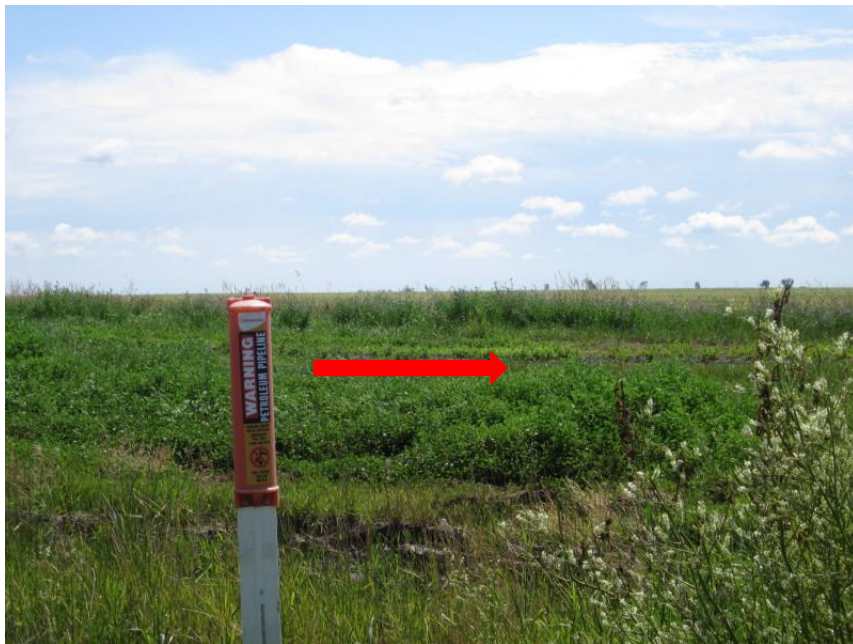
**Photo 36.** Direction: Southeast. Crossing of minimum maintenance 98<sup>th</sup> St SE at approximately Mile 789.5. The crops and road ditches were in good condition but there was a slight depression in the road bed where the open cut had crossed (red arrow) which should be monitored.

traffic. However, because these areas have potential to erode or settle further, Wenck recommends these locations be monitored to ensure they do not worsen over time.

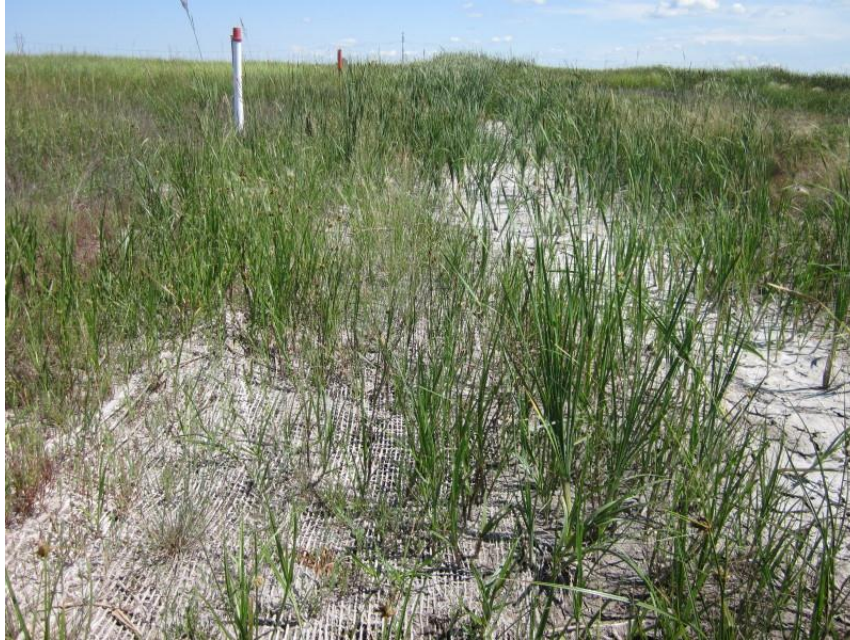
**Photo 37.** Direction: East. Ditch along minimum maintenance portion of 97<sup>th</sup> St NE between Miles 790 and 791, within the wetlands surrounding Juhl National WMA. Pipeline route is marked by the posts on the left. Jute netting was in place in the ditch to stabilize soils and was functioning well. New vegetation was growing through the netting, including many native species such as prairie cordgrass (*Spartina pectinata*) and cattails (*Typha* sp.) and the non-native but common grass quackgrass (*Agropyron repens*).

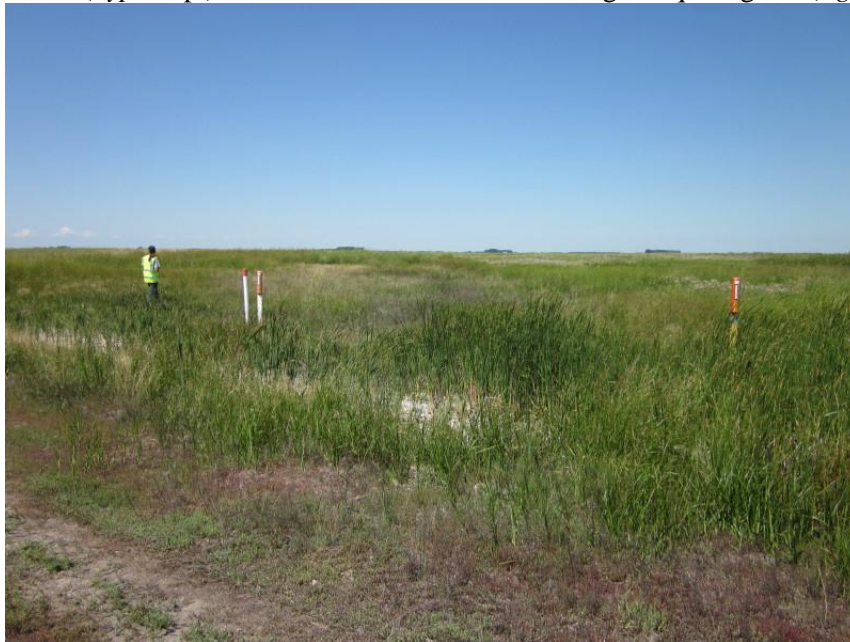
**Photo 38.** Direction: Northwest. On 97<sup>th</sup> St NE in the same location as above but showing the view of the pipeline route to the northwest. The plant composition was different within the pipeline route and the vegetation was not as tall or dense compared to outside of the route, however the species within the route were typical early successional native plants and regrowth of the vegetation should continue on its own with no problems.

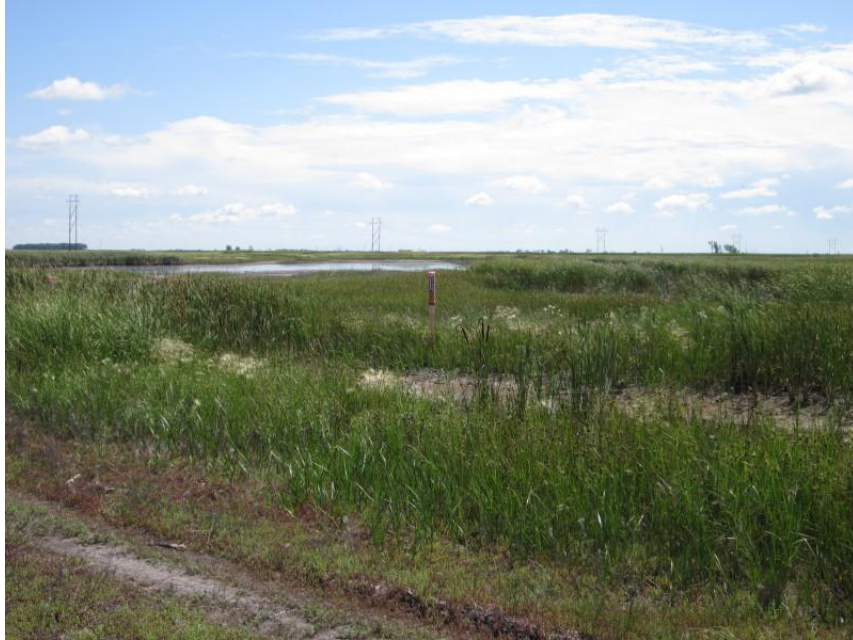
**Photo 39.** Direction: Southeast. Also on 97<sup>th</sup> St NE but showing the pipeline route on the other side of the road, which went through an extensive wetland area to the southeast. The Juhl National WMA intersects the pipeline route about 0.5 miles to the southeast of this point. The Joliette pumping station is just over one mile to the southeast.

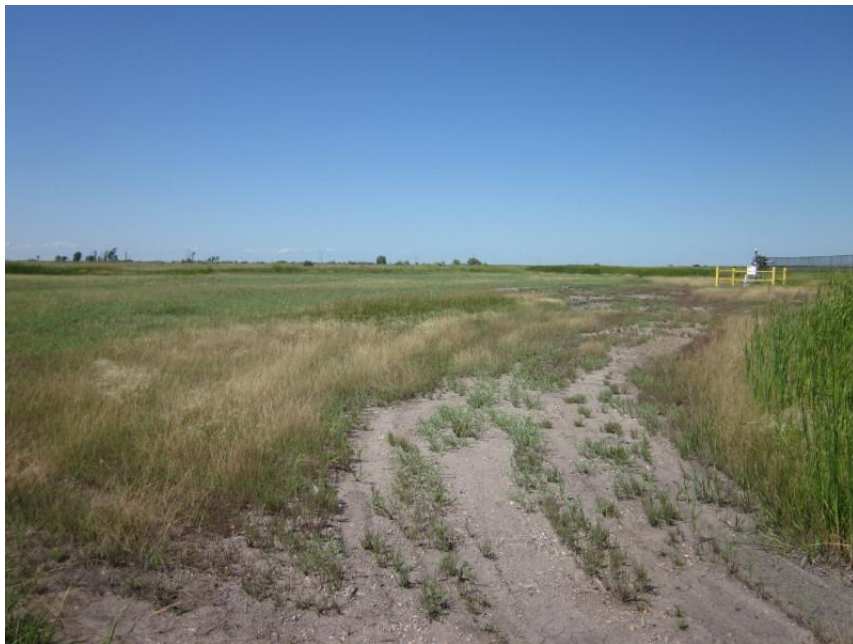
**Photo 40.** Direction: Northwest. West side of Joliette pumping station grounds near Mile 792 where the pipeline veers south to cross State Highway 5. Pipeline runs to the south of above-ground valve visible on right.

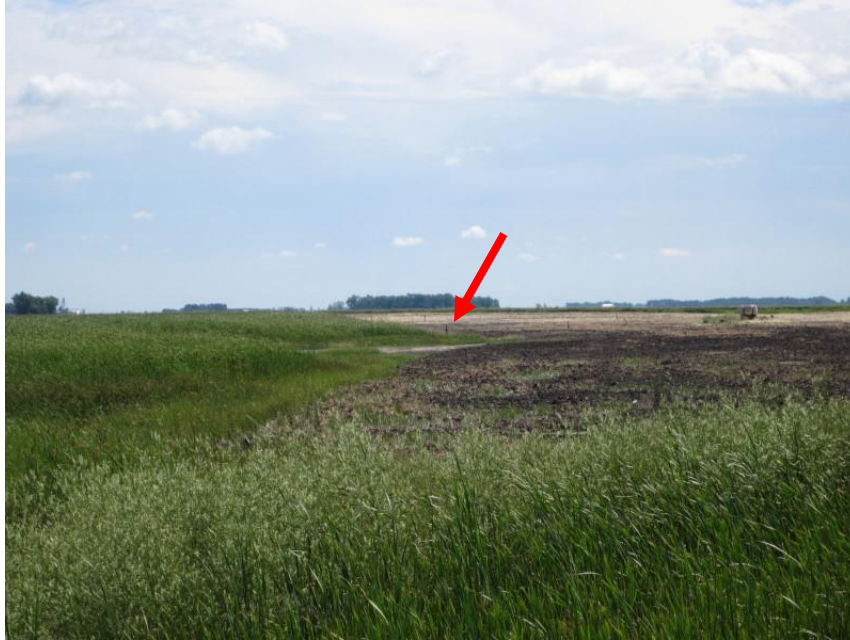
- Route Amendment around Very Deep Pond.* Wenck observed marker posts which indicated induction bends of the pipeline around a very deep wetland just to the south of Mile 793 (**Appendix A, Photo 41**).

**Photo 41.** Direction: Southeast. The pipeline route was altered to avoid a “very deep pond” just to the southeast of Mile 793, which is the deep wetland on the left of the photo. This view is from 158<sup>th</sup> Ave NE and the induction bends of the pipeline where it went around the pond are marked by posts along the edge of the field.
