In re: Enbridge Pipelines (Southern Lights) L.L.C.  
Case No. PU-07-075  
LSr Pipeline, Pembina County, North Dakota

105 PU-07-75 Filed: 6/28/2016 Pages: 5  
Response to request for report re reclamation activities

Enbridge Pipelines (Southern Lights) L.L.C.  
Follow up to Post Construction Inspection Report  
Case No. PU-07-075  
Attachment A

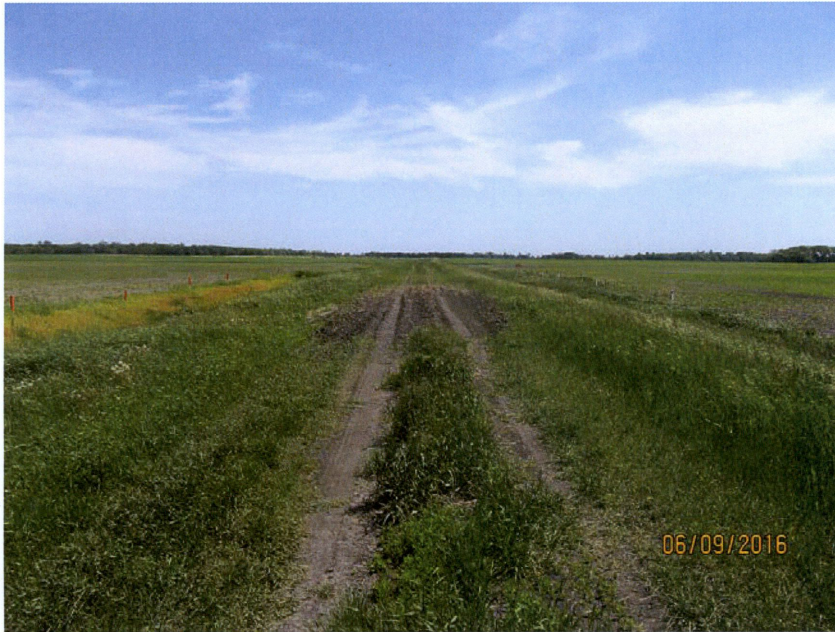
Photo 1 - Southeast of Mile 799 at crossing of 91<sup>st</sup> Street NE

(This location is Photo 11 from the Post Construction Inspection Report)

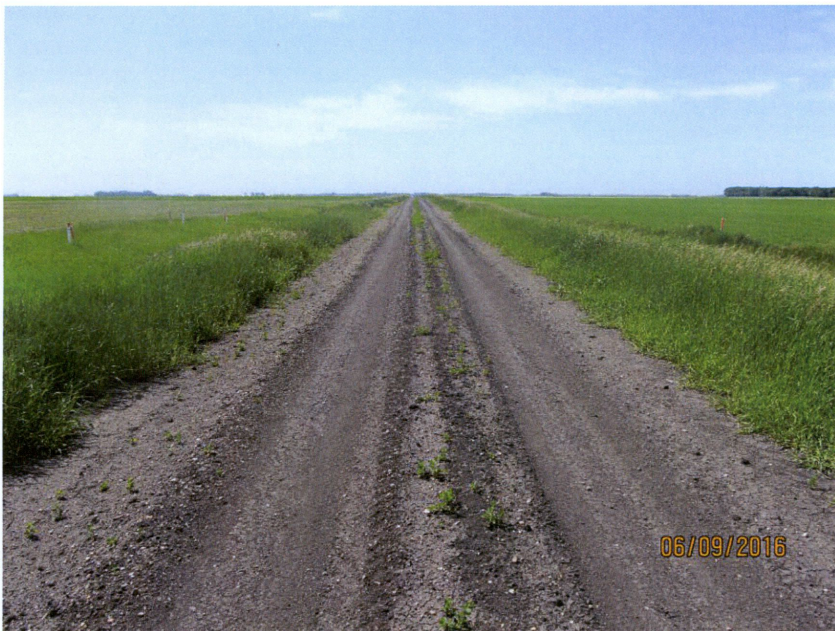
Photo 2 - 148<sup>th</sup> Ave NE just to the southeast of Mile 778

(This location is Photo 27 from the Post Construction Inspection Report)

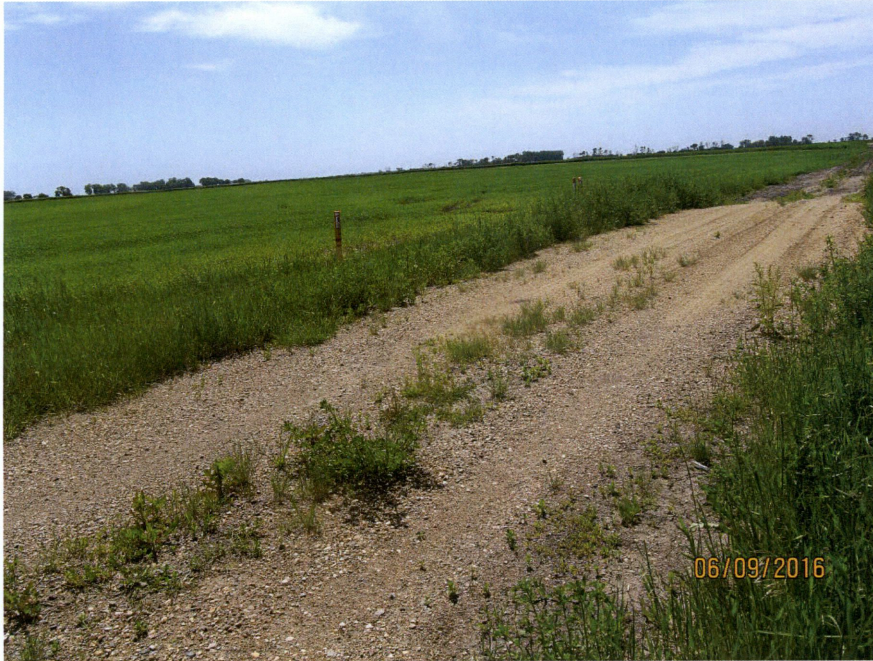
Photo 3 - 104th Street NE to the southeast of Mile 781

(This location is Photo 30 from the Post Construction Inspection Report)

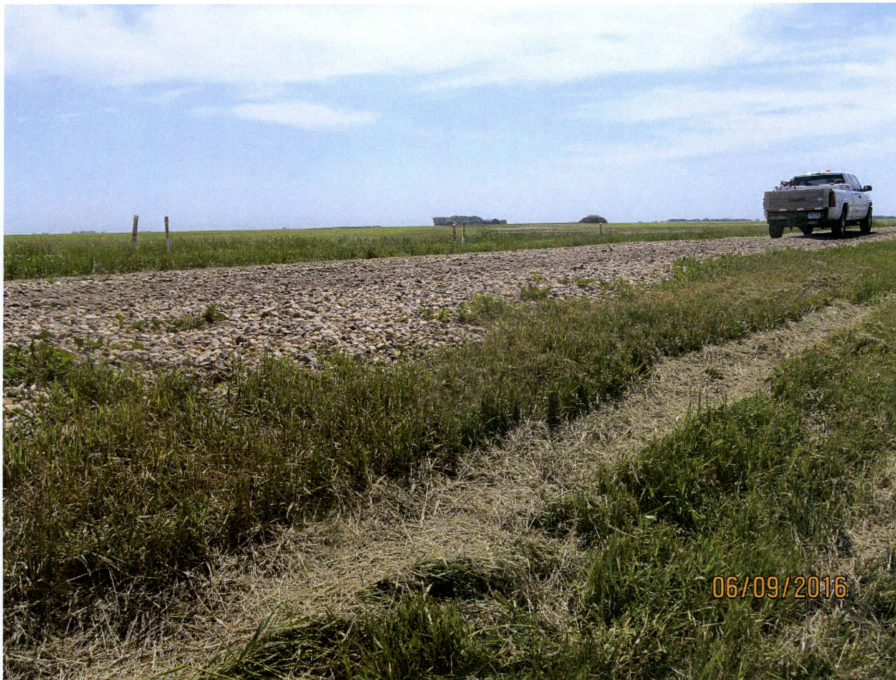
Photo 4 - 154<sup>th</sup> Ave NE at Mile 787

(This location is Photo 34 from the Post Construction Inspection Report)

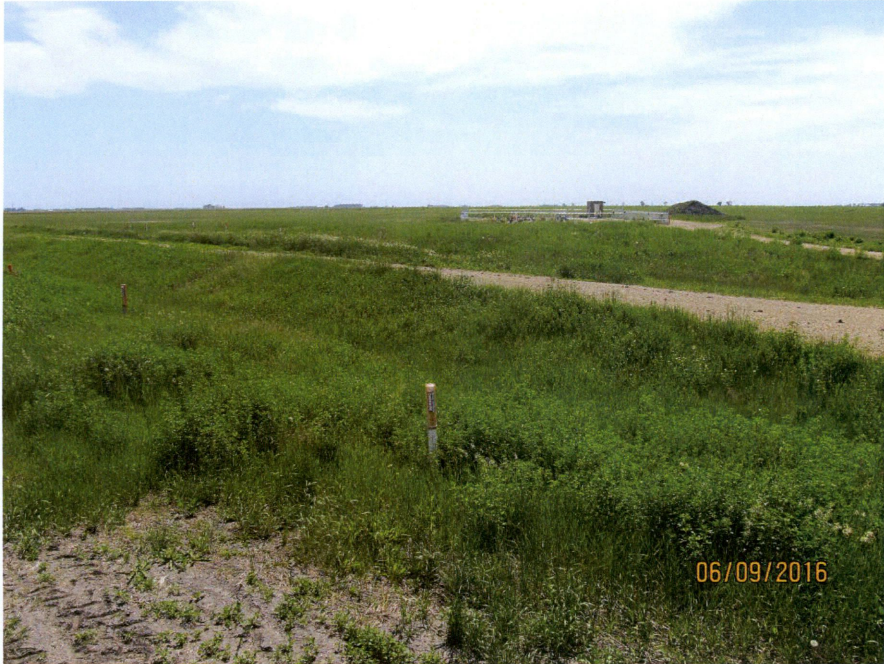
Photo 5 - 98<sup>th</sup> St SE at approximately Mile 789.5

(This location is Photo 36 from the Post Construction Inspection Report)
