Alberta Clipper Pipeline **Construction Inspection Report**

Enbridge Energy Co., Inc.

**NORTH DAKOTA
PUBLIC SERVICE COMMISSION**
600 E. Boulevard Avenue
Bismarck, ND 58505-0480

December 2011

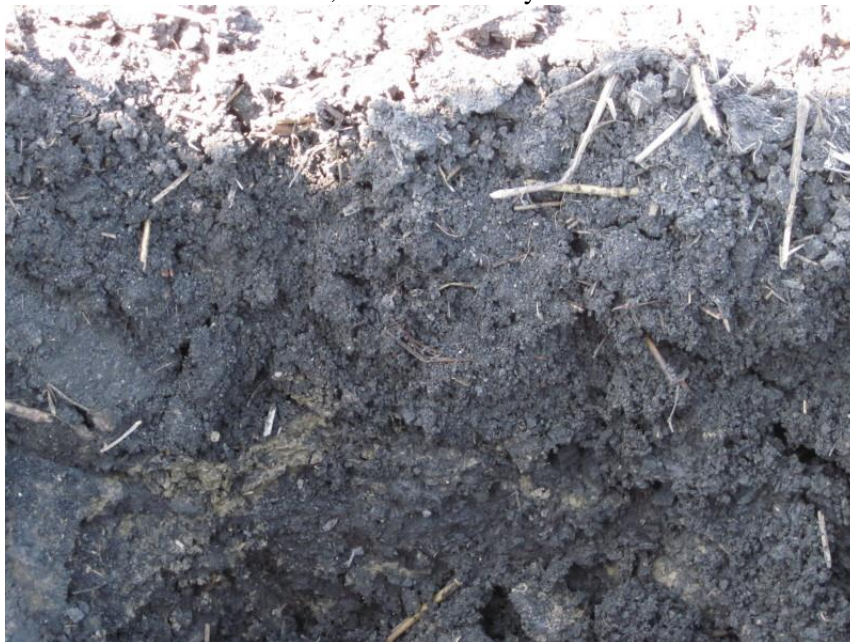
Photo 16. Topsoil exploration pit in an agricultural field south of 90th St SE within the pipeline right-of-way (at approximately Mile 800.6). Topsoil was very dark brown to a depth of 10-inches, underlain by light brown mixed clays in the subsoil layer.

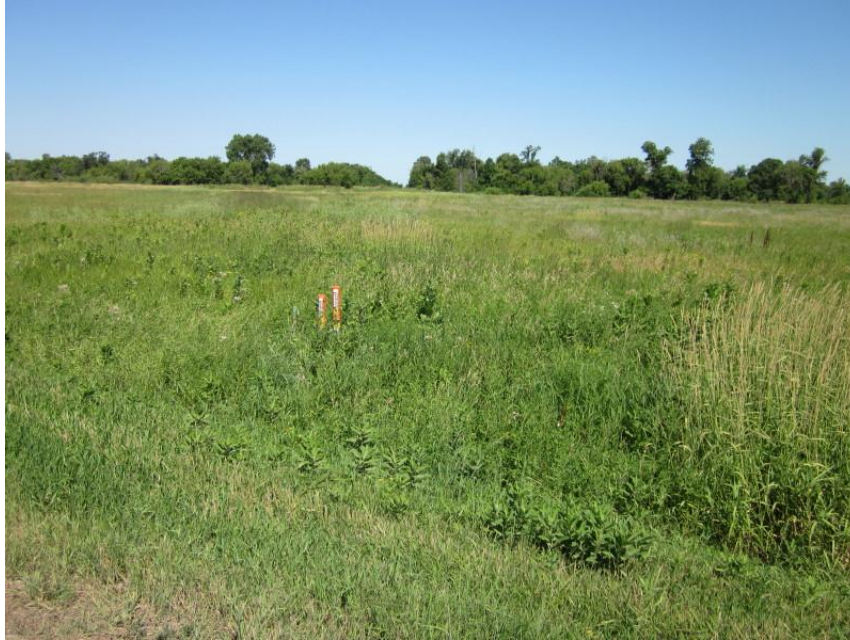
- *USFWS Juhl National WMA Avoided.* Wenck confirmed that the Juhl National WMA was avoided by moving the pipeline route less than 100 feet south and west at the southwest corner of the WMA, which was a mile north of the Joliette substation, between Miles 791 and 792. Two tracts of the Pembina Prairie National WMA and another tract of the Juhl National WMA were avoided by the pipeline route by a distance of between 0.3 to 0.5 miles. There was another WMA or conservation easement area bordering the south side of the Pembina River which was avoided by extending the directional boring underneath the Pembina River (**Appendix A, Photo 21**).

Photo 21. Direction: Northwest. View of WMA between the south bank of the Pembina River (trees in distance) to 108th St NE (ditch in foreground). This area and the road were avoided along with the river via one long directional bore that ended in a field on the south side of the road.

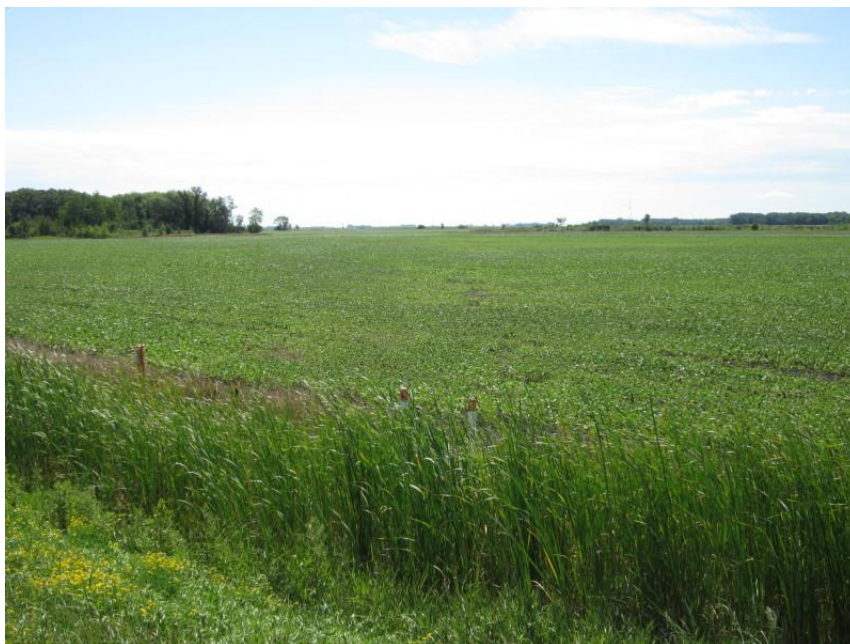
Photo 22. Direction: Southeast. Field to the south of 108th St NE along the pipeline route. There was a slight depression within the pipeline right-of-way which could have been subsidence after pipeline installation.

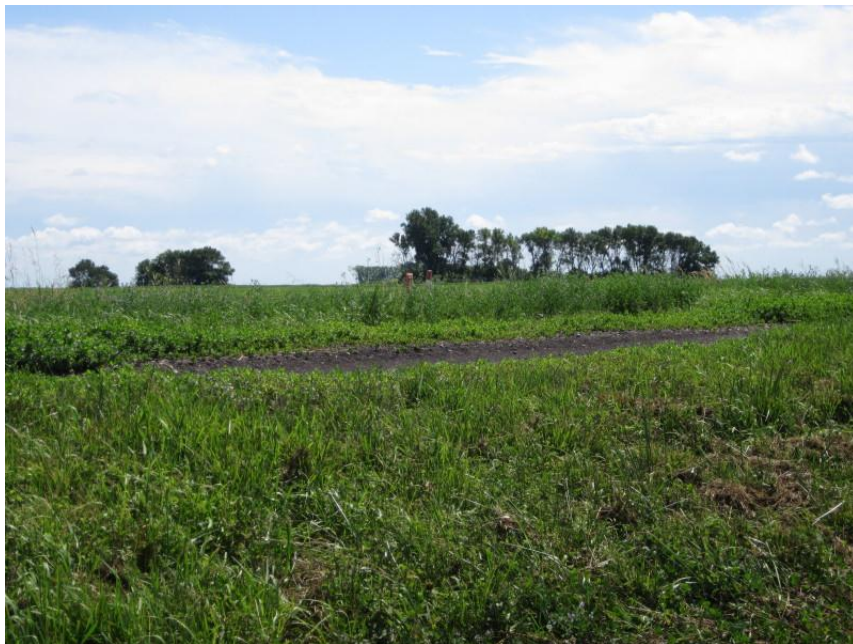
- *Road Crossings Bored, Unless Permitted to Open Cut*. Road crossings for the Project included both horizontally bored and open cut crossings. For bored crossings, Wenck verified that the pipeline route was marked and that the vegetation appeared undisturbed (**Appendix A, Photos 1-5, 22, 25, 33**). Enbridge reported that the bore for these crossings began and ended further out in adjacent agricultural fields, not in the road ditches. Most markers were in place, though a few locations were noted which were marked on one side only (**Figure 1**). For open cut crossings, Wenck verified that all soil had been replaced appropriately, that all road surfacing materials had been replaced, and that the vegetation in the ditch appeared to be similar to adjacent vegetation and had sufficient cover (**Appendix A, Photos 7- 8, 10-11, 27, 30, 34, 36**). There were a few examples of open cut road crossings where there was a slight dip in the roadway on the pipeline route (**Appendix A, Photos 11, 27, 30, 34,**

- 36). These depressions did not impair traffic and there was no erosion, but they should be monitored; if the dips worsen as soil continues to settle repair may be necessary.

Photo 34. Direction: Southeast. Looking across a minimum maintenance portion of 154th Ave NE at Mile 787 with ditch in the foreground and field in the distance. Crops, soils, and ditch vegetation were in good condition. The road had a slight depression from being open cut along the pipeline route.

traffic. However, because these areas have potential to erode or settle further, Wenck recommends these locations be monitored to ensure they do not worsen over time.
