Alexander Loop Pipeline Construction Inspection Report

Belle Fourche Pipeline Co.

December 2011

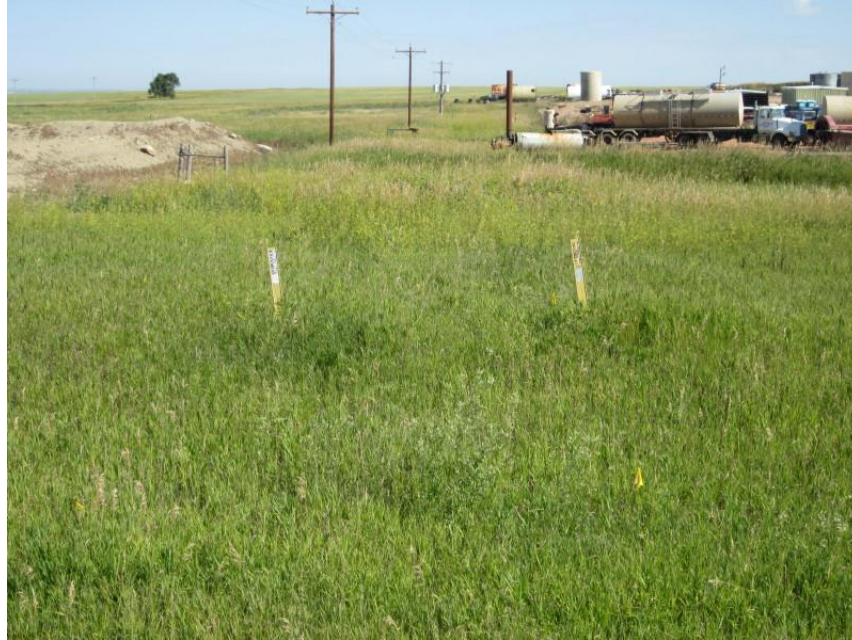
Photo 1. Direction: North. North end of pipeline route (denoted by yellow markers in ditch) looking toward oil service facility, which the pipeline tied into at the south end of the SW ¼ of Section 18, T152N, R101W, McKenzie County, ND.

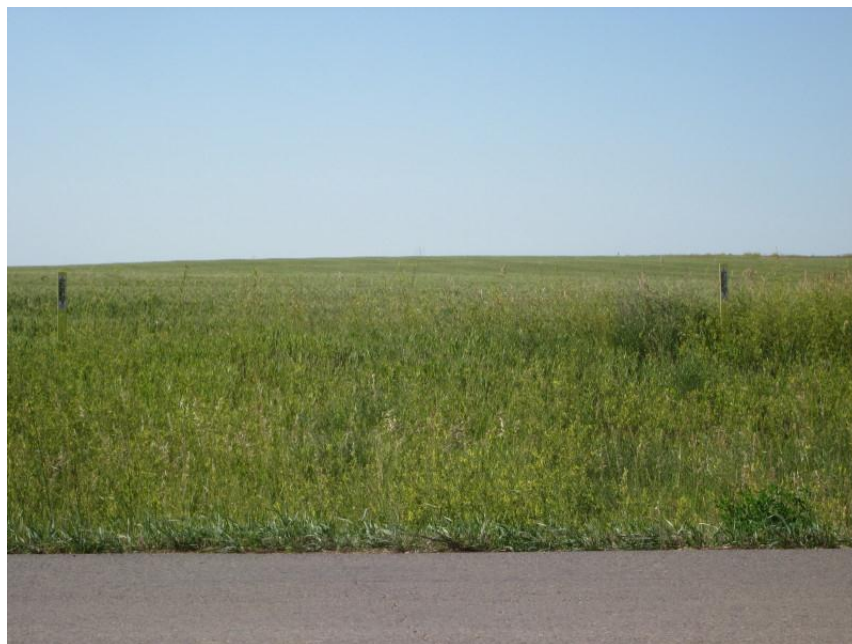
Photo 2. Direction: South. North end of pipeline route. The pipeline was bored underneath County Route 16, shown in the foreground, and went southwest, then south, through cropland. The ditches of the road appeared to be undisturbed and had mainly smooth brome grass (*Bromus inermis*) and yellow sweetclover (*Melilotus officinalis*). The cropland was in good condition with no problems resulting from the pipeline installation.

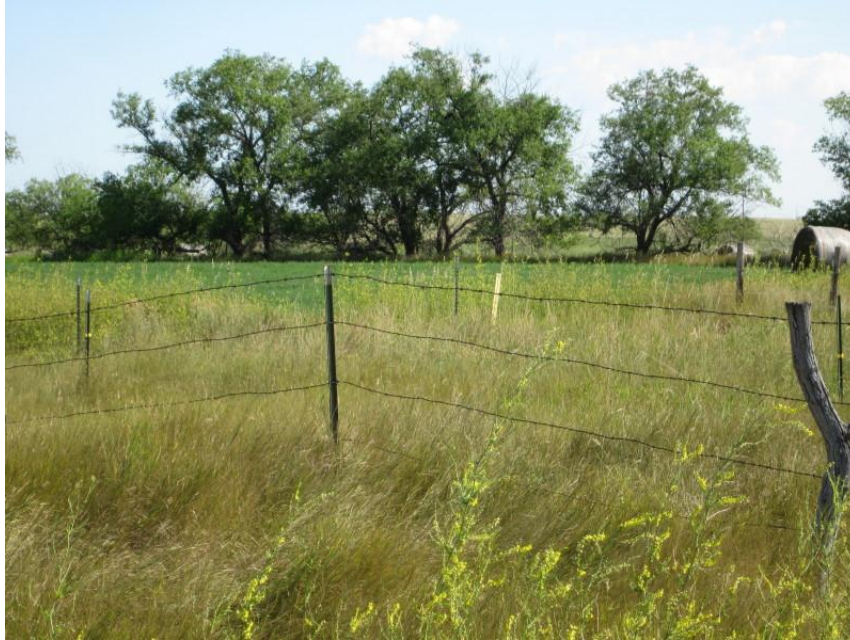
Photo 3. Direction: Northeast. Looking toward yellow pipeline marker at end of field in the SW ¼ of Section 19, T152N, R101W. The pipeline continued to the south of the field into unplowed pasture/rangeland, where it appeared smooth brome (*Bromus inermis*) had been planted in the pipeline right-of-way because it was dense.

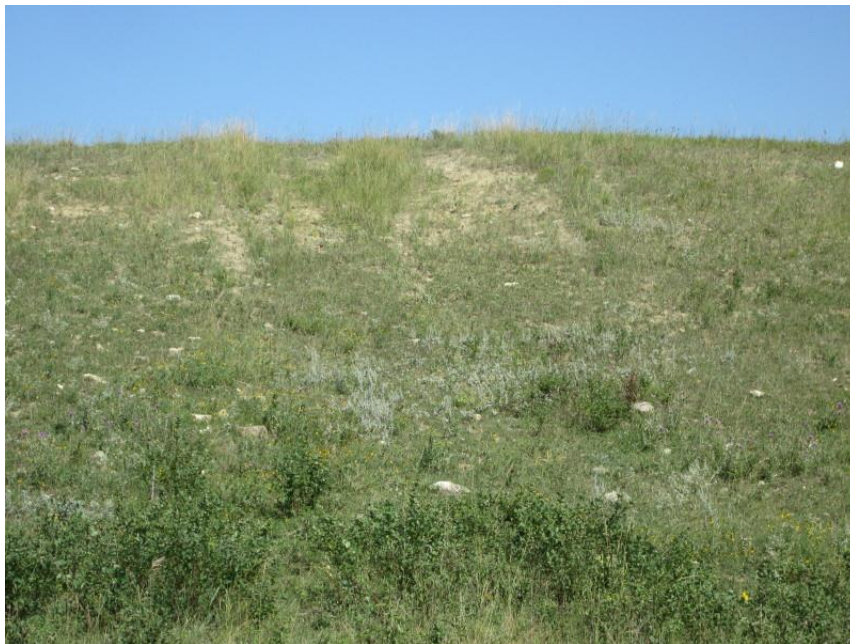
Photo 4. Direction: Northwest. Hill within pasture/rangeland on pipeline route in the NE ¼ of the NW ¼ of Section 30, T152N, R101W, leading into an unnamed drainage. There were minor areas of erosion and bare soils within the pipeline right-of-way on the upper slopes. The native vegetation of the surrounding pasture was spreading into the reclaimed route.

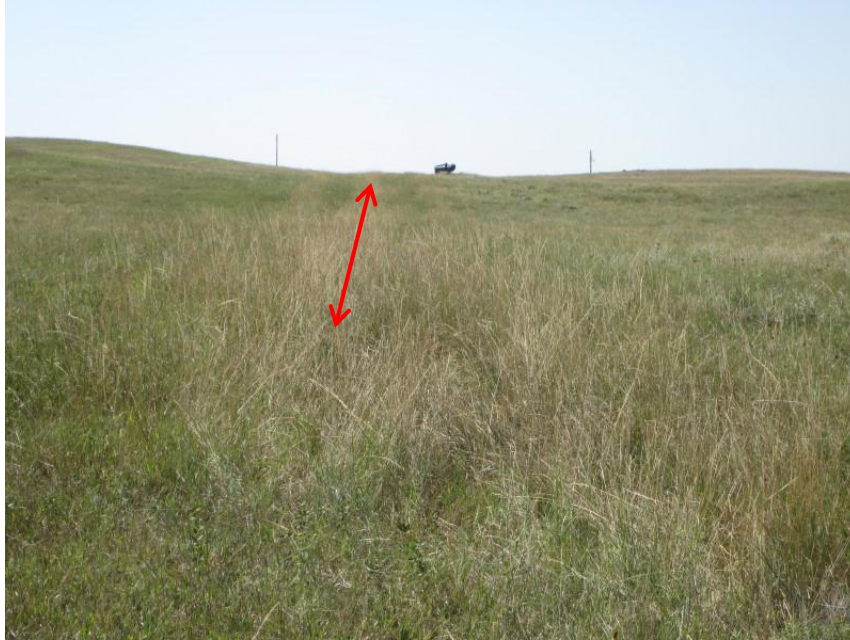
Photo 5. Direction: South/Southeast. Pipeline route continued to the south in the E ½ of the NW ¼ of Section 30. The vegetation on the pipeline route was visibly different from the adjacent pasture. Slender wheatgrass (*Agropyron caninum*), green needle grass (*Stipa viridula*), and smooth brome (*Bromus inermis*) were dominant in the pipeline right-of-way.

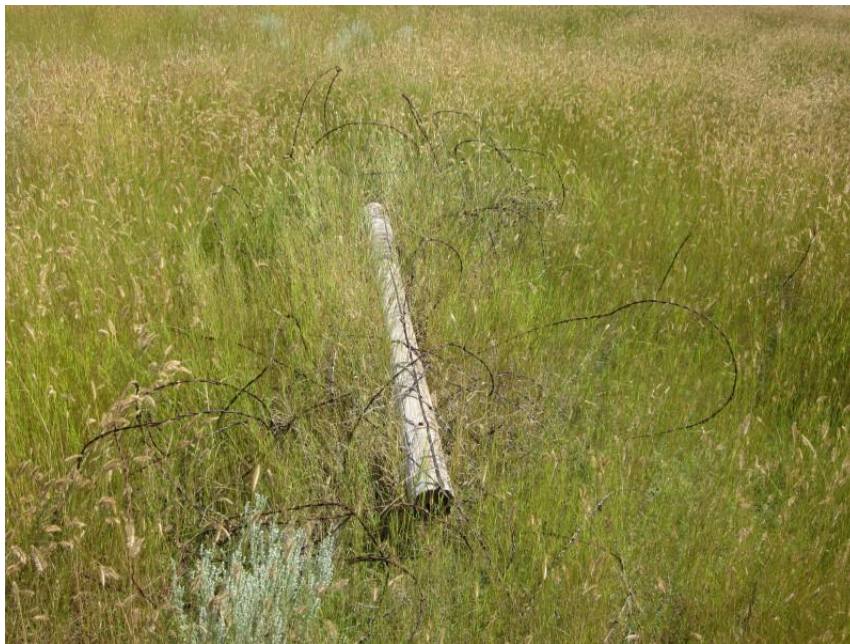
- *Fences/Gates Repaired/Replaced.* Wenck did not observe any gates which would have been impacted by construction. There were numerous fencelines crossed along the length of the pipeline, and it appeared all had been replaced properly (**Appendix A, Photos 2-3, 10, 18-20, 24-25, 32-33**). There was some loose fencing wire in the pipeline right-of-way in a pasture on the south side of Camp Creek (**Appendix A, Photo 6; Appendix B, Point 345**). It was unclear whether this was left by the landowner or from pipeline construction.

Photo 6. Direction: Northeast. In a pasture in the NE ¼ of the SW ¼ of Section 6, T151N, R101W on the south side of Camp Creek. There was some loose fencing wire in the pipeline right-of-way (at approximately pipeline distance 1460ft). It was unclear whether this was left by the landowner or from pipeline construction.

Though a very minor issue, there was a loose piece of fenceline wire noted within the pipeline right-of-way in the NE ¼ of the SW ¼ of Section 6, T151N, R101W. Wenck suggests the pipeline company clarify if the debris was left by the landowner or from pipeline construction and if so, to take responsibility for removing it.

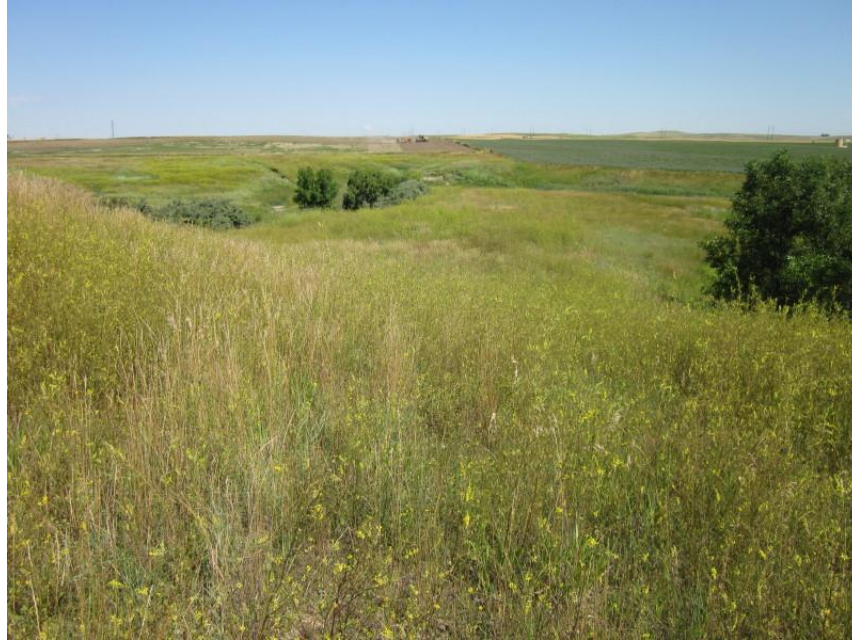
Photo 7. Direction: North. Revegetation within pipeline right-of-way on hill leading down toward Camp Creek in the NE ¼ of the SW ¼ of Section 6, T151N, R101W. Dominant plants were green needlegrass (*Stipa viridula*), slender wheatgrass (*Agropyron caninum*), and yellow sweetclover (*Melilotus officinalis*), curlycup gumweed (*Grindelia squarrosa*), with minor amounts of Japanese brome (*Bromus japonicus*).

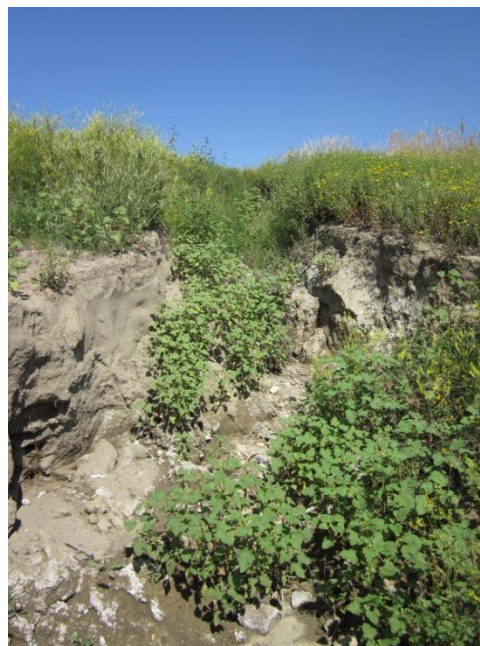
Photo 8. Direction: North. Eroded trench on north Bank of Camp Creek (NE ¼ of the SW ¼ of Section 6, T151N, R101W, at approximately pipeline distance 1463ft). The erosion was within the pipeline right-of-way and appeared to be due to settling and water erosion around the pipeline. At its deepest, the trench was four to five feet deep and had large rocks in the bottom.

Erosion was the most significant problem noted during the site visit (Section 3.2.1). Examples included ruts and depressions on roads; channels, settling, and cracking in agricultural fields and non-cultivated pastures and grasslands; and deep holes and washouts on steep slopes typically near drainage channels. Though it was confirmed that Belle Fourche has routine maintenance in place, many of these erosion and sedimentation problems need to be addressed as soon as possible, with solutions that prevent long-term issues. Wenck recommends the company provide a maintenance/follow-up reclamation plan to be implemented this spring or summer 2011.

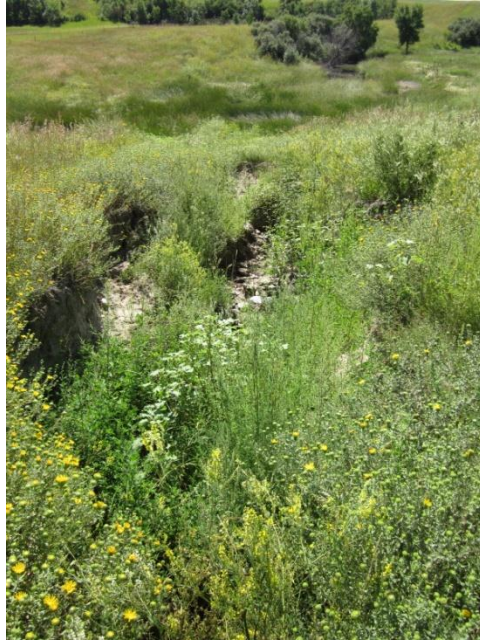
Photo 9. Direction: South. View of eroded trench from north to south looking towards Camp Creek (dark green vegetation visible in distance). As-built drawings indicated it had been open cut. The channel of Camp Creek itself appeared to be in good condition with no erosion problems and complete revegetation. Tree and shrub patches were avoided.

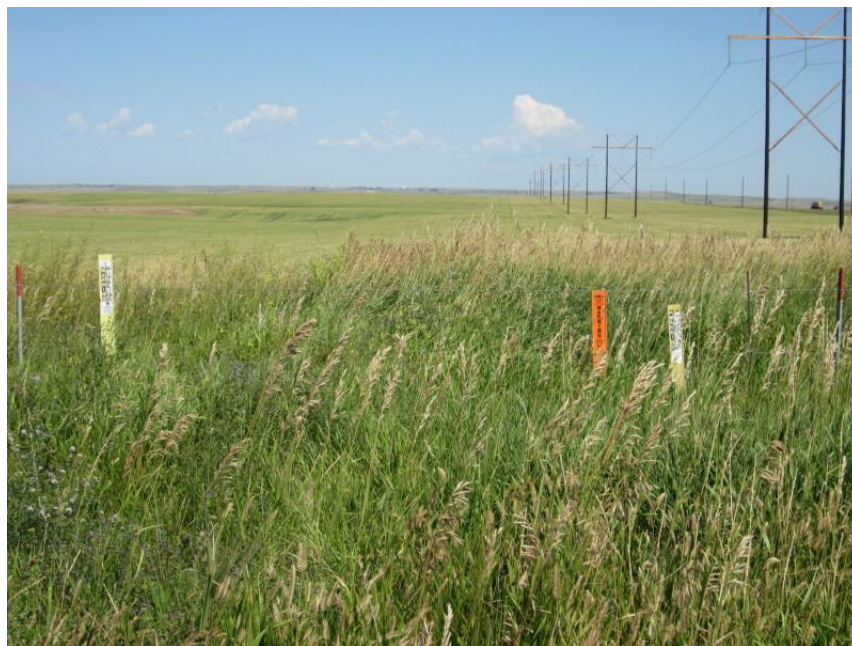
Photo 10. Direction: North. View of cropland in good condition in the SE ¼ of the SE ¼ of Section 19, T151N, R101W. Pipeline markers are in the ditch of Highway 200 and indicate the horizontal drill used to cross the road, which runs east-west between Sections 19 and 20. The ditch vegetation had good cover except for a few insignificant bare spots.

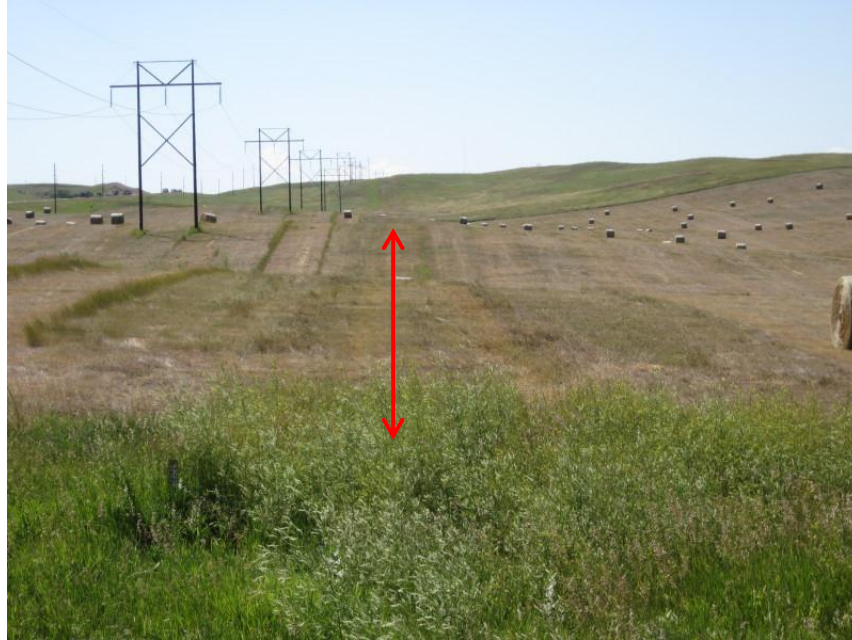
Photo 11. Direction: South. To the south of Highway 200 showing pipeline right-of-way going straight south through a hay field and then into pasture on the E ½ of the E ½ of Section 30, T151N, R101W. The route parallels the above-ground utility line. The hay field and pasture had revegetated well.

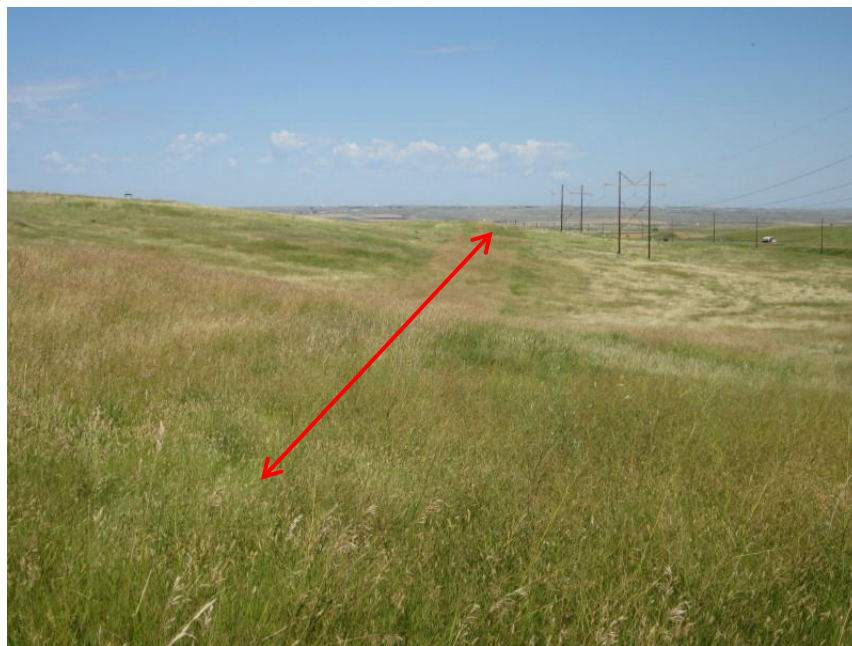
Photo 12. Direction: North. Pipeline right-of-way in pasture in the SE ¼ of the SE ¼ of Section 30, T151N, R101W, paralleling the above-ground utility line (on right). The reclaimed route of the pipeline had good vegetation cover, though the species composition was visibly different. It was nearly a pure stand of smooth brome grass (*Bromus inermis*).

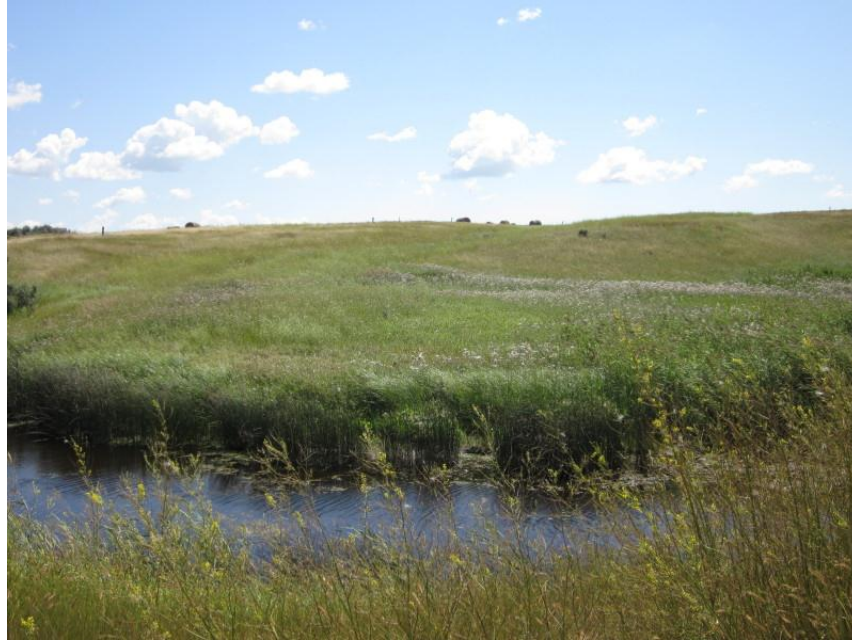
Photo 13. Direction: Southeast. Crossing of Lonesome Creek in the NE ¼ of the NE ¼ of Section 7, T150N, R101W (at approximately pipeline distance 1117ft). The creek was directionally bored underneath. There were no markers on either bank to denote the pipeline route. The revegetation on the banks was dense with yellow sweetclover (*Melilotus officinalis*) and crested wheatgrass (*Agropyron cristatum*). There was a patch of Canada thistle (*Cirsium arvense*) on the east bank, though it extended beyond the pipeline route and was likely not a new population caused by pipeline disturbance.

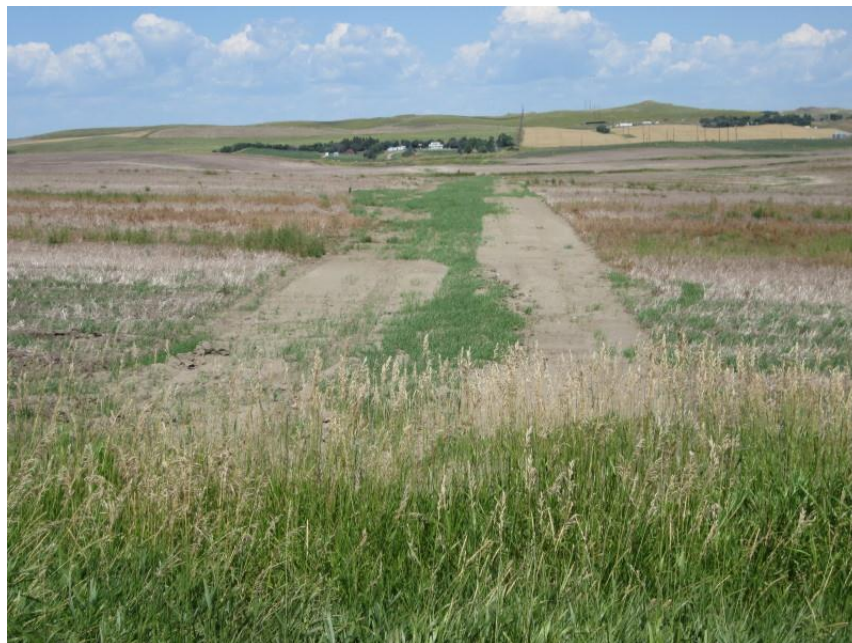
Photo 14. Direction: North. Pipeline right-of-way recently bladed to repair low areas upon landowner request. Photo taken from private east-west gravel road between Sections 7 and 18, T150N, R101W, which had been bored underneath, according to the as-built drawings. The stubble field was in the SE ¼ of Section 7.

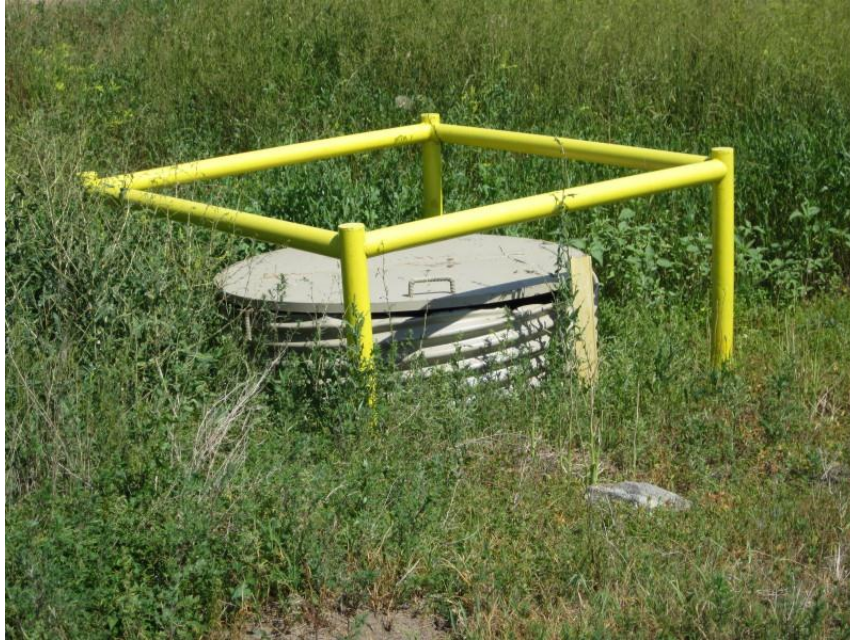
Photo 15. Direction: Northeast. Block valves for the pipeline along the gravel road between Sections 7 and 18. There was some settling around the valves and through the middle of the ditch, which was dense with yellow sweetclover (*Melilotus officinalis*).

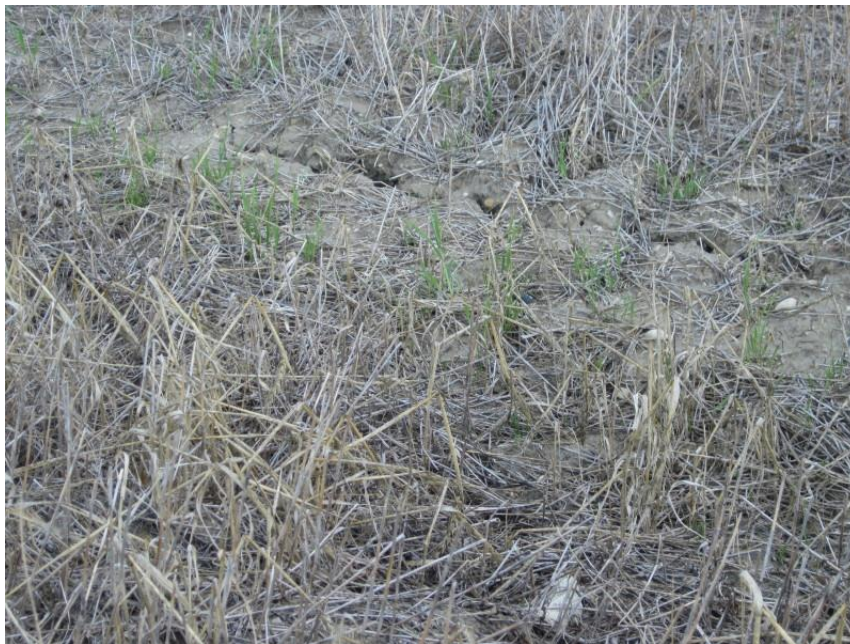
Photo 16. Direction: Northeast. Cracking in soil on pipeline right-of-way. This was on the edge of a stubble field to the north of County Route 15, which went east-west through the center of the SE ¼ of Section 18, T150N, R101W.

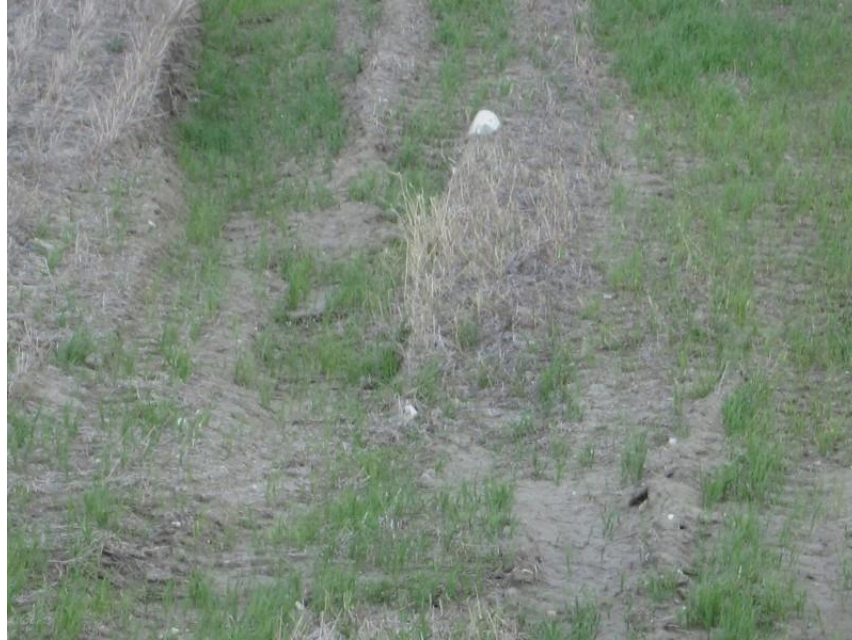
Photo 17. Direction: Northeast. Trenches/settling in pipeline right-of-way in stubble field to the north of County Route 15. There was a shallow coulee/drainageway in this portion of the field where water runs across the right-of-way during precipitation events and probably contributes to the settling in this location.

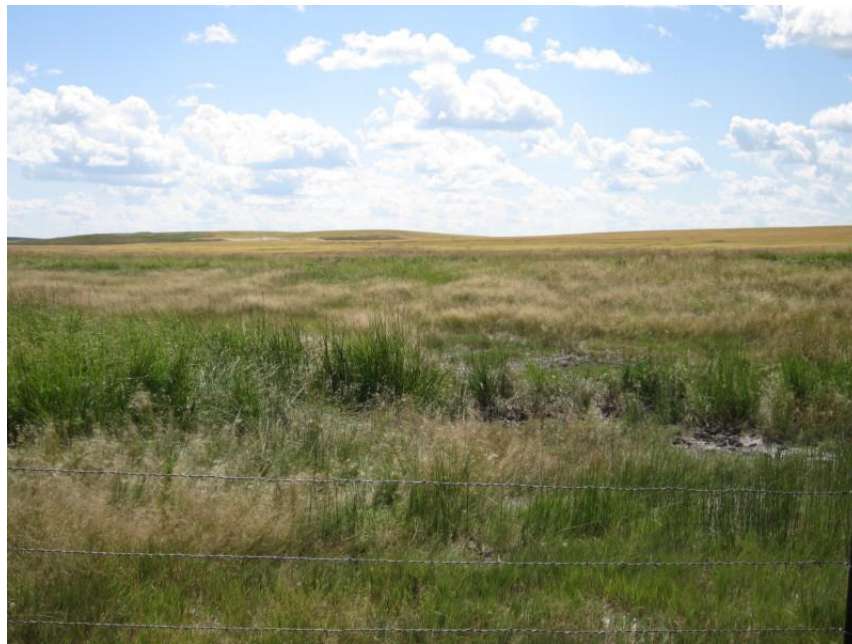
Photo 18. Direction: South. Pipeline crossing of Antelope Creek in the NE ¼ of Section 31, T150N, R101W. As-builts indicated this crossing was open cut. Revegetation of the creek appeared satisfactory. Native plants had colonized the right-of-way including prairie cordgrass (*Spartina pectinata*), Nuttall's alkali grass (*Puccinellia nuttalliana*), and dock (*Rumex* sp.). There were no trees or shrubs along the creek. The cropland to the south appeared to be in good condition. Note the fenceline in the foreground which was new and had been replaced after pipeline construction. Markers were not present.

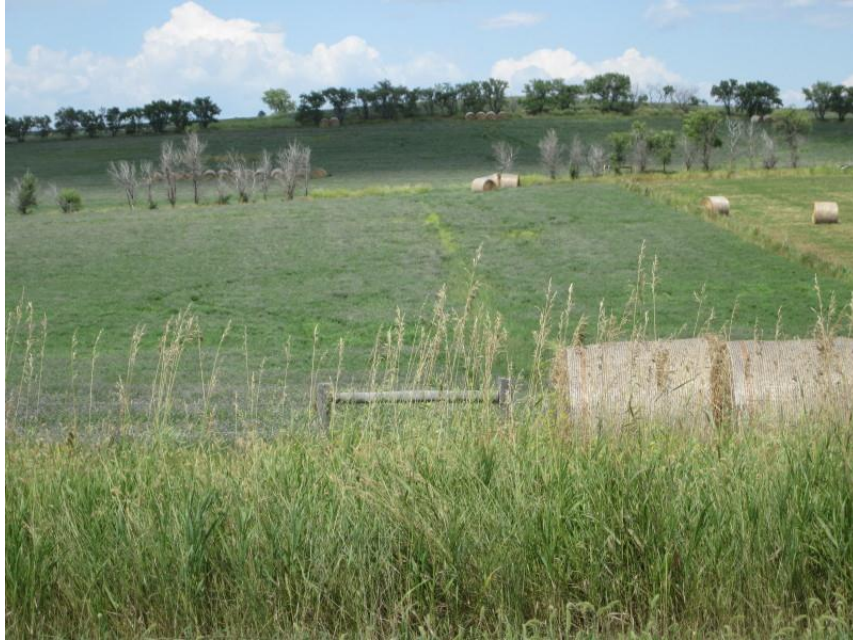
- *Tree Removal Minimized, Lost Trees Replaced, Woodland Crossing Width Reduced to 50ft.* Natural woodlands within the Project area were concentrated along streams or drainages. Some of these woodlands had been avoided by directionally boring underneath the drainage or by the choice of the location of the crossing point (**Appendix A, Photos 9, 13, 18, and 20**). There was one crossing of a Spring Creek tributary drainage that, according to the as-builts, had been open cut, with trees removed at a total width less than 50ft, as required (**Appendix A, Photo 28**). There were also locations where the route went through mature planted tree rows and trees had been removed, but Wenck verified the width of impact was less than 50ft

(**Appendix A, Photo 19**). Tree replacement for trees removed due to the Project is discussed above.

Photo 19. Direction: North. From 22nd St NW between Sections 7 and 18, T149N, R101W to the north showing the pipeline route through hay fields. Trees were cut down from the tree rows in the fields at a width less than 50 feet for the pipeline right-of-way. The road had been bored underneath, according to the as-built drawings, and was in good condition, as were the hay fields to the north and the south.

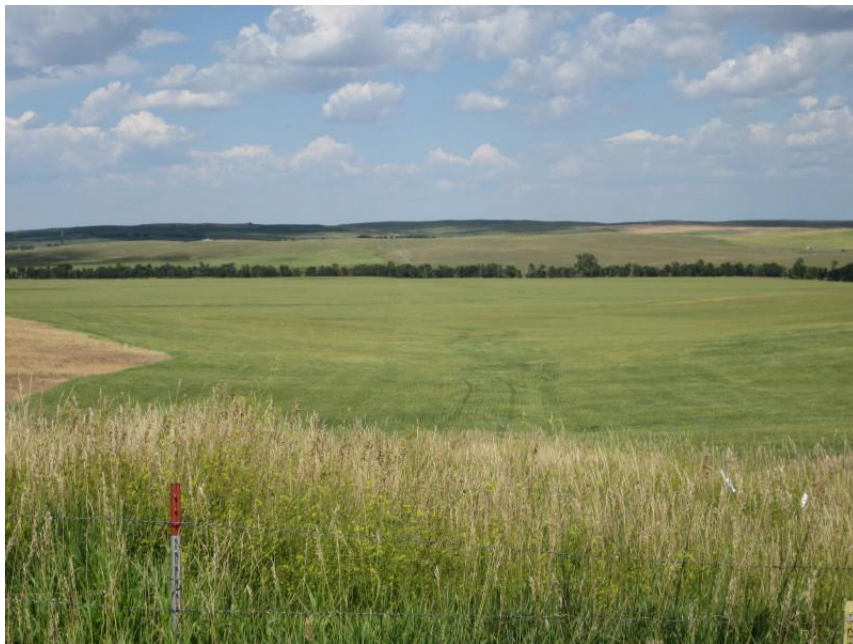
Photo 20. Direction: Northeast. Pipeline right-of-way through fields in the E ½ of Section 19, T149N, R101W. It ran in a northeast-southwest direction. The cropland to the north and south of this point appeared to be in good condition. Charbonneau Creek is visible in the distance as the dense line of trees. This waterway was crossed by directionally boring underneath which avoided disturbance of the creek and trees. Beyond the creek in the distance the pipeline crossed hills of unplowed pasture/rangeland. There appeared to be no erosion problems, but the route was visible from differences in vegetation.

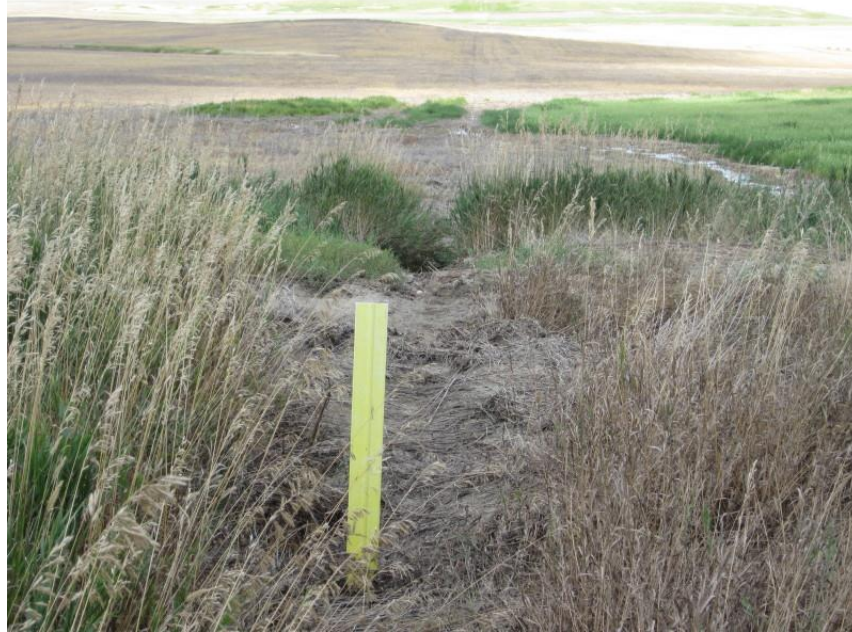
appeared to be in good condition, however a few had erosional problems, including some deep ruts on the sectionline road of 19th St NW and erosional channels extending from that road into adjacent fields (**Appendix A, Photos 21-22; Appendix B, Point 375**); and a depression on a two-track sectionline road where the pipeline crossed with a small washout into hayland downslope (**Appendix A, Photo 25; Appendix B, Point 379**).

Photo 21. Direction: South. At intersection of pipeline with 19th St NW, a sectionline trail which ran east-west between Sections 30 and 31, T149N, R101W. Markers were present which indicated the pipeline right-of-way. This road had been open cut, according to the as-built drawings. There was an extensive area of erosion about ¼ mile north and ½ mile south of this point in fallow fields. The road had deep ruts and erosion 12-18 inches deep and the fields had ruts 6-12 inches deep.

| Point | Feature | Northing (m)* | Easting (m)* | Observation Notes |
|---|---|---|---|--|
| 375 | Road Crossing | 5292278.83 | 150344.55 | Open cut two-track road/sectionline, 19th St NW. Road reclamation poor condition, deep ruts, erosion extends into fields. Markers present. |

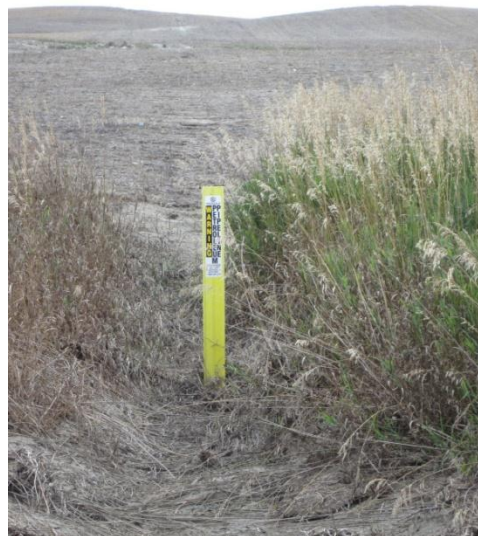
Photo 22. Direction: North. Another view of erosion in fields to north of 19th St NW. There appeared to be a natural spring or a plugged culvert just to the east of the pipeline intersection along the road. There were very deep ruts in the road in that area. This was outside the pipeline right-of-way but the water accumulation was contributing to the erosion problems.

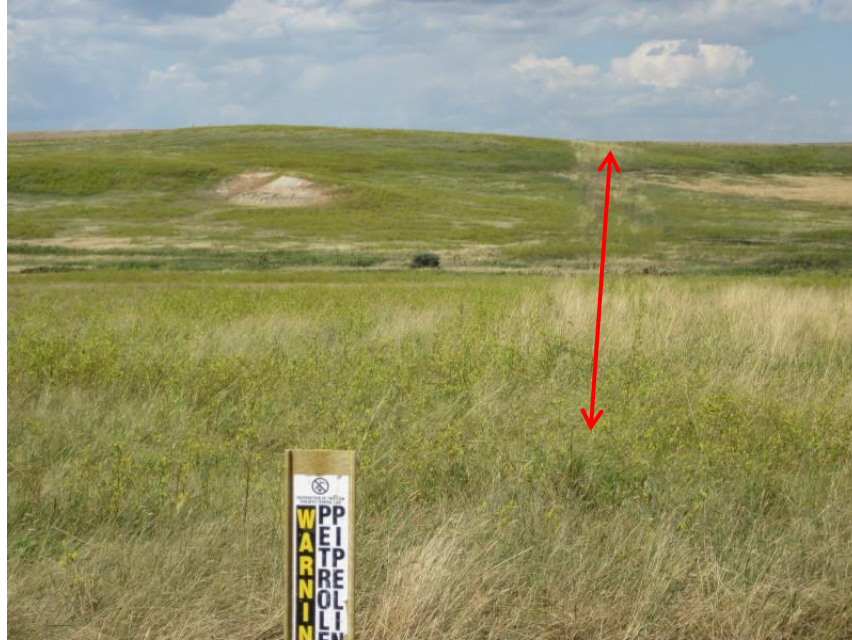
Photo 23. Direction: North. Pipeline right-of-way through pasture in the E ½ of the SW ¼ of Section 31, T149N, R101W. There was a visible difference in vegetation on the pipeline route (note red arrow). The pipeline crossed an unnamed drainage in the pasture. The marker in the foreground indicated the intersection with State Highway 68, which ran east-west between Section 31 and Section 3, T148N, R102W. The as-builts indicated the highway had been bored underneath.

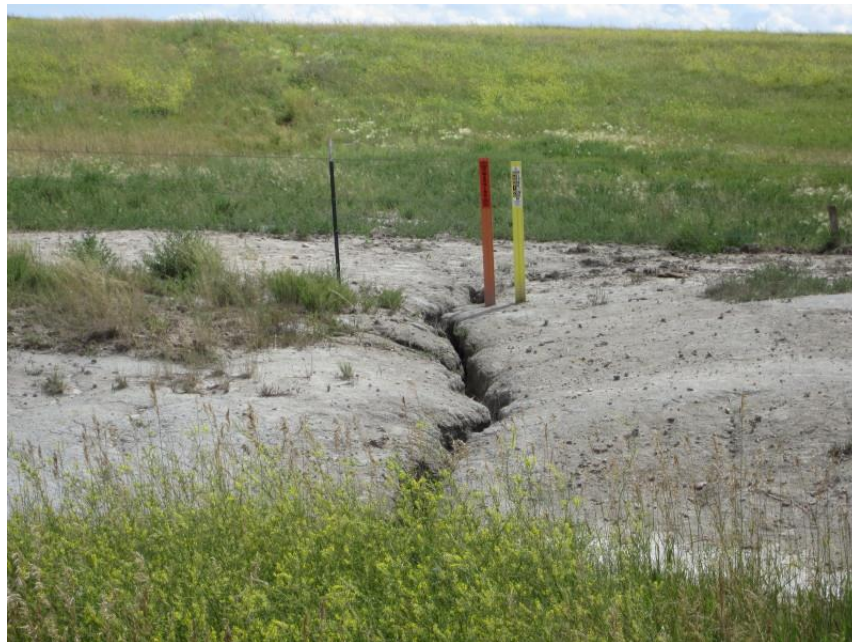
Photo 24. Direction: South. South ditch of State Highway 68 showing erosion of clay soils within pipeline right-of-way. The highway had apparently been bored underneath, so the erosion may not have been due to the pipeline. High amounts of spring runoff this year may have prompted the particularly deep erosion channels.

| Point | Feature | Northing (m)* | Easting (m)* | Observation Notes |
|---|---|---|---|--|
| 378 | Erosion | 5290643.95 | 150242.55 | Bare soils and cracks in clay soils in south ditch of Hwy 68. |

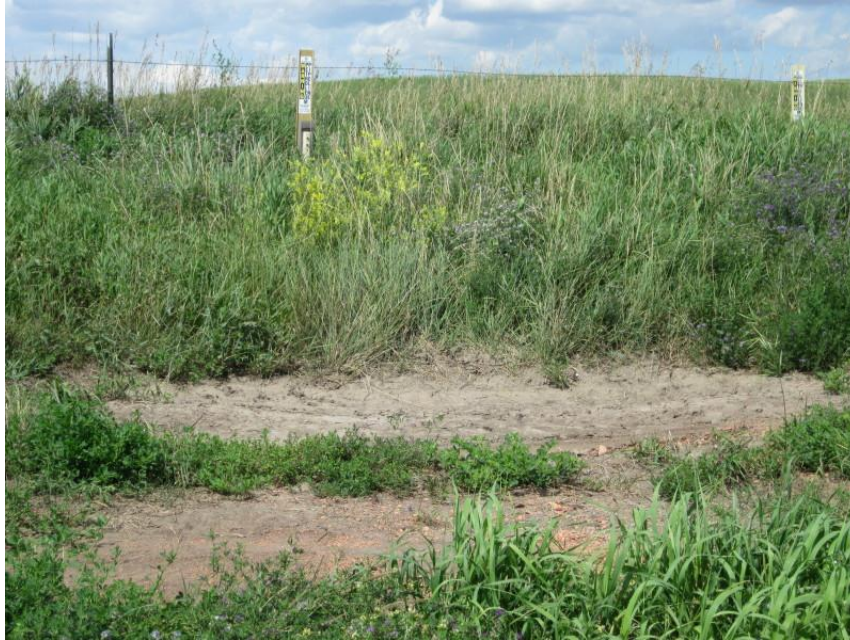
Photo 25. Direction: North. Pipeline intersection at sectionline between Sections 3 and 10, T148N, R102W, with markers. There was a field to the north and hayland to the south which both appeared to be revegetated, except that the hayland had noticeably higher proportions of annual weeds within the pipeline route. The two-track road on the section line had a depression where the pipeline crossed (open cut), with a small washout of soils and scoria into the hayland downslope to the south.

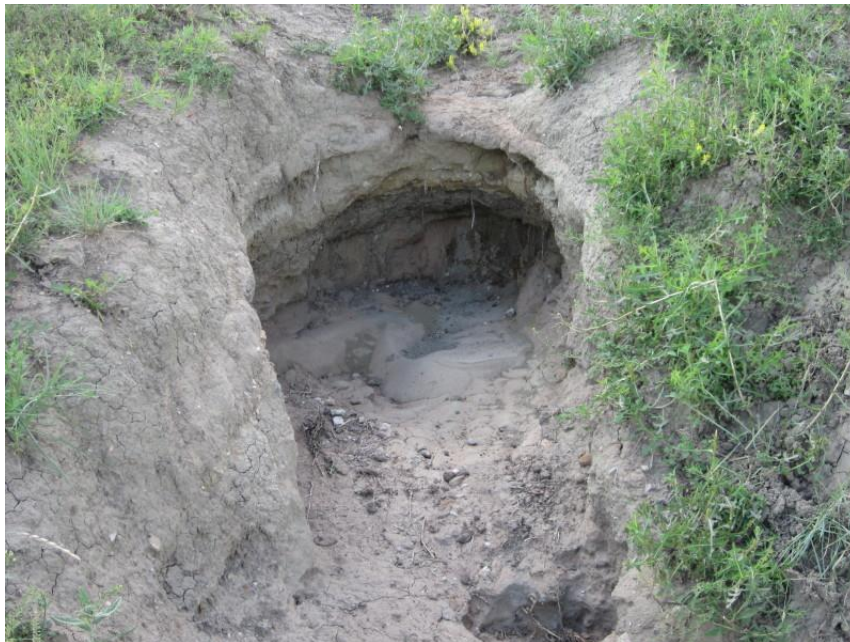
Photo 26. Direction: Northwest. Erosion from runoff in ditch of Forest Service Road 835 in the N ½ of Section 15, T148N, R102W, at the point where the pipeline crossed. Markers were in place on both sides of the road. The pipeline also intersected Spring Creek at this point. The as-built drawings were unclear and difficult to distinguish but appeared that Spring Creek and the road had been bored underneath.

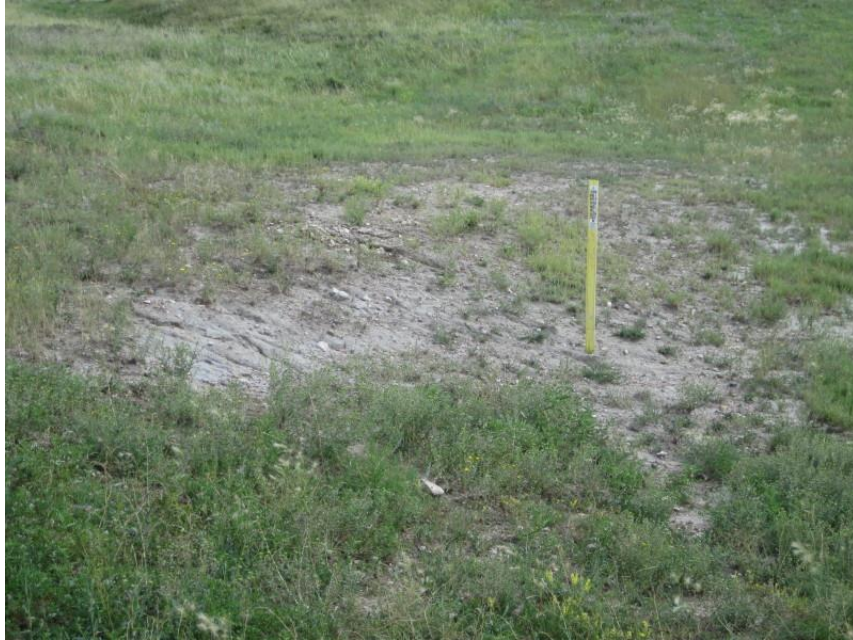
Photo 27. Direction: Southwest. Pipeline right-of-way to the south of Spring Creek in the S ½ of Section 15, T148N, R102W upslope toward a gas plant in the SW ¼. The revegetation of the route was good overall, but with a few bare areas.

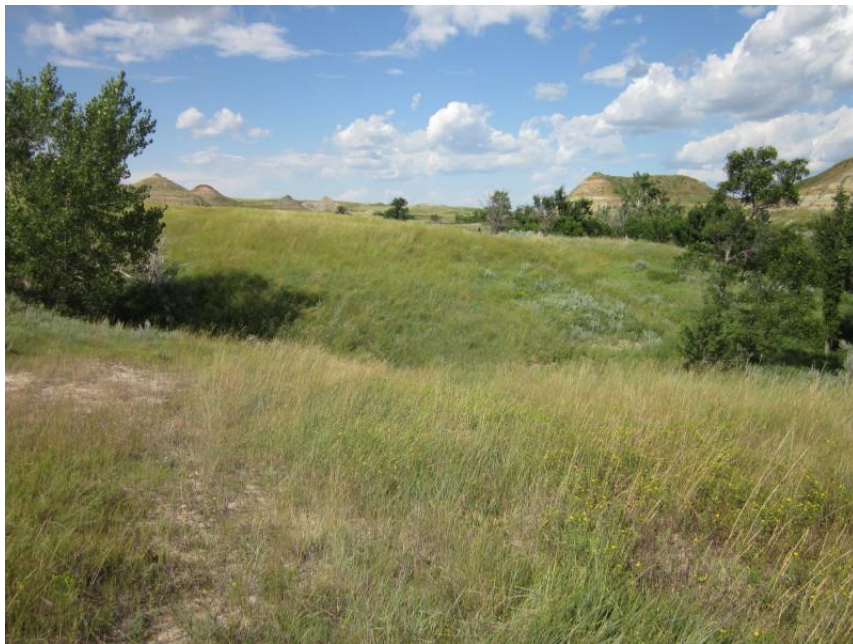
Photo 28. Direction: North. Pipeline right-of-way across steep banks of a drainage flowing into Spring Creek in the NW ¼ of the NE ¼ of Section 27, T148N, R102W. Vegetation cover was good. It appeared there were several trees removed from the drainage, though at less than 50 feet width. The as-builts indicated the drainage had been open cut.

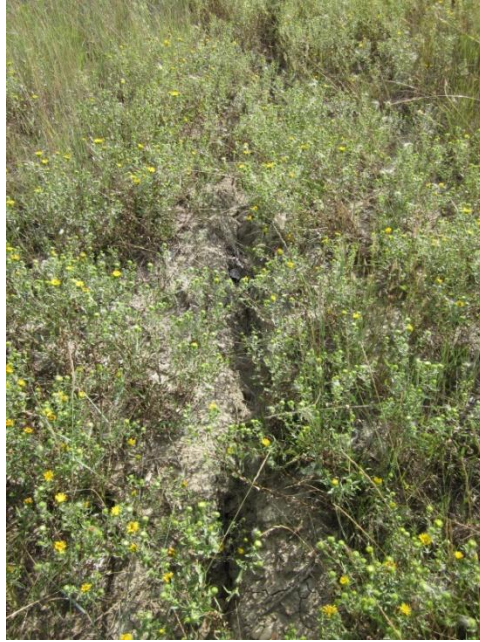
Photo 29. Direction: Southwest. Close-up of narrow, but deep, channels of erosion on the steep banks of the drainage in Photo 28. The drainage channel itself was in good condition with no erosion or sediment control problems.

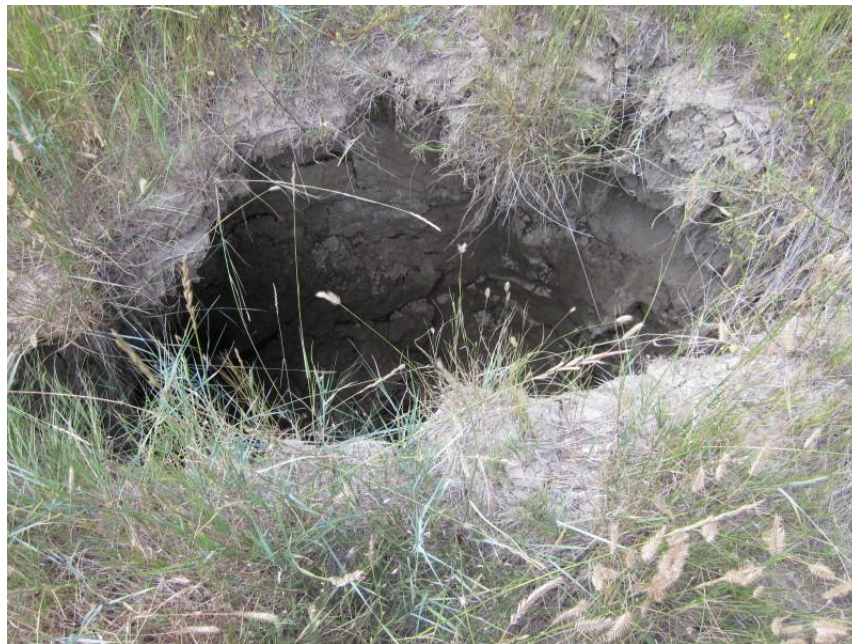
Photo 30. Close-up of a hole to a depth of 5 to 6 feet within pipeline right-of-way leading up to the north edge of another tributary drainage of Spring Creek in the SE $\frac{1}{4}$ of the SE $\frac{1}{4}$ of Section 27, T148N, R102W. The hole was likely caused by piping of water, in which flow is concentrated along the buried pipeline and begins to erode the recently reclaimed loose soils, eventually reaching the surface and forming a hole.

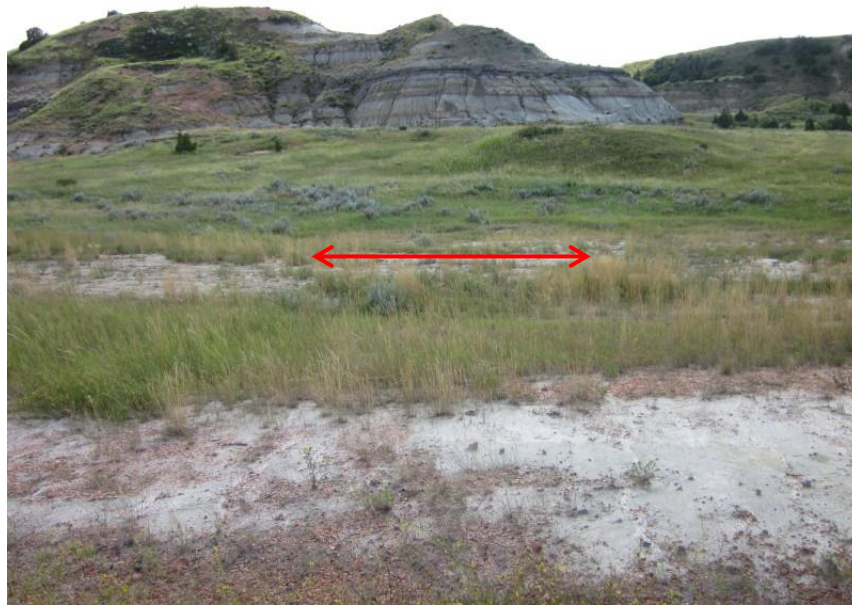
topsoil had been segregated and replaced above the subsoil, but was not at the required depth of 12in. However, in this region of the state topsoil is generally less than 12in deep, so it is evident the company fulfilled its requirements to the best of its ability using what topsoil was available. One area of concern regarding topsoil replacement is for portions of the pipeline in non-agricultural areas, particularly rangeland on the National Grasslands and other private pastures. It is not clear whether topsoil was segregated in these areas. Examples in non-cultivated areas tended to show zones of bare ground and vegetational differences between the pipeline right-of-way and adjacent, undisturbed grassland (**Appendix A, Photos 4-5, 7, 12-13, 23, 27, 31-32**). The vegetational differences were likely caused primarily by the different species that were planted compared to adjacent vegetation. However soils can also be a factor, particularly in this region of the state where subsoils have high clay and salt contents; if they are not segregated from the limited topsoils, it often causes long-term problems for revegetation. Wenck suggests the procedures of topsoil segregation and replacement should be clarified with Belle Fourche and a decision should be made whether follow-up topsoil replacement and re-seeding may be necessary. The main area of concern that showed extensive re-vegetation problems which may need to be addressed would be the portion of the pipeline that paralleled a FS Road and went across some small hills and buttes through the center of Section 35, T148N, R102W (**Appendix A, Photos 31-32; Appendix B, Points 393-395**).

Photo 31. Direction: South/Southwest. Looking perpendicular to pipeline route as it paralleled an unnamed Forest Service Road diagonally through the center of Section 35, T148N, R102W. Re-vegetation of the right-of-way in this area was sparse and inadequate, with a significant amount of bare clay soils.

ameliorating topsoils and/or reseeded for any of these areas that were extensive, particularly a portion of the route that paralleled a FS Road through the center of Section 35, T148N, R102W. Wenck also recommends that the policy on topsoil segregation and replacement be clarified between what was stated in the company's Environmental Mitigation Plan for non-agricultural open areas and the PSC requirements. In the region of the Project area, Wenck feels topsoil segregation would be critical to revegetation success because topsoil is so limited and subsoils have properties which could hinder restoration.

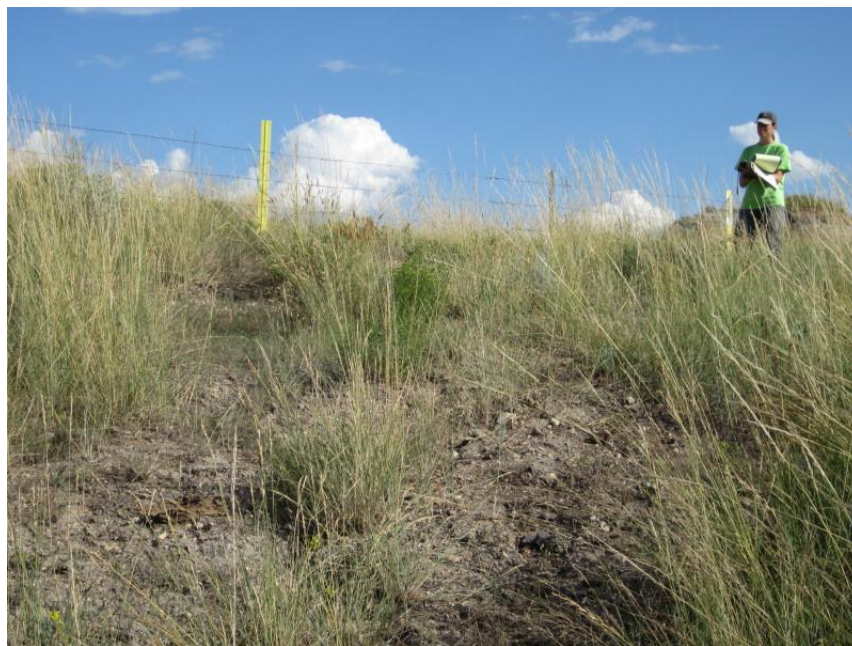
Photo 32. Direction: Southeast. Hillslope on pipeline route in the extreme northeast corner of Section 2, T147N, R102W. Re-vegetation was sparse, with clumps of grasses and bare soils in between.

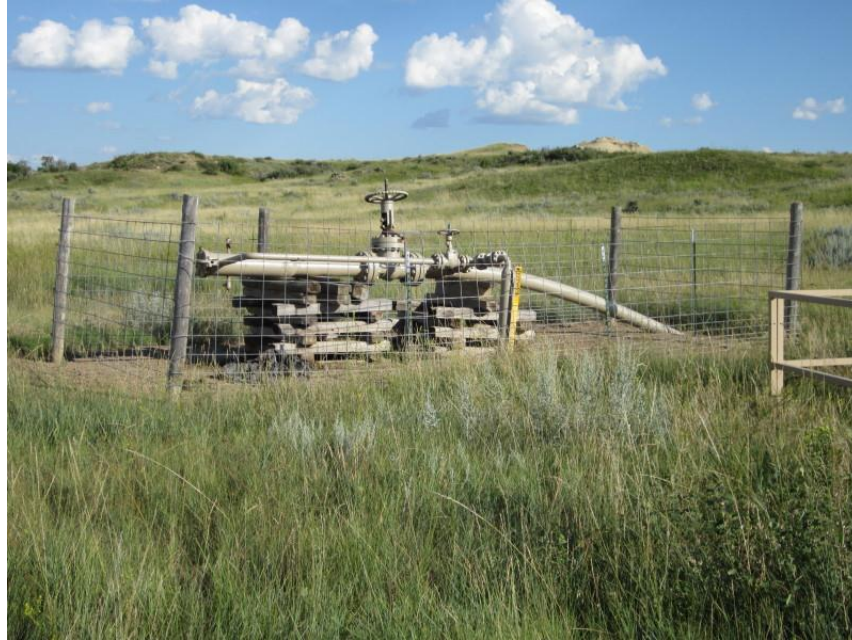
Photo 33. Direction: Southeast. Above-ground valve setting along pipeline route in the N ½ of the NW ¼ of Section 1, T147N, R102W.

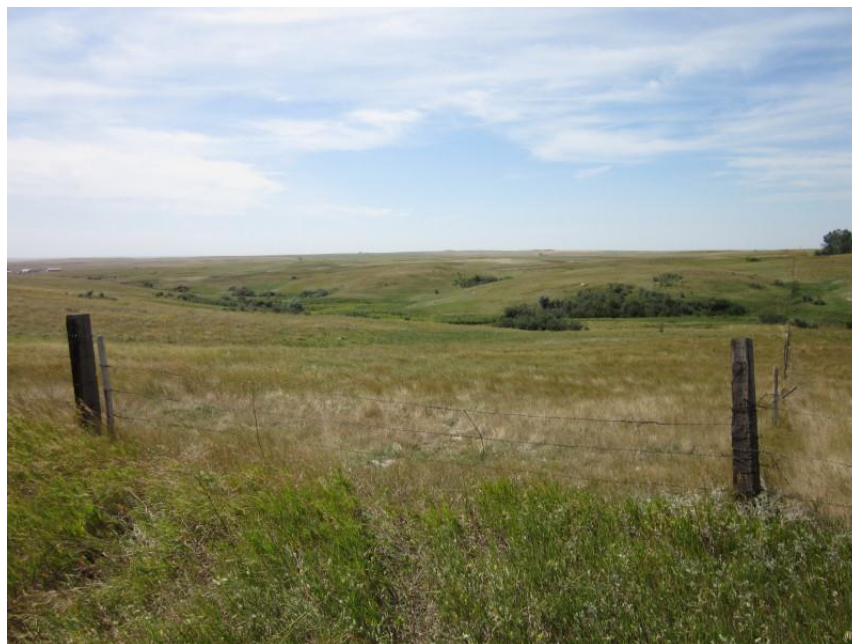
Photo 34. Direction: Southwest. Overview of drainage where about 95 chokeberry or chokecherry shrubs were planted in the NW ¼ of Section 30, T150N, 101W.

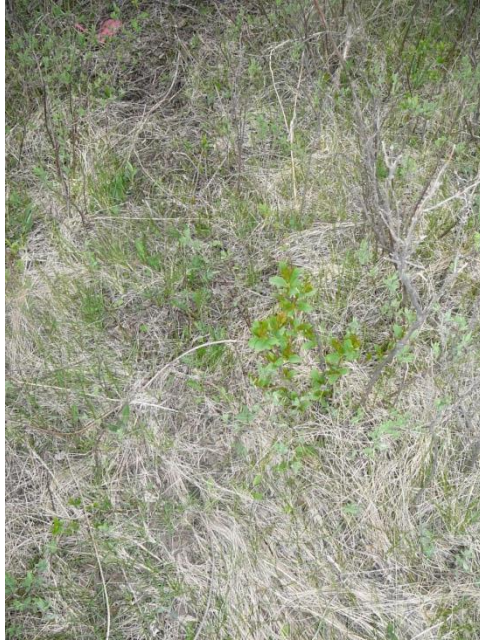
Photo 35. Close-up of shrub seedling planted in the drainage in the NW ¼ of Section 30, T150N, 101W. Photo taken by Cindy Geiger, tree/shrub planting contractor, in early spring 2011, about one year after planting.
