Alexander Loop Pipeline Construction Inspection Report

Belle Fourche Pipeline Co.

December 2011

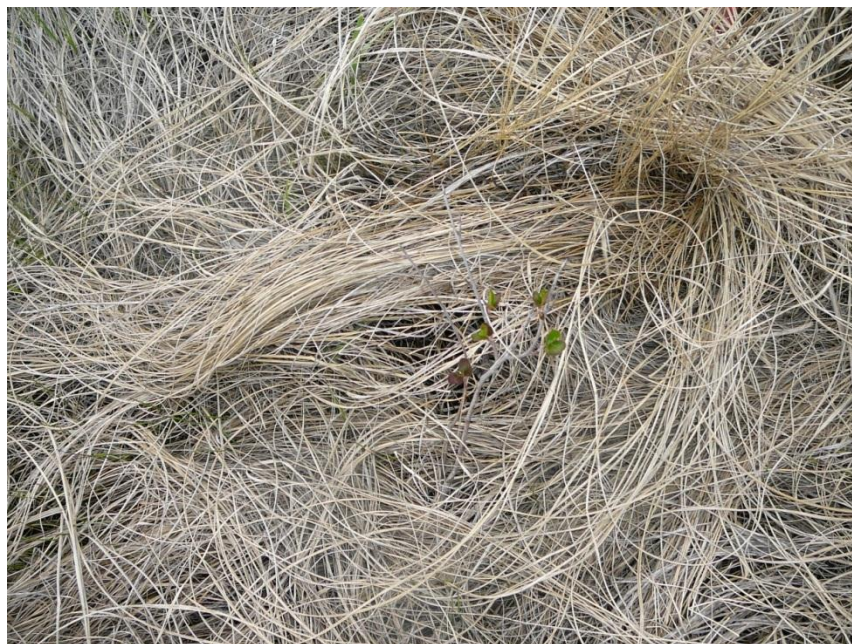
Photo 36. Close-up of another shrub seedling planted in the drainage in the NW ¼ of Section 30, T150N, 101W. Photo taken by Cindy Geiger, tree/shrub planting contractor, in early spring 2011, about one year after planting.

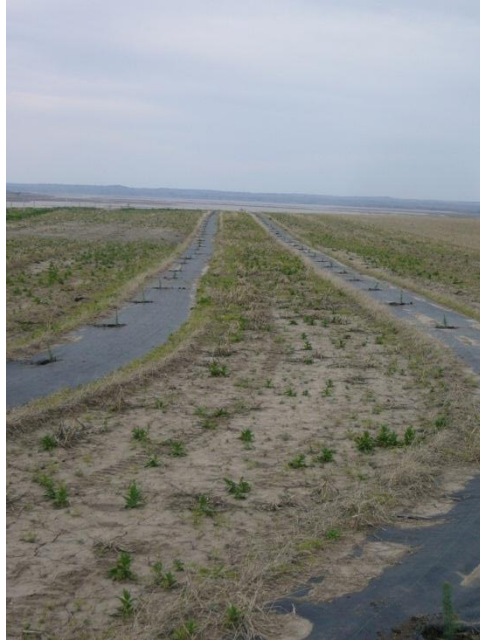
Photo 37. Direction: East. Alternate planting of 170 blue spruce trees in the NW ¼ of Section 18, T153N, 100W as a replacement for a failed planting of chokecherry and buffaloberry shrubs in Section 7, T150N, R101W. Photo taken by Cindy Geiger, tree/shrub planting contractor, in early spring 2011, shortly after planting.

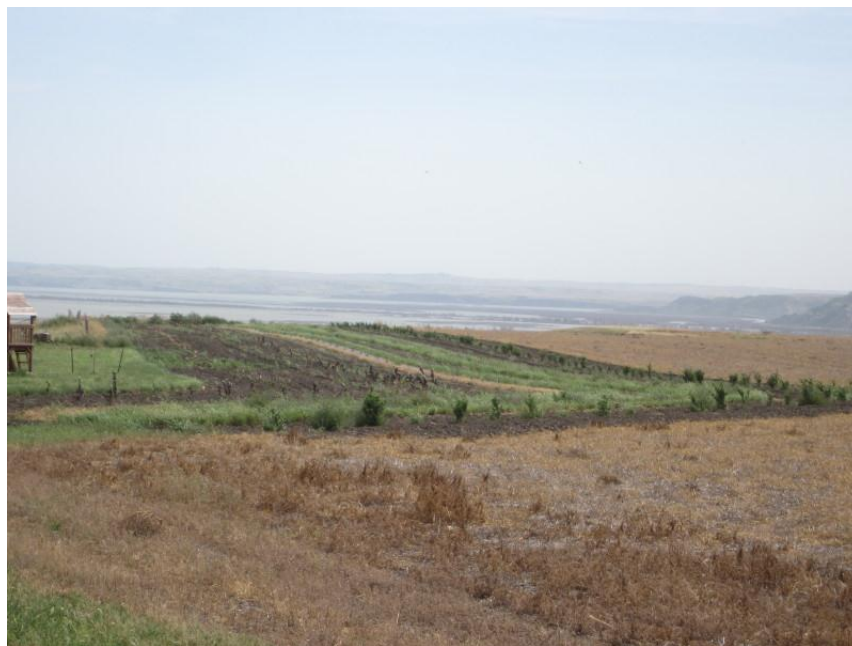
Photo 38. Direction: East/Southeast. View of tree planting in the NW ¼ of Section 18, T153N, 100W in late summer 2011.
