Reference: **2018 Tree and Shrub Mitigation Monitoring Report
 CapX2020 Fargo-St. Cloud 345 kV Transmission Line
 Case No. PU-07-759
 Cass County, North Dakota**

APPENDIX A: Photo Log

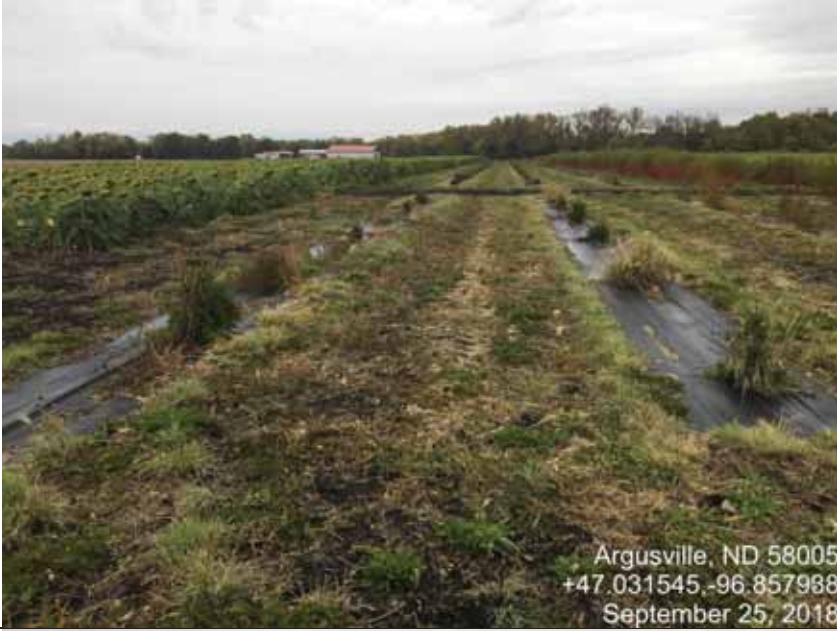
Photo 1

Site overview looking north from the southwest corner of the field. Competing vegetation mowed between the rows and less weed pressure was observed within the fabric openings than previous years.

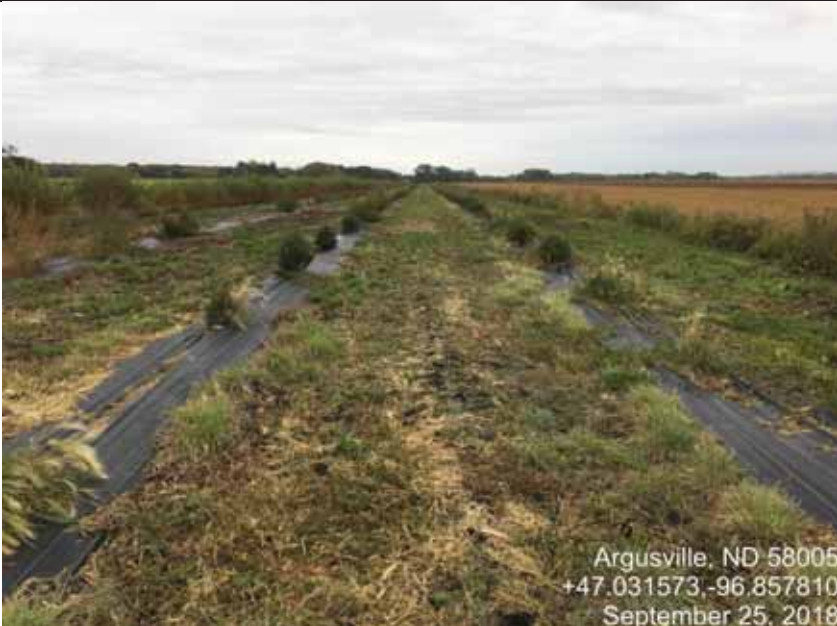
Photo 3

Spruce trees in rows 1 and 2 had the highest survival rate of the field.

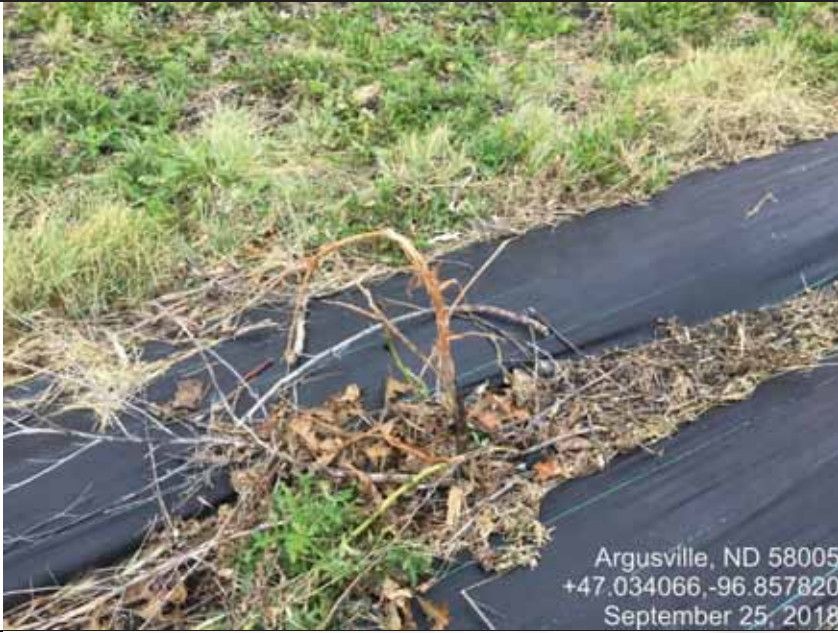
Photo 4	Date: 9/25/2018
Location: Fercho Family Farms Field 1	
Description: Bur oak damaged by wildlife (deer)

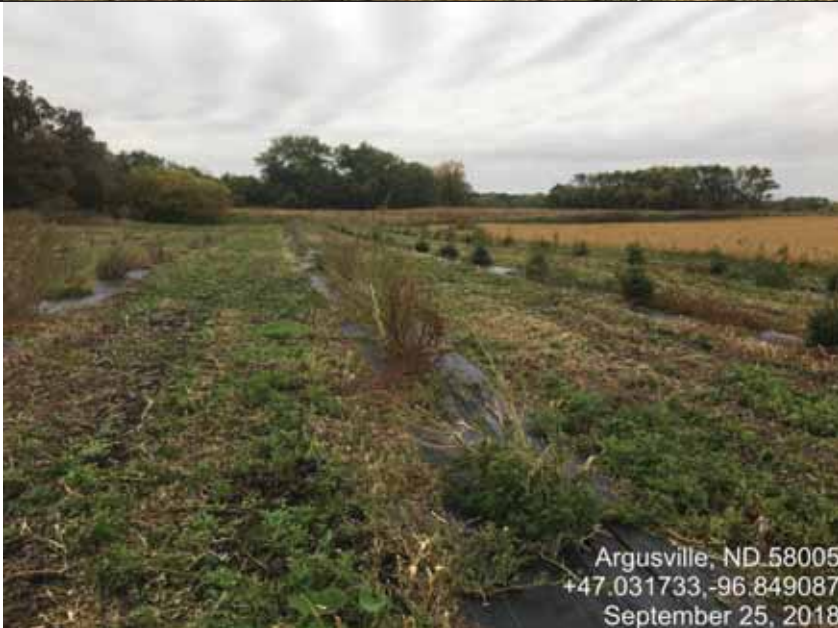
Photo 6	Date: 9/25/2018
Location: Fercho Family Farms Field 1	
Description: Flame willow and other deciduous species were not growing as well in the eastern portion of the field.

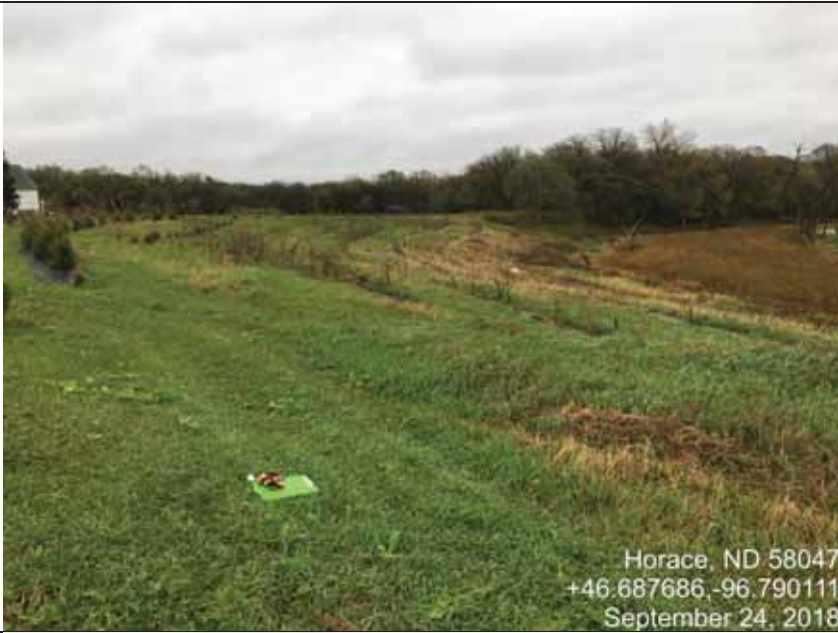
Photo 7

Site overview of looking northeast. Weed pressure in 2018 was less than 2017.

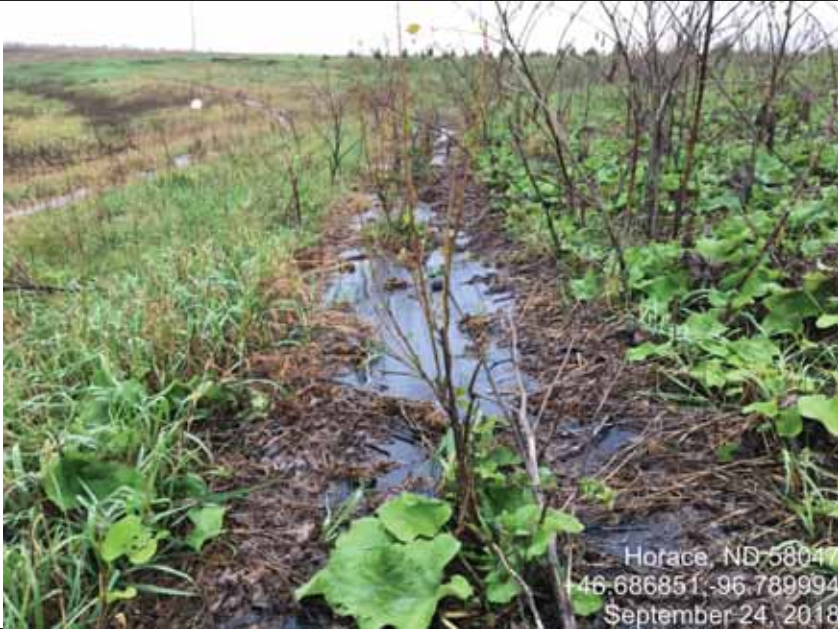
Photo 9

Sandbar willows were starting to complete with weed pressure and a some stems counted as dead in 2017 had a new stem growing next to the dead stem.

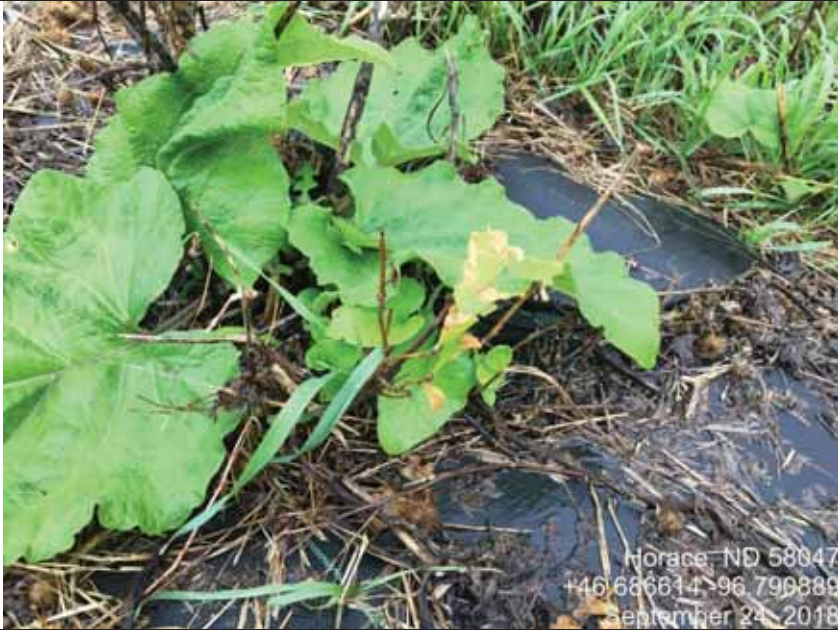
Photo 11	Date: 9/24/2018
Location: Brian and Kelly Duchscherer Field 1	
Description: Oaks observed in field one had little growth observed from the previous year (2017)

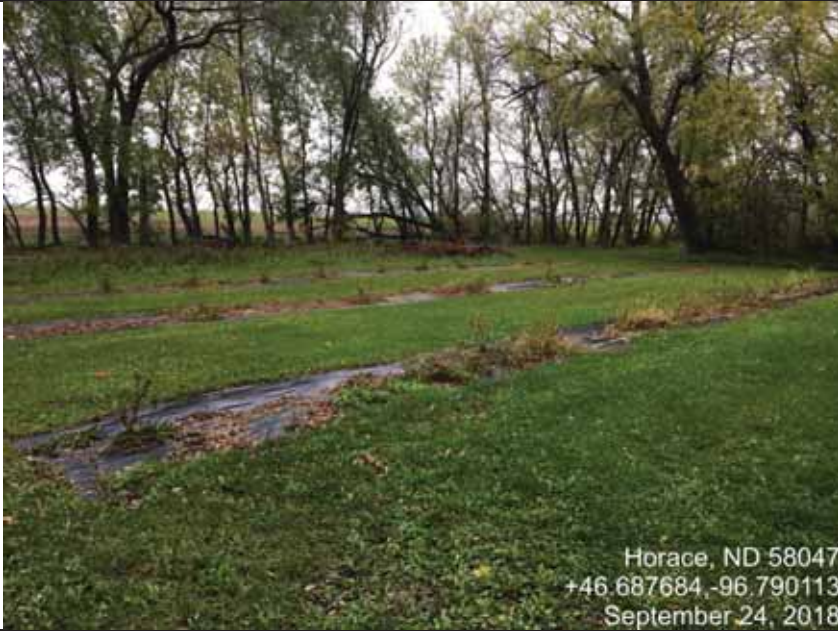
Photo 12	Date: 9/24/2018
Location: Brian and Kelly Duchscherer Field 2	
Description: Field overview photo of rows 1-4, trees remain small even with low weed pressure.

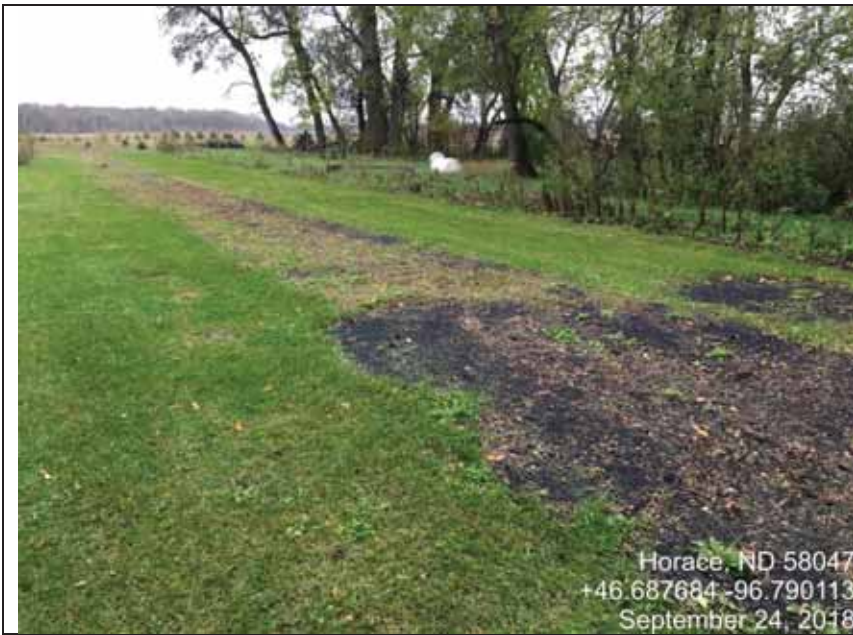
Photo 13	Date: 9/16/2017
Location: Brian and Kelly Duchscherer Field 2	
Description: Field overview photo of rows 5-6 were removed by the landowner due to poor survival and to gain the ability to mow down the weeds.

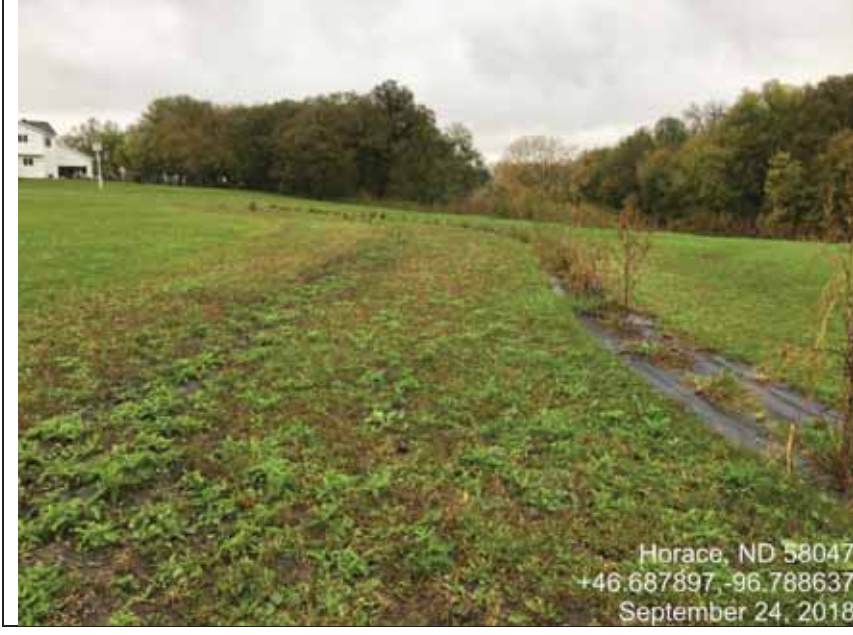
Photo 15	Date: 9/24/2018
Location: Brian and Kelly Duchscherer Field 3	
Description: The end of rows 4 and 5 were removed in the turf area as the landowner removed the fabric due to poor survival.

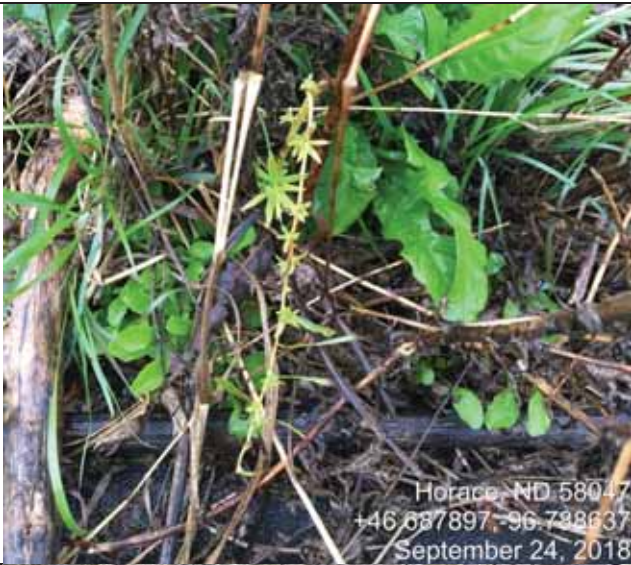
Photo 16

Willow sapling growing next to dead stem from 2017.

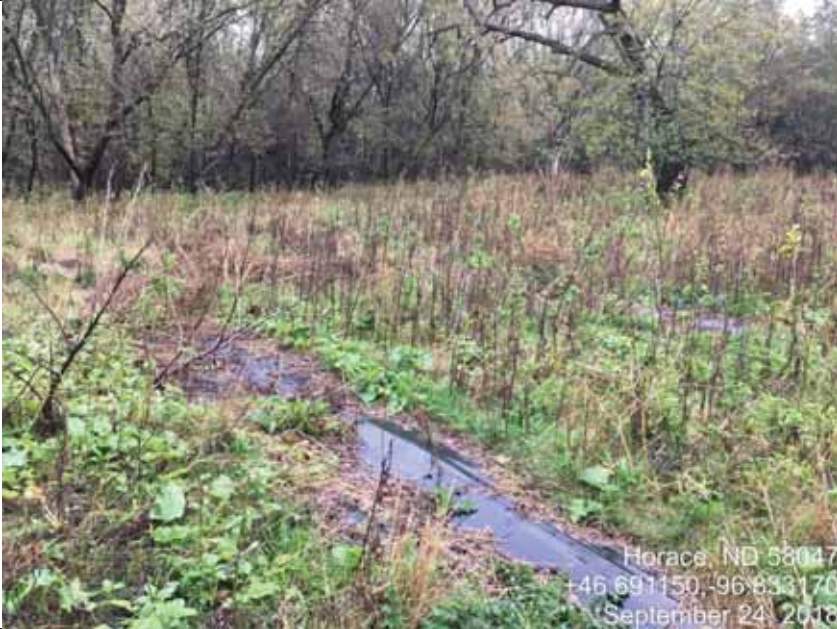
Photo 17

Although the fabric row was in good condition, competing vegetation from between the rows would suppress the trees.

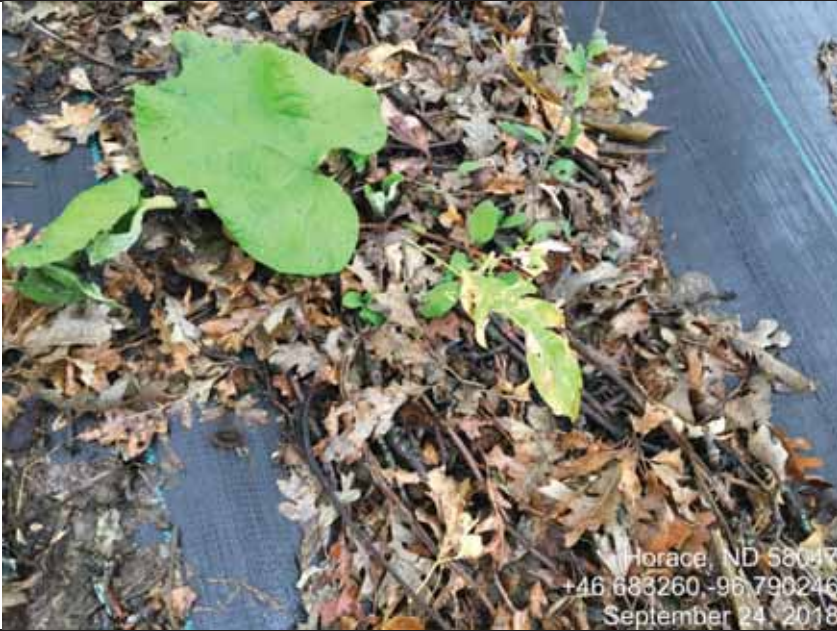
Photo 21

Little growth observed in the Green Ash row

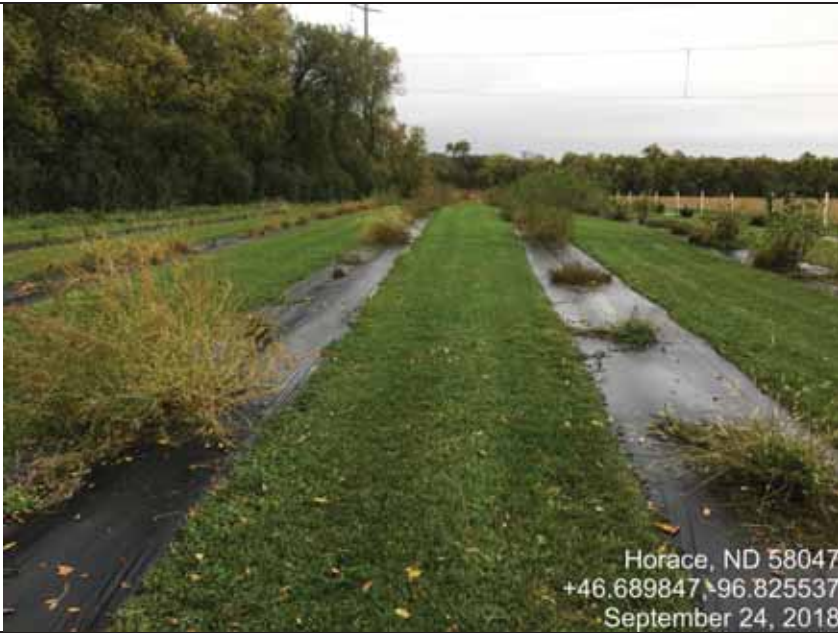
Photo 22

Field 1 looking north, rows well maintained, but had some areas of high weed pressure in with the trees in the fabric.

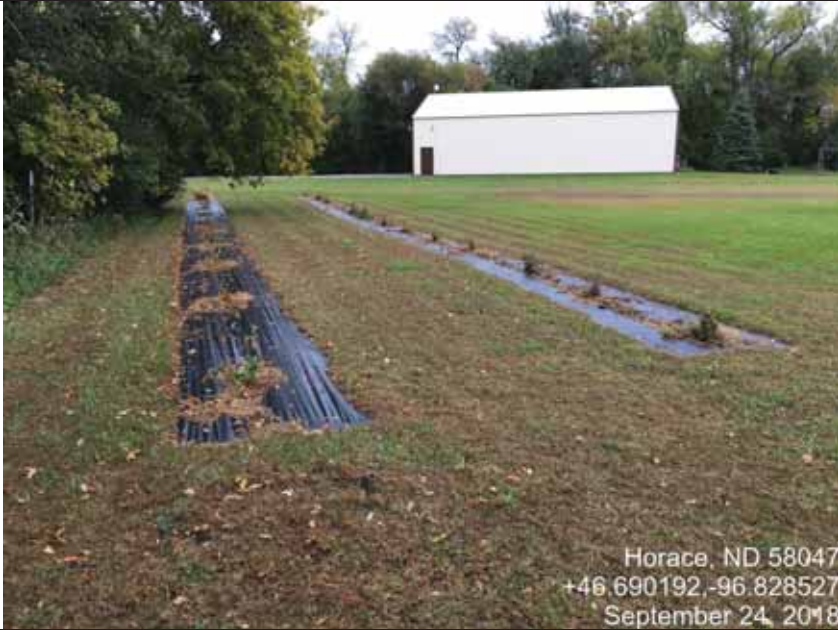
Photo 23

Field 2 looking east, rows well maintained with little growth observed from 2017.

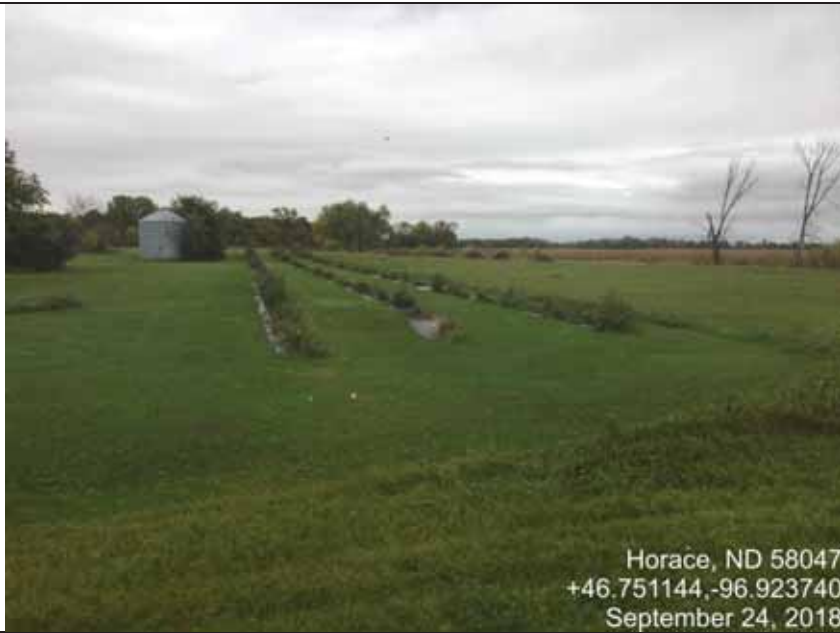
Photo 25

Site overview looking north. Rows are mowed between, but no maintenance has been done around the planted trees.

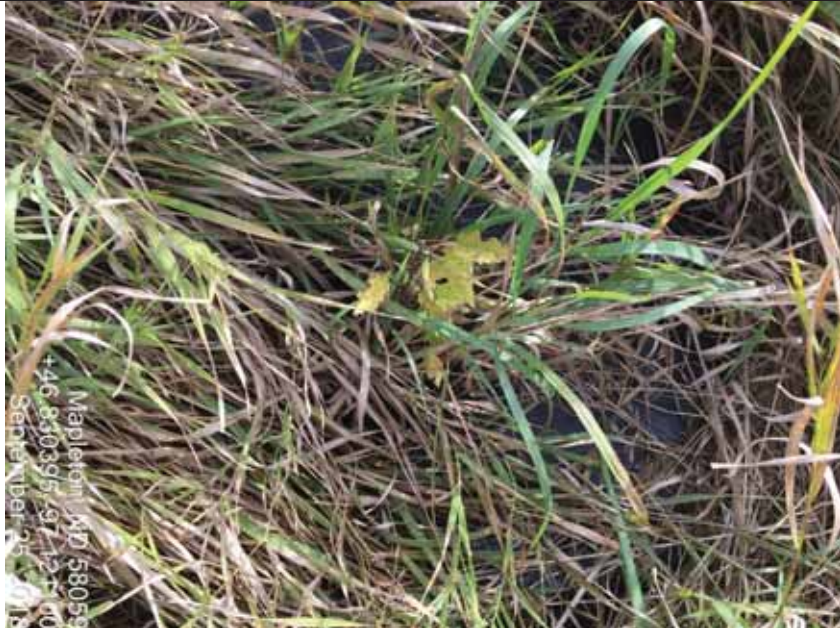
Photo 29

A silver maple observed growing in 2018 was a new sprout from the roots with the original stem missing.

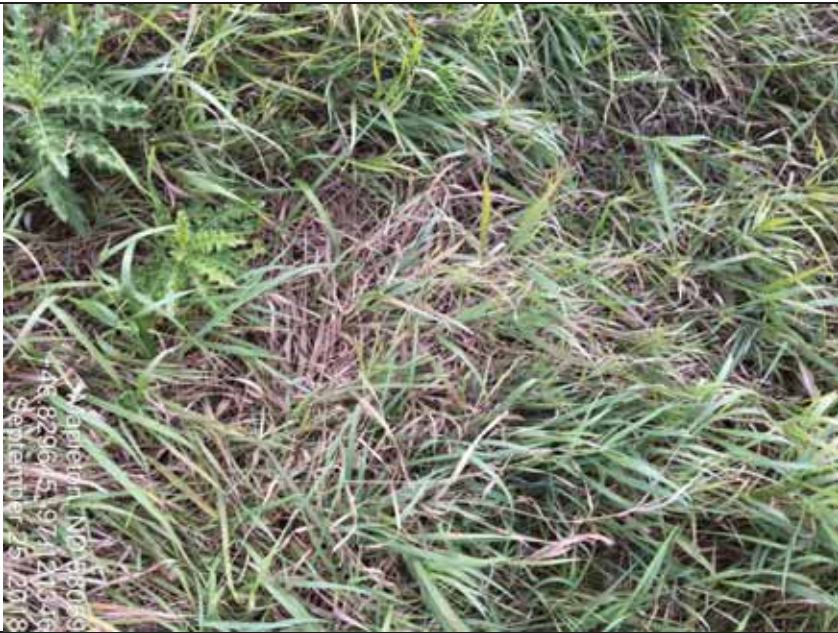
Photo 31

Fabric square covered with grass.

Almost all of the fabric squares were engulfed in reed canary grass. Dead stems of the 2017 surviving Chokecherry were observed.

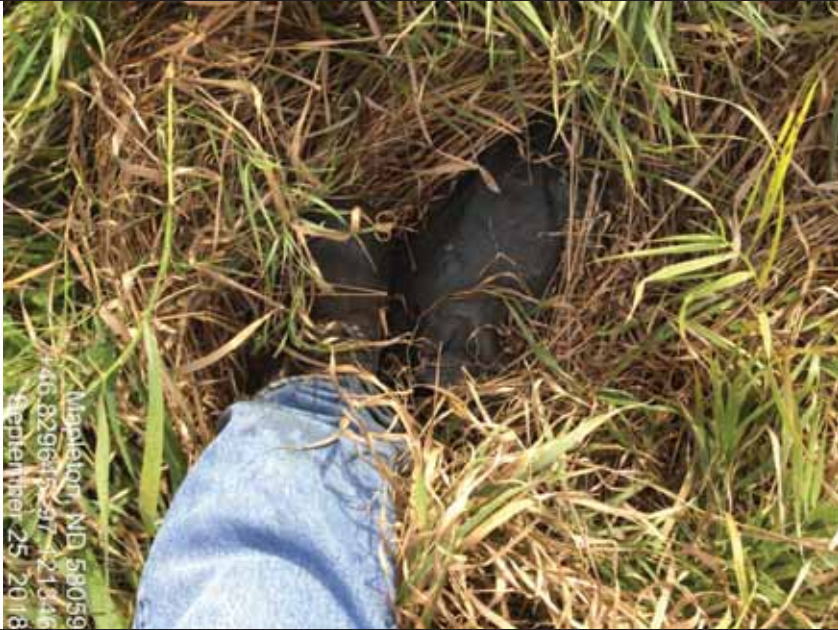
Photo 32

Fabric square from photo 31 exposed.

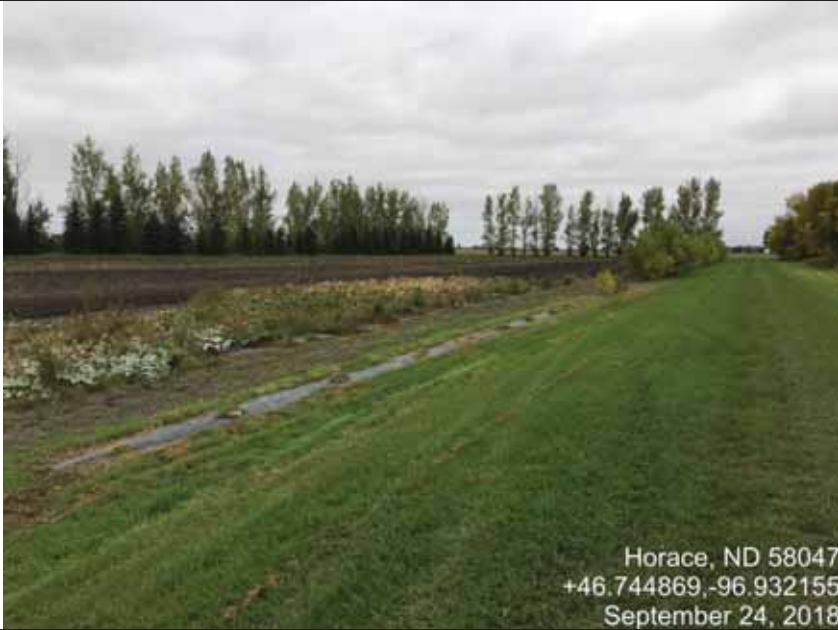
Photo 35

Field 1 over view looking north where trees are not protected by to the west by a tree line.

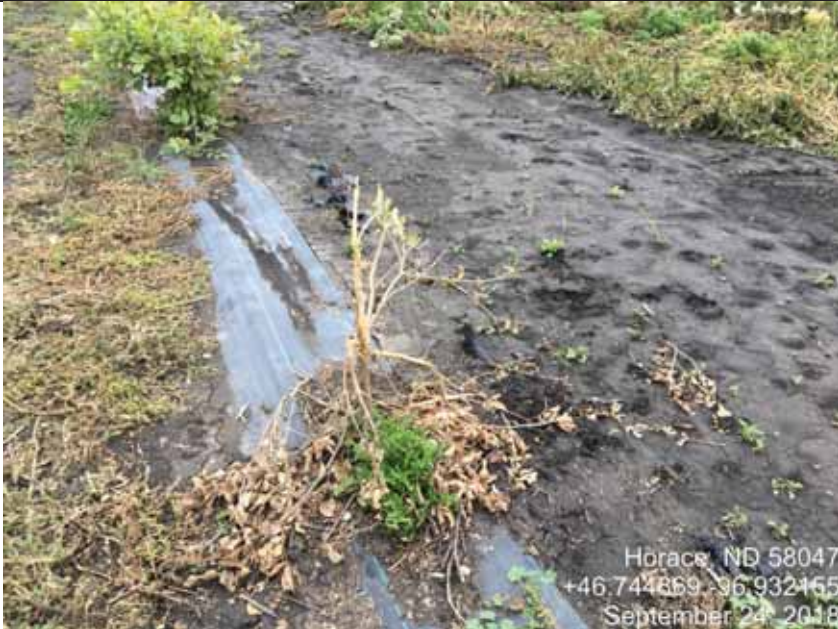
Photo 36

Green ash damaged by wildlife (deer)

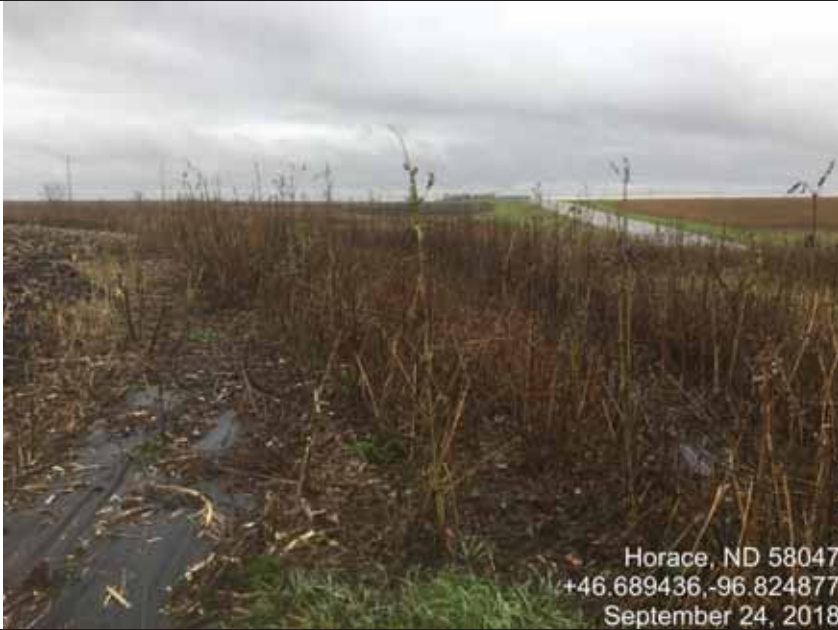
Photo 38

Site over view looking southwest. Heavy weed pressure in and between the rows.

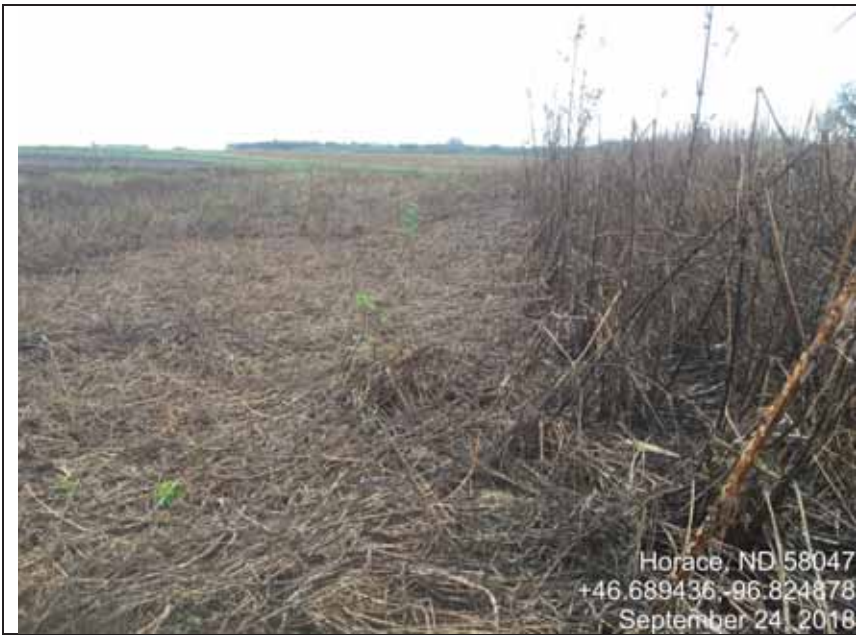
Photo 37	Date: 9/24/2018
Location: Dorothy Dubord (Mike)	
Description: Giant ragweed damaged along rows.

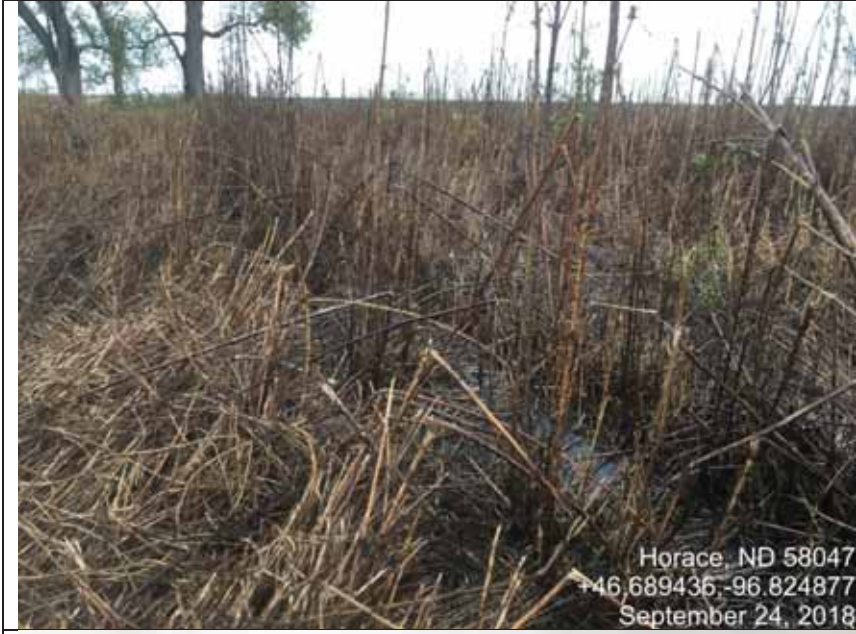
Photo 38	Date: 9/24/2018
Location: Dorothy Dubord (Mike)	
Description: No surviving sandbar willow stems observed.
