*Hankinson-Ellendale
Transmission Line
Reroute*
**Construction
Inspection Report**

Otter Tail Corporation

**NORTH DAKOTA
PUBLIC SERVICE COMMISSION**
600 E. Boulevard Avenue
Bismarck, ND 58505-0480

January 2012

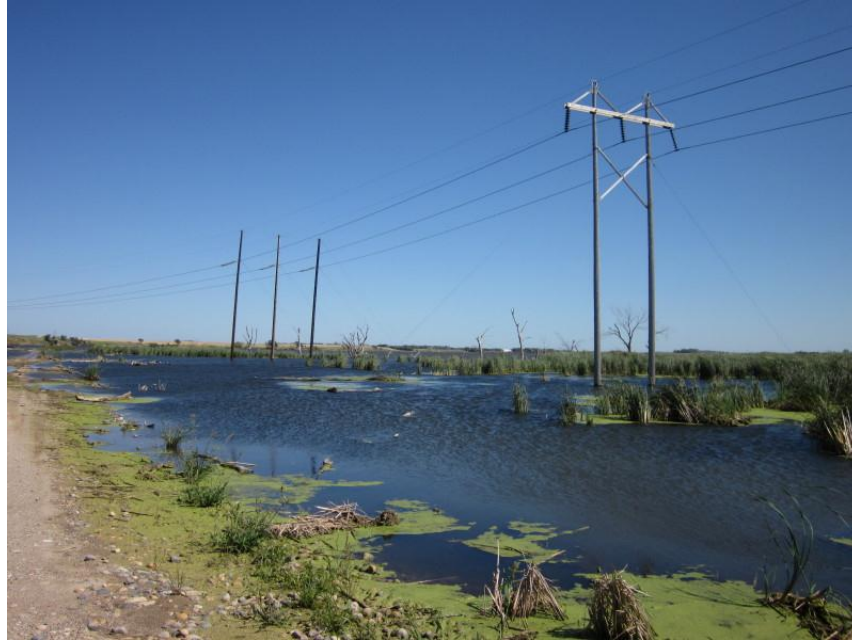
- *Reclamation/Reseeding According to NRCS or Landowner, if applicable.* It appeared that the locations of the poles along the reroute where there would have been soil disturbance were all within or nearby the ditch of the existing gravel road 90th St SE and would not have required reseeding. However some of the poles were in standing water and not able to be assessed at the time of the survey (**Appendix A, Photo 1; Appendix B, Point 464**). The vegetation around the poles outside of the flooded area

The justification for the short reroute of this transmission line was to avoid the waters of Grass (Sand) Lake. However flooding in the region has continued to raise the level of the lake and the west end of the reroute was within standing water at the time of the survey. Standing water may lead to long-term damage or problems to the poles or lines, as was the concern with the original route. Wenck suggests the reroute should be regularly monitored for problems.

Photo 1. Direction: East/Southeast. West end of transmission line reroute. The H-frame structure in the right foreground was likely part of the original route. The three monopole structures on the left were the beginning of the reroute. The monopoles had guy wires attached. All structures were in standing water at the time of the survey.

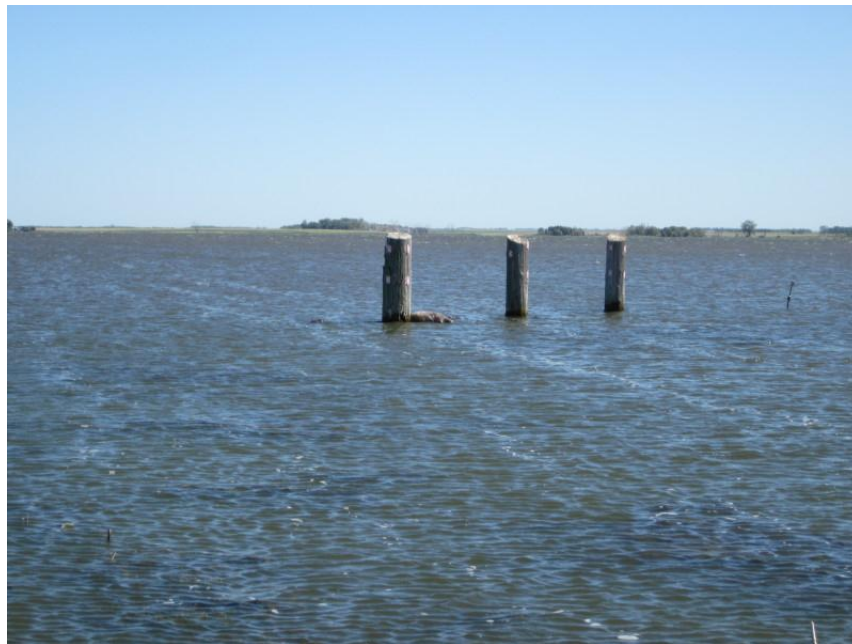
Photo 2. Direction: South/Southeast. Close-up photo of the remnants of the post structures from the original route on the west end, which were in deeper standing water to the south of the reroute line.

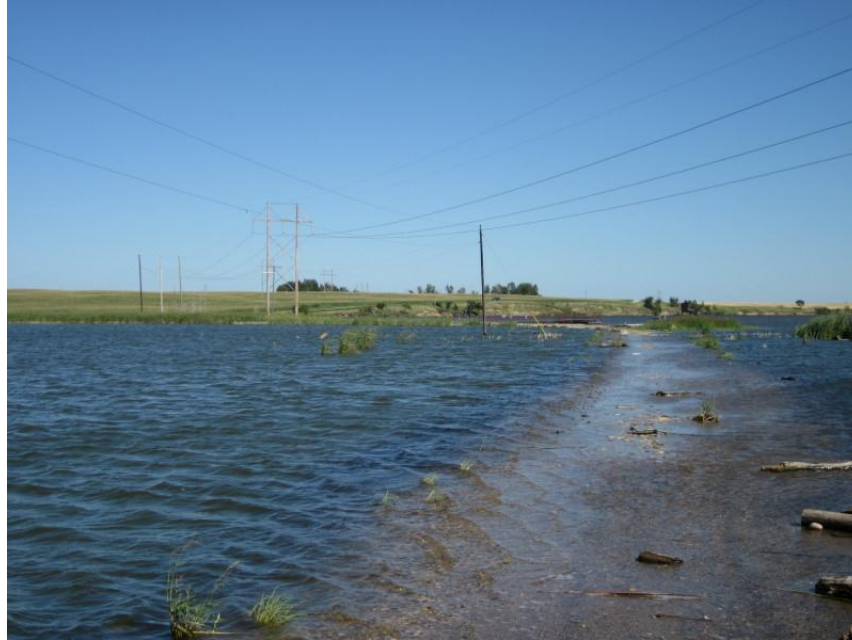
Photo 3. Direction: East/Northeast. Overview of east end of transmission line reroute. From the monopole structures in Photo 1, the reroute line crossed a gravel road (90th St SE), attached to a wooden H-frame structure (distant left of photo), then attached to another set of three monopoles (distant far left), then connected back to the original route. Grass (Sand) Lake flooded the road at the time of the survey. The east end of the reroute was accessed by walking across the shallow water on the road.

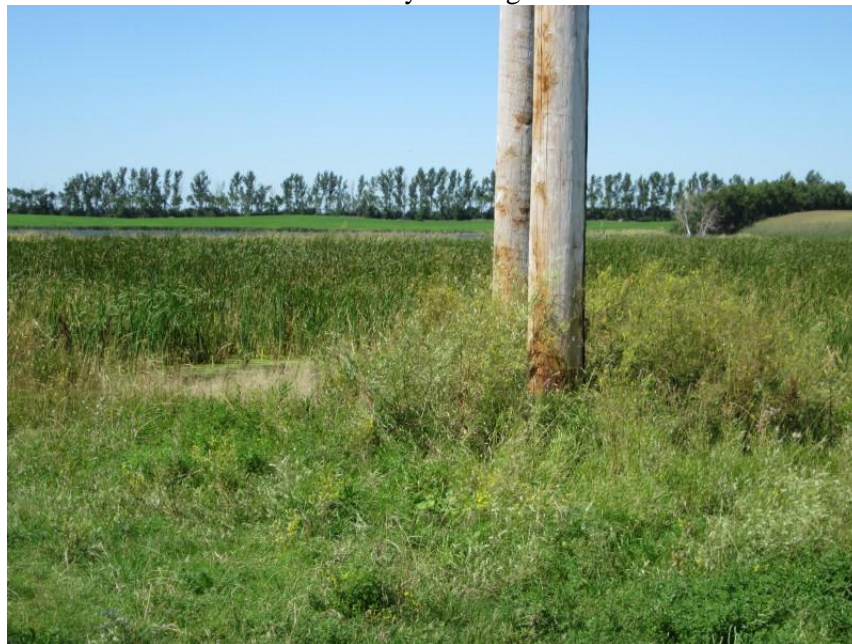
appeared to have naturally revegetated and cover was satisfactory (**Appendix A, Photos 4-5; Appendix B, Point 465**).

Photo 4. Direction: North. Base of posts of wooden H-frame structure on the east end of the reroute. This portion of the reroute was outside the flooded area.

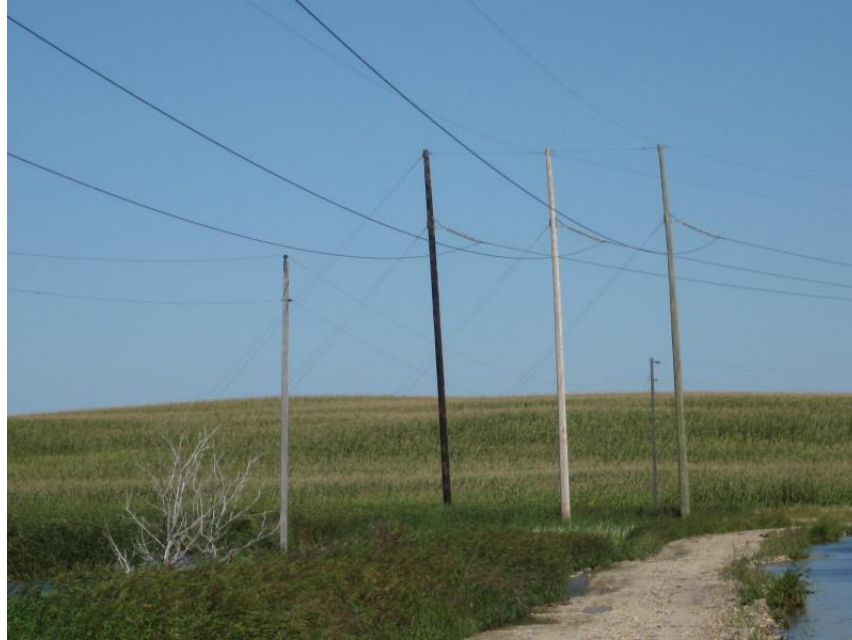
Photo 5. Direction: Northeast. Set of three monopoles at the east end of the reroute. The monopoles had guy wires attached and were also outside the flooded area.

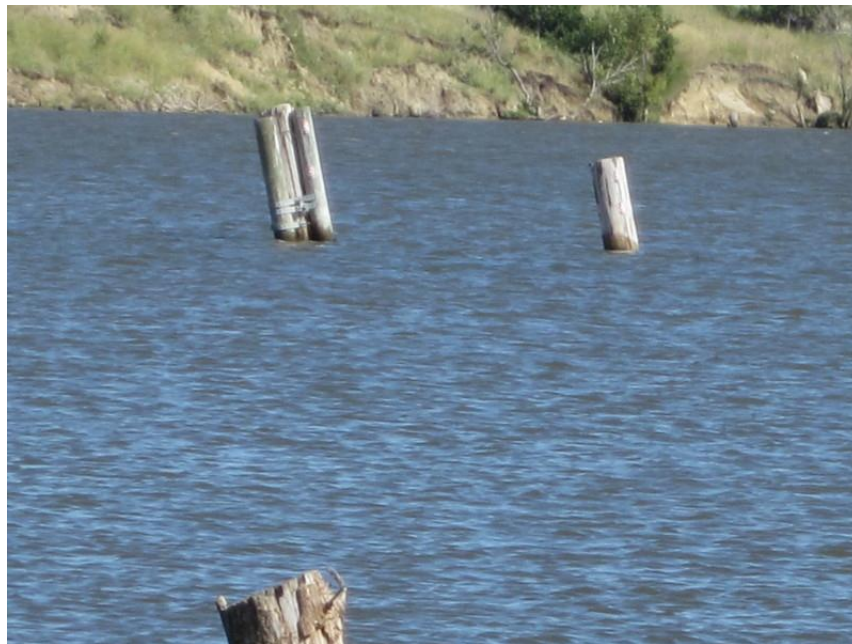
Photo 6. Direction: Southeast. Remnants of old posts from the original transmission line route within deep standing water of Grass (Sand) Lake.
