# Ashtabula I Wind Energy Center Post-Construction Inspection Report PU-08-032

## **NORTH DAKOTA PUBLIC SERVICE COMMISSION**

## **WENCK ASSOCIATES, INC.**

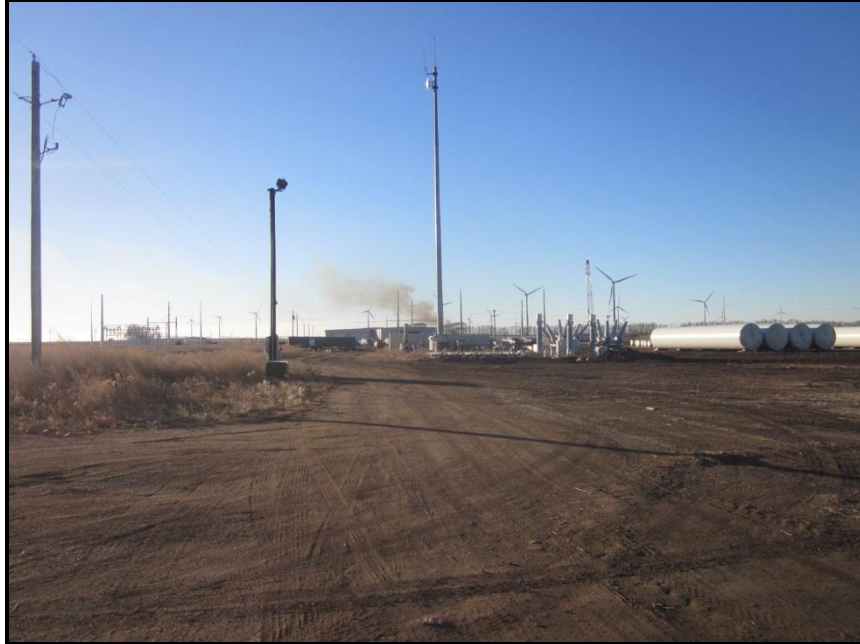
**Photo 1.** Direction: West. View across the O&M building and laydown grounds from the east side to west side, located in the southwest corner of Section 10, T142N, R57W. The east side of the grounds in the foreground, along with the north side (not visible), was still being utilized for construction and staging purposes. Maintenance and operations activities and equipment were situated around the O&M building in the distance on the west side of the grounds.

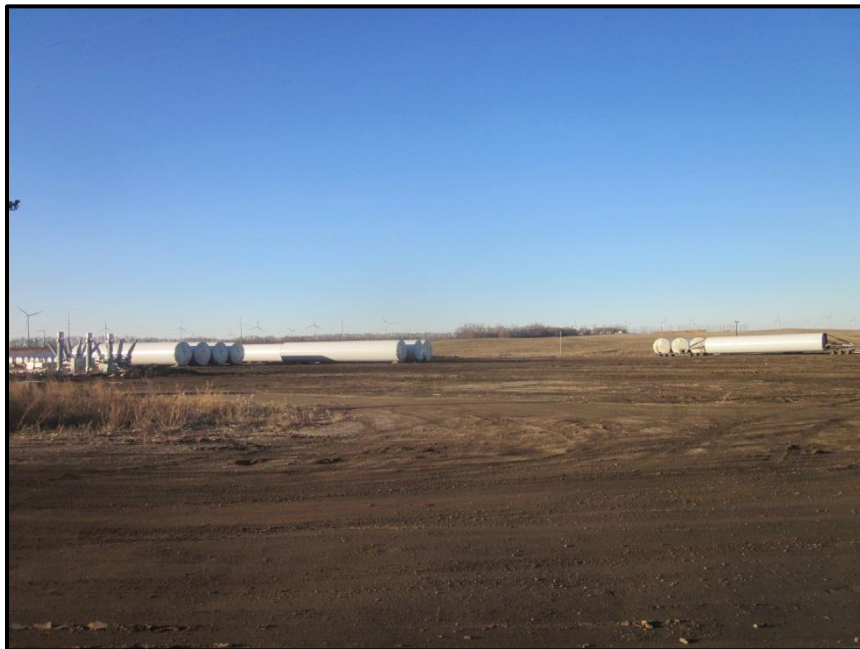
**Photo 2.** Direction: North. Central portion of O&M grounds used for construction staging where tower sections were being stored.

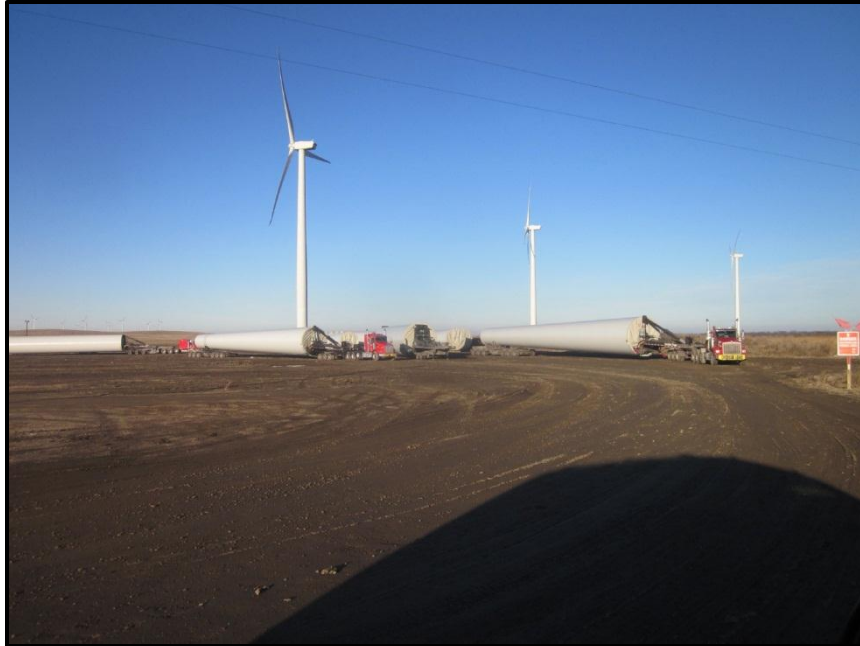
**Photo 3.** Direction: Northeast. Far eastern side of laydown area where tower sections were being moved by semi-truck at the time of the site visit. Note the safety sign on the far right of the photo warning of overhead power lines. Turbines 63-65 are visible in the distance.

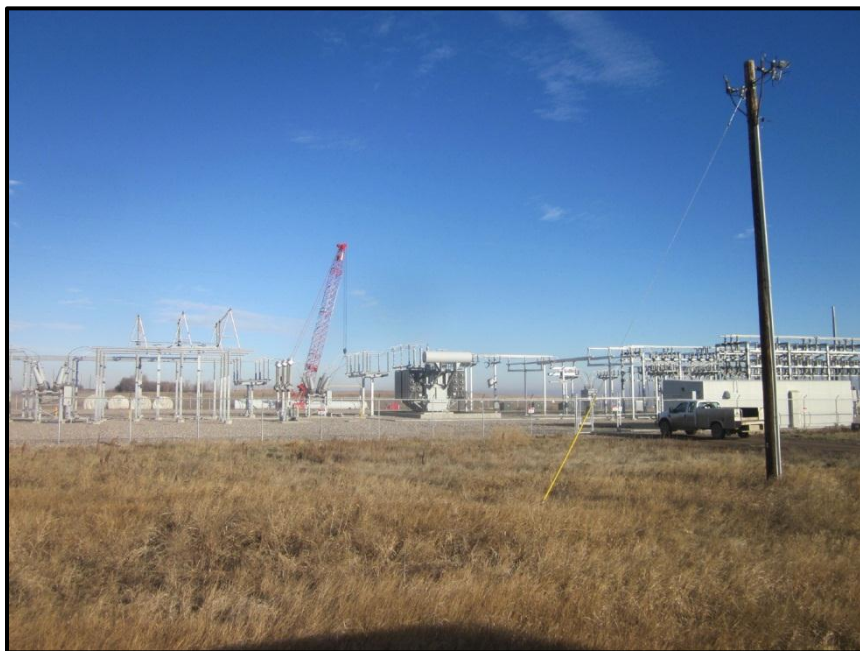
**Photo 4.** Direction: Northeast. Barnes Substation serving the Ashtabula I turbines, to the west of the O&M building and grounds. Note the crane in the distance to the north of the substation which was still being actively used for construction staging, storage, and maintenance purposes. The area around the substation had been reclaimed and the vegetation was established and in good condition.

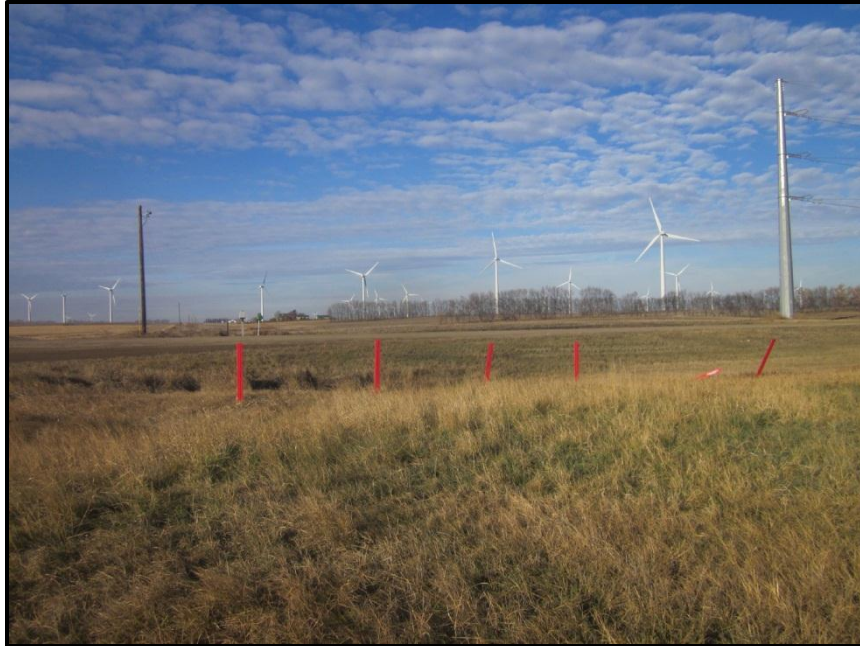
were noted (**Appendix A, Photos 5, 26**). Markers were in place. The collection line tied into a 230kV transmission line at the new substation, as proposed (**Appendix A, Photo 5**).

**Photo 5.** Direction: West. Series of red markers noting locations of numerous underground collection lines leaving the substation from its southwest corner. The lines had been bored underneath County Road 27, visible beyond the ditch running north-south. Several turbine strings for Ashtabula I are visible in the distance.

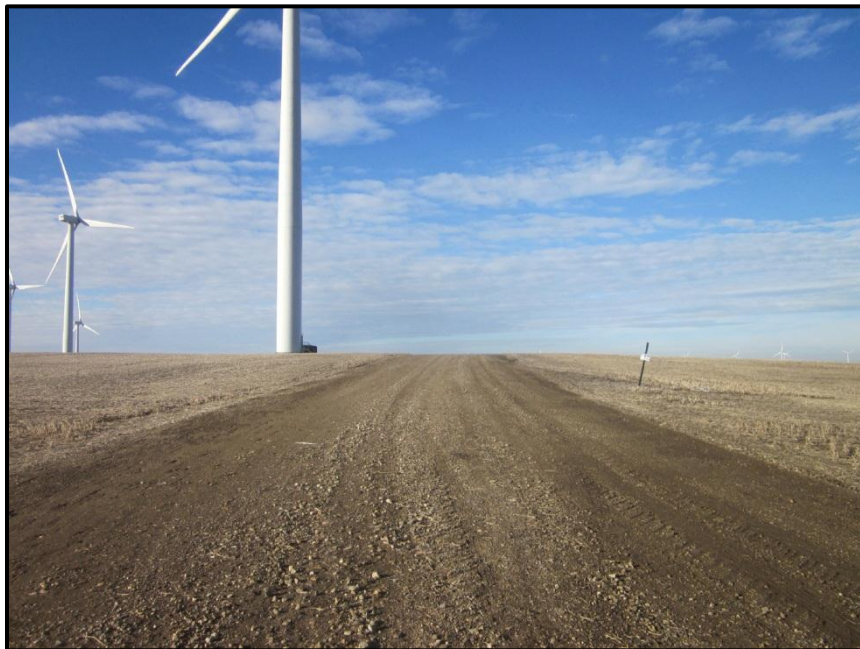
**Photo 6.** Direction: West. Access road entrance to Turbines 131-125 from its intersection with 125<sup>th</sup> Ave SE. Proper safety and public access signage was in place, though the sign with the turbine names was missing. Cropland adjacent to road and turbines were in good condition and had been satisfactorily reclaimed. An archeological site on this hill had been destroyed by plowing and was deemed not necessary to avoid during Project construction.

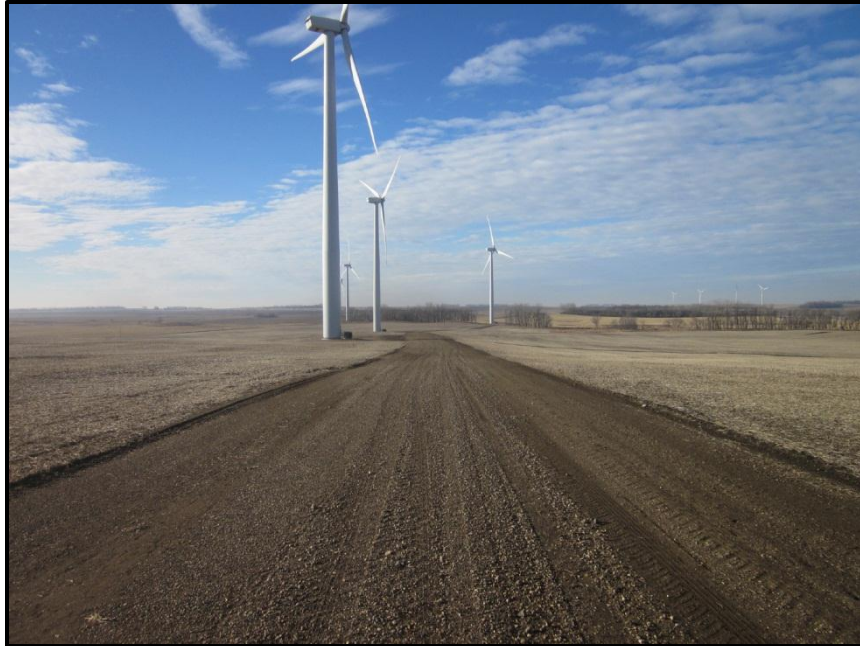
**Photo 7.** Direction: Southwest. Continuation of access road along turbine string 131-125. Turbines, roads, and cropland were all in good condition with no concerns.

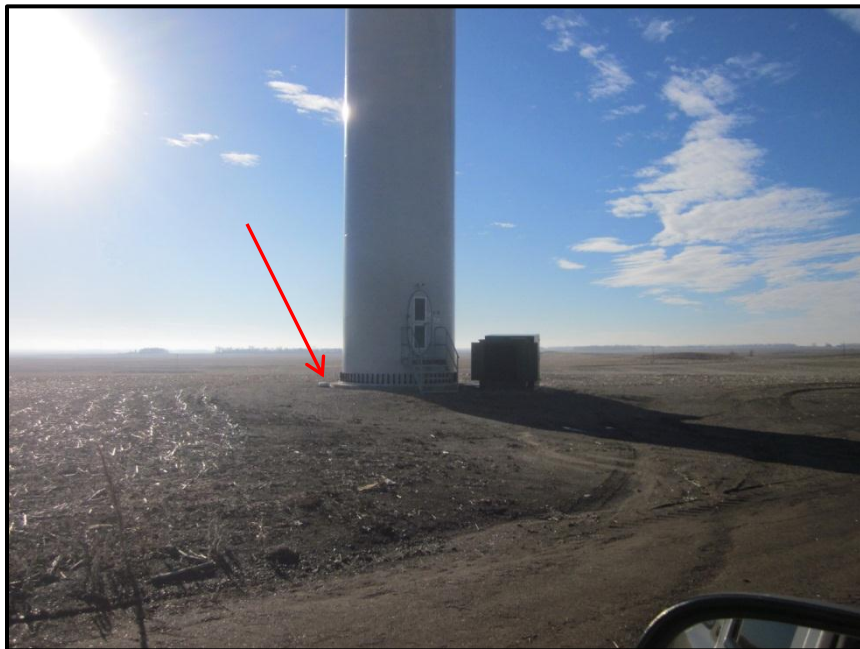
All turbines were constructed as specified, 1.5 MW, 80 m hub height, 77 m rotor diameter. Each turbine had a concrete foundation, a control panel in the tower base, a pad-mounted transformer, and lightning protection (**Appendix A, Photos 8, 29**). Turbines were connected to a SCADA system, observed in the O & M Building control area. Lighting was not confirmed since the inspection took place during daylight hours but is assumed to be in compliance with the FAA.

**Photo 8.** Direction: Southeast. Base of Turbine 129 showing example of typical conditions on the site. Cropland and gravel pad were in good condition. Safety signs were in place. Pad-mounted transformer is on right of tower base. This tower was one of several being controlled for mice infestations; note the small white trap to the left of the tower base (marked with red arrow).

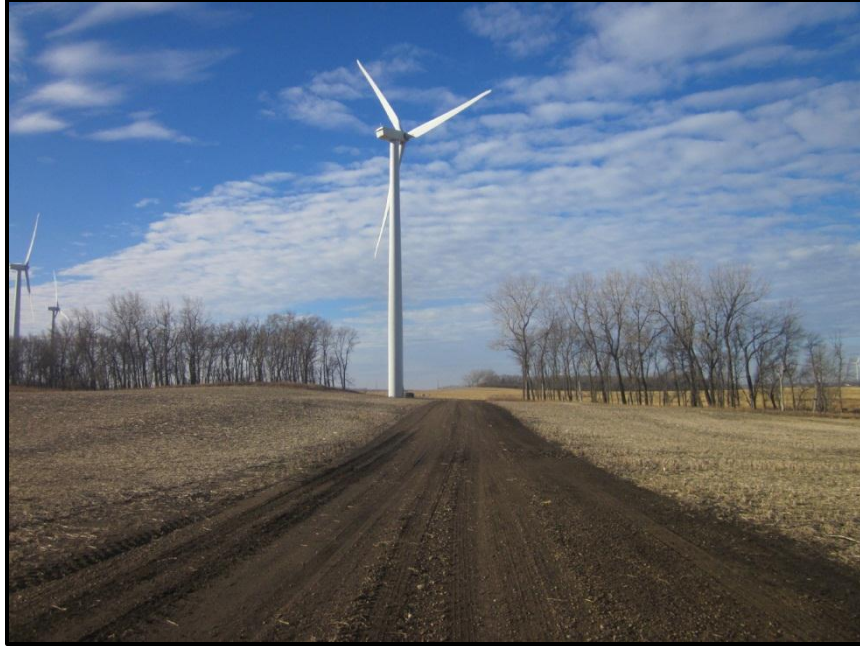
**Photo 9.** Direction: Southwest. Road between Turbines 129 and 128 where several trees had been removed from a tree row between fields.

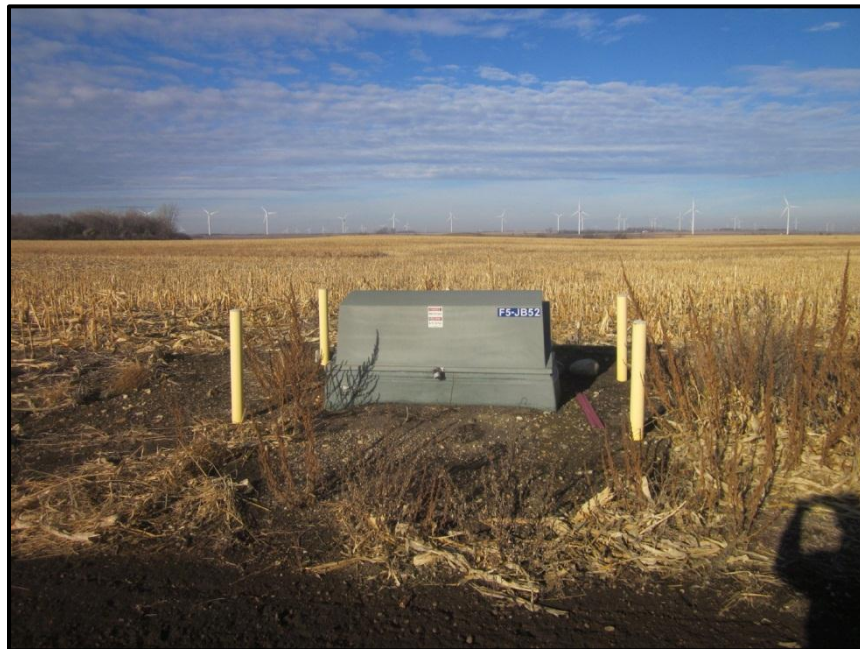
**Photo 10.** Direction: Northwest. Example of junction box conditions showing close-up of JB52 adjacent to access road. Cement bollards and gravel were in place around the box with no indication of erosion. Weeds appeared to have been sprayed on the gravel area, though there were a few annual weeds (tall brown vegetation) that had grown this past season. Safety warning signs were in place.

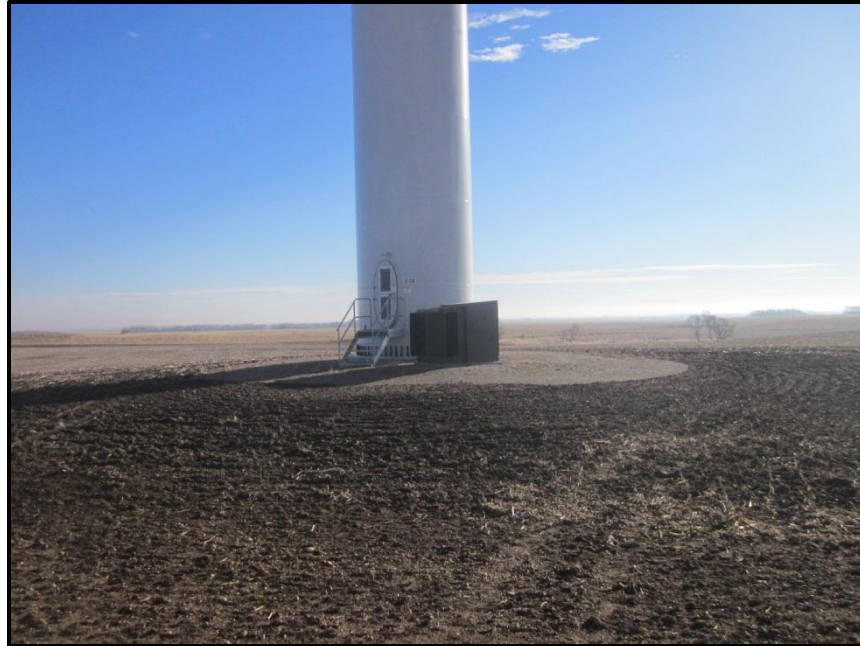
**Photo 11.** Direction: Southeast. Base of Turbine 126. The landowner had tilled through the gravel pad here and at Turbines 125 and 127, ruining the gravel surface and preventing access to the tower. NextEra was actively addressing the issue, since landowners have agreed not to disturb the gravel maintenance pad as part of the lease agreement with the wind company.

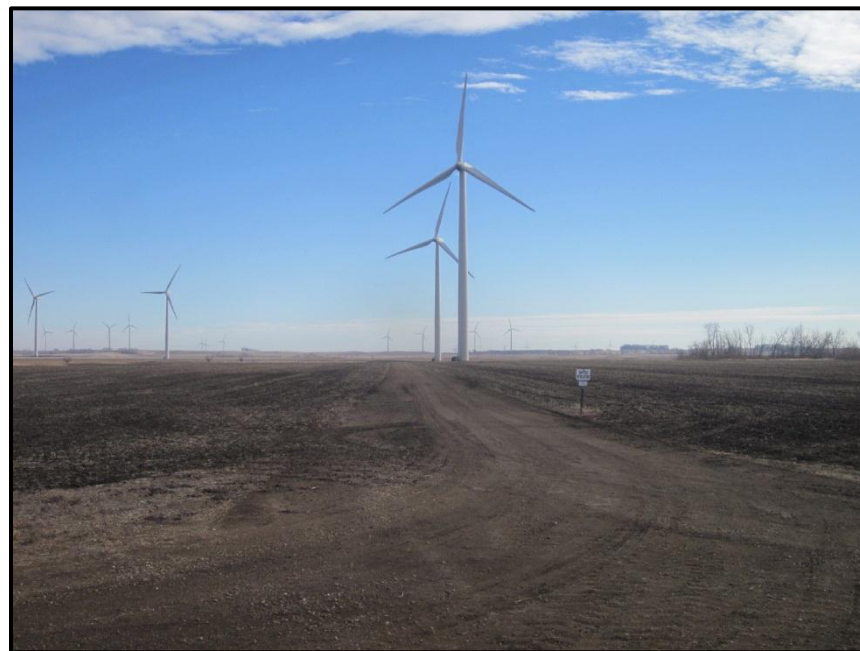
**Photo 12.** Direction: East. Entrance to access road to Turbines 105-108 from 120<sup>th</sup> Ave SE. Signs, crops, and the road were in good condition.

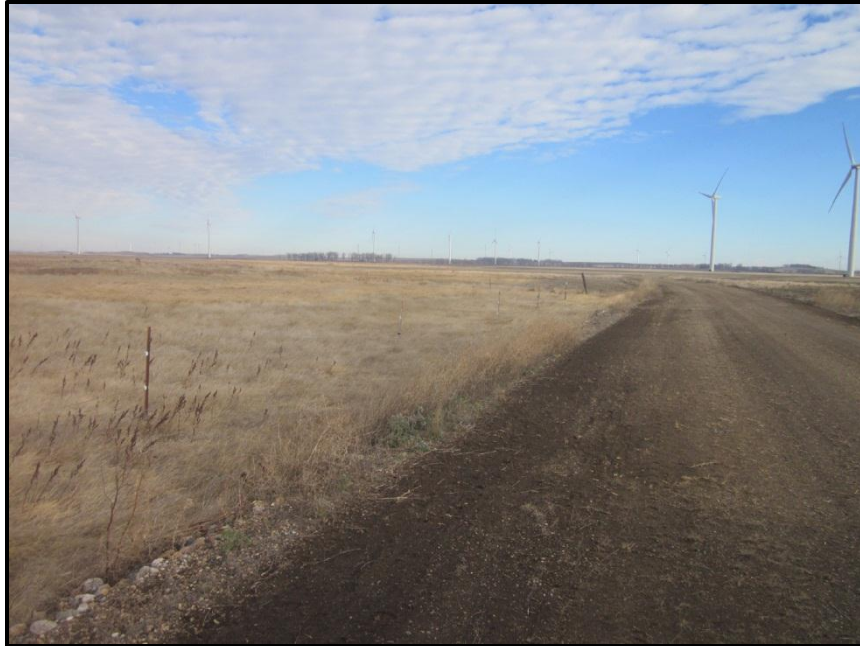
During the construction inspection, Wenck confirmed that wetlands were avoided in the overall Project design (**Appendix A, Photos 13, 14, 28, 29**). A Wetland Summary report submitted to the PSC noted that wetlands under USFWS easement and USACE jurisdictional wetlands would be completely avoided by Project facilities using siting or boring techniques, and would be protected from impacts using erosion control structures (Docket #25-08, Wetlands Delineation Summary). Other wetlands not within easements were planned to be avoided to the extent possible. The final Wetland Report stated that as designed the Project was eligible for no notification authorization under the USACE Nationwide General Permit #12 Utility Line Activities (Docket #308, Wetland Delineation Report). A list of wetlands to be completely avoided or bored were listed in the summary report and appeared to have been followed when checked during the site visit (**Appendix A, Photo 15, 29**). There were also numerous remarks in the Plans of the Day relating to wetlands, including notes about developing wetland impact prevention plans and maps, marking and monitoring environmentally sensitive areas, reviewing environmental awareness with all crews and subcontractors (example Docket #41, Plan of Day 7-2-2008); photos of wetlands marked (example Docket #43, Plan of Day 7-3-2008); photos of erosion control structures (example Docket #51, Plan of Day 7-10-2008); notes about silt fence installation, photos of wetland sign

**Photo 13.** Direction: North. Access road along Turbine string 105-108, which was sited to avoid a low prairie/wetland complex to the north and west. It did not appear that the edges of the road had been disturbed beyond the actual road width during construction and thus had not been reseeded.

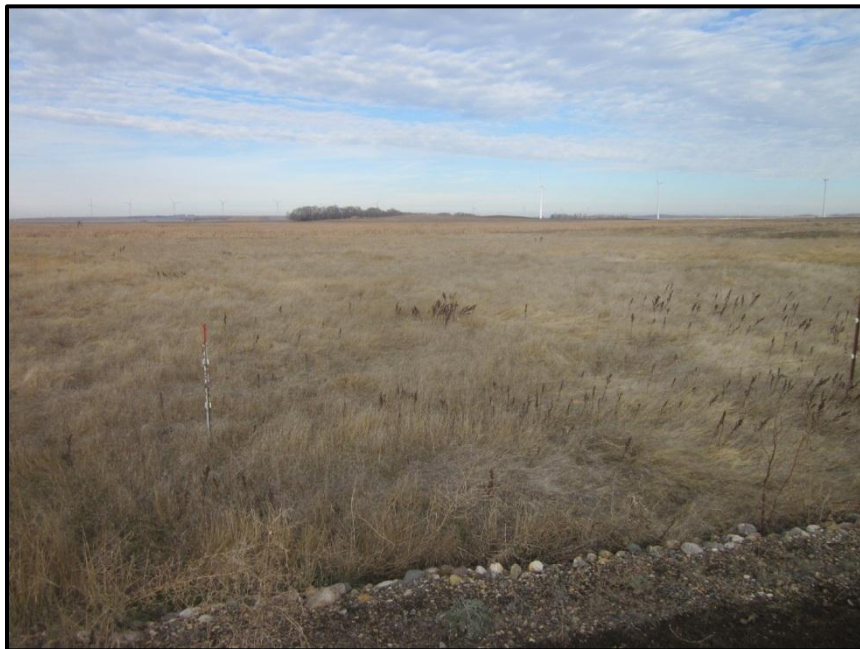
**Photo 14.** Direction: Northwest. Another view of the low prairie/wetland complex avoided by siting.

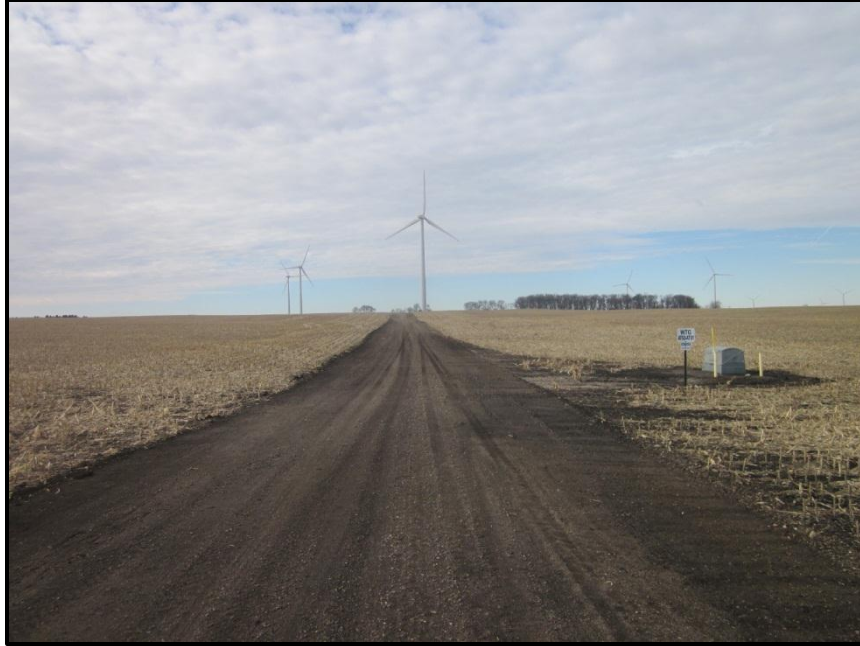
**Photo 15.** Direction: West. Access road entrance to Turbines 93-91 through cropland. Proper signs were in place. Cropland, roads, junction box, and towers were in good condition. This turbine string was on land under USFWS wetland easement. All drainages and wetlands had been avoided.

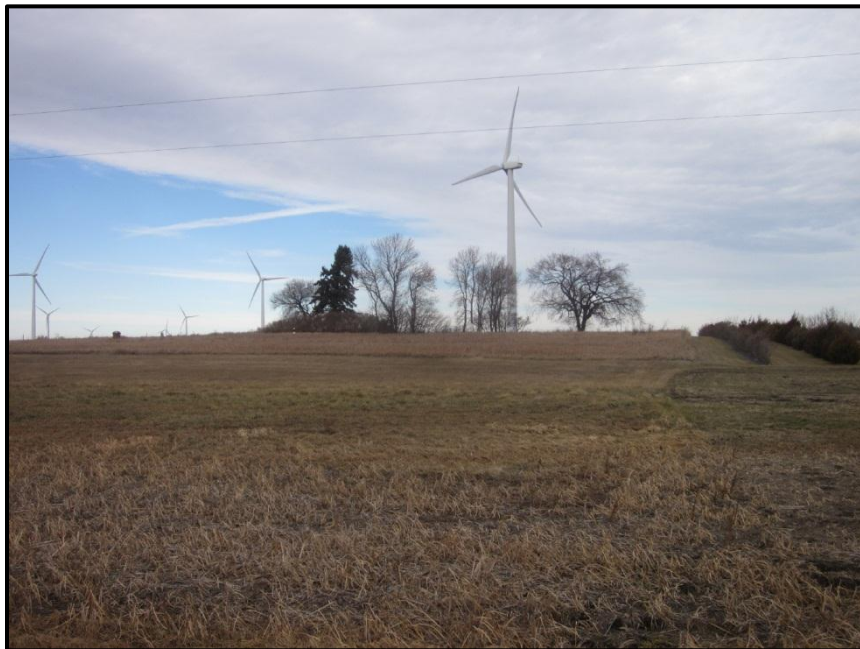
**Photo 16.** Direction: North. View of cemetery amidst scattered trees on hilltop, in the SW ¼ of Section 9, T142N, R57W (Grand Prairie Township), on the north side of 20<sup>th</sup> St SE. This architectural site had been avoided through siting of infrastructure of the wind farm.

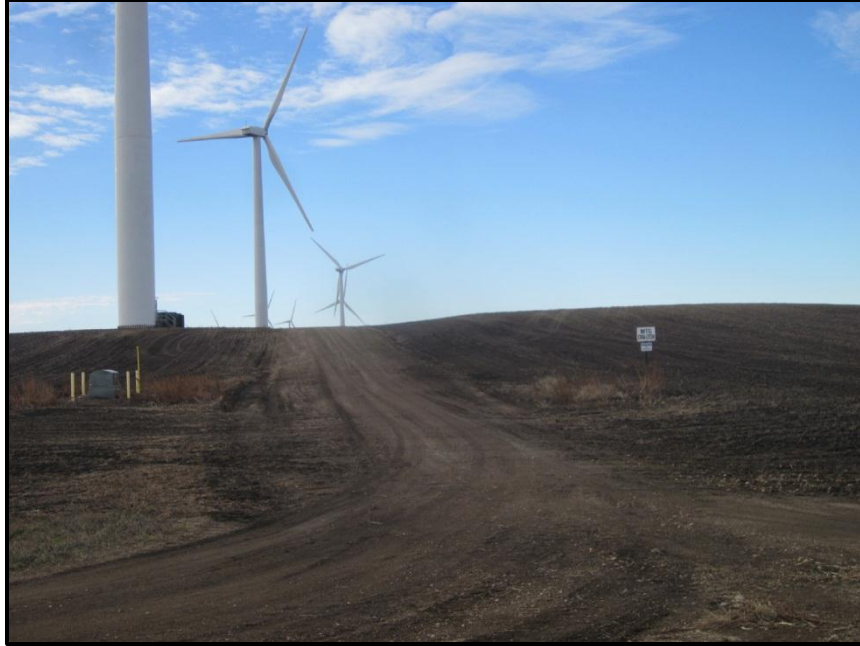
**Photo 17.** Direction: West. Access road for Otter Tail (OT) owned Turbines 48-39, at the intersection with 121<sup>st</sup> Ave SE. The east half of the turbine string went through cropland and the west half went through rolling native prairie. Proper signs were in place. Roads, towers, junction box, and cropland were for the most part in good condition.

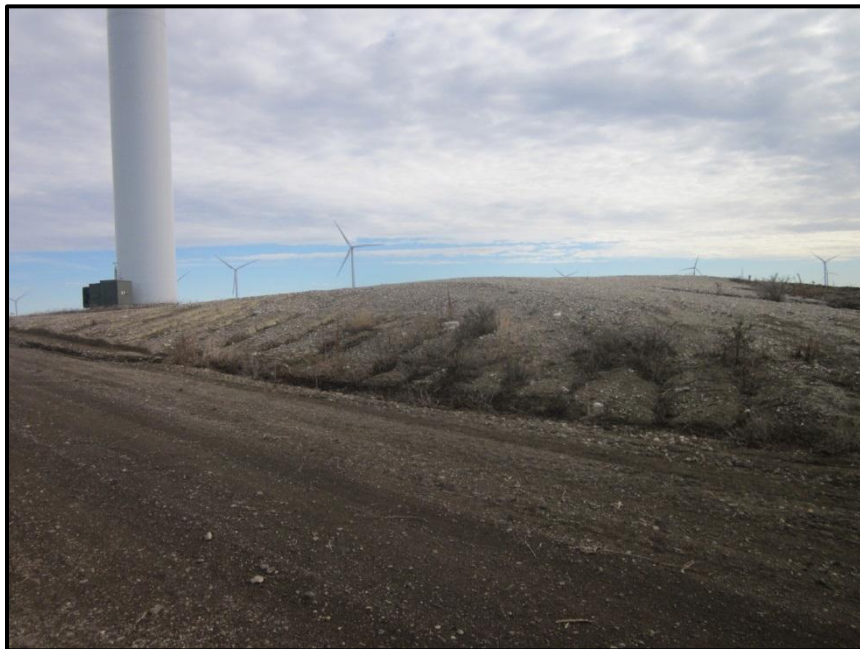
**Photo 18.** Direction: Southeast. The edges of the gravel pad of Turbine OT48 had eroded channels, which drained toward the edge of the access road, where a deep eroded channel had formed.

Several minor concerns were noted relating to erosion control and maintenance at the site. These included 1) minor erosional channels on the edges of the access roads or minor ruts on roads, particularly on hills, 2) erosion on gravel pads surrounding some turbine bases, and 3) damage of gravel pads from agricultural equipment. None of these issues stemmed from the construction phase. All were being actively addressed by NextEra, as evidenced by recent grading and repairs to roads and gravel pads, and communication about the gravel pad damage during the inspection. Wenck considers regular maintenance to be sufficient to control these issues. However the PSC may want to bring these minor issues to the attention of NextEra for their information.

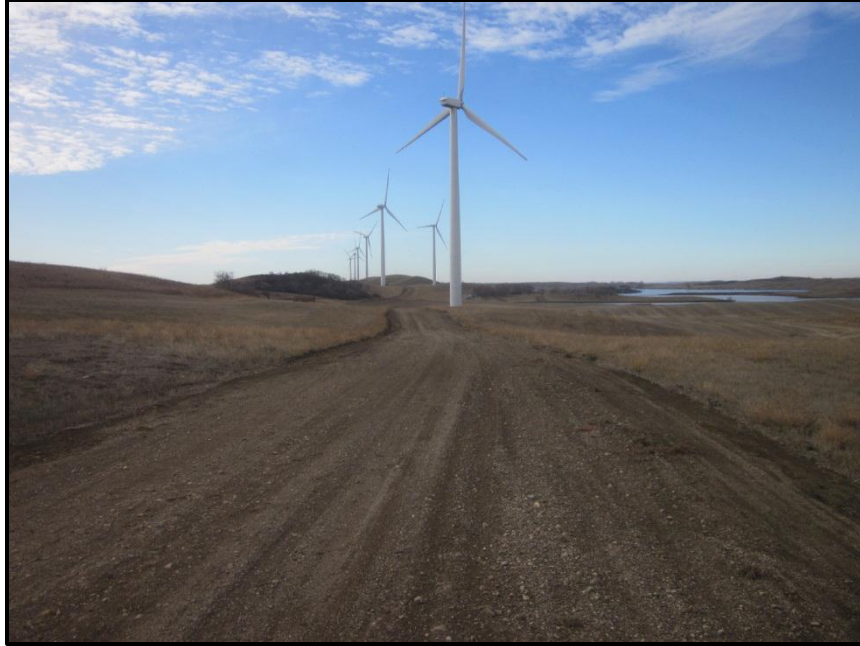
**Photo 19.** Direction: West. Road near Turbine OT46 showing the rest of the string across rolling hills. The road edges did not appear to have been planted with grass during reclamation. Rather the adjacent, existing hayland of alfalfa appeared intact up to the edge of the road; it appeared to have not been disturbed during construction or it had naturally grown back in since being disturbed.

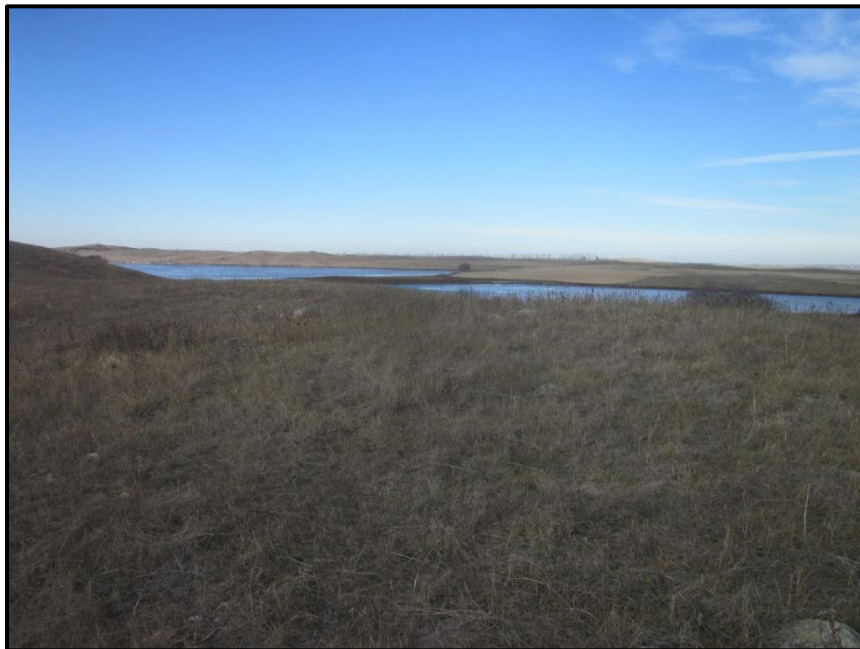
**Photo 20.** Direction: Northwest. Area between Turbines OT44 and OT43 where a potentially eligible cultural site had been avoided during construction. The site, which had a stone circle and rock cairn on a hilltop, appeared to be intact.

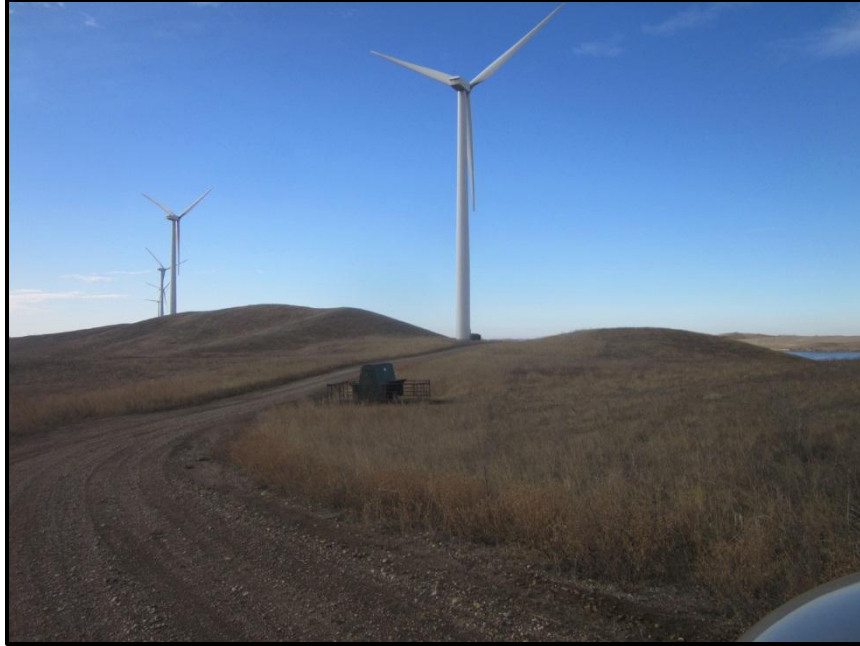
**Photo 21.** Direction: West/Southwest. Access road continued through rolling hills of native prairie from Turbines OT43-39. The edges of the road appeared to have been planted with intermediate wheatgrass (*Agropyron intermedium*). There were also weeds present within the area that had been disturbed on the edges of the road, including the noxious weed absinthe wormwood (*Artemisia absinthium*).

Of particular concern in a few areas of the site were outbreaks of absinthe wormwood (*Artemisia absinthium*), a perennial noxious weed that is difficult to control and spreads readily. This weed was seen along the edges of several access roads. It is likely that the source of the plant was from adjacent pastures, but the disturbed soils from construction of the road had allowed the plant to increase in population. Wenck recommends a concerted effort to control this plant by spraying. Wenck also observed several gravel pads around turbine bases with vegetation and annual weed growth from the past growing season. Though the vegetation was not particularly dense or out of control, Wenck would suggest more frequent spraying to maintain the pads for improved access and safety.

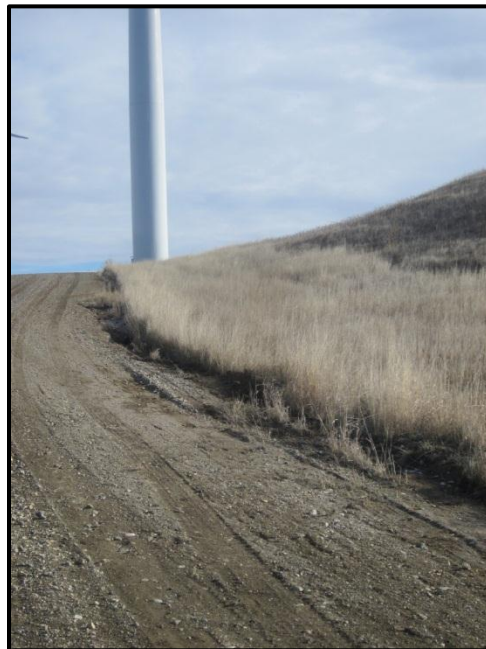
Best Management Practices (BMPs) were used as part of the construction and maintenance of the Project to minimize erosion and control sediment. Plans of the Day remarks indicated when SWPPP inspections were taking place (example Docket #32, Plan of Day 6-24-2008); photos of erosion control structures (example Docket #51, Plan of Day 7-10-2008); notes about silt fence installation (example Docket #61, Plan of Day 7-17-2008); notes about BMP repairs (example Docket #74, Plan of Day 7-25-2008); and silt fence removal and repairs at the end of construction (example Docket #237, Plan of Day 11-12-2008). Culverts were installed where necessary to allow for the natural flow of drainage. No erosion problems were observed around the utility junction boxes; cement bollards and gravel were in place around each (**Appendix A, Photos 10, 15, 17**). In general, erosion problems were minor and infrastructure of the Project area was well-maintained. There were a few locations where erosion on the access roads or gravel pads was a problem or where ruts or channels had formed, particularly where there were steeper slopes (**Appendix A, Photos 18, 22**). NextEra noted these areas were on the maintenance list and were being addressed. Wenck observed that numerous access roads had been recently graded which was evidence of regular maintenance (**Appendix A, Photo 22**).

**Photo 22.** Direction: East. Looking back toward Turbine OT43. There were several spots on hills along this access road where erosion channels had formed on the edges; however as shown in this photo this problem was being addressed through routine maintenance by grading the road and filling in the channels. Also note the different coloration of the grasses seeded for reclamation along this portion of the road.

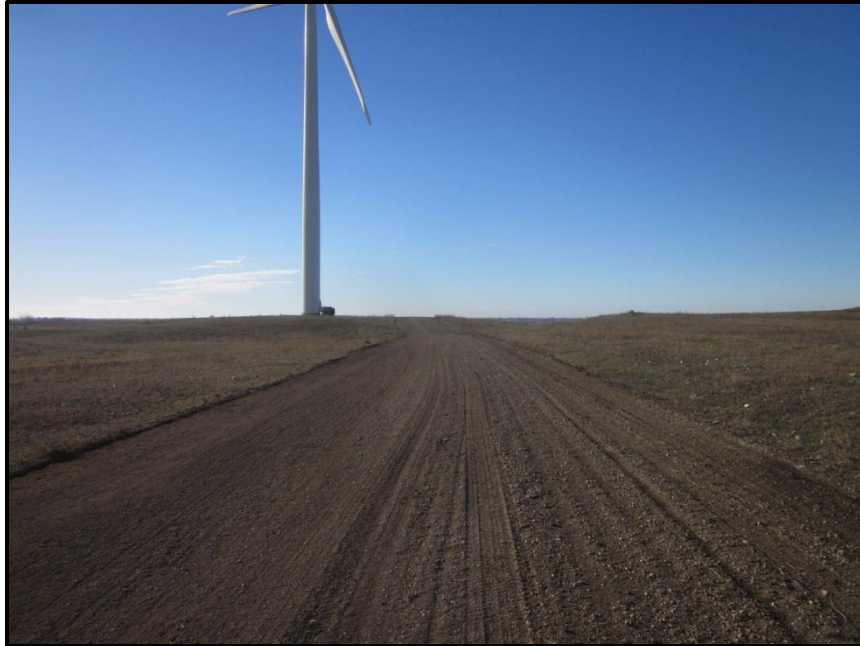
**Photo 23.** Direction: West. Access road leading to Turbine OT39. Conditions were good with no concerns. The native prairie along this portion of the access road did not appear to have been disturbed during construction; however there did appear to be drill rows in the soil and vegetation.

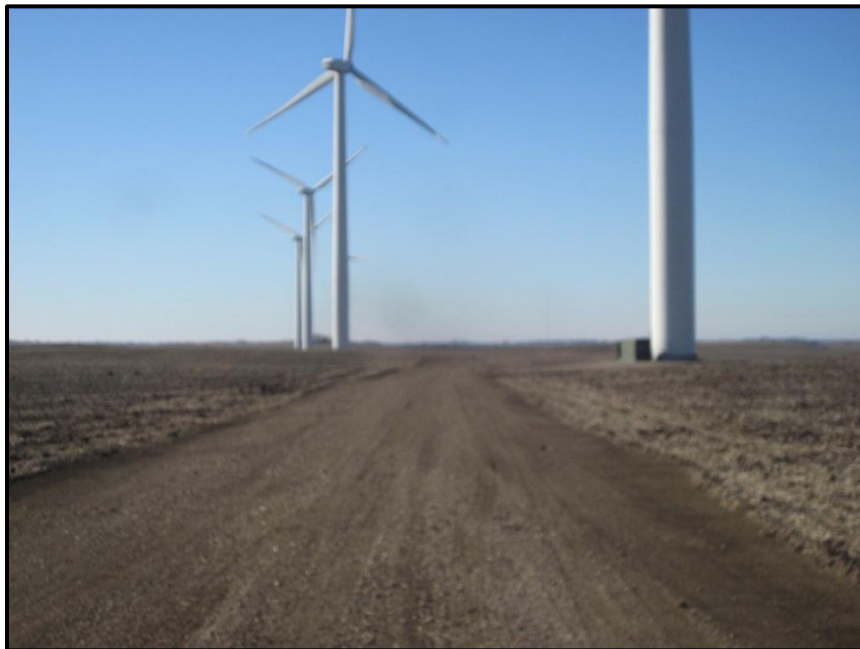
**Photo 24.** Direction: West. Access road leading to Turbines OT38-34. The portion of this string near Turbine 37 that was within pasture (uncultivated land but invaded, poor quality prairie) had an outbreak of absinthe wormwood.

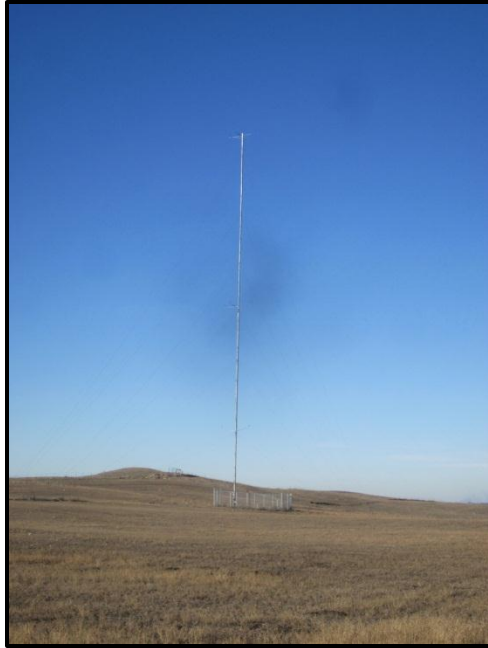
Some measures recommended by the USFWS were not implemented. MET towers were not self-standing; some had bird deterrents on the guy wires to help prevent bird collisions (**Appendix A, Photo 27**), though some did not (**Appendix A, Photo 25**).

**Photo 25.** Direction: Northwest. MET tower to the northwest of Turbine OT34 in the NW ¼ of Section 6, T142N, R57W. The tower had guy wires. No known birdsafe design features were visible.

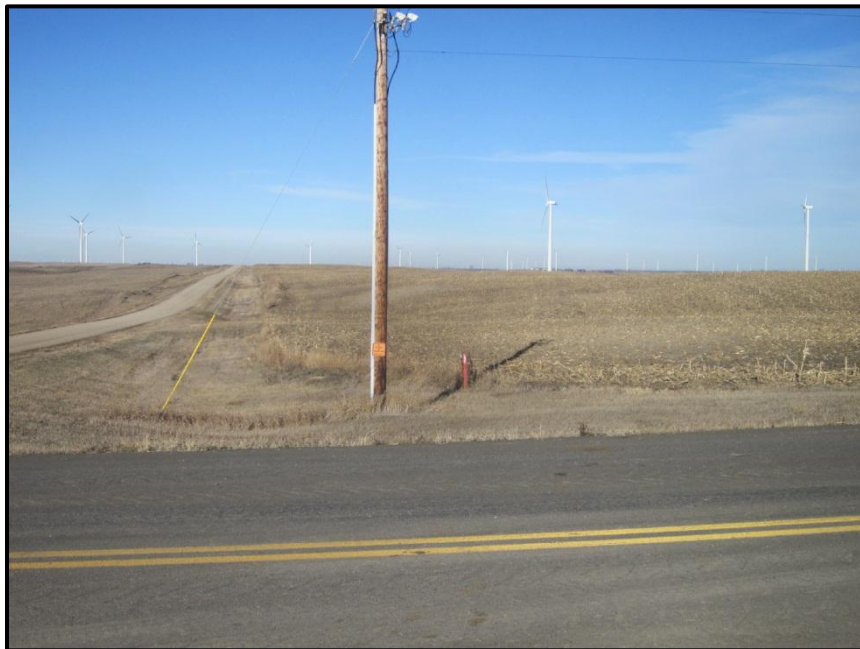
**Photo 26.** Direction: North. Collection line crossing of 18<sup>th</sup> St SE/County Road 6, which had been bored. Note the red marker in the north ditch.

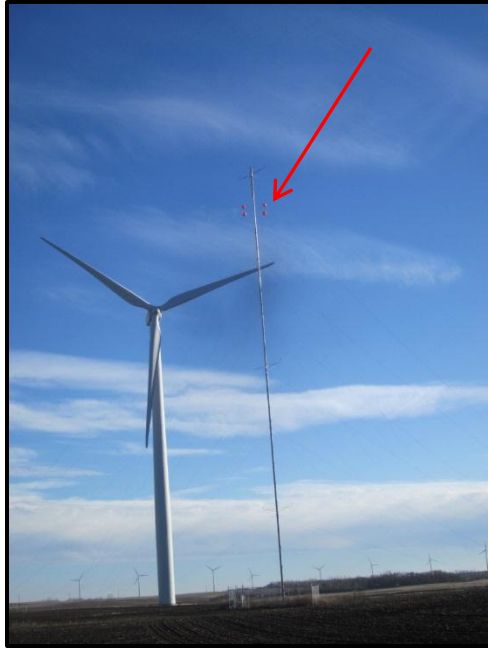
**Photo 27.** Direction: Southeast. MET tower to the northwest of Turbine 4. This tower had guy wires, but it also had the large orange balls on the wires as a bird deterrent (red arrow).

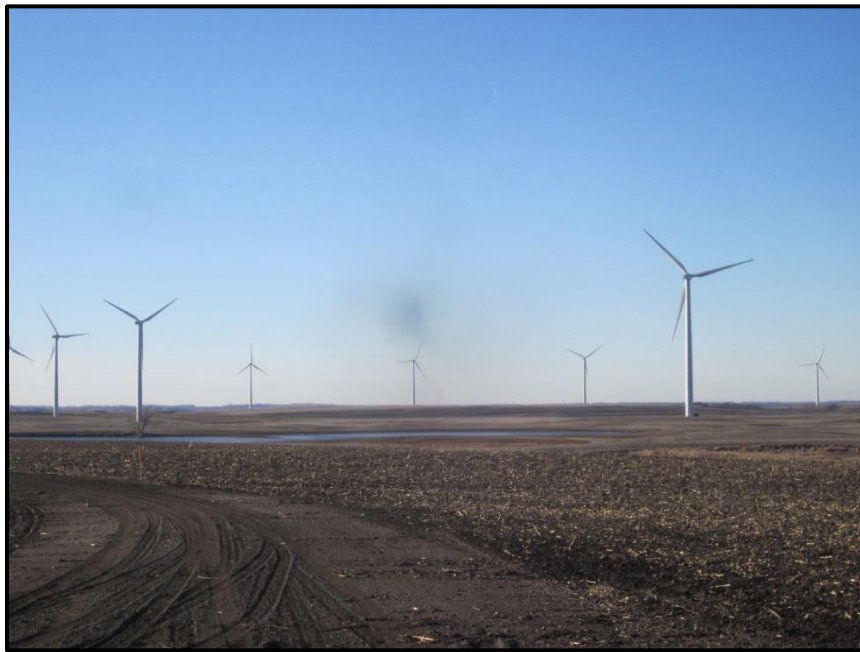
**Photo 28.** Direction: Northwest. View of turbines on landscape, showing wetlands avoided through siting of the turbines and roads.

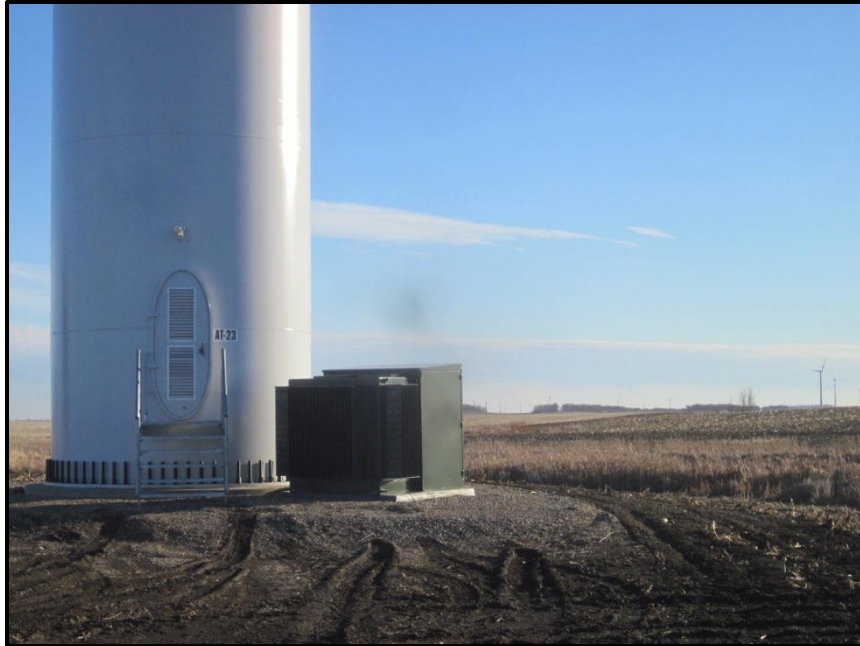
**Photo 29.** Direction: Southeast. Close-up of base of Turbine 23, showing example of a transformer with extra containment for oils in the pad mount. This is for extra protection in the case of a spill, since this turbine is near a wetland area (visible in the right background) which was under USFWS wetland easement.

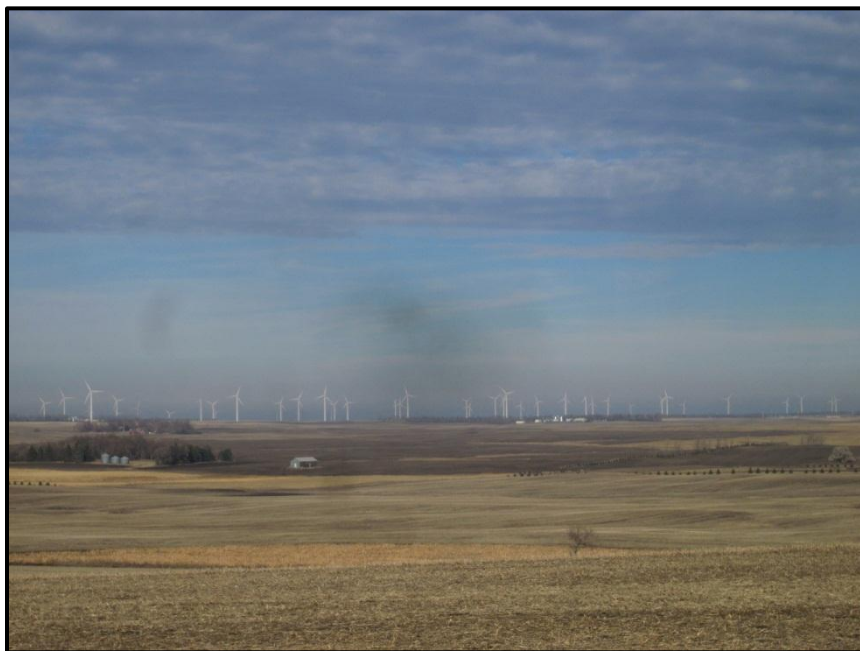
**Photo 30.** Direction: Northwest. View of turbines across the landscape, from the southeast corner of the project area looking toward the northwest at the core area of turbine strings.
