**BASIN ELECTRIC
POWER COOPERATIVE**

Re: Case No. PU-08-075

As described in our April 8, 2014, letter, issues 3 and 4 would be addressed when conditions allow access to the affected areas. Basin Electric conducted a field inspection on August 14, 2014, to assess and address the unresolved issues. Basin Electric's response to issues 3 and 4 are discussed below, including a brief synopsis of the NDPSC issue followed by Basin Electric's response. The sequence of responses is consistent with the order of the issues raised in your letter.

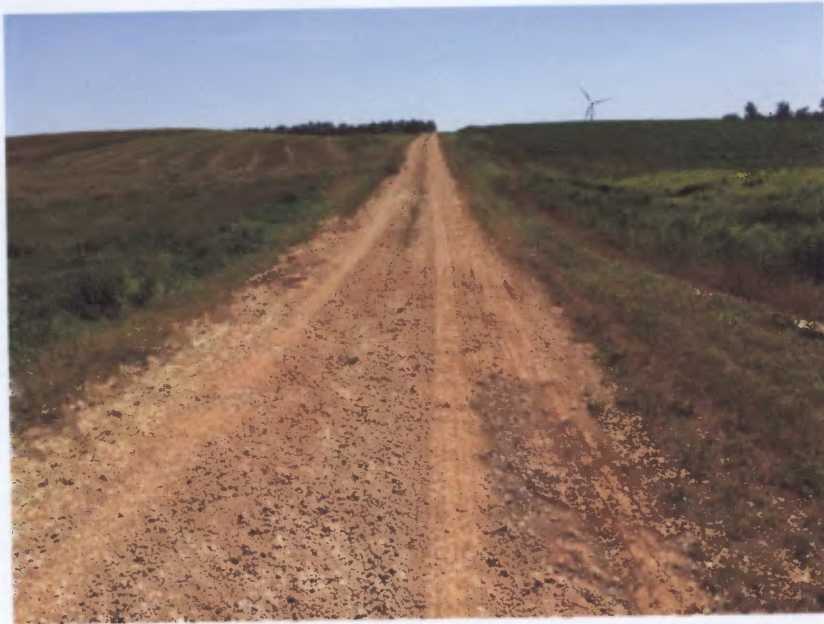
Response: Two culverts were installed on 42nd Street SE. On August 14, 2014, the condition of two culvert areas appeared consistent with other portions of this road. See attached photos. No further action is proposed.

Location: PrairieWinds ND1
Date: August 14th 2014
Subject: Culvert crossing
Photographer: K. Solie

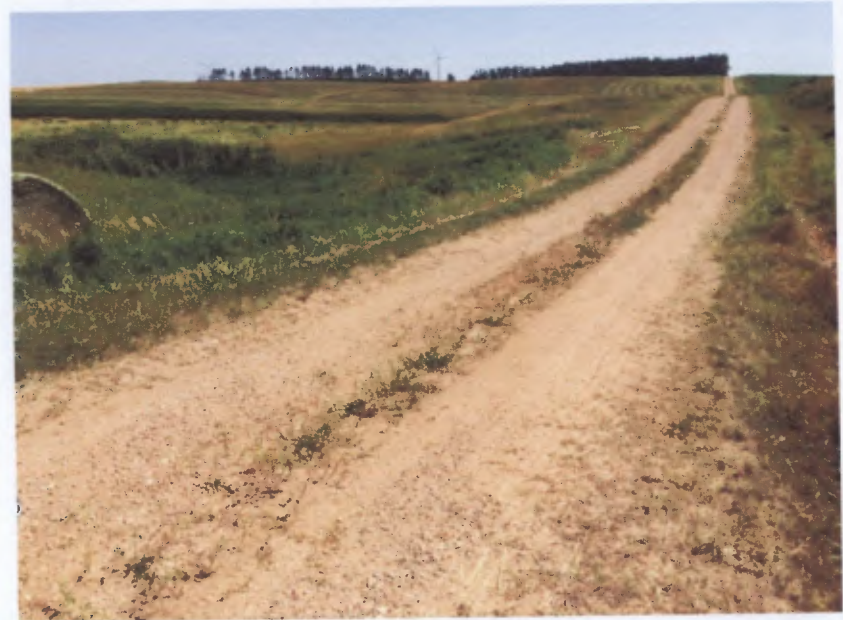
Location: PrairieWinds ND1
Date: August 14th 2014
Subject: Culvert crossing
Photographer: K. Solie

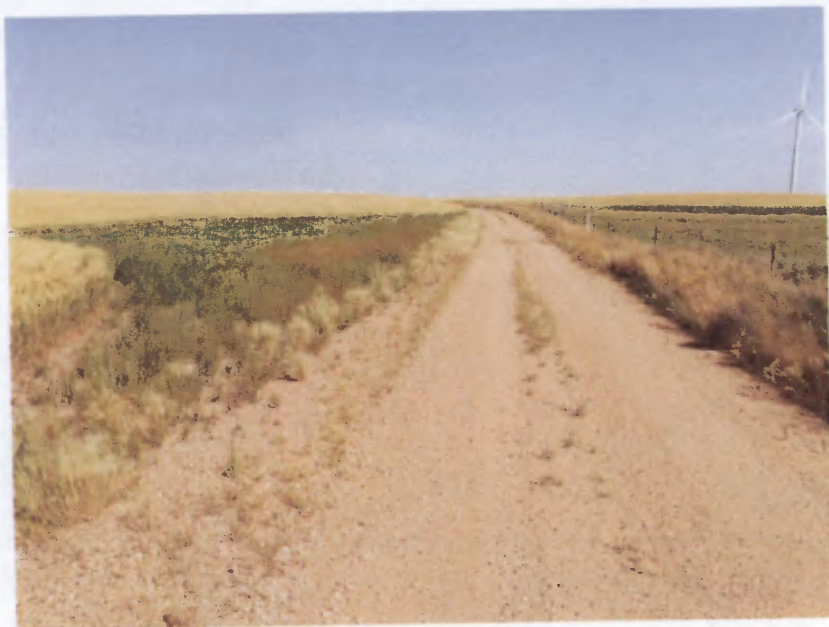
Response: A review of engineering documents indicates there are no collector line crossings on this portion of road. Two low water crossings, however, are present along this road segment. Low water crossings, which appear as small swales that cross the road roughly perpendicular to the flow of traffic, are part of a facility design that results in less impact than crossings with culvert installations. The road surfaces of low water crossings are typically protected with crushed rock or articulated concrete mats. Photos of representative low water crossings are attached. No further action is proposed.

Location: PrairieWinds ND1
Date: August 14th 2014
Subject: Low water crossing near turbine B29
Photographer: K. Solie

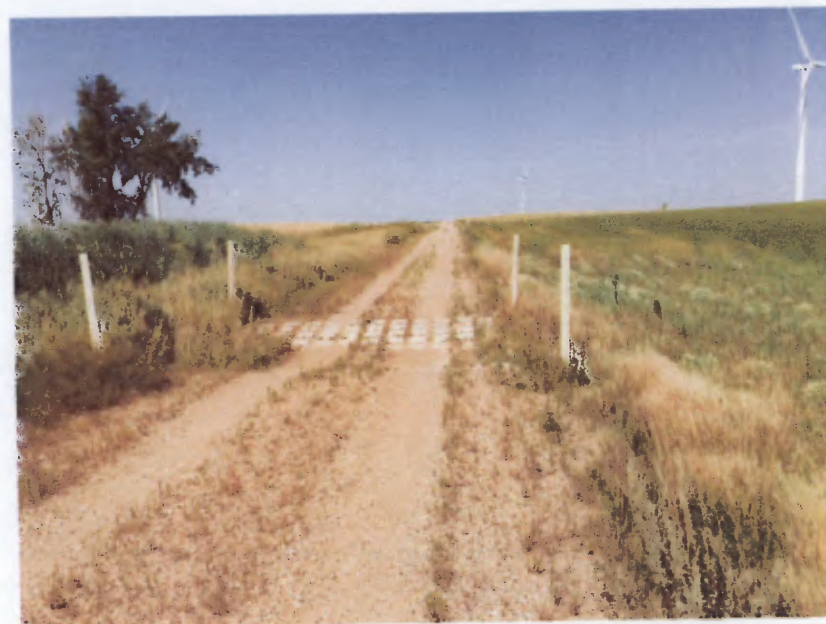
Response: A review of engineering documents indicates there are no collector line crossings on this portion of road. Again, we suspect the PSC's third-party inspector erroneously identified a low water crossing as a sunken collector line trench. No further action is proposed.

Location: PrairieWinds ND1
Date: August 14th 2014
Subject: Low water crossing 42nd Street SE
Photographer: K. Solie

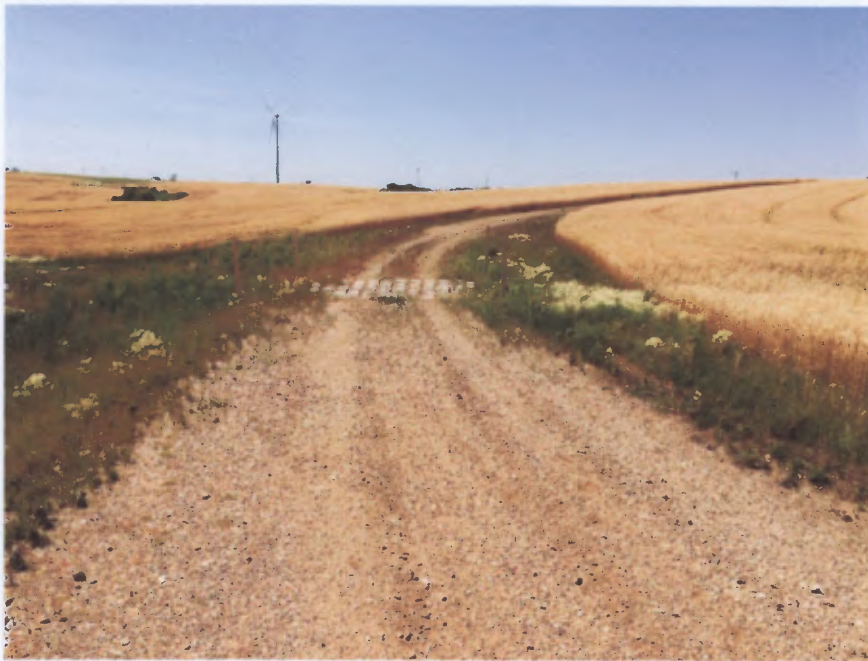
Response: A review of engineering documents indicates there are no collector line crossings on this portion of road. Again, we suspect the PSC's third-party inspector erroneously identified a low water crossing as a sunken collector line trench. No further action is proposed.

Subject: Low water crossing near turbine E63
