CRT LABORATORIES, INC.

LWR NO.: 17936 DATE: April 29, 2009

Product ID: Fargo Gas Riser with approximately 3ft pigtail with an in-line PE coupling fused to Century PE tan tubing

RE: Plastic welds
Laboratory Work Request 17936

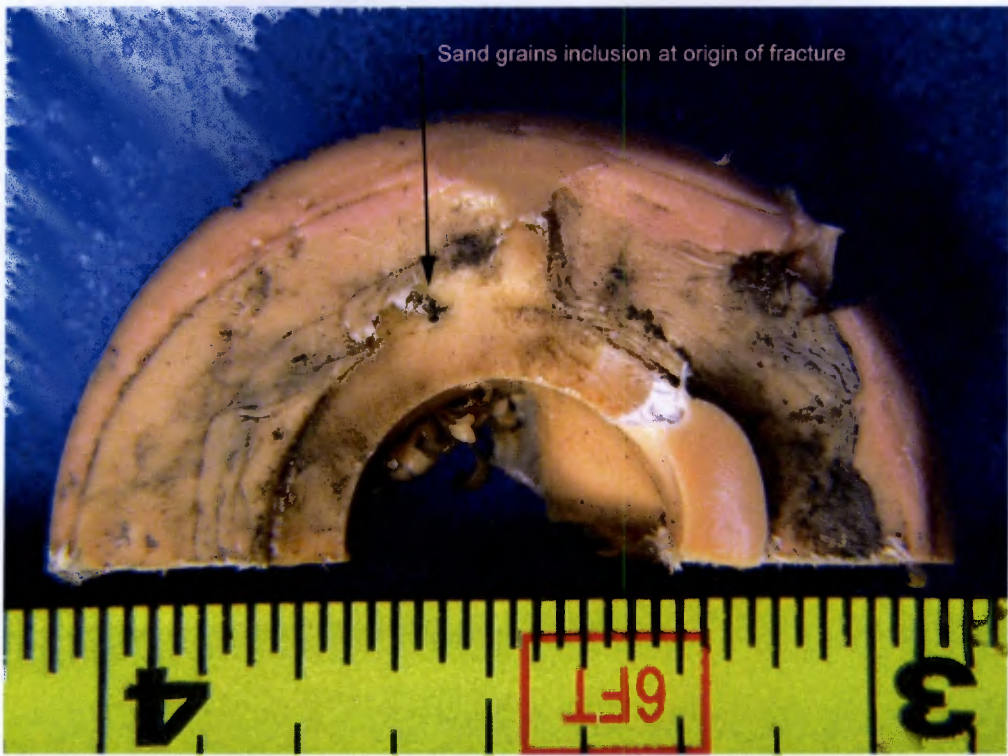
The welded joint of the failed item appeared similarly sound, with two exceptions. The cross section displayed a lack of fusion for a length of approximately 0.03 inch at the end of the fitting, although there was no evidence that this feature had contributed to the crack in the tube. More significantly, the fracture surface at this weld exhibited a cavity containing approximately eight particles of apparent sand. Chevron marks and radiating patterns on the fracture surface indicated that the crack had originated at the inboard edge of this cavity. These features revealed that this void had served as a stress concentrator that contributed to the failure.

The failure of the cracked tube was attributed to the combination of a cavity formed by debris entrapped at the time of welding that served as a stress concentrator and a relatively high bending load at the time of failure.

Sand grains inclusion at origin of fracture

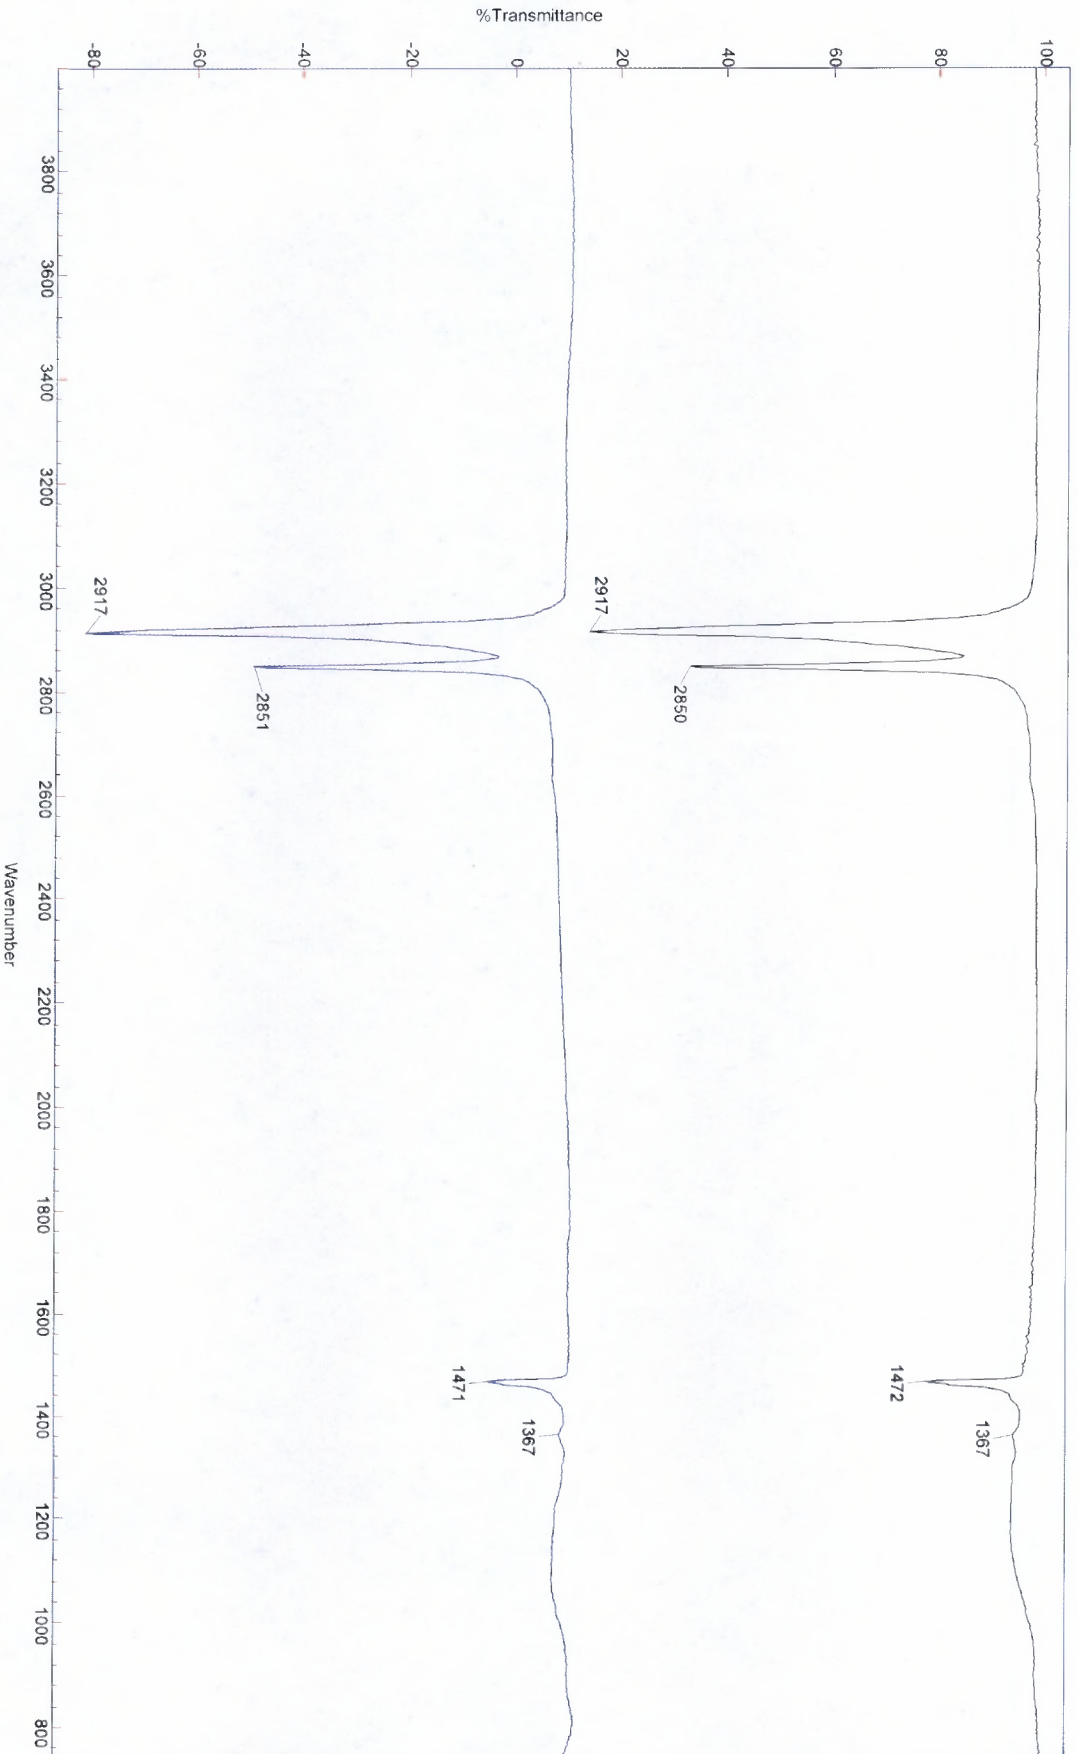
No significant differences are seen between the spectra.
