**INTRASTATE NATURAL GAS DISTRIBUTION SYSTEM
INCIDENT INVESTIGATION REPORT**

**NORTH DAKOTA PUBLIC SERVICE COMMISSION
NATURAL GAS DISTRIBUTION SYSTEM
INCIDENT INVESTIGATION
STAFF REPORT**

Case number: GS-08-765
Report Date: August 20, 2009

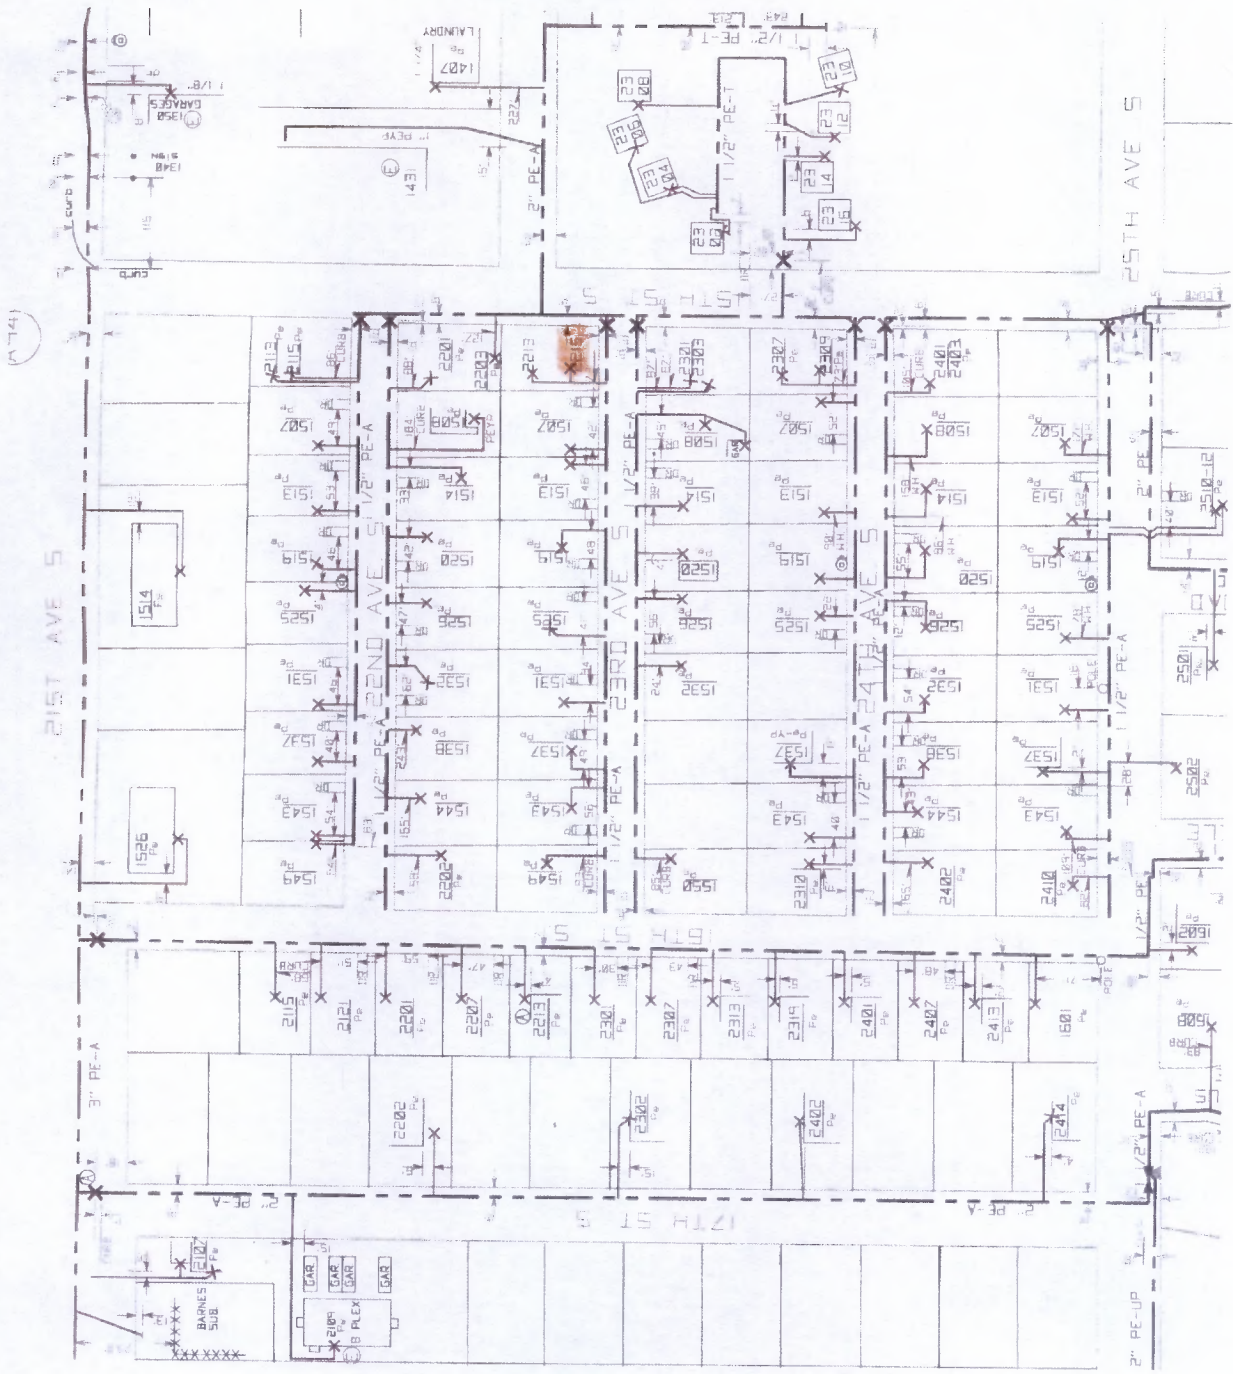
Drawing #1

- Service risers and tapping tees at 2213, 2203, 2301, 2303 15th St. S and 1507, 1513, 1508, 23rd Ave. S had been checked and no gas leaks were found. (Attachment 1, Drawing #1)

- At 1525 23rd Ave. S., 2301 15th St. S., and 2203 15th St. S., NSP had tested, with the aid of an ordrometer, and found odorant to be readily detectable. (Attachment 1, Drawing #1)

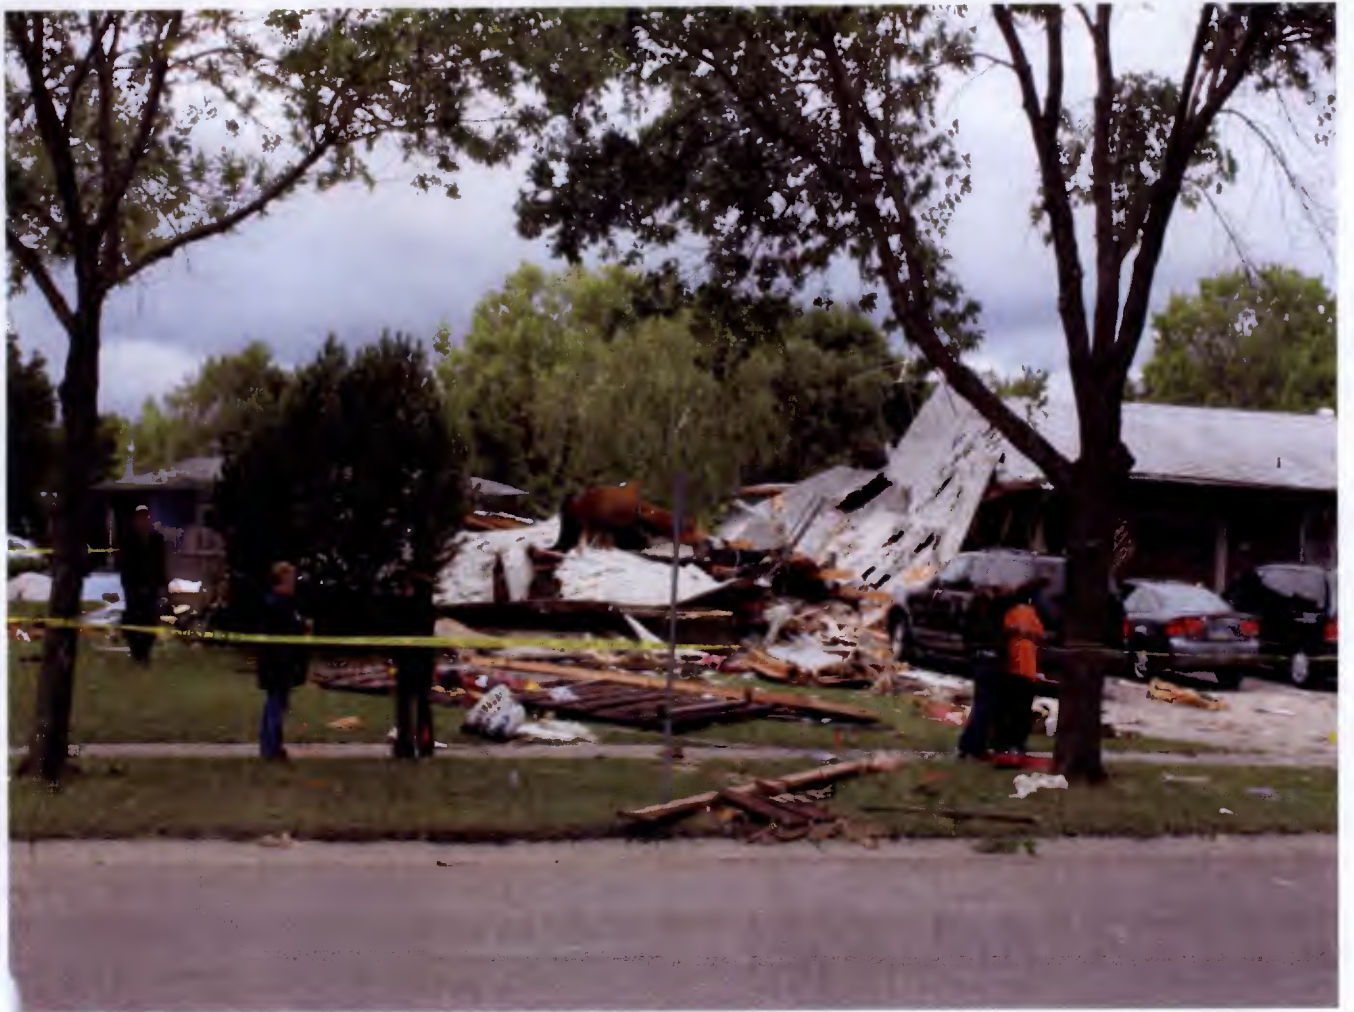
Photo #1

- The 2215 unit along with the single stall attached garage was completely destroyed (Attachment 1, Photo #1, 2 and 3).
- A vehicle in the driveway of the 2215 unit sustained damage.
- The 2213 unit sustained damaged to the adjoining wall and roof area.
- A vehicle in the garage of the 2213 unit sustained damage when the adjoining wall and roof fell.
- No fire damage was readily apparent.

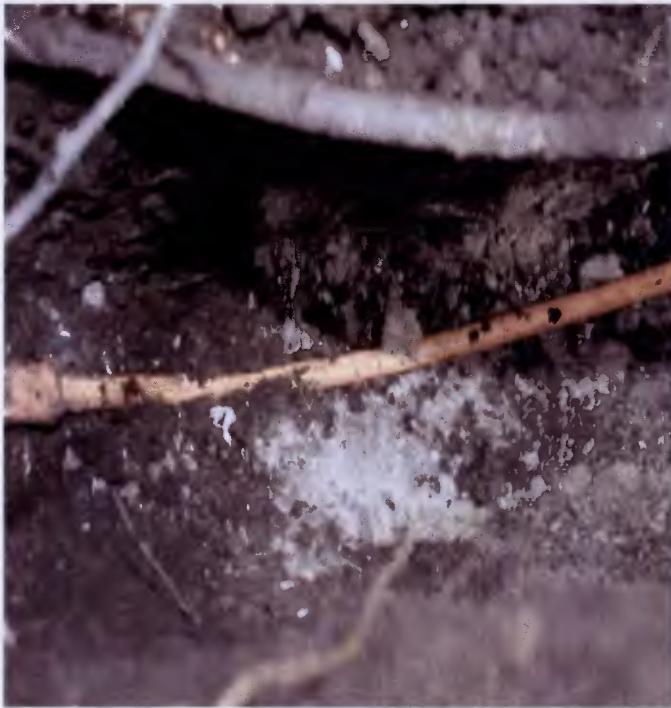
The service riser was then excavated and Staff observed an area of grey-colored soil between the service line and the house foundation. (Attachment 1, Photos #4-7). At the service line, the grey soil was adjacent to a polyethylene (PE) socket coupler that joined the buried PE distribution system service line to the service riser (Attachment 1, Photos #8-9). The grey soil was dry and smelled strongly of natural gas odorant.

area of grey soil by socket coupler
Photo #4

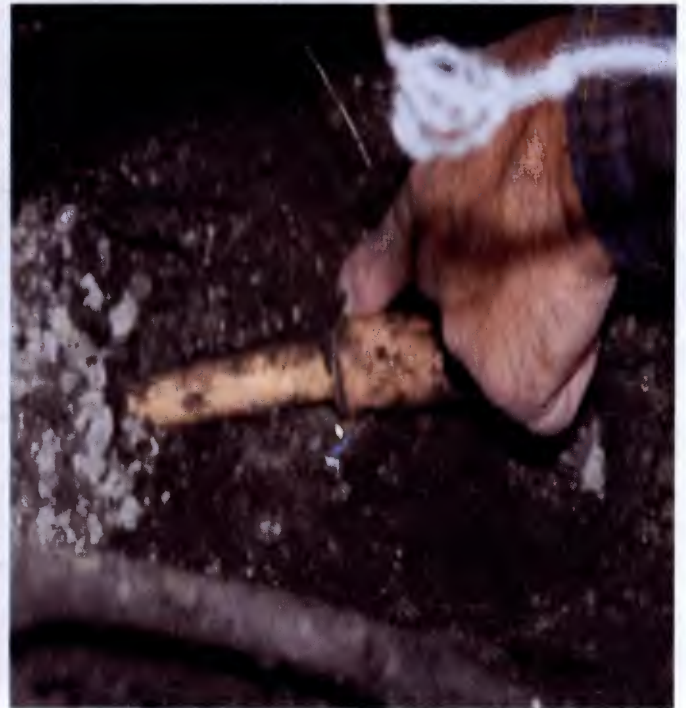
area of grey soil by socket coupler
Photo #5

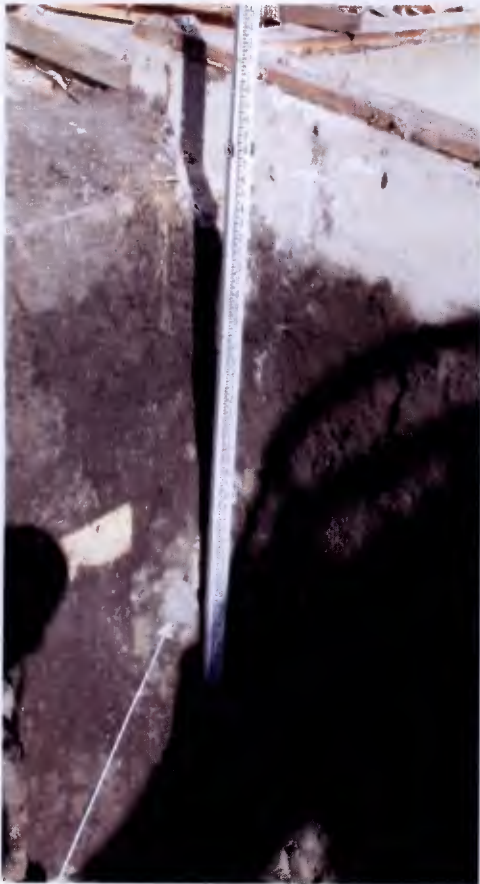
area of grey soil 3 feet below surface
Photo #6

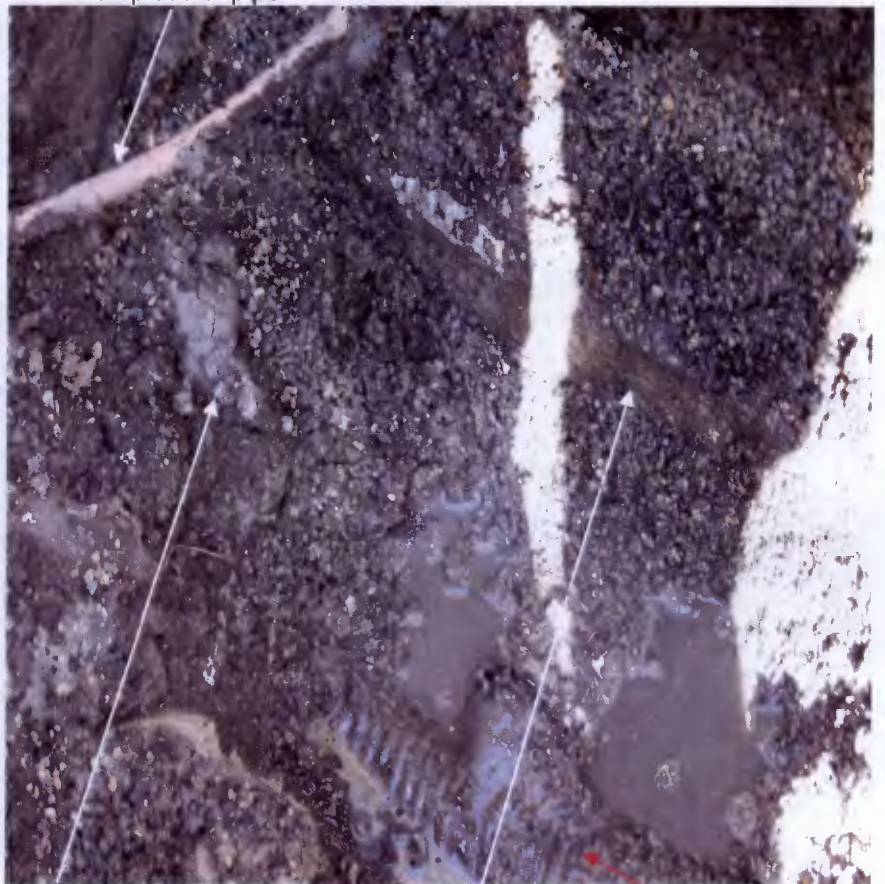
Excavation continued. NSP personnel preserved the segment of pipe including the socket coupler for the possibility of further testing (Attachment 1, Photo #10). Staff visual inspection of the coupler fusion joint from the failed pipe at 2215 dwelling revealed that the joint was not straight (Attachment 1, Photo #11) and that the fusion bead on the riser side of the socket coupler was irregular (Attachment 1, Photo #12). The segment was sent to an NSP secure storage facility. The grey soil area was further excavated. The path of grey soil continued from the socket area to the foundation footing and drain field, approximately eight feet underground. (Attachment 1, Photo #7)

area of grey soil at drain field
house foundation
drain tile
Photo #7

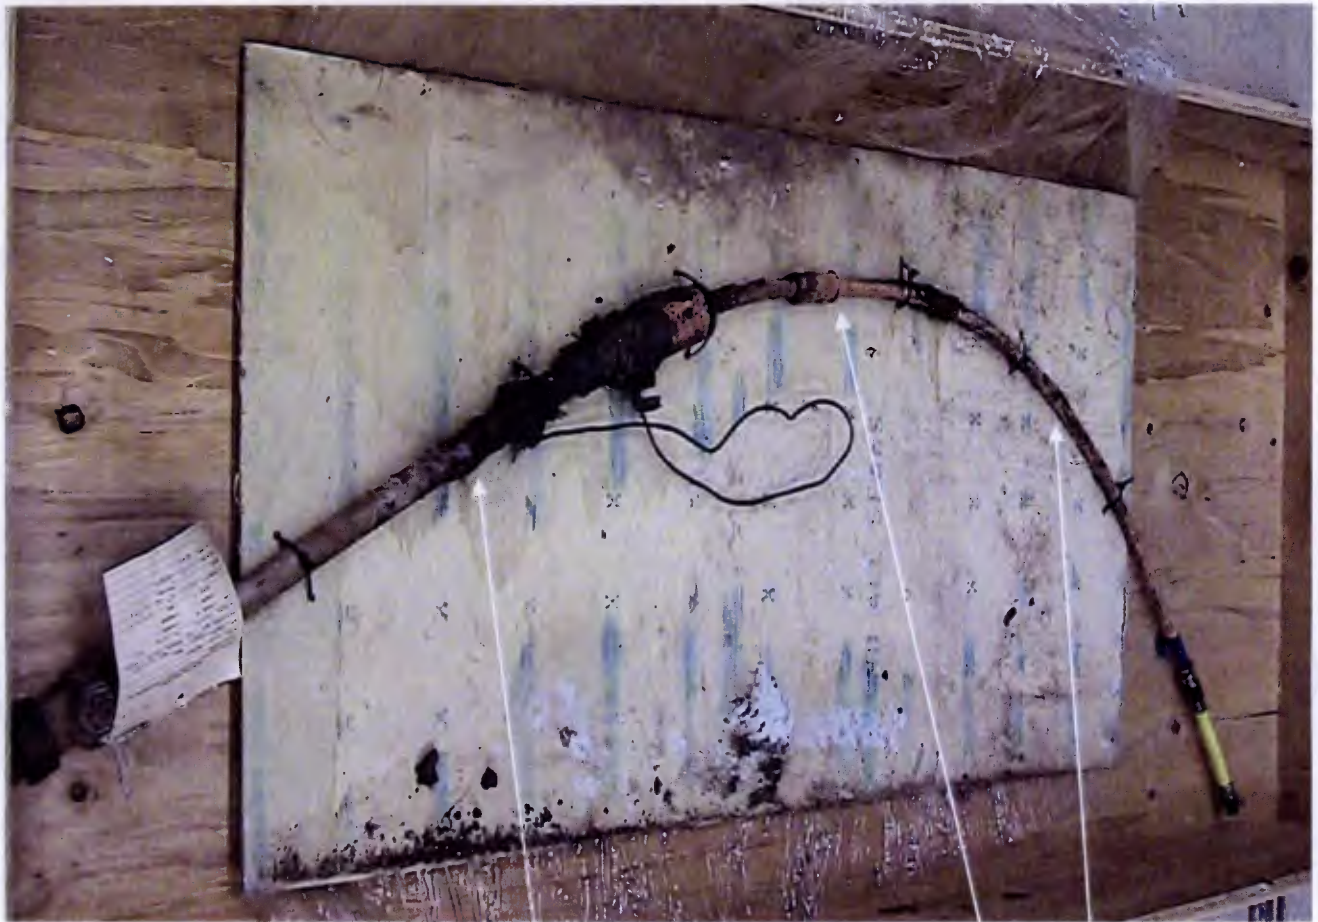
Photo #10

Riser socket coupler service line
pipe section sent to CRT Laboratories, Inc.

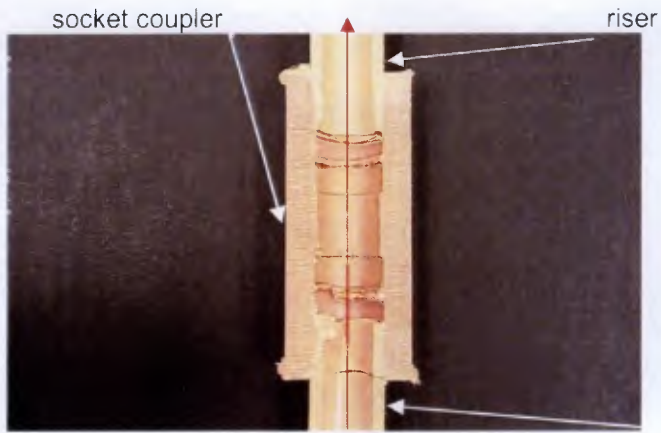
In 1975, when the service was constructed, NSP's operations manual included a procedure for socket fusion (Attachment 9). Staff visual inspection of the coupler fusion joint from the failed pipe at 2215 dwelling revealed that the joint was not straight (Attachment 1, Photo #11) and that the fusion bead on the riser side of the socket coupler was irregular (Attachment 1, Photo #12). Forensic Engineering Consultants, LLC concluded that the PE socket coupler fusion joint appeared strong but laboratory inspection of a cross section of the weld joint displayed a lack of fusion for a length of approximately 0.03 inches at the end of the fitting as well as the presence of entrapped debris. One cavity formed at the time of welding contained approximately eight particles of apparent sand. This cavity served as a stress concentrator that contributed to a fracture in the service line at the welded joint of the socket coupler.

Service pipe out-of-alignment with socket coupler
Photo #11

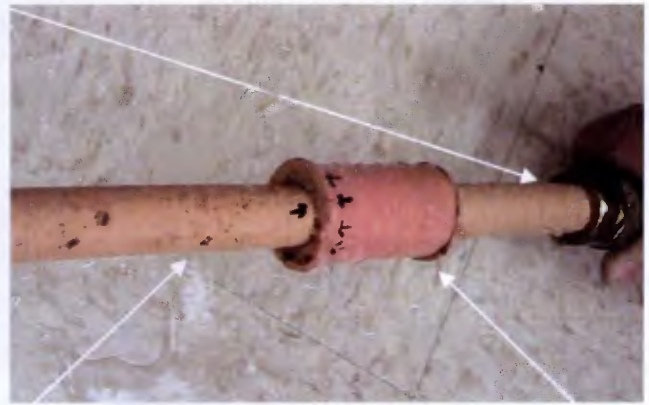
Service line
 irregular socket fusion bead
Photo #12

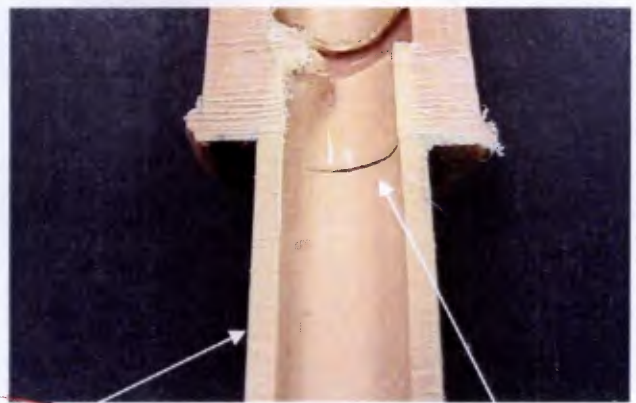
Service line
 interior stress fracture
Photo #14

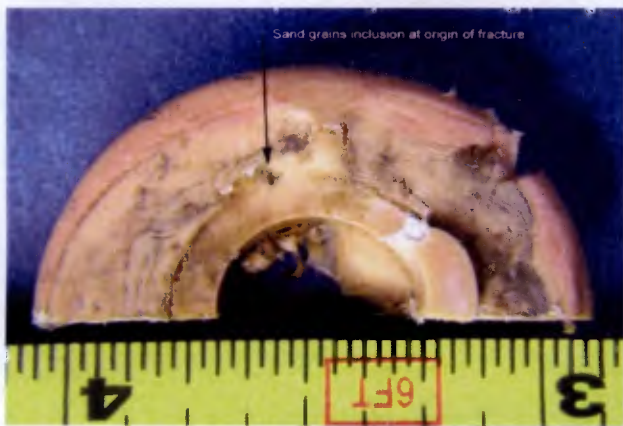
Excavation of the service line at the 2215 unit revealed an area of grey-colored soil located between the service line and the house foundation drain field pipe (Attachment 1, Photo #4-7). At the service line, the grey soil was adjacent to a polyethylene (PE) socket coupler that joined the buried PE distribution system service line to the service riser (Attachment 1, Photo #8-9). The grey soil was dry and smelled strongly of natural gas odorant. Soil will turn grey when exposed to natural gas for a period of time. Subsequent pressure testing revealed a leak at a PE socket coupler that joined the service line to the service riser. Laboratory testing revealed a pinhole leak in the service pipe at the fusion to the socket coupler (Attachment 1, Photo #13) and a crack on the inside of the service pipe at the pinhole (Attachment 1, Photo #14). Laboratory testing also revealed the presence of debris entrapped in the socket coupler joint fusion at the pinhole (Attachment 1, Photo #15-18).

sand grain inclusion
Photo #15

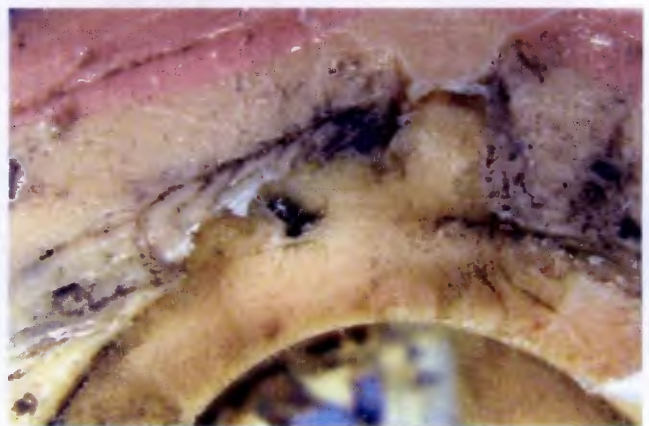
sand grain inclusion
Photo #16

magnified images of sand inclusion

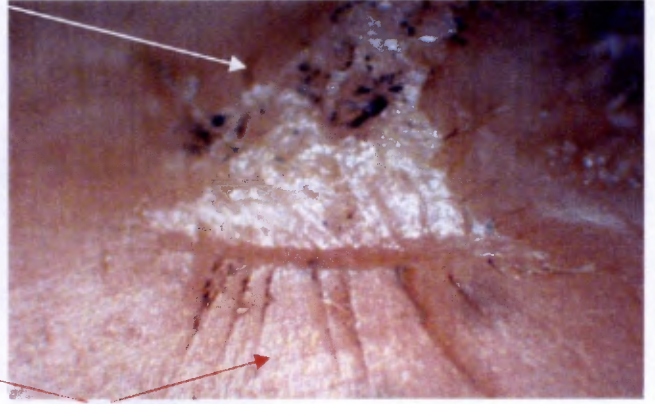
Photo #18

Radiating pattern

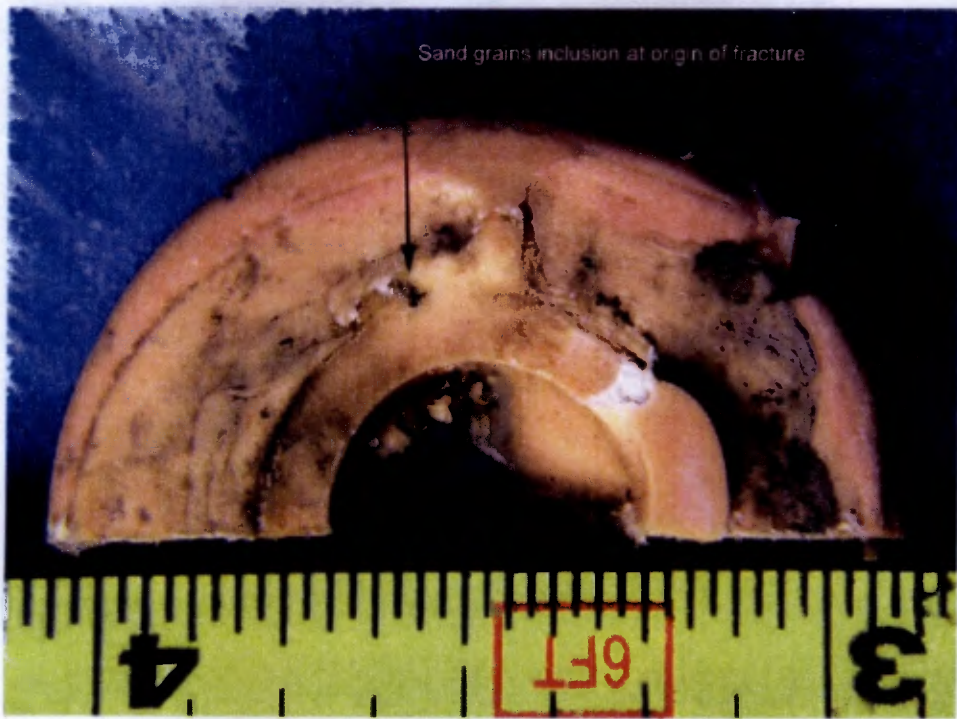
Sand grains inclusion at origin of fracture

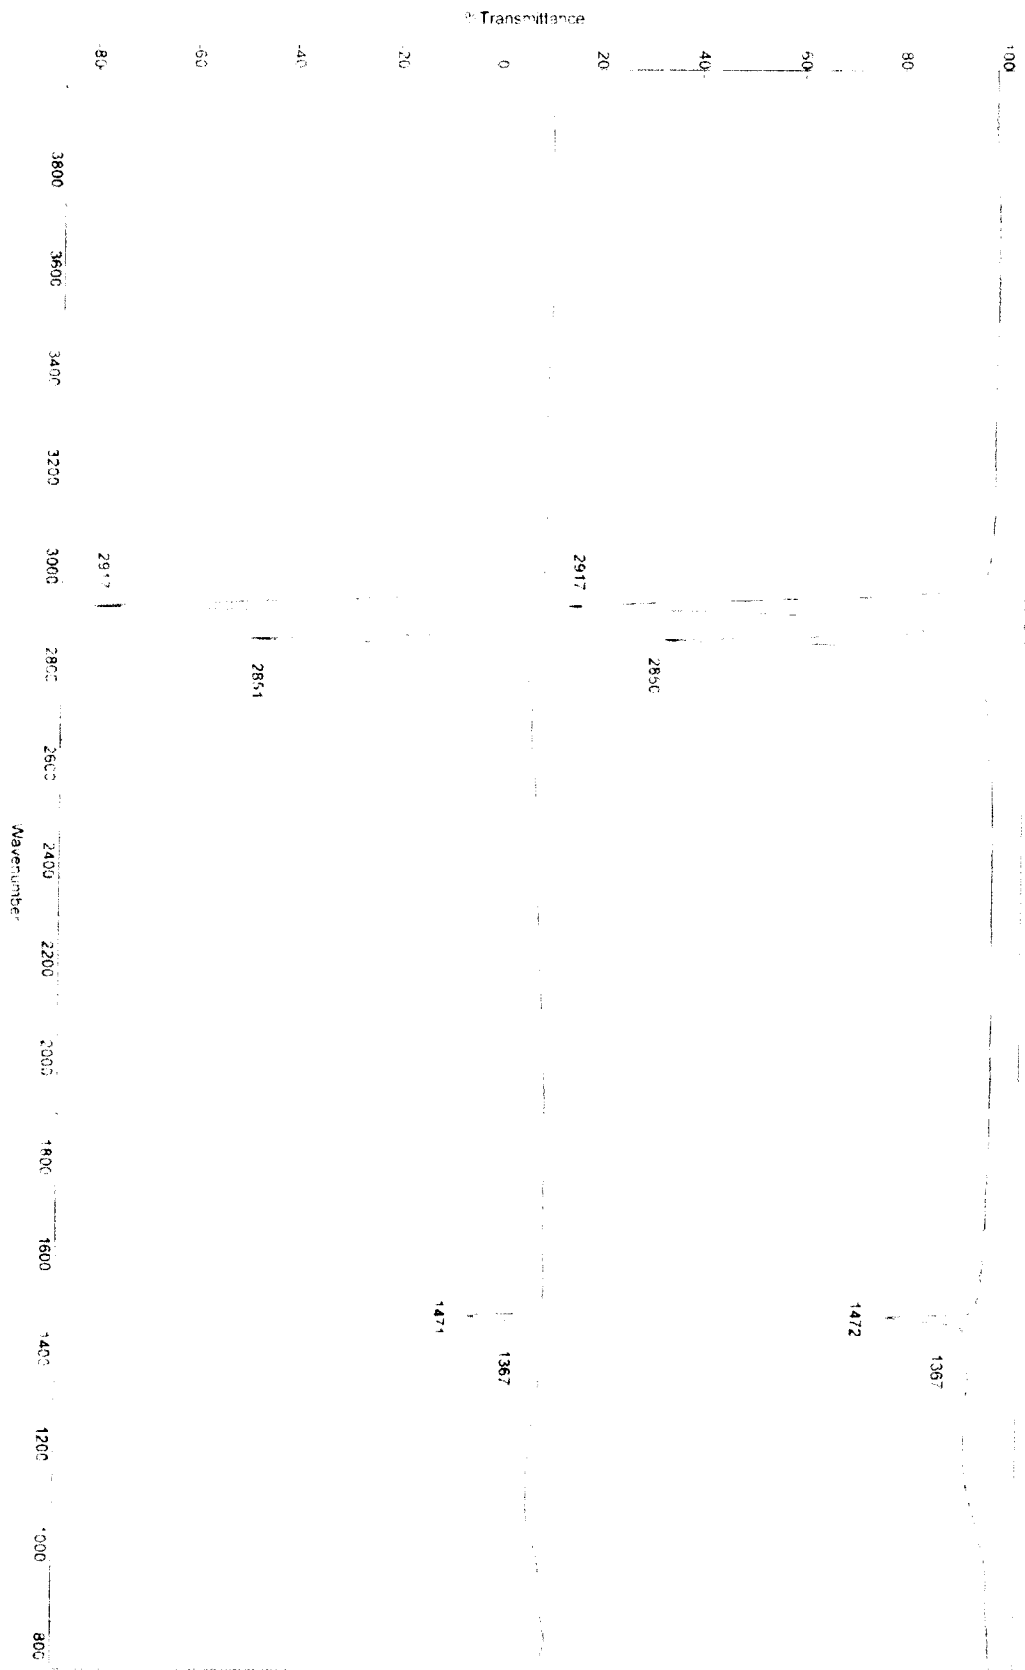
No significant differences are seen between the spectra.
