Public Service Commission  
State of North Dakota

INSPECTION REPORT

DATE OF INSPECTION: January 27, 2009  
TYPE OF INSPECTION: Complete  
PERMITTEE - MINE: Dakota Westmoreland - Beulah Mine  
PERMITS INSPECTED: KRSB-8603, KRSB-8802  
PERSONS ACCOMPANYING INSPECTOR: Jeff Frohlich (Morning), Jesse Noel (Afternoon)  
INSPECTION CONDITIONS: The inspection was conducted between 9:30 a.m. and 3:00 p.m., CDT. Skies were mostly clear. The temperature ranged from 0-10° F. Access was limited due to drifted snow.

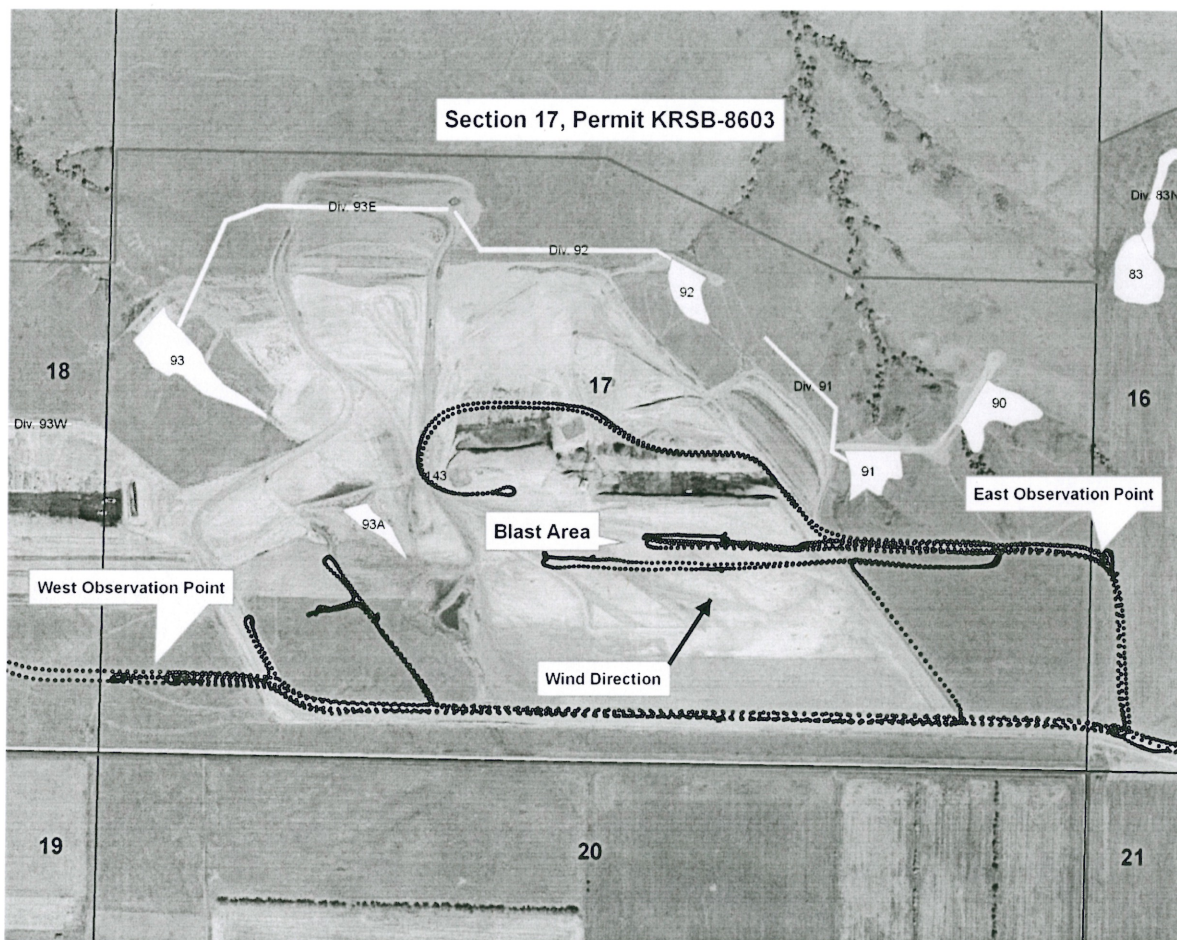
Figure 1:

The wind was blowing 15-20 mph from the south/southwest at the time of the blast. The blast warning siren was faintly heard at a distance of approximately one half mile east/southeast of the blast truck. The blast truck was in the pit several hundred feet east of the coal blast and the siren was located on the blast truck. The all clear signal was not heard approximately one half mile west/southwest of the blast truck. The blast truck was radioed and the all clear signal was sounded a second time. The siren was not heard while located approximately one half mile west/southwest of the blast truck. Figure 1 shows the locations of the blast and where this inspector was located during the blast.
