Informal Conference NOV 0804

**Dakota Westmoreland Corp.
&
North Dakota PSC**

Dakota Westmoreland
Corporation Beulah Mine

Overview of NOV 0804

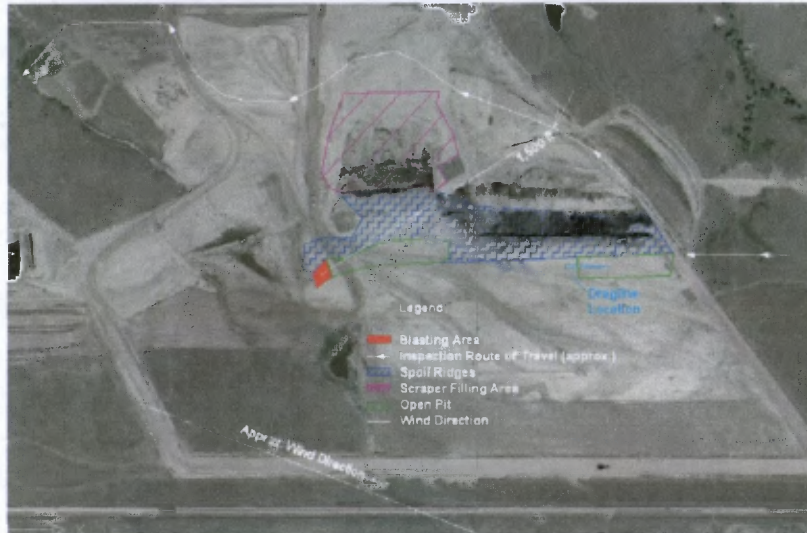
- ✓ Wind: 15 - 25 mph (33 mph gusts)
- ✓ Wind Direction: WNW (approx. 50° perpendicular to blast)
- ✓ Temperature: 35°F
- ✓ Cover: Partly Cloudy (approx. 60%)

- ✓ Actual Distance from Blast: 1,600 ft
- ✓ Reported Distance from Blast: 900 ft
