PU-08-932/PU-19-144

**Merricourt Wind Power Project
Reclamation Inspection Report**

July 2022

Stantec Consulting Services Inc.
3303 Fiechtner Drive, Suite 100
Fargo, ND 58103

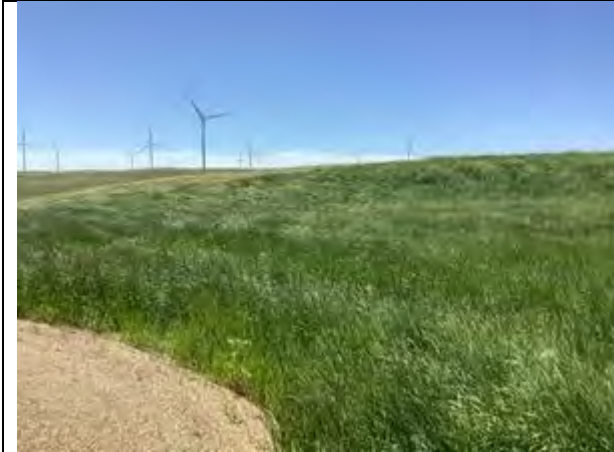
Observation Point: 10

Absinthe wormwood (*Artemisia absinthium*) and Canada thistle (*Cirsium arvense*) are ND noxious weeds, and were observed in the reclaimed hay and pastureland areas (**Observation Points 10 and 11**).

Stantec recommends mechanical, chemical, or biological control measures be taken place to control these populations.

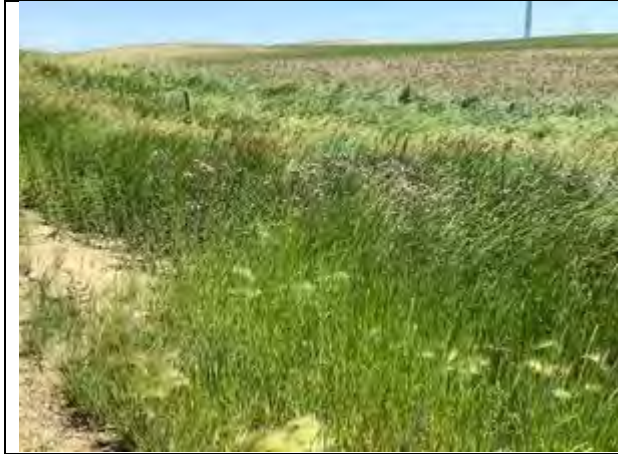
Observation Point: 11
Date Taken: June 30, 2022 12:07 PM
Direction Photo is Taken: Northeast

Photo Description: Seeded vegetation is coming in. Crested wheatgrass, quackgrass, foxtail barley. Canada thistle population off road, and is going to seed.

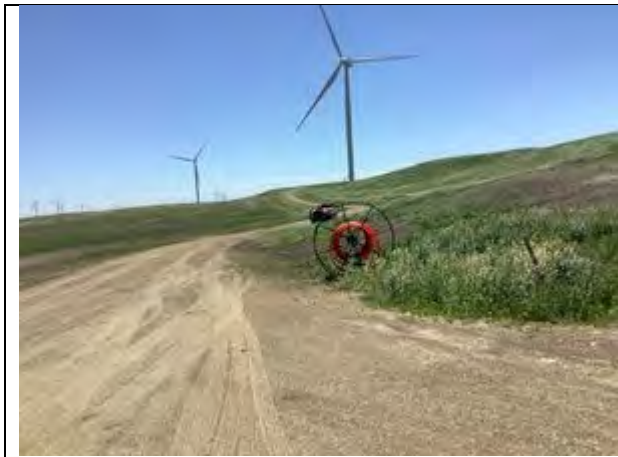
Observation Point: 12
Date Taken: June 30, 2022 12:42 PM
Direction Photo is Taken: East

Photo Description: Overall well reclaimed. Seeded vegetation coming in.

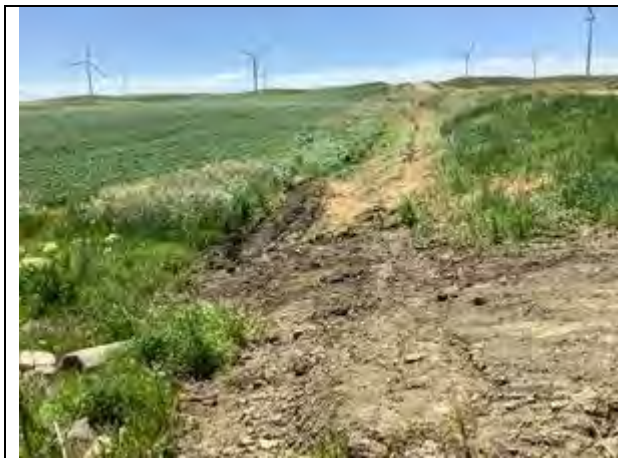
Photo Description: No BMPs along ditch. Culverts are free of sediment. Reseeding recommended. Disturbance currently is from communication utility installation that was observed nearby.

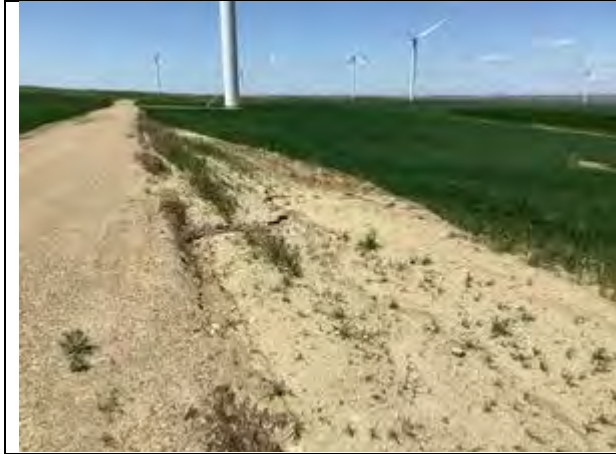
Observation Point: 14

One reclaimed area near a wetland was examined. The final topography matched surrounding areas and the seeded vegetation was established (**Appendix B; Observation Point 14**). There was also appropriate BMP's around the reclamation area to prevent adverse impacts to the wetland.

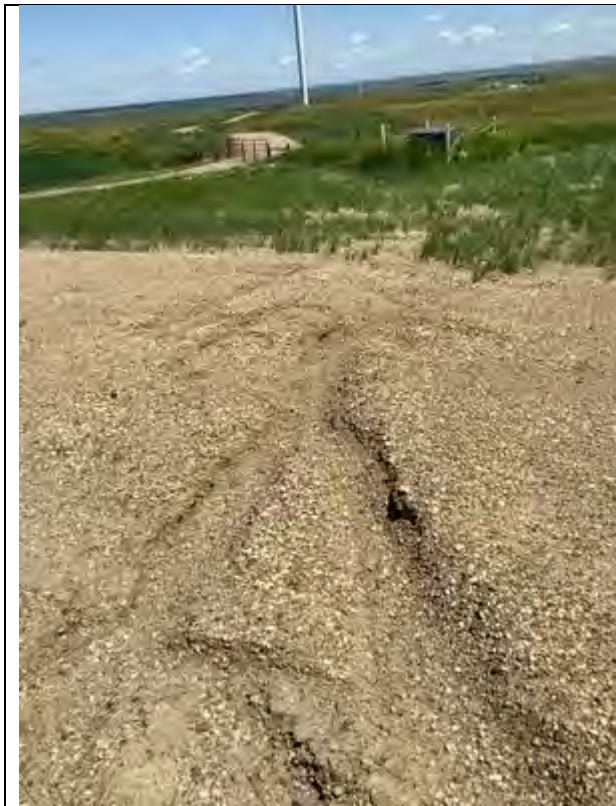
Observation Point: 15

Absinthe wormwood (**Observation Points 10 and 15**) and Canada thistle (**Observation Points 11,15, 24, 49**) were the only noxious weed observed (**Appendix B**).

Stantec recommends weed management where ND noxious weeds were observed, and for wherever they are identified. The prevalence of other weeds were moderate to low. Canada thistle and absinthe wormwood have seed viability of ≤ 20 and 3 years, respectively. Therefore, effective management is needed to significantly reduce weed presence in following years. For Canada thistle control, Stantec recommends areas with weedy species be treated immediately and in the growing season of 2023. Canada thistle is best controlled by repeated mowing to prevent plants from producing seeds, or by applying correct herbicides at the “rosette” vegetative stage, when the herbicide has the greatest chance at killing the plant (Lym, 2013). Absinthe wormwood can be controlled in a similar fashion of mowing, or chemical treatment in its growing stage (at least 12 in tall; Meehan et al., 2017).

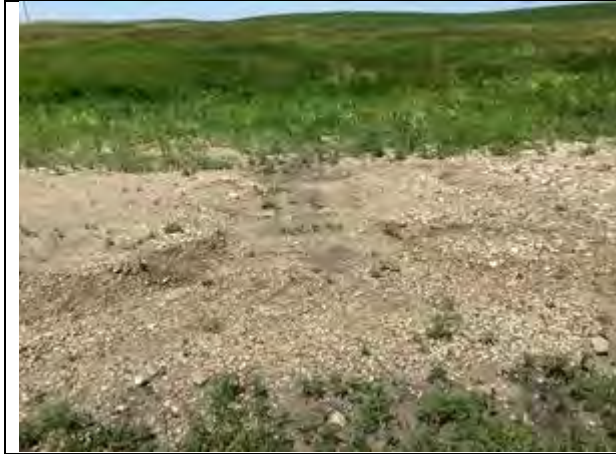
Observation Point: 16

Photo Description: Road washing out, deep towards turbine. Vegetation cover is overall appropriate. Species observed: field bindweed, lambsquarter, foxtail barley, smooth brome, quack, sweet clover

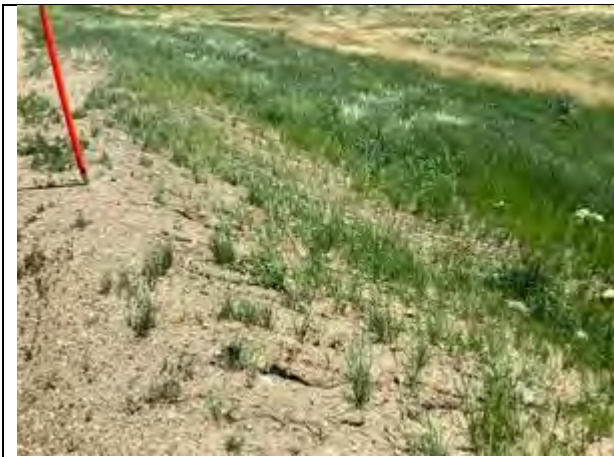
Photo Description: Reseeding slope recommended. Road to east eroding. Other areas road right-of-way has acceptable vegetative cover.

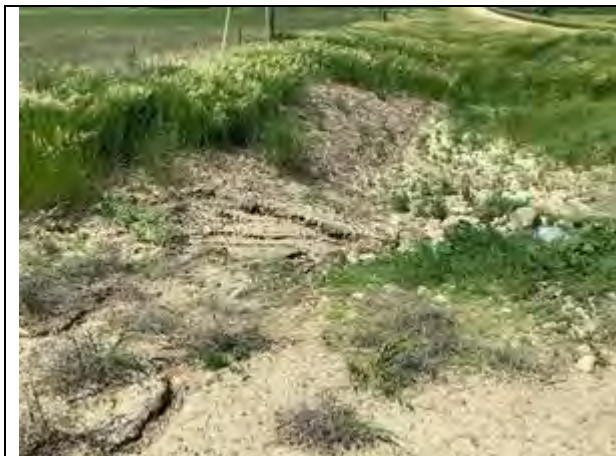
Observation Point: 43

Photo Description: Lack of vegetation and erosion of road material into ditch. The rock enforcement has also washed out. Recommend addressing.

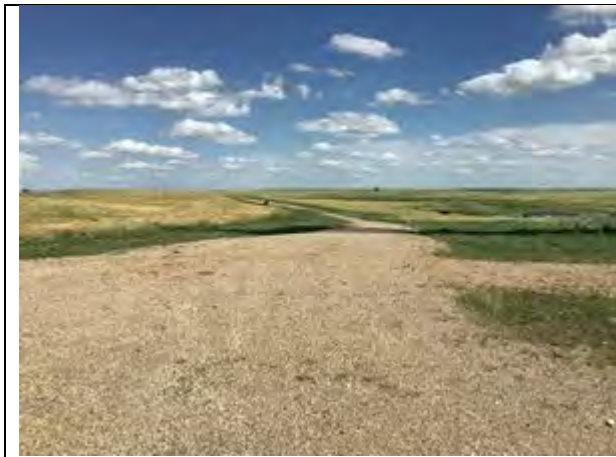
Observation Point: 48

Photo Description: Adequate vegetation cover. Seeded grass, too small to confidently identify. Observed common species are ragweed, brome, and quackgrass.

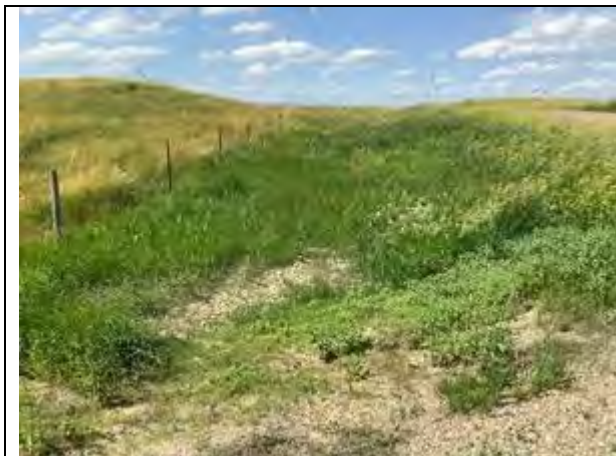
Observation Point: 49

Lastly, the ND noxious weed Canada thistle was observed at **Observation Point 49**.

Photo Description: Noxious weed (Canada thistle) present. Overall appropriate vegetive cover but a lack of seeded species as ragweed and sweet clover was observed.

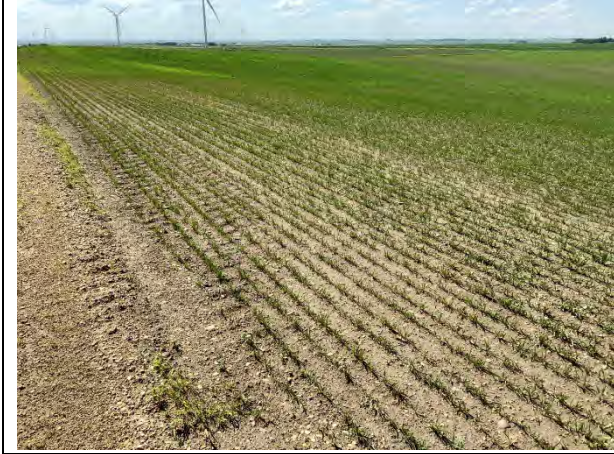
Photo Description: Excellent crop growth along access road. No visible signs of stress. Soybeans were planted through T-70 pad.

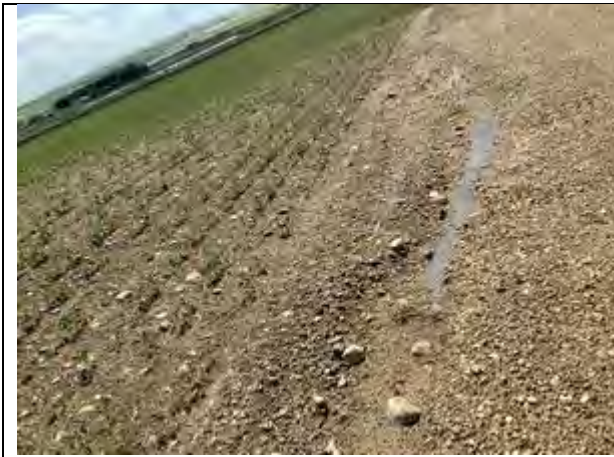
Photo Description: Erosion of access road downslope unaddressed, but adequate crop growth along access road.

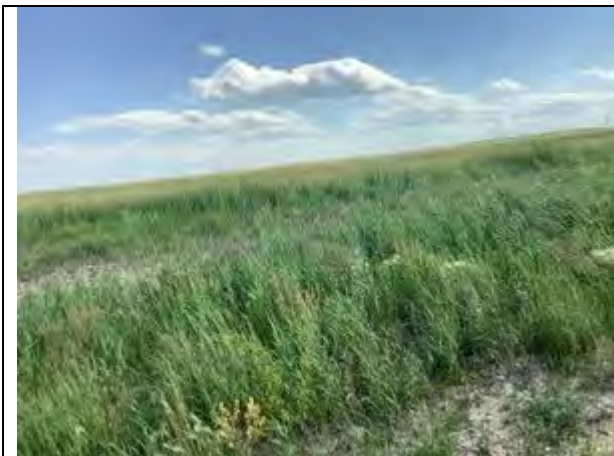
Photo Description: Unvegetated area from last visit is now under 60% vegetation cover (of non-seeded vegetation), recovering to surrounding area.
