THE FALKIRK MINING COMPANY
2801 1st St. SW
P.O. Box 1087
Underwood, ND 58576-1087
(701) 442-5751 • Fax (701) 250-2473

April 7, 2009

RE: Interim Measures for Notice of Violation No. 0901

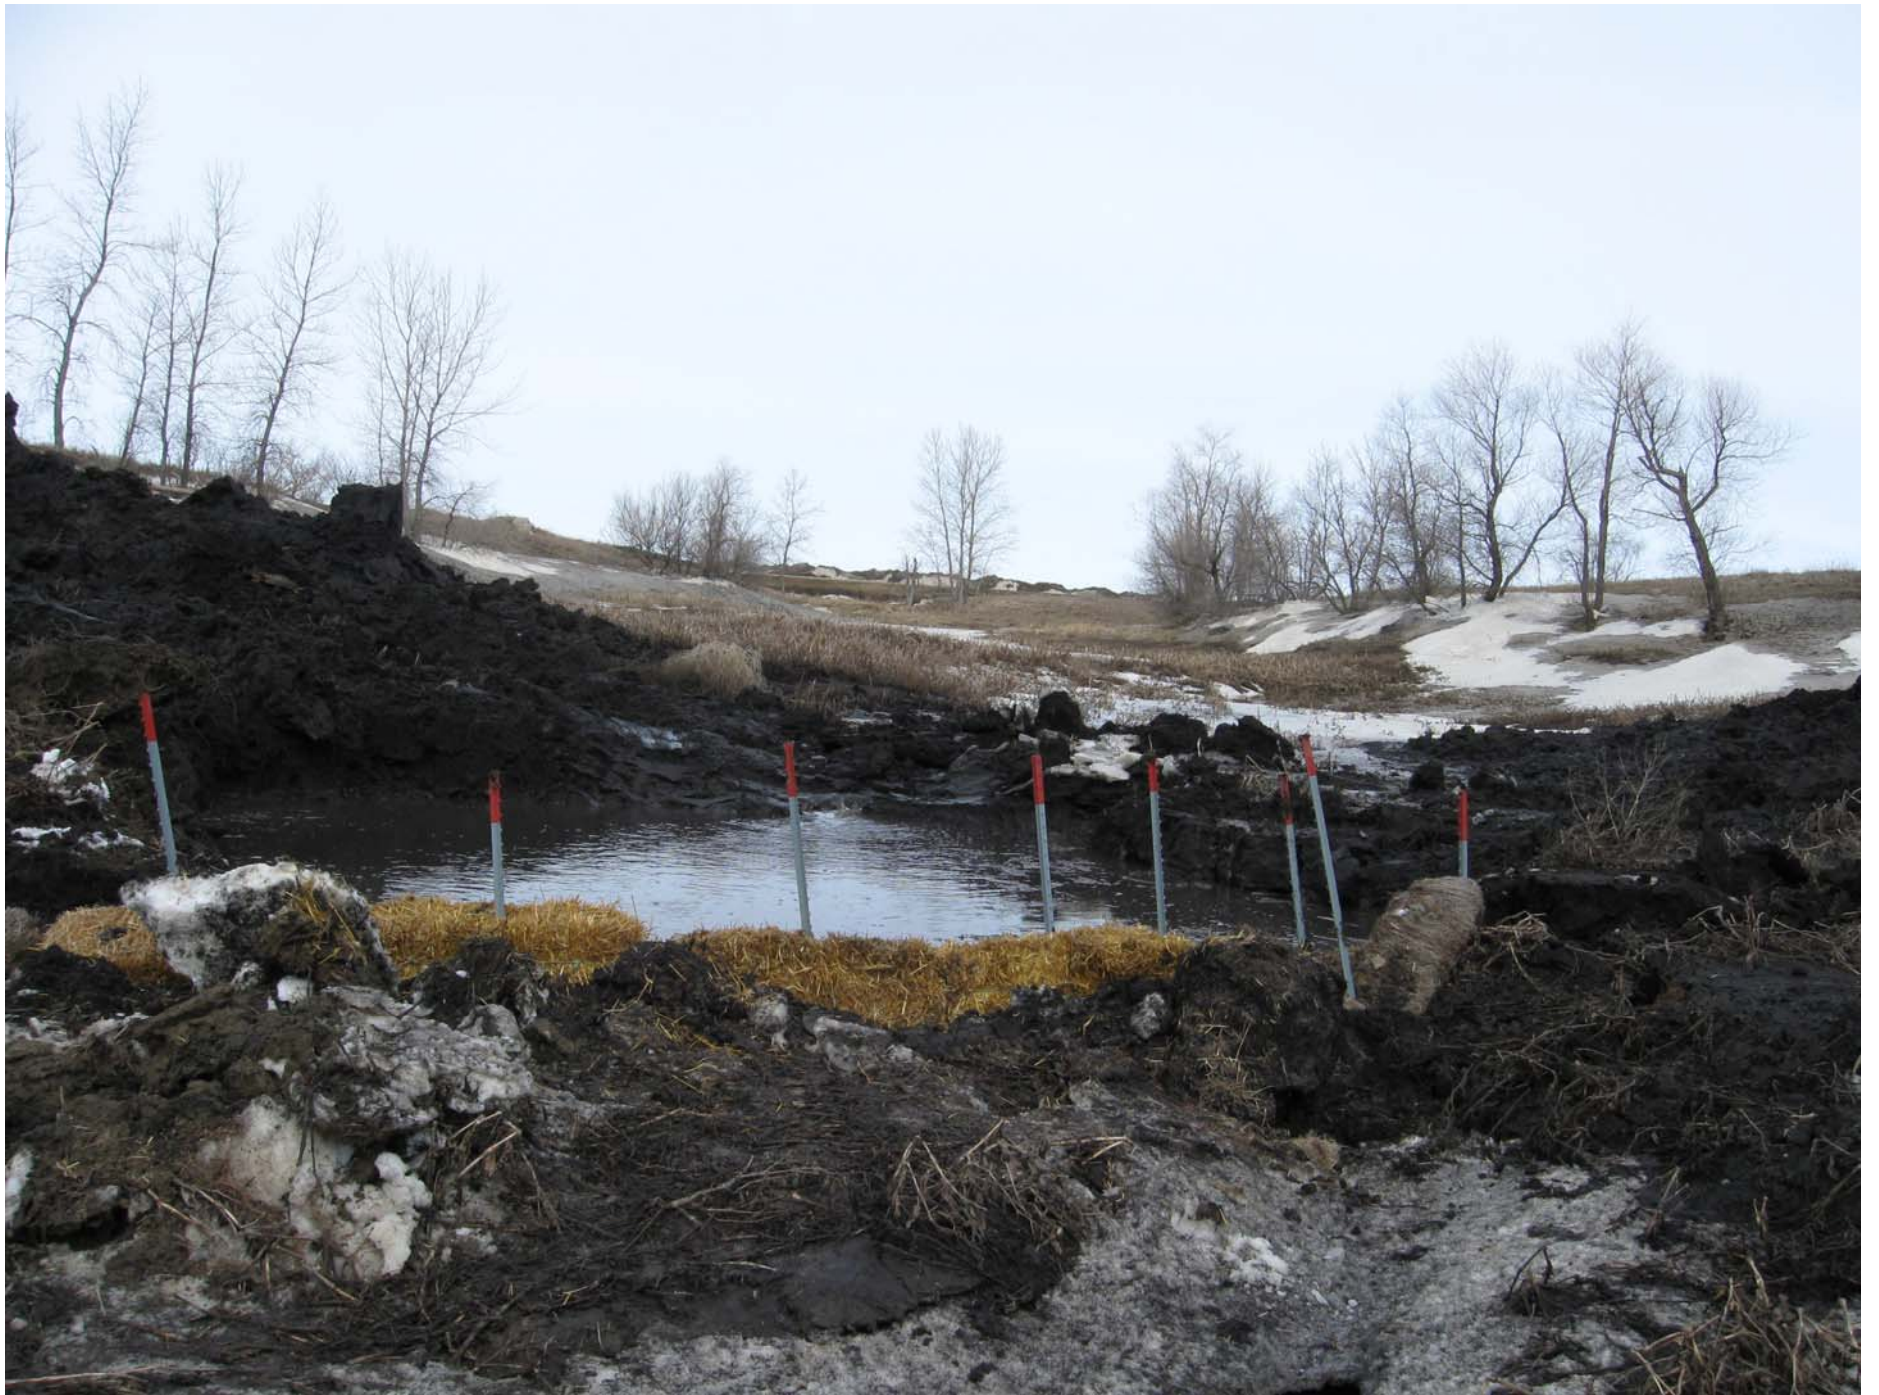
On April 4, 2009, a sump was excavated with a backhoe in the basin of a Pre-Mining Stockpond, SP-SW13-1, located immediately upstream of Sedimentation Pond P-E13-01 (refer to attached photo #1). The embankment of this stockpond was removed during the construction of Sedimentation Pond P-E13-01. A bale dike was installed on the downstream side of the sump

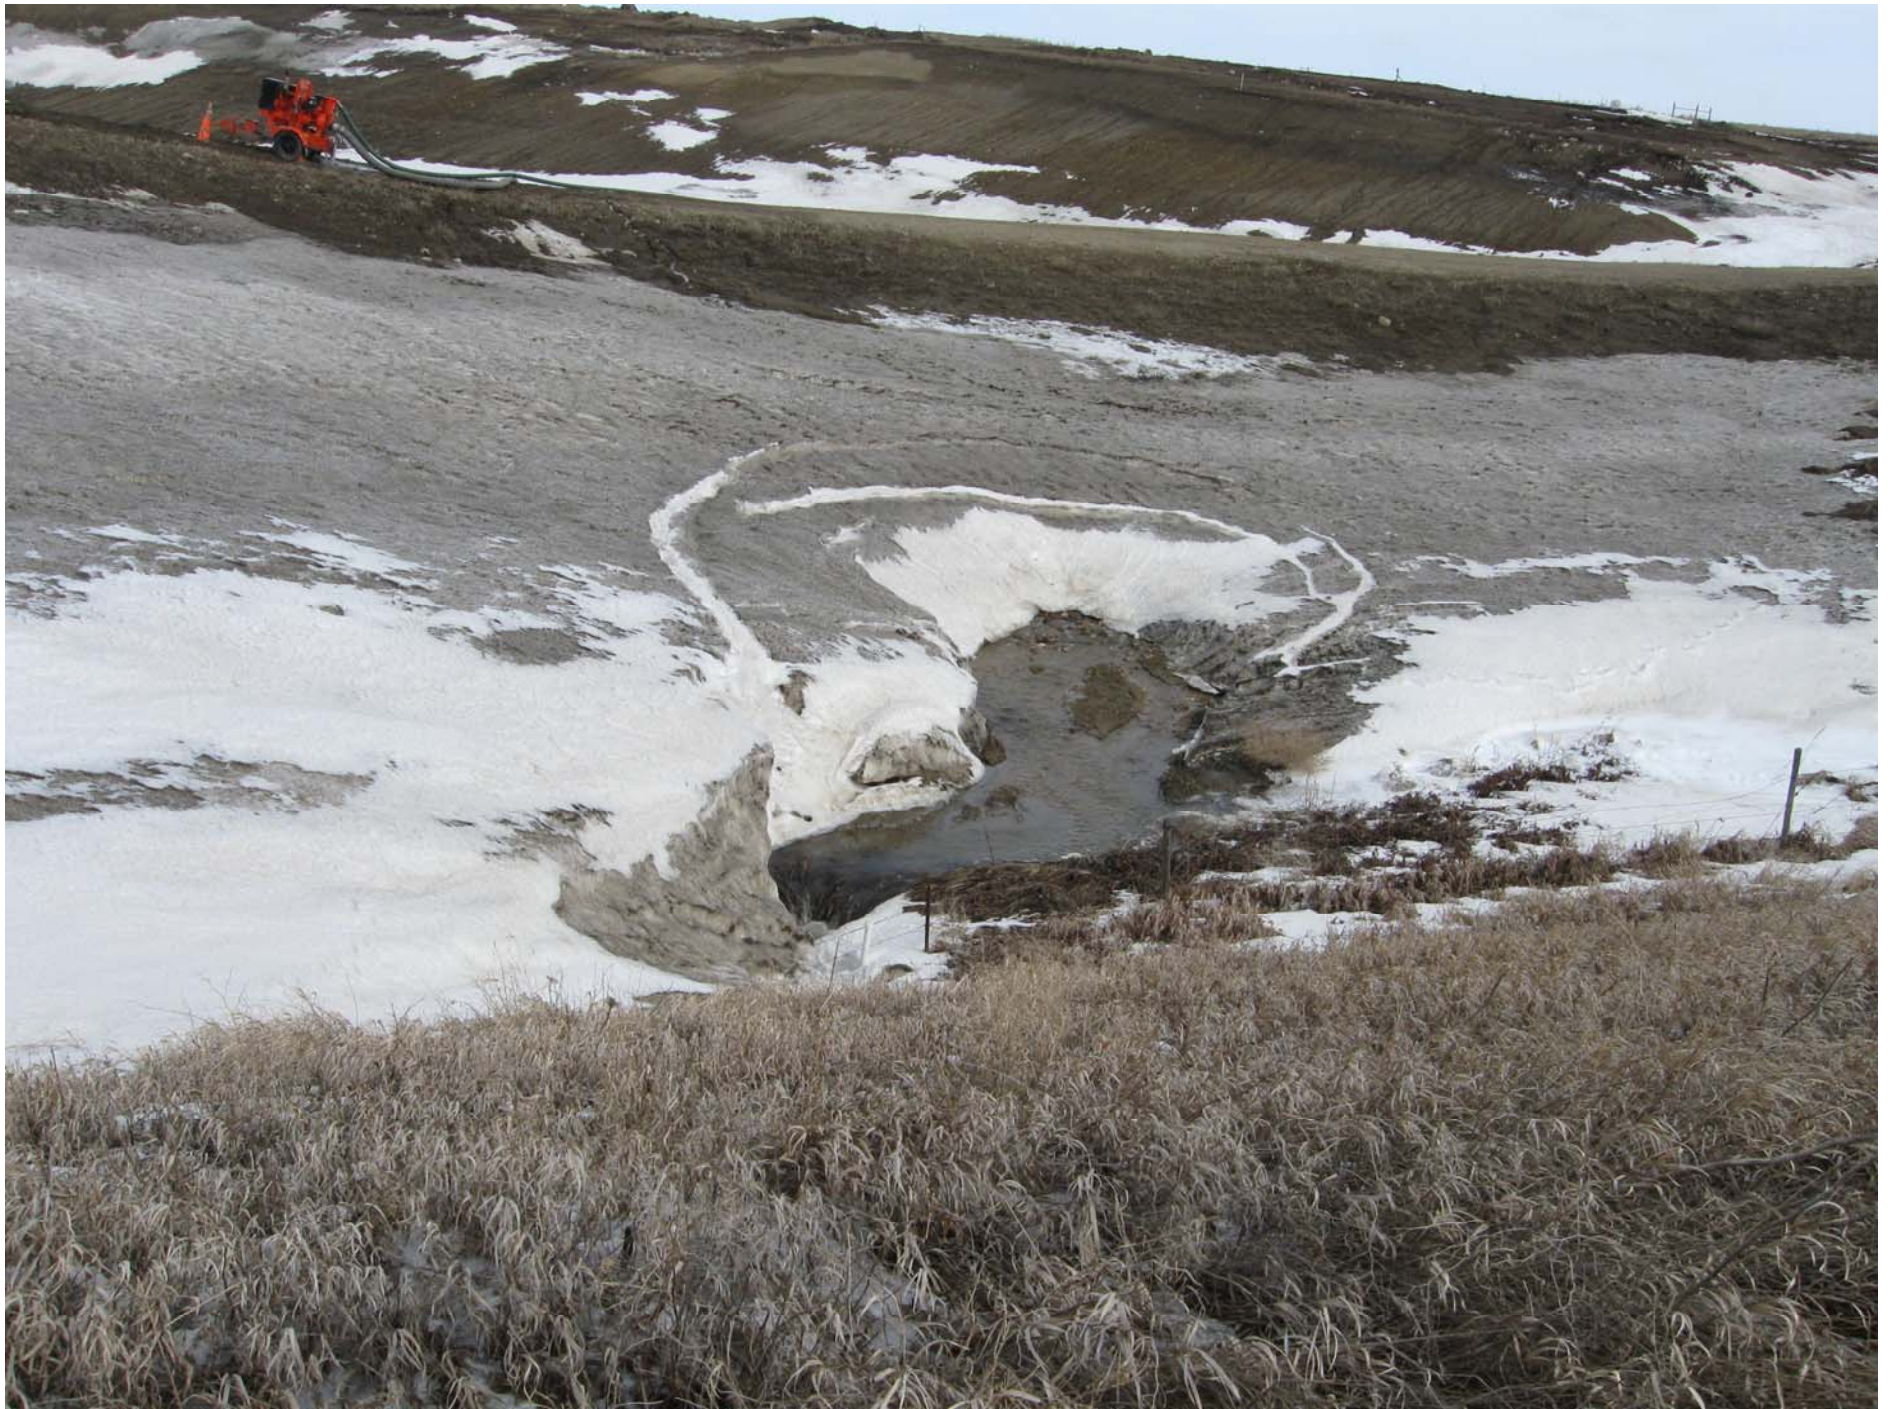
as shown on the attached photographs of the sump. An additional silt fence will be installed on the downstream side of the embankment once the snow has melted (refer to attached photo # 2).
