# Public Service Commission

### INSPECTION REPORT

PERMITTEE - MINE: Falkirk Mining Company - Falkirk Mine

Sediment Pond P-E13-01, Permit NAFK-8405, and drainageway below the pond

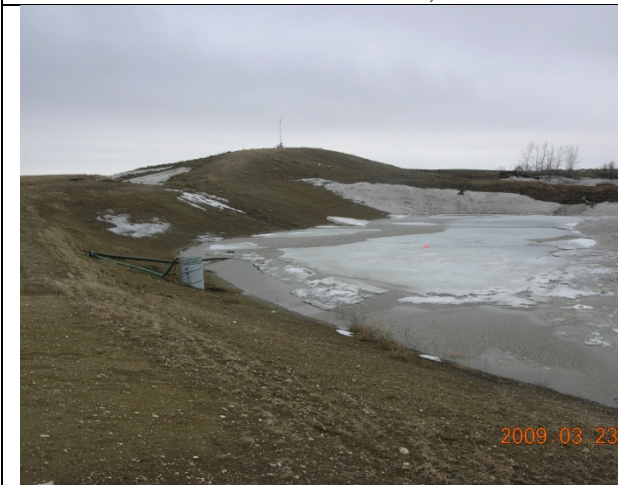
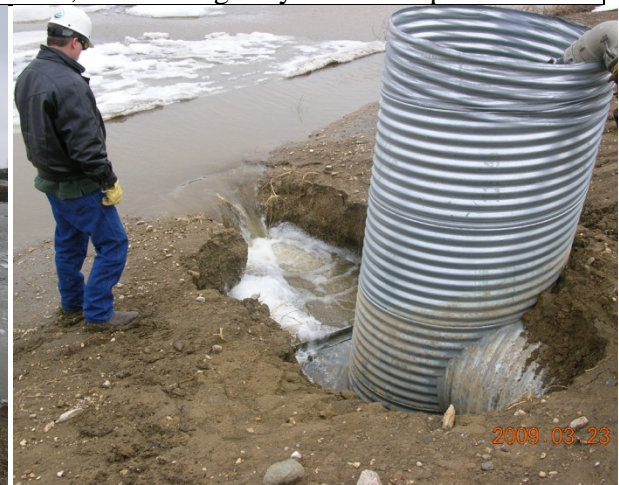
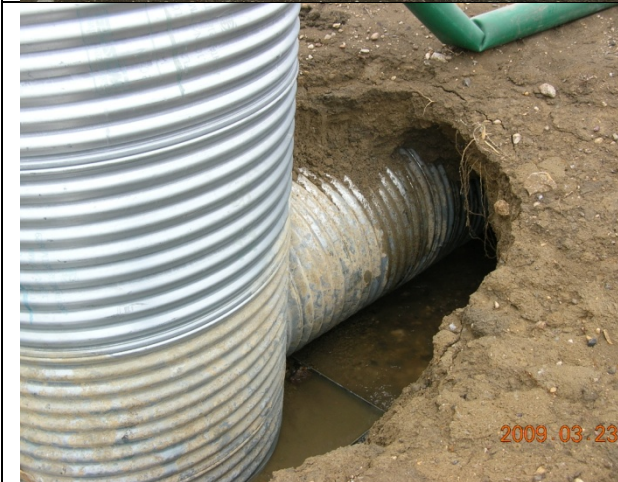
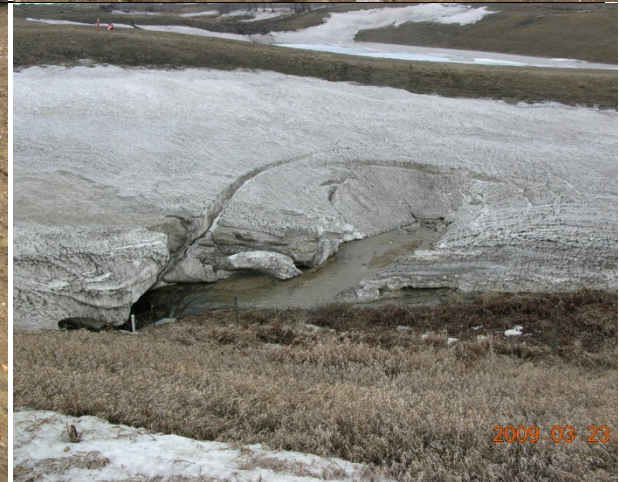
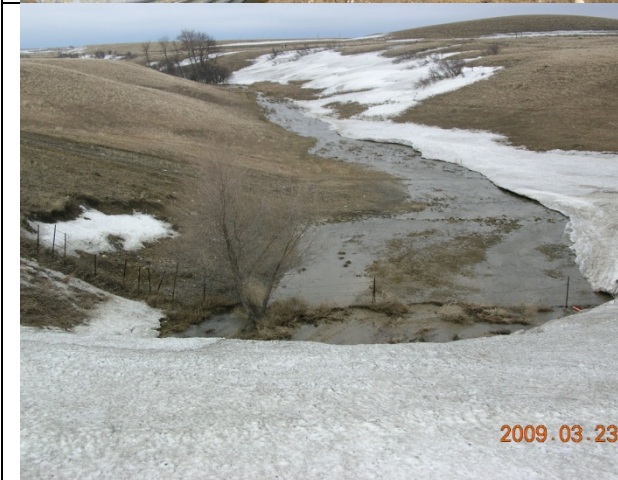
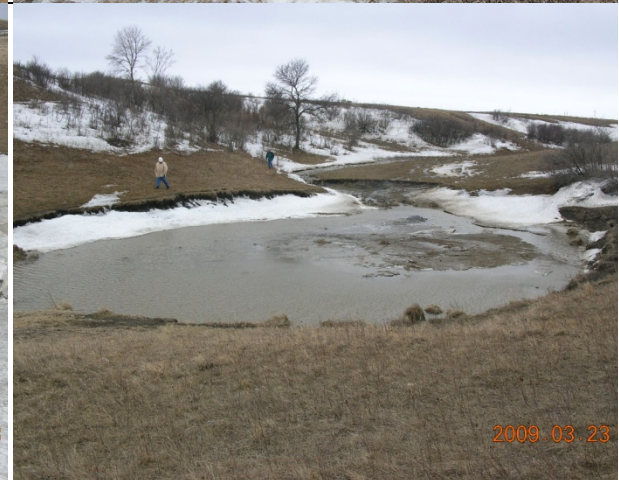
It was readily evident that the embankment fill material had washed away from around the drop inlet spillway. The breach in the embankment on the upstream side of the embankment was approximately 4 feet in diameter. The downstream side of the embankment could not be seen due to an accumulation of snow. The pond was holding water approximately 1.5 feet above the bottom of the riser, or approximately 6 feet above permanent pool elevation (PPE). The PPE marker was not seen, presumably it is under water. There were still considerable inflows into the pond from the melting snow within the watershed.

At the time of the inspection, the discharge through the breach was estimated at about 2000 gallons per minute. The discharge flows downstream from the pond approximately 50 feet before entering a culvert under Highway 200A. The runoff then traveled down an undisturbed natural drainageway into Coal Lake, located approximately one mile to the south. The permit boundary is about one-half mile downstream from the pond.

There was a thin (approximately 1/8" thick) layer of sediment deposited on the bottom of the drainageway where the discharge water from the pond had passed. In a few small areas, less than 100 square feet in size, it appeared that deposition of materials was greater than 1" but less than 2" in depth. A thin layer of sediment also was noted on the snow drifts in the drainageway where water had accumulated while breaking a path through the snow. A dugout pond is located in the undisturbed drainage channel approximately 1350 feet downstream from Pond P-E13-01. There was also a deposition of sediment on the ice of this pond. A head cut in the drainage immediately above the dugout pond is not attributed to the pond discharge, but it may have been enlarged from high flows. The downstream drainage channel was inspected to a distance of approximately 200 yards beyond the dugout.

Pumping water from the sediment pond to minimize or eliminate additional erosion through the embankment was discussed with Falkirk and Mr. Kowalski. It was agreed that the pond should be pumped down as much as possible to allow for storage of additional runoff. The water is to be pumped through the riser of the pond as a plunge pool exists at the outlet of the spillway. Since there apparently was no storage room in the adjacent sediment ponds, the discharge will be treated as an overflow. The immediate forecast at the time of the inspection was that the area could receive 1 to 2 inches of additional precipitation in the form of rain and snow.
