THE FALKIRK MINING COMPANY
2801 1st St. SW
P.O. Box 1087
Underwood, ND 58576-1087
(701) 442-5751 • Fax (701) 250-2473

April 14, 2009

RE: NOV 0901 Investigation Report for Impoundment P-E13-01

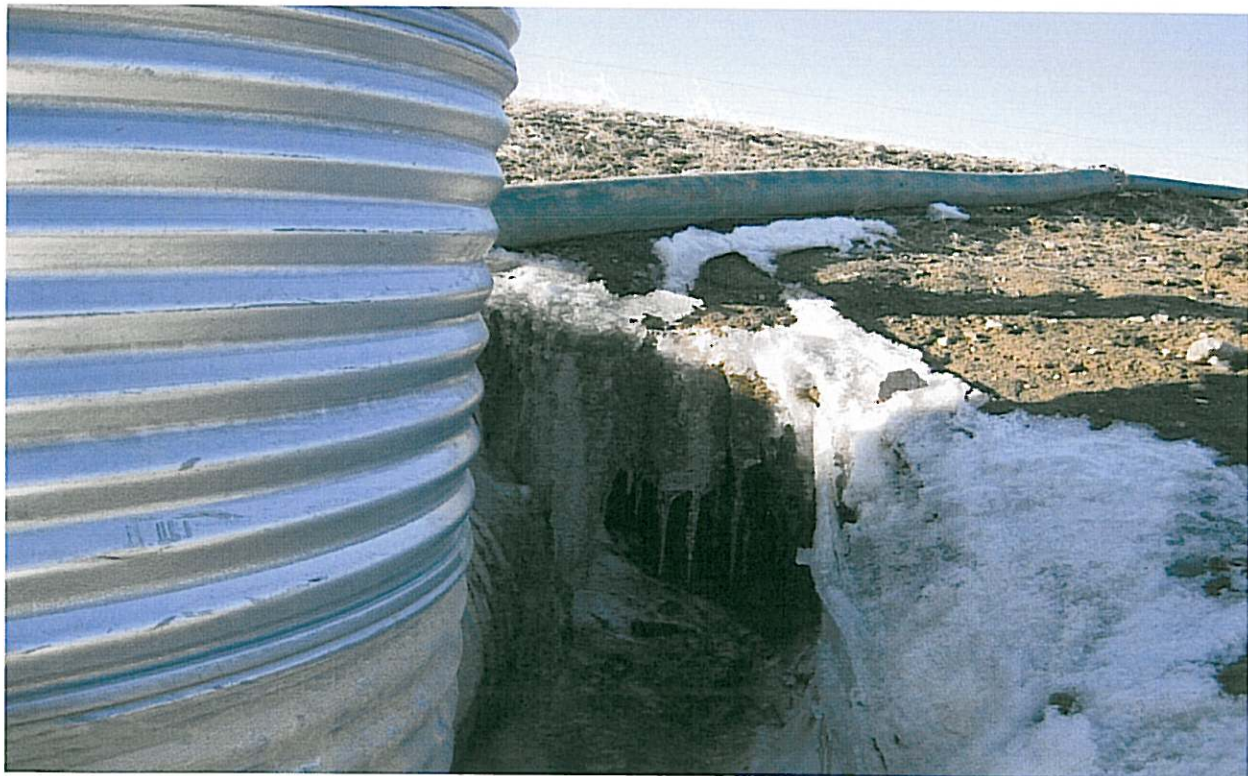
The exact cause of the piping feature is difficult to discern, as we have not been able to clearly link the failure with some obvious shortcoming of construction or the materials utilized. The failure likely can be attributed to either the properties of the fill material that was placed along one side of the spillway barrel, the degree of compaction of the fill material, or a combination of both.

The subsoil material used as embankment fill was classified as sandy lean clay which is a common material used to construct pond embankments. The subsoil material placed along the barrel of the emergency spillway may have had a higher content of sand and gravel than normal which could have contributed to the development of the piping feature. It is not uncommon to periodically find sand and gravel lenses within subsoil borrow areas, but this type of material is usually placed on a subsoil stockpile. If this type of fill material was visually similar to surrounding borrow material and compacted in a similar manner, it is possible that a fill material

A second factor is the degree of compaction of the subsoil material along and under the haunch of the spillway barrel. Emergency spillway barrels present a challenge in regards to achieving a similar level of compaction as compared to the embankment. If backfill material is not placed under the haunches and adjacent to the barrel and compacted to the same degree as the remainder of the embankment, this can result in a potentially weak zone of fill that can be more susceptible to erosion. This may have been another factor contributing to the development of the piping feature.

The riser and barrel of the emergency spillway were placed on virgin ground after the topsoil was stripped. The base of the piping feature follows the virgin ground adjacent to the barrel. The piping feature is approximately 2.5 feet in diameter as shown in Photo #1. Water tight bands were used at each barrel joint to prevent seepage at each joint. This was not a factor in the failure as no discharge occurred through the spillway before the development of the piping feature. The piping feature developed on the upstream face of the embankment as the pond filled within four inches of discharging through the emergency spillway.

Photo #1- Piping feature on upstream slope of embankment.

The Falkirk Mining Company requests an extension to repair the pond embankment from 45 days to 90 days. This request is being made considering the current conditions of the mine-site. With a late spring, wet conditions, and frost still in the ground, suitable fill material isn't readily available to repair the embankment. Falkirk will repair the embankment as soon as conditions allow. During the repair of the embankment, the impoundment construction guidelines will apply and Midwest Testing Laboratory, Inc. will be onsite to perform compaction testing.
