# **Bison I Wind Facility Post-Construction Inspection Report PU-09-151**

## **NORTH DAKOTA PUBLIC SERVICE COMMISSION**

## **WENCK ASSOCIATES, INC.**

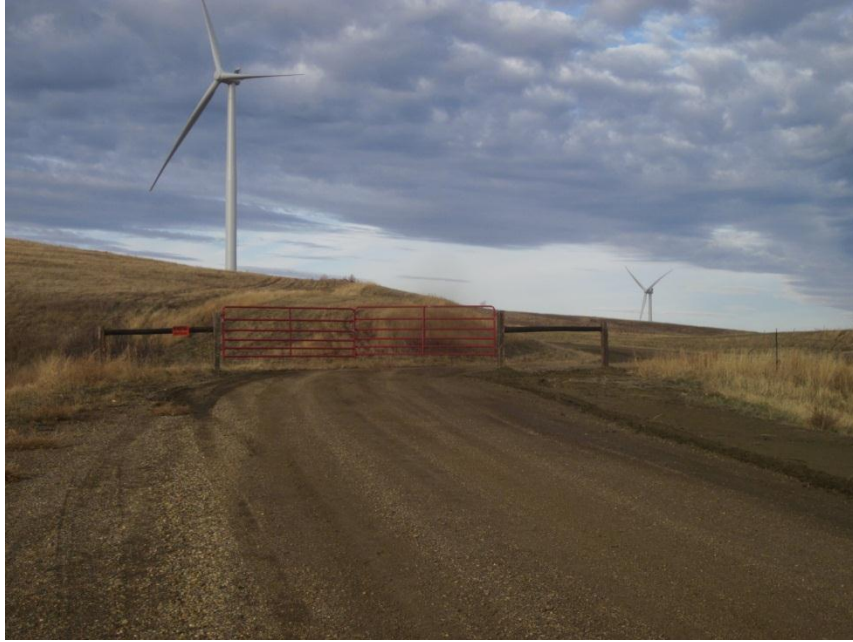
**Photo 1.** Direction: West. Access road and cattle guard for Structures 30, 2, 10, 1, and 27; Structures 30 (left) and 2 (right) are shown here. The access road was well maintained, and road margins appeared to have been reclaimed with native species successfully.

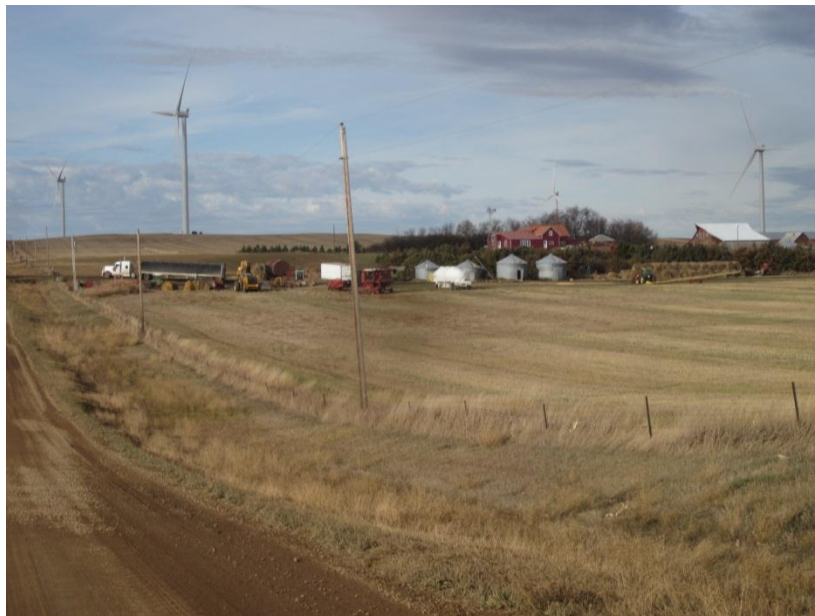
Most of the areas of the Project which had been disturbed during construction appeared to be properly restored (**Appendix A, Photo 2**). During the construction inspection, Wenck noted that all county roads and highways within the Project area appeared to be in good condition and properly maintained. The gravel pads surrounding the tower structures were all well-maintained and in excellent condition (**Appendix A, Photos 3, 5, 12**). They appeared to have been constructed properly. There was no soil slumping or settling, no open trenches, and no areas of erosion. Crops were planted as close as possible to the tower bases. None of the crops showed visible signs of poorer production or vigor, which would indicate improper topsoil replacement. Also refer to Section 3.5.6 Reclamation and Reseeding.

**Photo 2.** Direction: Northwest. Laydown yard that had been reclaimed by Minnesota Power and put back into cropland by landowner.

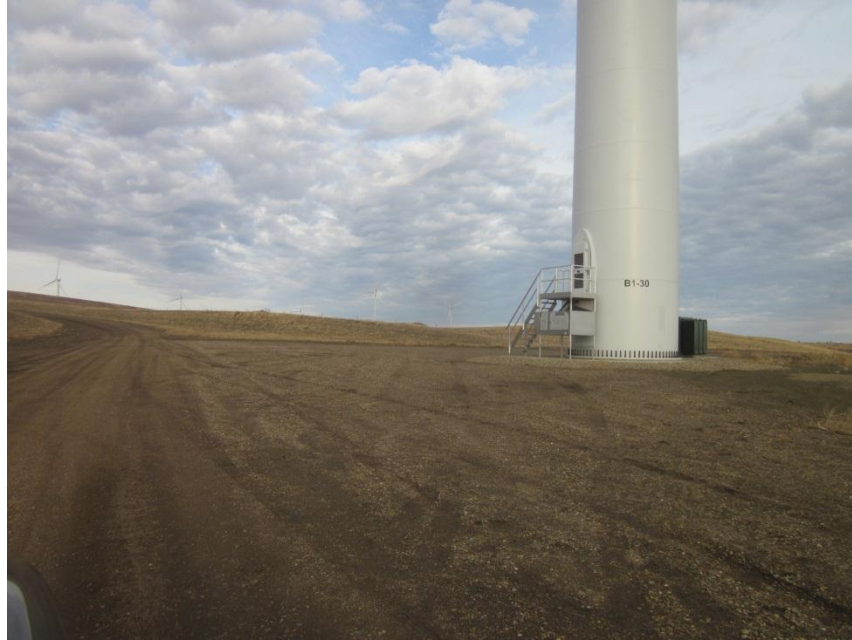
**Photo 3.** Direction: Northwest. Typical turbine pad and turbine for the project; Structure 1-30 is shown here. The gravel pad was well maintained and free of noxious weeds.

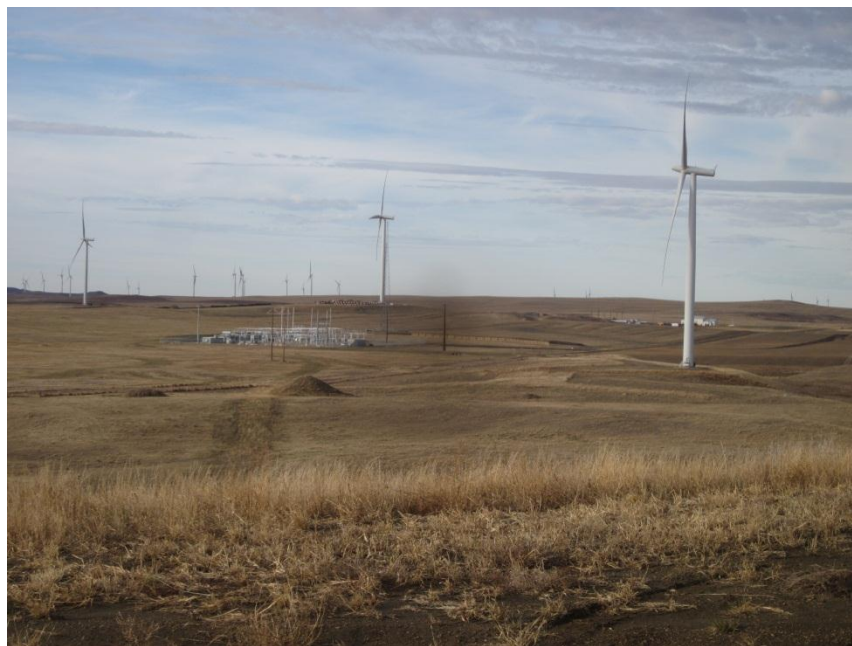
**Photo 4.** Direction: Southwest/West. Substation, operations and maintenance yard (buildings seen behind the turbine on the right) and, from right to left, Structures 18, 5, and 14. A restored feeder line scar is also shown here going towards the substation.

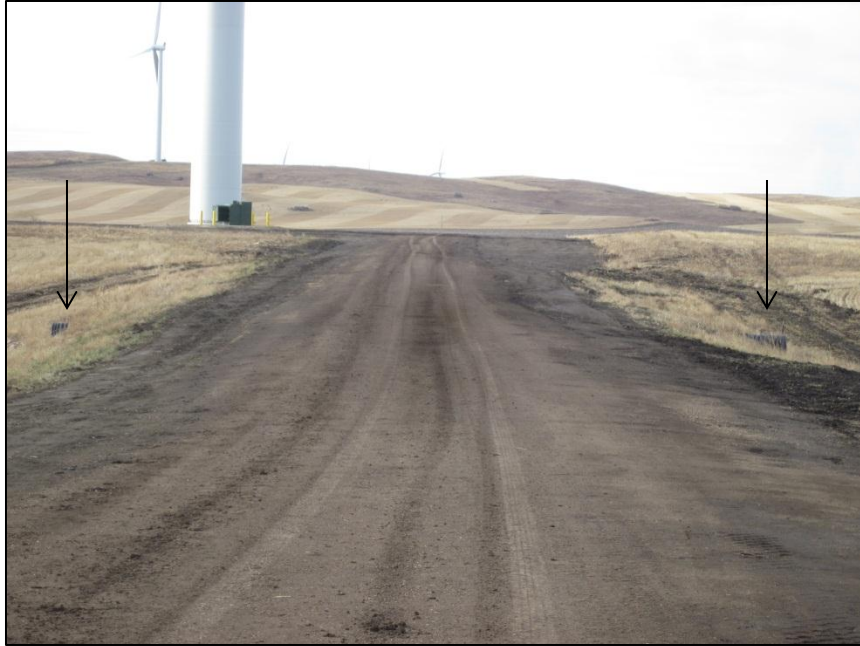
**Photo 5.** Direction: South. Access road to Structure 28. Note culverts in place along roadway (black arrows).

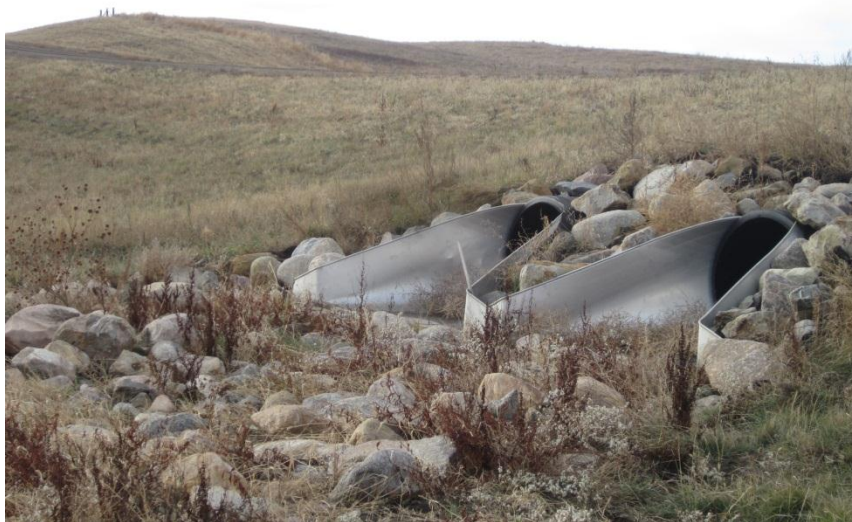
**Photo 6.** Direction: Southwest. Culverts installed along access road to Structure 26.

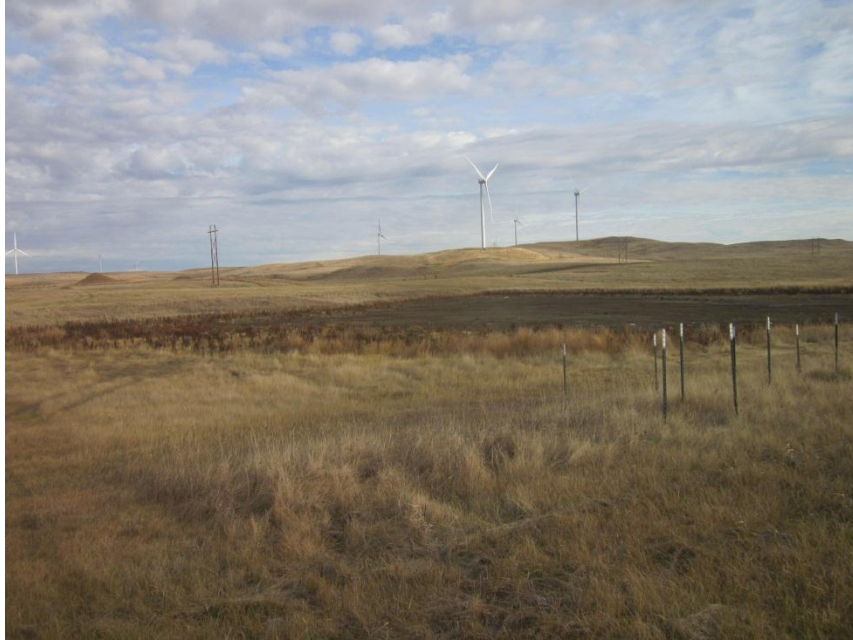
**Photo 7.** Direction: Northeast. Wetland mitigation site and tree and shrub mitigation site for Bison 1A. Planted trees are indicated by green fence posts (right).

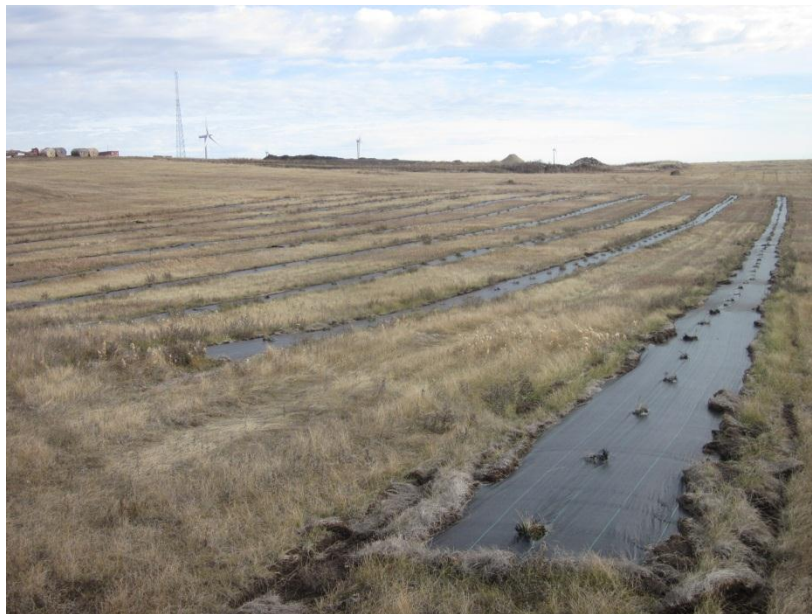
**Photo 8.** Direction: South. Tree and shrub mitigation site for Bison 1B. Tree and shrubs appeared to be well established, but given the timing of the inspection (late fall after leaf drop), no estimate of survival was documented.

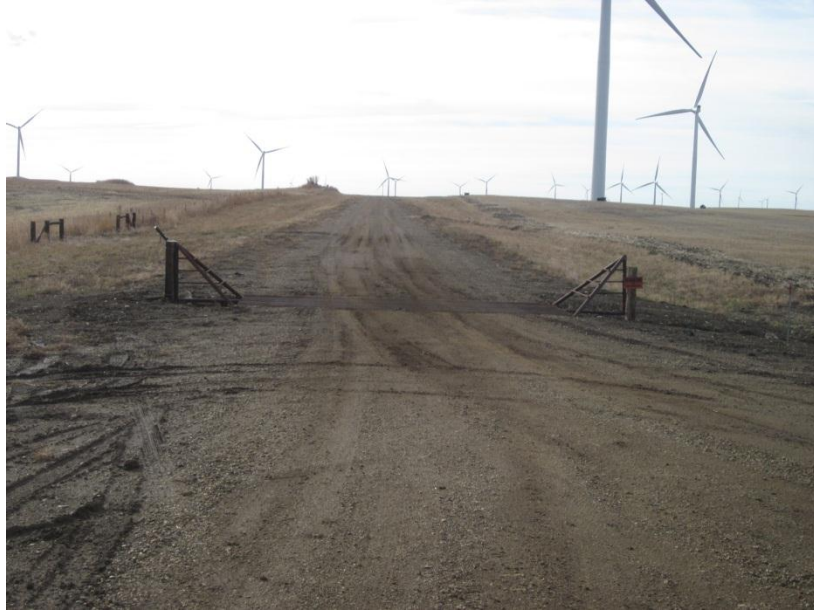
were installed at the gates when necessary (**Appendix A, Photo 9**). Minnesota Power reported there had not been any agricultural fields with drainage tile impacted by construction of the Project. There was no waste, debris, or abandoned equipment observed during the inspection. The site appeared to be regularly maintained and no remnants of the construction phase were noted. Several weekly construction reports documented cleaning up waste and debris around the Project site (Docket #65, 87).

**Photo 9.** Direction: South. Cattle guard installed along access road.

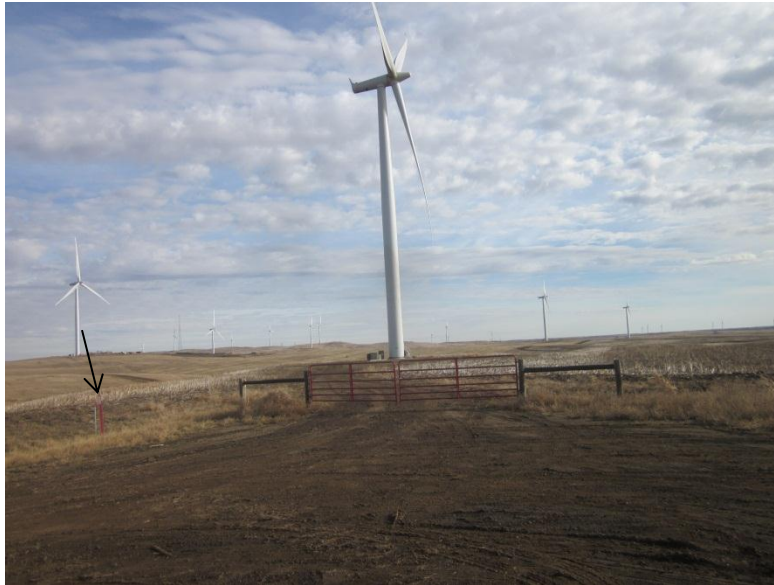
**Photo 10.** Direction: Structure 32 with associated access road, gate, and feeder line marker (black arrow).

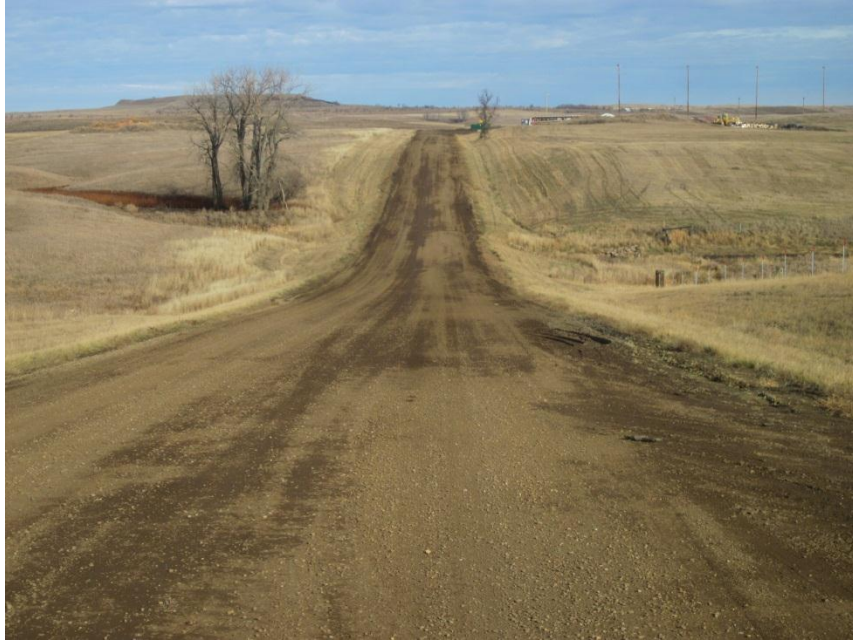
**Photo 11.** Direction: North. View of 52<sup>nd</sup> Ave, which had been improved by Minnesota Power and was currently in good condition and well maintained. This was typical for roads in the project area. Reclamation of the road margins was successful, as evidenced by establishment of vegetation.

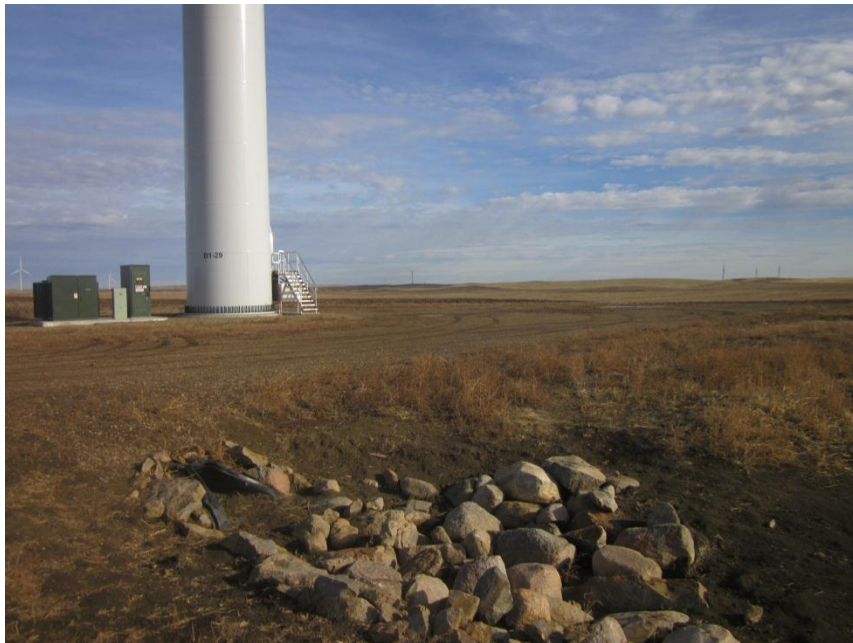
**Photo 12.** Direction: South. Structure 29 with associated culvert.
