Public Service Commission

INSPECTION REPORT

DATE OF INSPECTION: April 14, 2009

PERMITTEE - MINE: Dakota Westmoreland - Beulah Mine

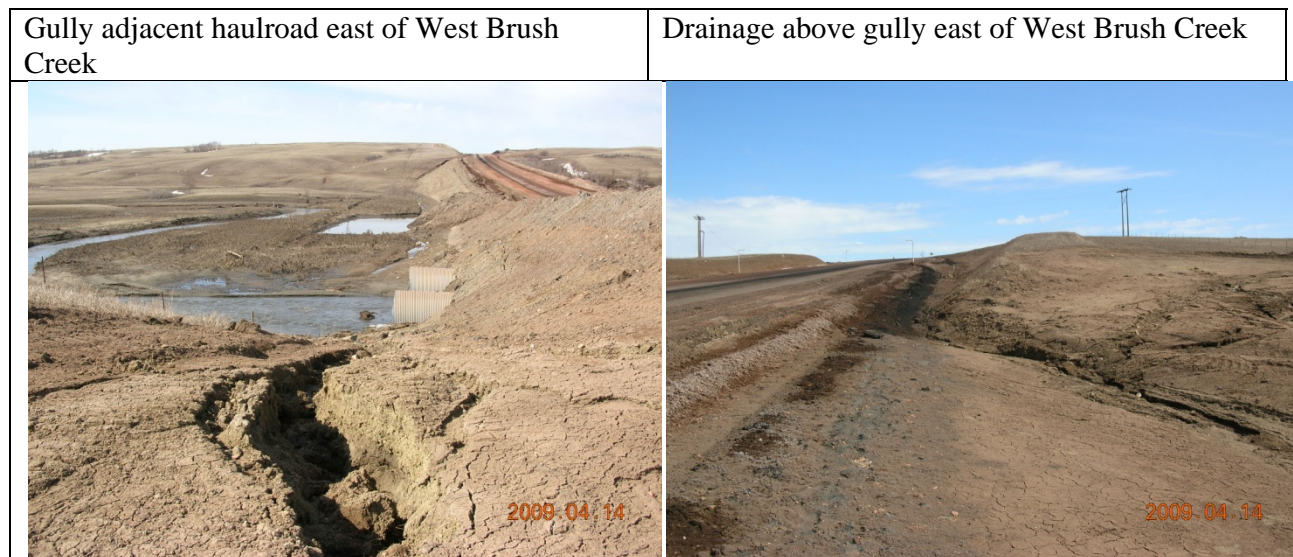
An erosion gully was noted along the south side of the haulroad located immediately east of West Brush Creek. This feature is located on a steeper portion of the slope below a rock check dam. The gully is about 1-2 feet wide and 1.5 feet deep and runs a length of about 30 feet. The runoff from this site (haulroad and ditch) goes directly into West Brush Creek. Mr. Frohlich indicated that there was a sump above the rock check dam, but the sump had filled with silt and runoff passed around the north side of the rock check dam. This area drains a portion of the haulroad to the east and a small portion of an area stripped of SPGM for the dragline trail. The south side of this haulroad was widened last fall to accommodate the dragline. There was no evidence that the disturbed area had been mulched and the single rock check dam and sump were the only BMP's noticed. The slope below the rock check dam should have been stabilized with erosion control fabric or other BMP's. This issue will be further evaluated to determine if a violation is warranted. Photographs of the area were taken and are on file. A few are shown below.

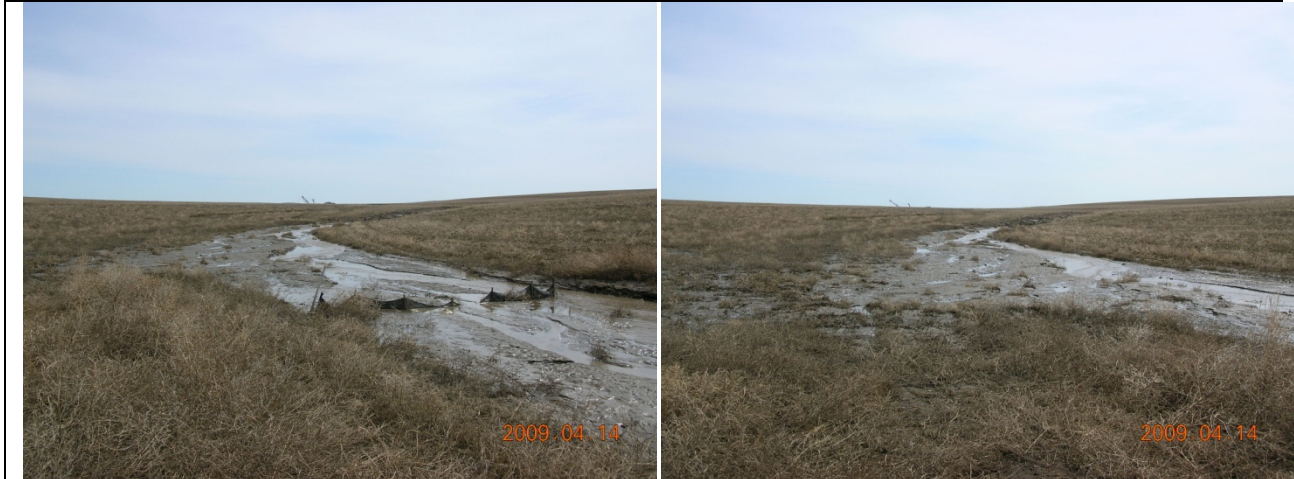
The drainage channel in the SW¹/₄ of Section 13, where runoff from the Orange Pit spoil flows to sedimentation Pond 52, was inspected. Reclaimed land lies on both sides of the drainage channel on a portion of this area and it appeared that runoff from the Orange Pit spoils has passed over reclaimed land in this area. There appeared to be a layer of gray colored deposition on the reclaimed lands located immediately north of the channel. The deposition appeared to extend a distance about 200 feet north of the drainage on reclaimed land. The ground was too soft and muddy to allow one to

walk to the area where it appeared sediment deposition had occurred. Water was flowing through the drainageway as intended and it was passing through a silt fence in the drainageway. It appears that the silt fence, when functioning properly might have backed water onto the adjacent reclaimed lands or perhaps the snowmelt runoff from the Orange Pit spoils was greater than the drainageway could handle. This area will need to be more closely inspected when conditions dry out and allow access to the area to determine if appropriate BMP'S are in place at the interface between the graded spoil and reclaimed areas. Photographs of this site are on file and a few are shown below.

Drainageway in SW¼ of Section 13, Permit KRSB-8802. Sediment deposition on reclaimed lands.
