Public Service Commission State of North Dakota

INSPECTION REPORT

DATE OF INSPECTION: May 29, 2009

PERMITTEE - MINE: Falkirk Mining Company - Falkirk Mine

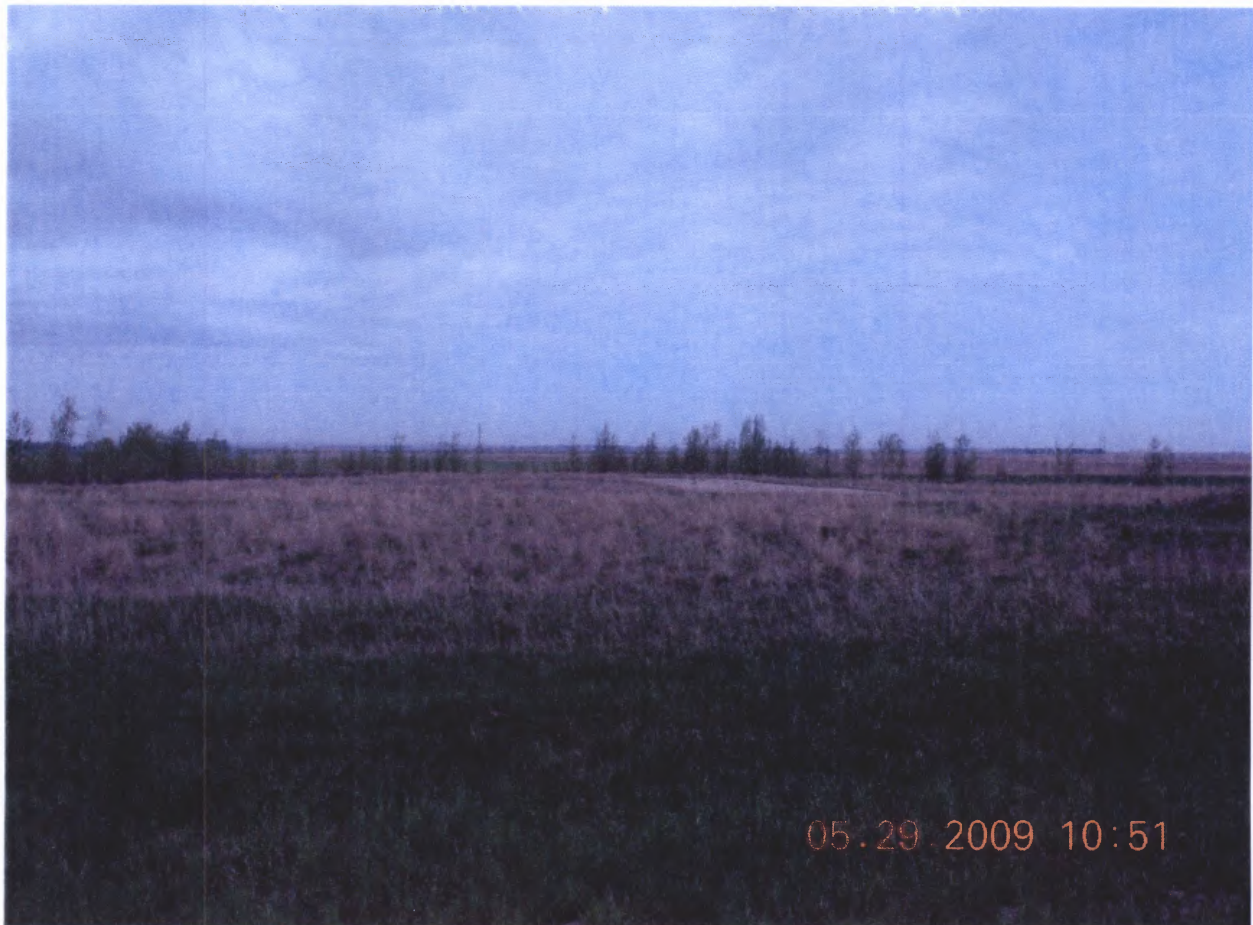
The site of the former dragline erection site in the SE $\frac{1}{4}$ of Section 22 in Permit NAFK-8705 was visited to determine its status. All equipment has been removed and only the cement slab remains. Grasses and weeds are growing over the site (Figure 1 below).

Figure 1. The former dragline erection site in Section 22 of Permit NAFK-8705.
