# Bison I Wind Project Transmission Line Post-Construction Inspection Report PU-09-587

**NORTH DAKOTA  
PUBLIC SERVICE COMMISSION**

**WENCK ASSOCIATES, INC.**

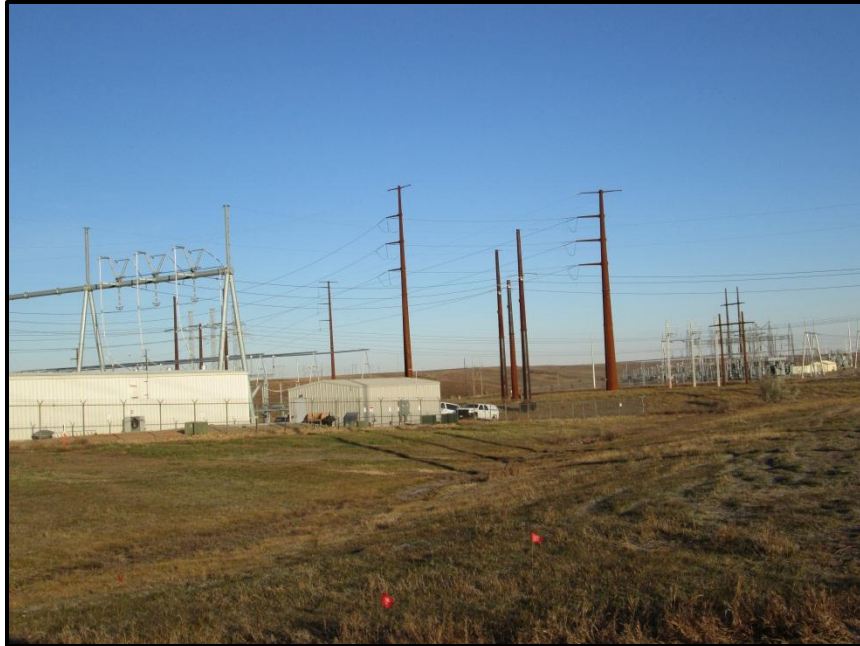
**Photo 1.** Direction: North/Northwest. View of the transmission line (monopole structures) on the east end of the route at the Square Butte substation.

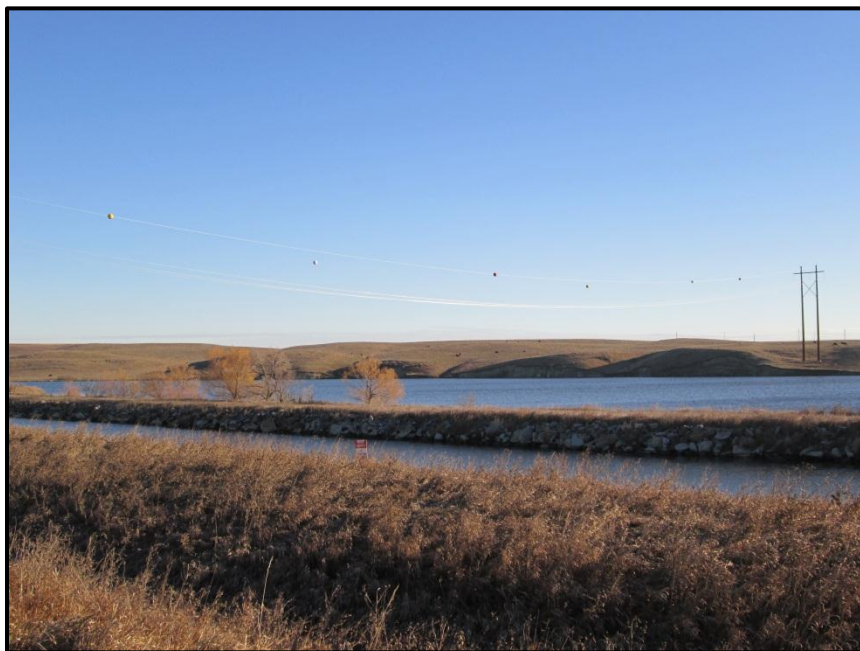
There were several areas along the transmission line route that crossed wetland areas (**Figure 1; Appendix A, Photos 2, 4, 5-7**). It did not appear that vegetation along most wetland margins had been disturbed; in one area, a structure was located within an intermittent drainage way (**Appendix A, Photo 6**), but Minnesota Power indicated that appropriate permits were filed and a mitigation wetland was created (**Appendix A, Photo 10**). The mitigation wetland was created to offset impacts from construction of the transmission line and construction of access roads for the Bison 1 Wind Project (PU-09-151). The mitigation wetland was created just to the east of the Bison 1 Substation. No copies of the U.S. Army Corps of Engineers permits were on file; however, no impacts were observed to surface drainage or groundwater flow patterns. It did not appear that any machine clearing or disturbance of vegetation occurred near rivers or streams. No Waterfowl Production Areas were located within the project corridor. It appeared that construction of the Project avoided impacts to wetland areas as specified in the Application.

**Photo 2.** Direction: Northeast. View of the transmission line as it crossed Lake Nelson. Bird diverters were installed on the transmission line around the lake.

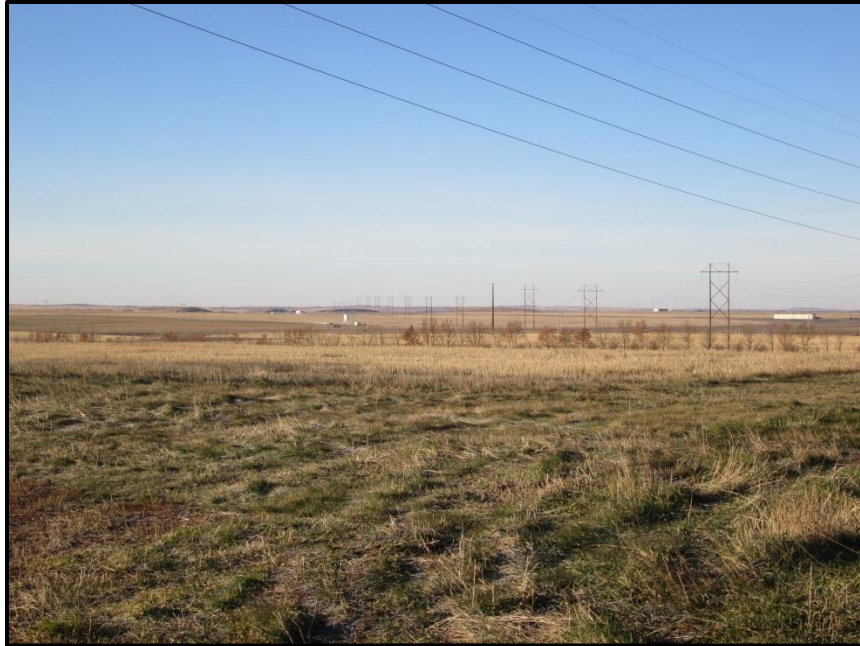
**Photo 3.** Direction: Southwest. View as the transmission line veered from a generally east/west route to a southwest/northeast route near the existing BNI Center Mine.

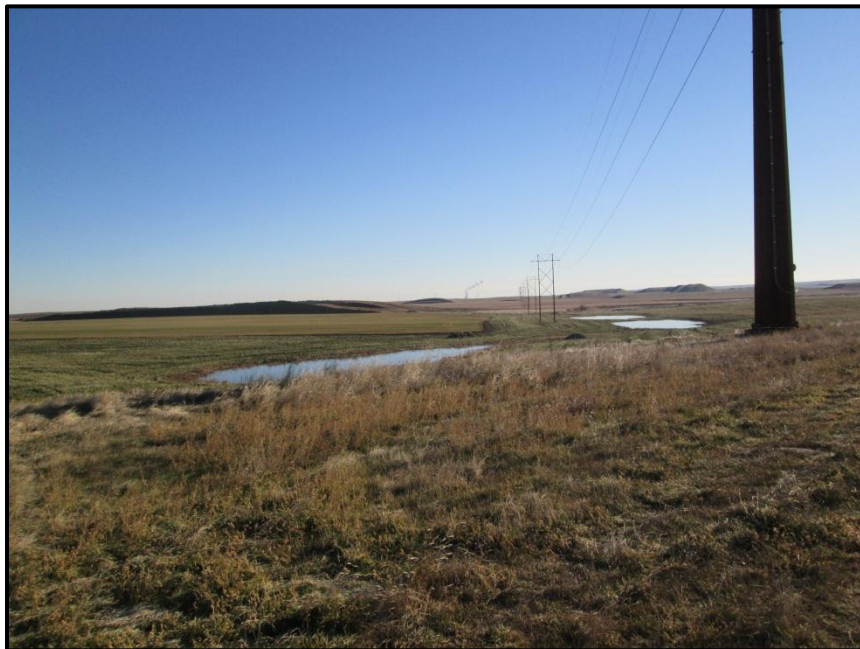
**Photo 4.** Direction: East. View of the transmission line as it spanned a wetland area west of the Center Mine. The transmission poles were in upland areas and no construction-related disturbance to the wetland was noted.

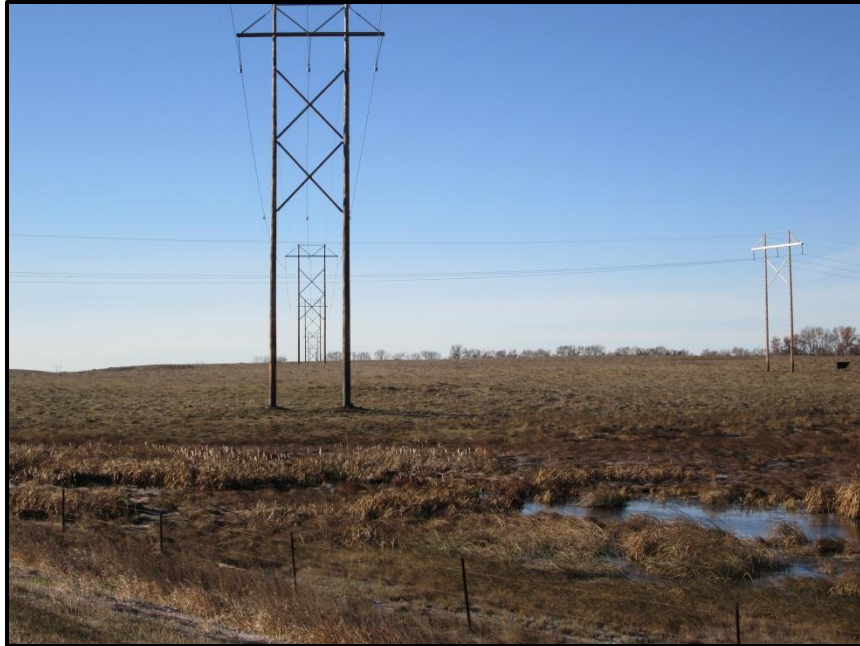
Construction activities appeared to have had minimal disturbance; only minor reclamation would have been necessary around structure bases. It was not clear if reseeded had occurred following construction because most of the poles were in agricultural land. However, in non-agricultural areas, it appeared that vegetation surrounding poles matched that of the surrounding area (**Appendix A, Photos 5-8**).

**Photo 5.** Direction: Southwest. View of a wetland spanned by the transmission line. No construction-related disturbance was noted in this area.

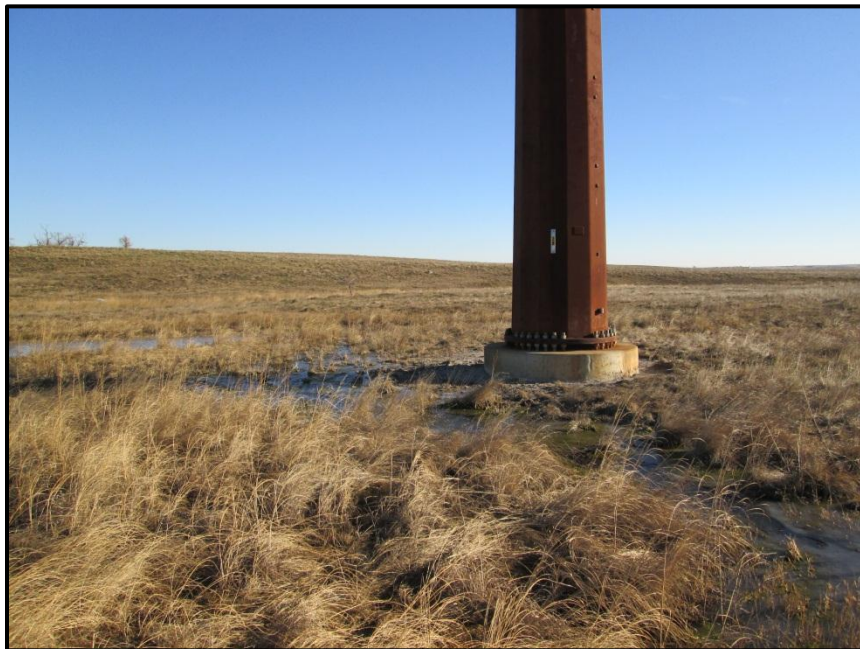
**Photo 6.** Direction: East. View of a transmission structure within a wetland. Disturbance to the wetland was minimized to the extent possible. Wetland vegetation had reestablished and no residual sedimentation from construction was observed. A mitigation wetland was created to mitigate wetland impacts (Photo 10).

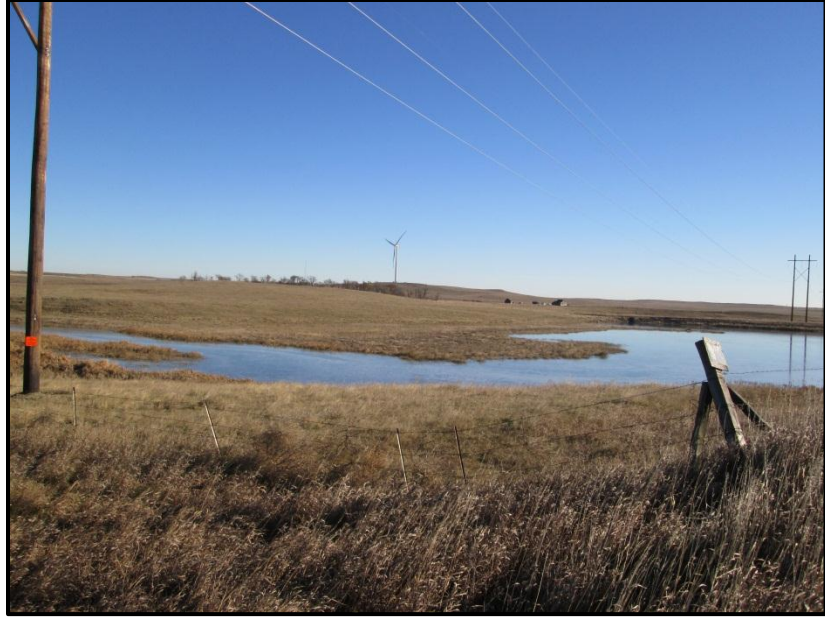
**Photo 7.** Direction: Northeast. View of a wetland crossing along the transmission line route. It appeared the transmission line poles were in upland, with no apparent impacts to the wetland area.

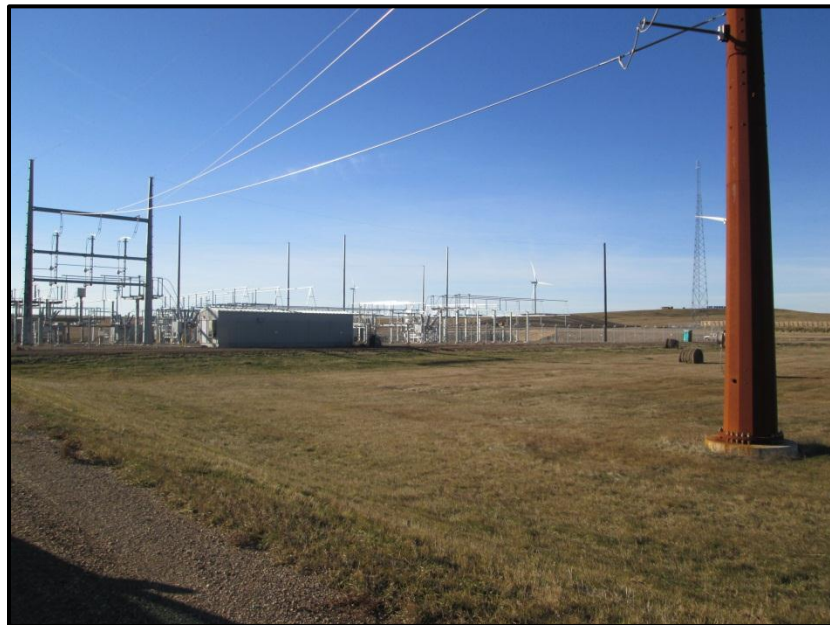
**Photo 8.** Direction: South/Southwest. View of the transmission line at the Bison Substation on the west end of the route.

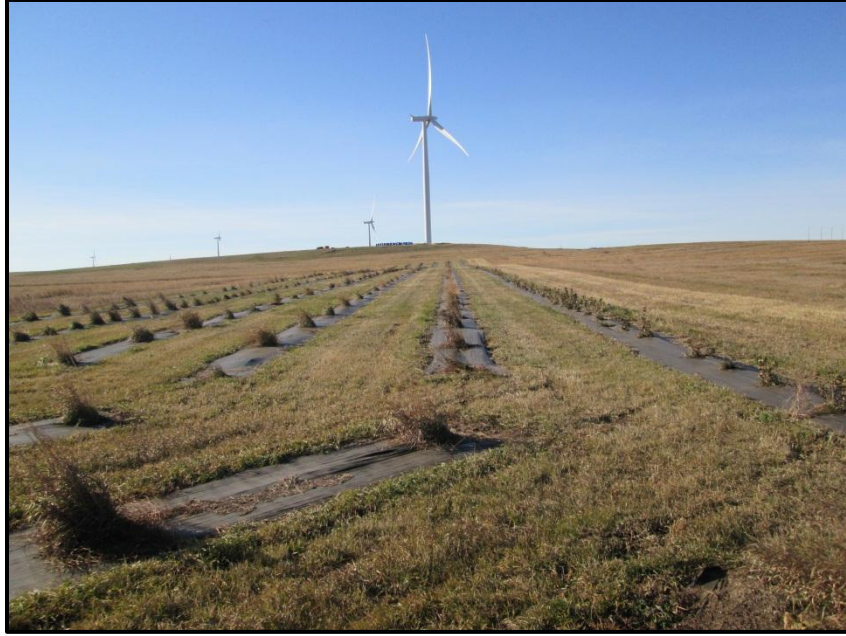
A mitigation plan was approved for the Project (Docket #78, Tree and Shrub Mitigation Plan). A 2012 Survival Monitoring Report (Docket #86) was submitted on 10 September 2012 for both plantings. The report indicated that trees/tall shrubs had adequate survival, but low shrubs had only 30% survival. These shrubs were replaced in 2012 to meet the survival requirements. So far, Minnesota Power has adequate survival, with an average survival across plantings of 167%. Wenck observed the plantings and they appeared in good condition (**Appendix A, Photos 9, 10**). A Tree and Shrub Survival Report for the year 2013 has not been submitted to date. Two more years of survival monitoring will be required for the mitigation to be considered complete.

**Photo 9.** Direction: South. View of a tree and shrub mitigation area west of the Bison Substation.

The mitigation of trees and shrubs removed during construction of the Project had been planted in the spring of 2011 at a 3:1 ratio (2:1 was required). Wenck verified that the replacement plantings were installed; and the latest report indicates that the average survival across plantings stands at 153%. However, survival monitoring is required for three years after the anniversary of the planting to confirm that survival is over 75%, until spring of 2014. Wenck recommends that the PSC proceed with its requirement for the full three years of survival monitoring to ensure 75% survival of the replacement planting.

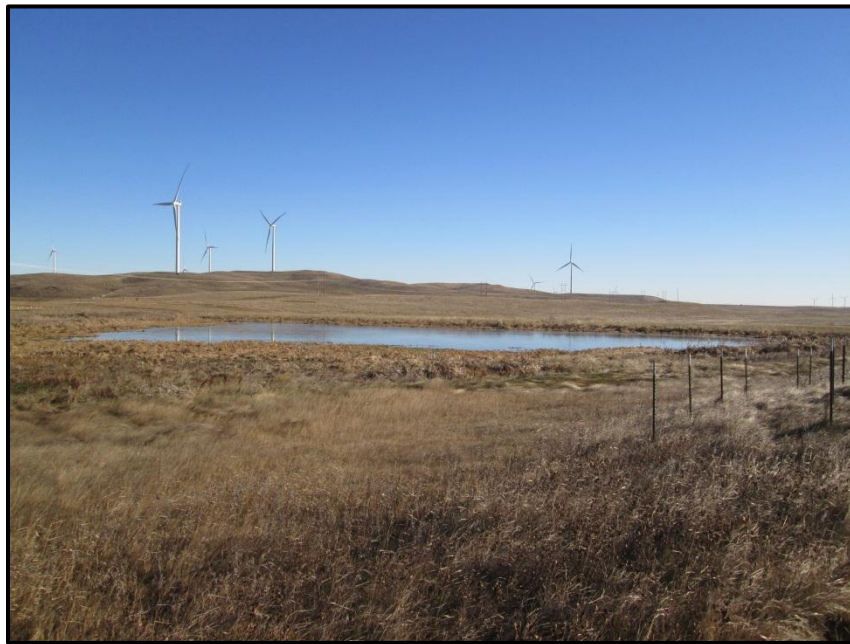
**Photo 10.** Direction: East. View of the wetland mitigation area. Additional tree and shrubs were planted around the wetland.
