Center to Grand Forks Project

► CGF Project Weekly Status Report

Case No. PU-09-670

Michael Hennes ► Minnkota Power Cooperative, Inc. ► 10/11/2013

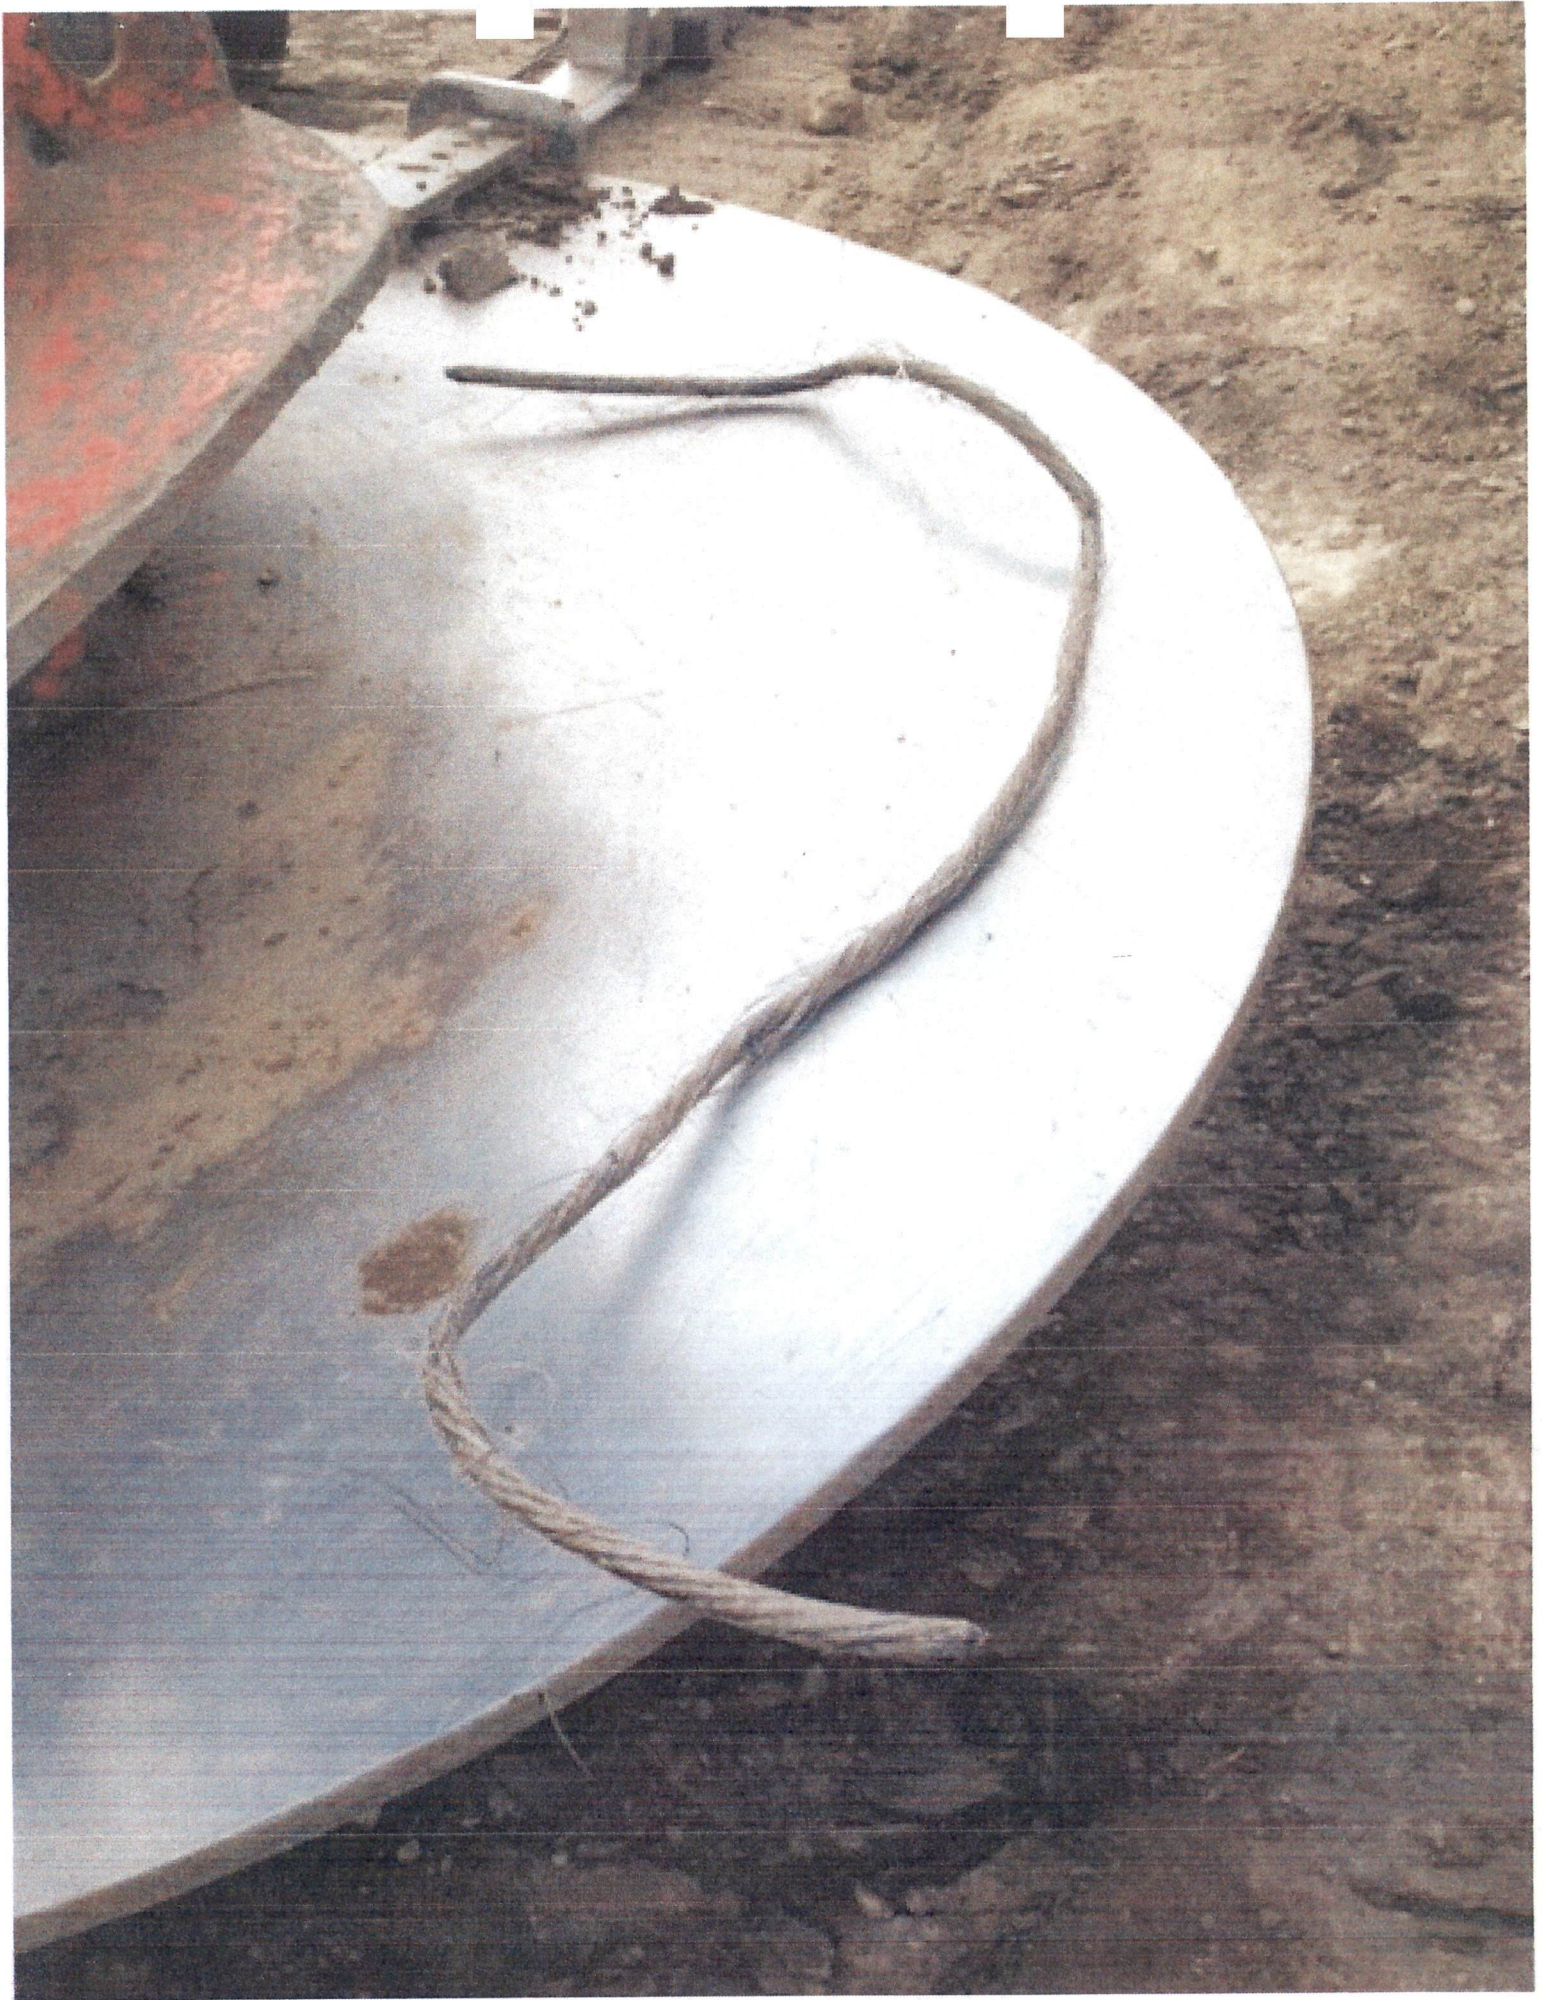
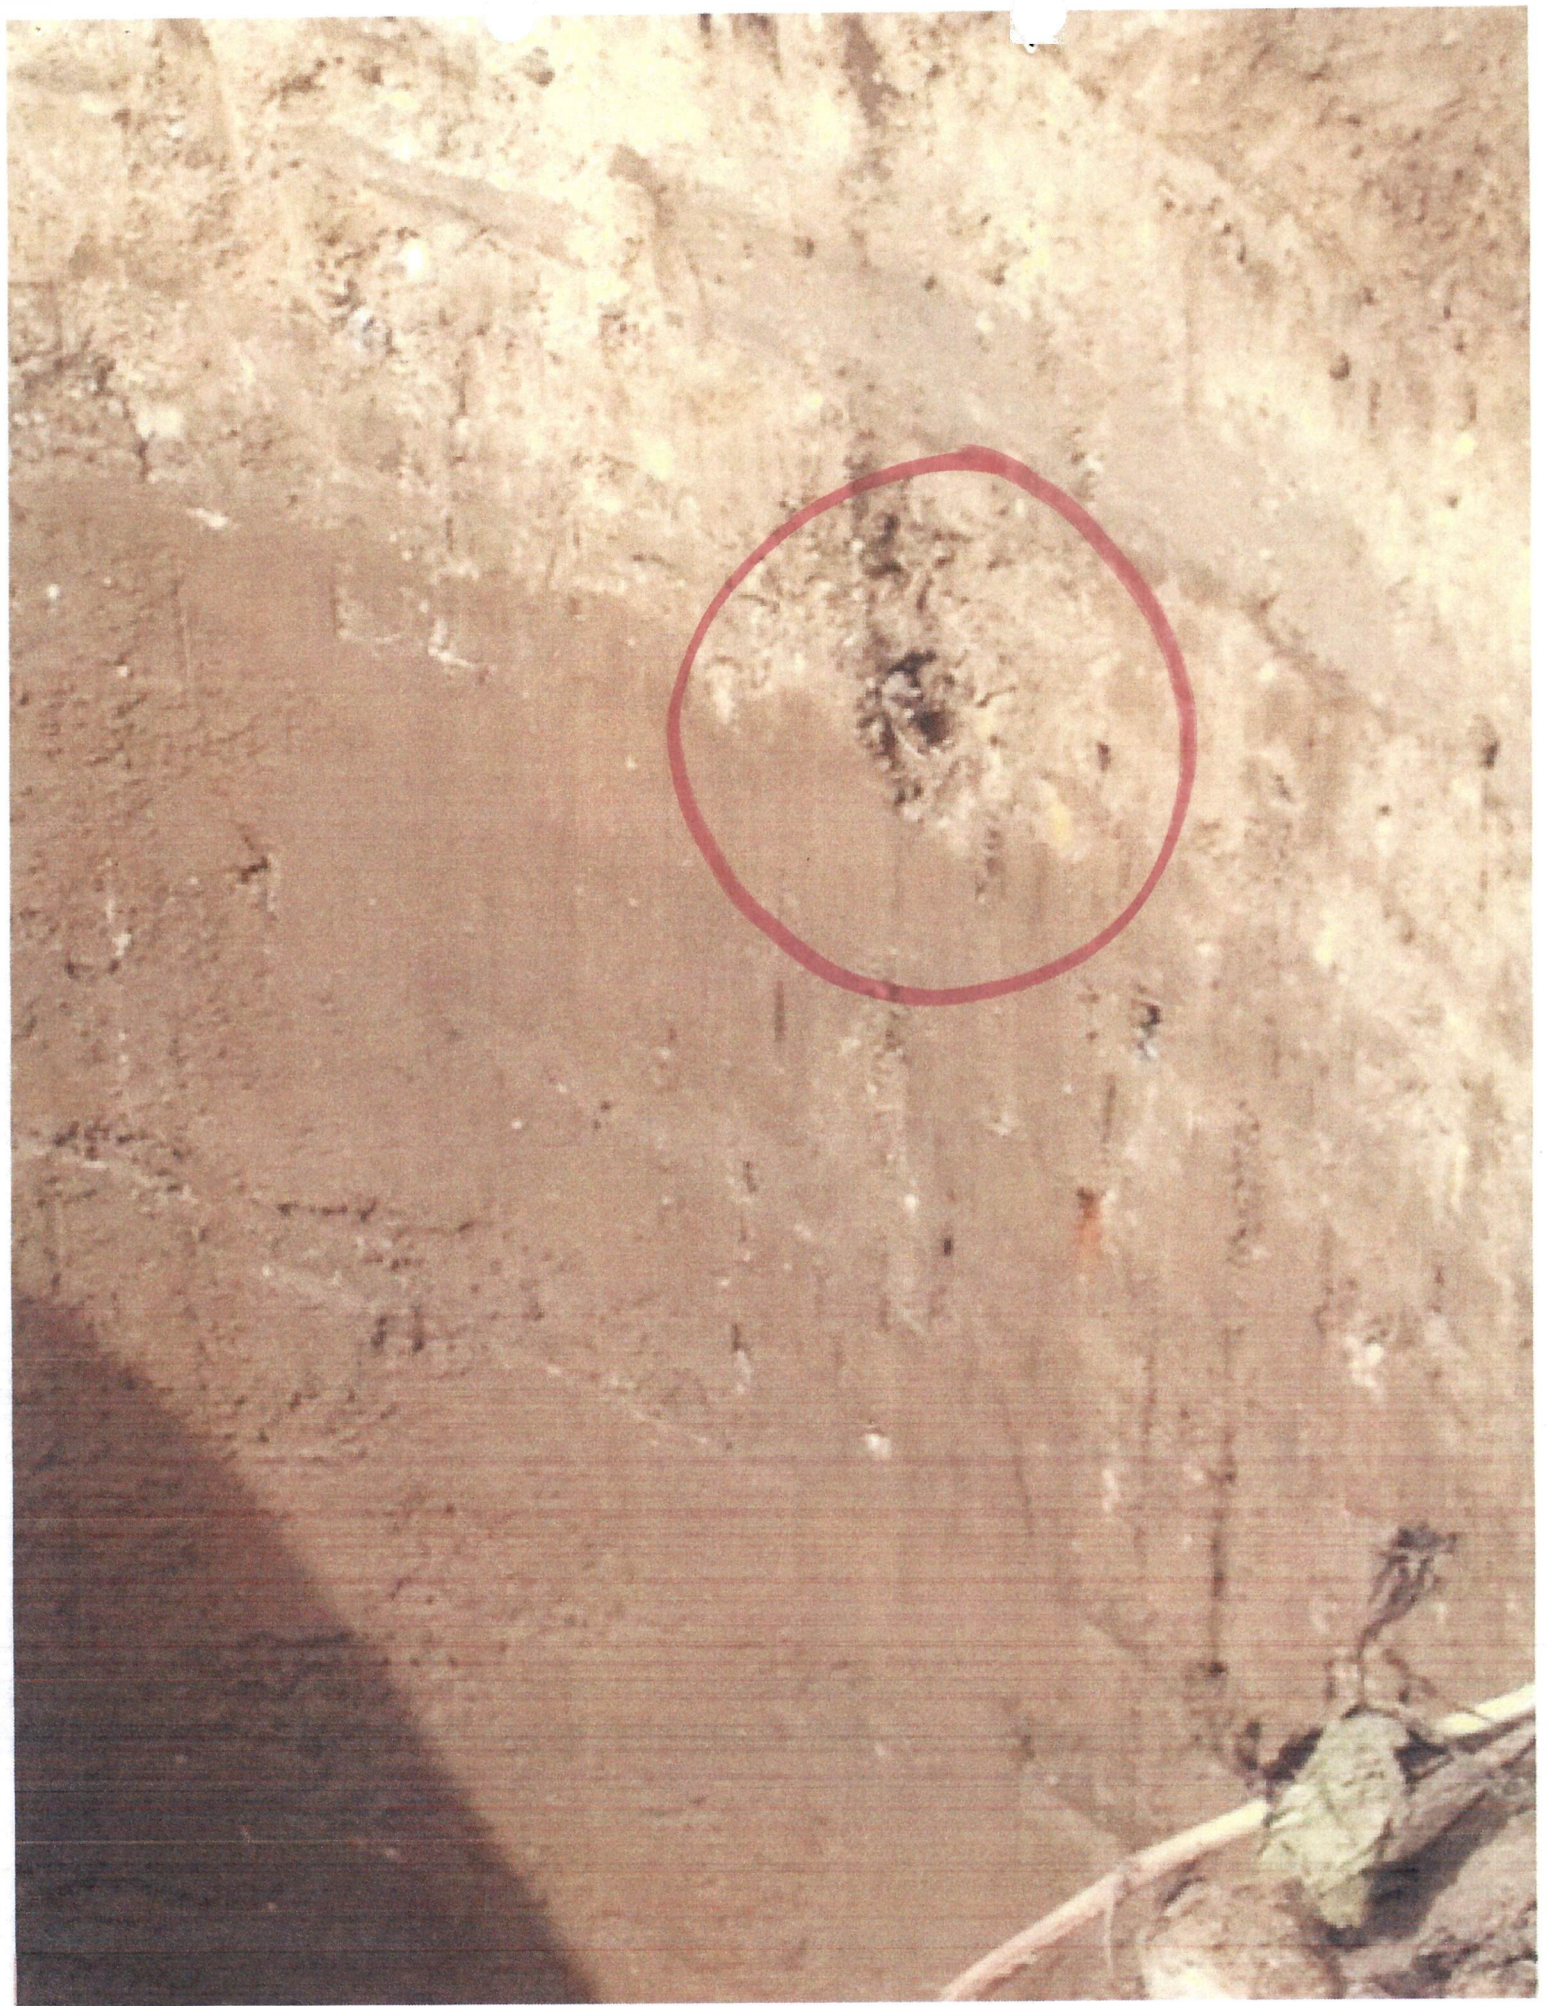
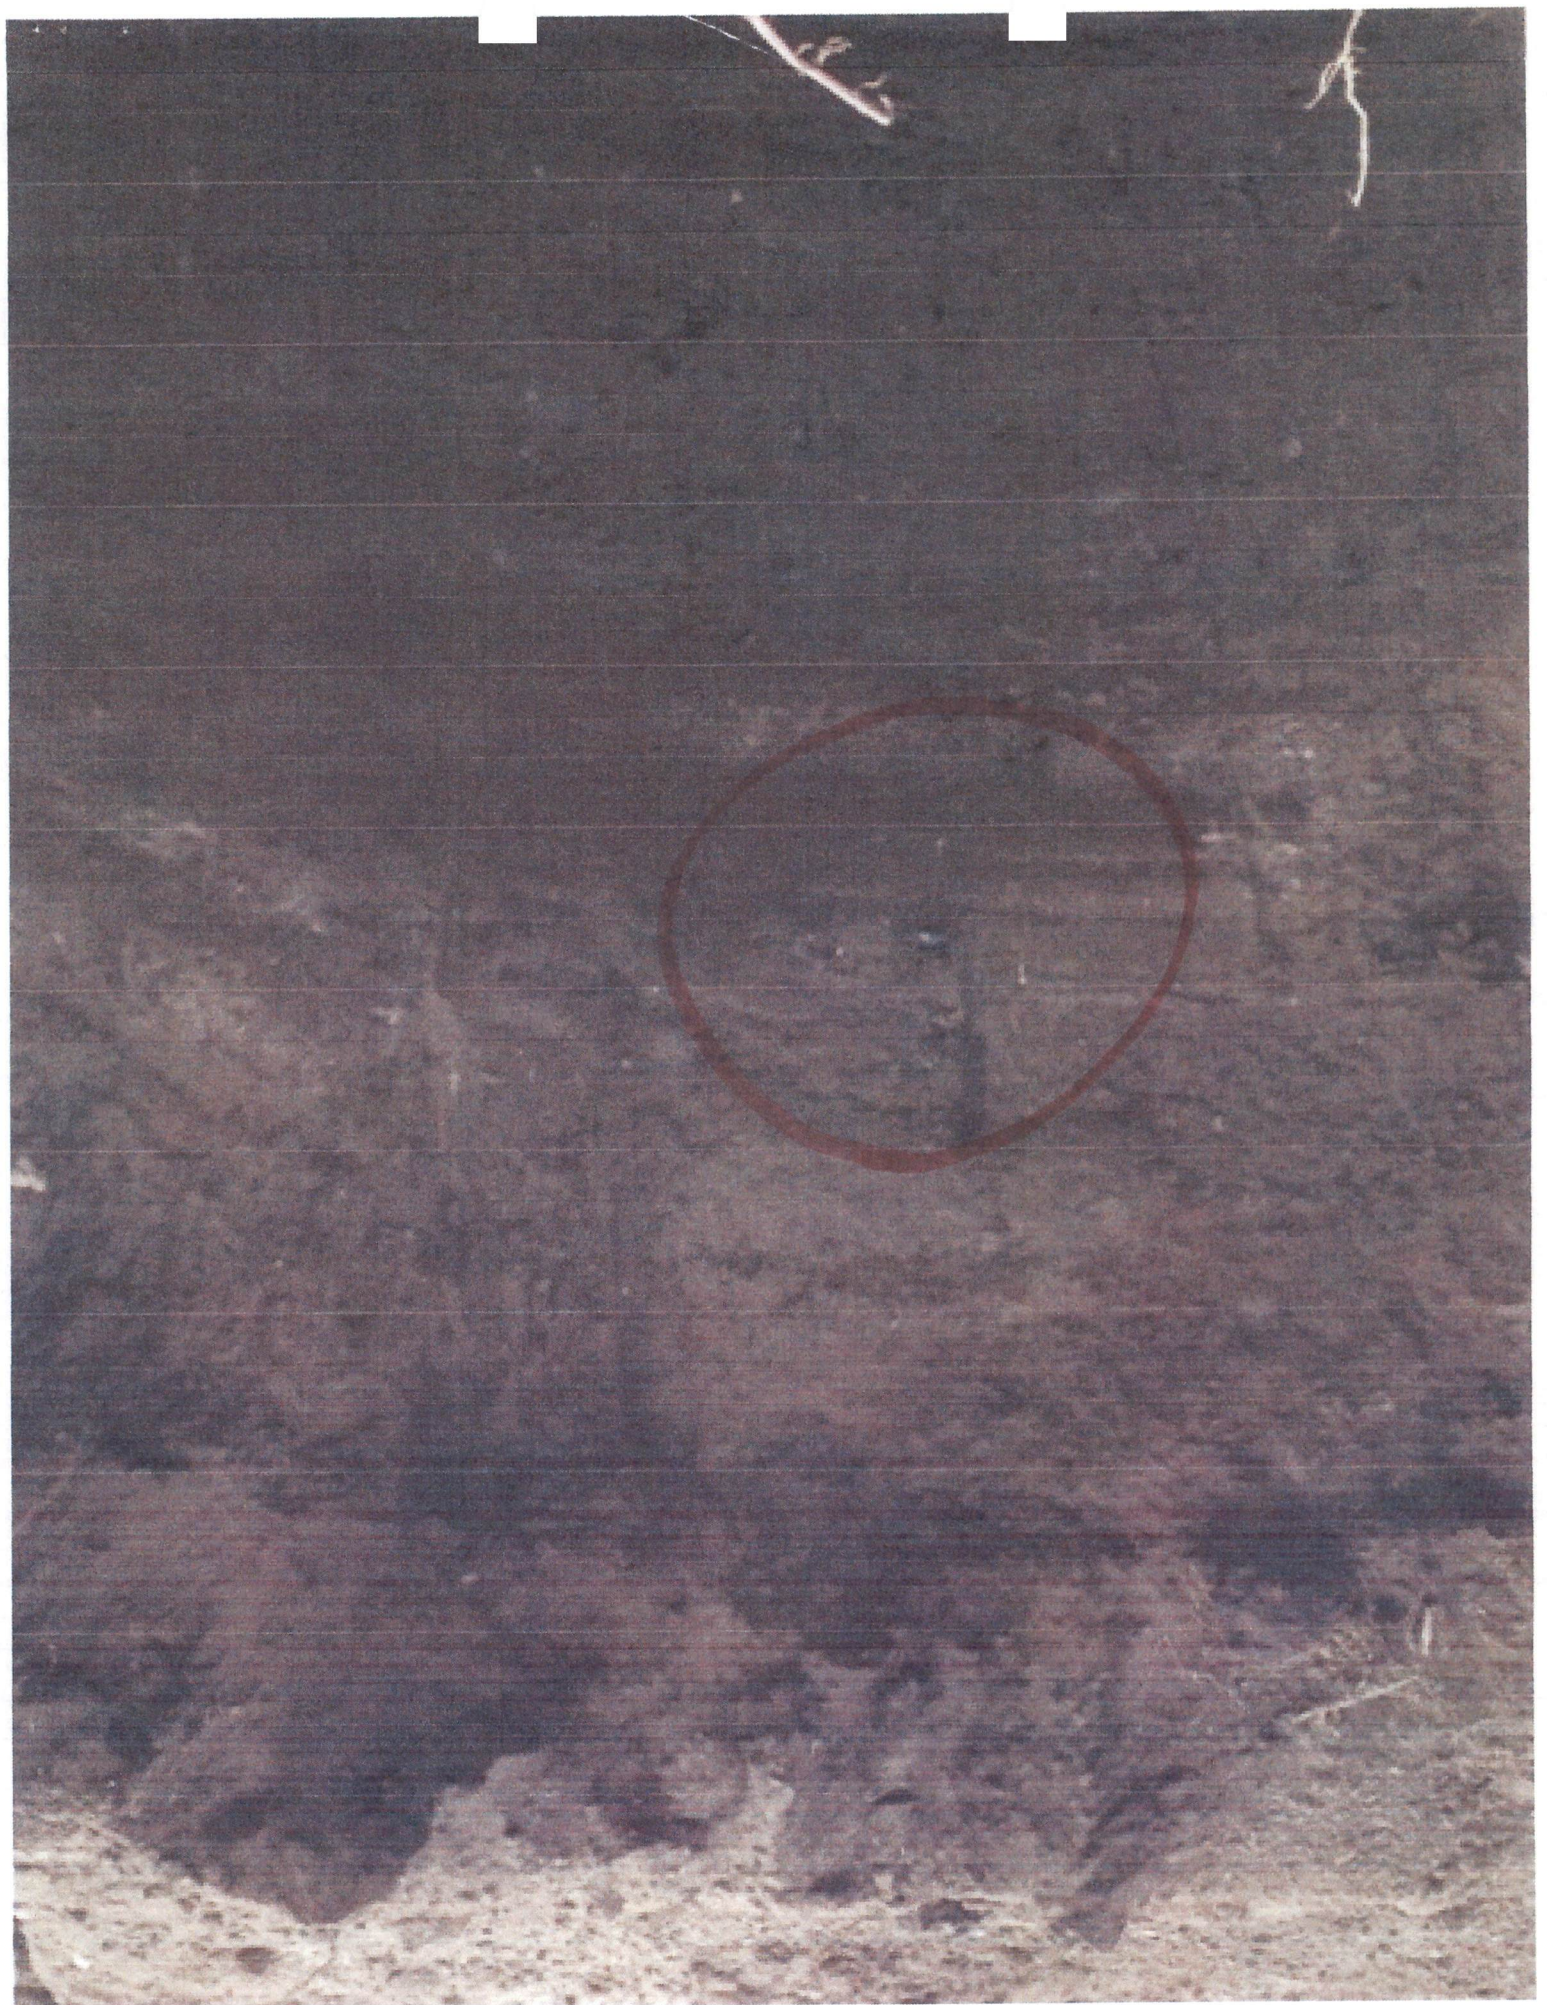
While performing excavation for foundation installation work at 381 on 9/26/13, a drill auger broke through an underground power line – there were no injuries or damage to equipment. Locates had been called in for that location, but there were no markings for this secondary underground lines at the 381 site. The power company and one-call were notified, came out and completed investigation and repairs prior to work re-commencing. This is a separate event from that reported in week 74. The full incident report is being prepared for that strike at structure 67 and will be submitted separately.

Nature of Injury/Illness, Treatment Received and/or Description of Damages: (Body Part, Equipment Name or Number) Please Explain: Broken 240v underground power line causing an outage for Verendrye Elec. Coop.					
INCIDENT	Employee's Report of Events Leading to the Accident / Incident: Description of what happened (who, what, where, and how?): What job task was being performed? How was it being done? What equipment was being used? Location of personnel involved? What was the unexpected event? What was the result or potential result? Explain: While drilling structure 381 at the depth of 3 ft. an underground power line was unearthed. There was no arc flash and no one was injured. See attached photos.				
	What caused the Accident/Incident? Locators failed to mark the underground utility. The locate ticket #13156818. Locate was requested on 9/13/13 at 3:23 pm. Work Begin date was 9/17/13 at 3:30 pm. (See locate ticket for additional information)

INCIDENT	<p>Supervisor's Report: Description of what happened (who, what, where, and how?): What job task was being performed? How was it being done? What equipment was being used? Location of personnel involved? What was the unexpected event? What was the result or potential result? Explain:</p> <p>While drilling structure 381 the rig unearthed a 240v power line at a depth of 3 ft. Once the line was pull out the crew immediately stopped work until the electric company came out to verify that the line was dead. There were no marks distinguishing the underground utility before drilling began. A valid locate was in place prior to drilling operations.</p>	
	<p>Type of Treatment (check all that apply)</p> <input type="checkbox"/> No Treatment <input type="checkbox"/> On-Site First Aid Treatment Only <input type="checkbox"/> Clinic <input type="checkbox"/> Emergency Room <input type="checkbox"/> Hospitalization <p>Describe Treatment:</p>	<p>Doctor, Clinic or Hospital Name:</p> <p>Mailing Address</p> <p>Phone #</p> <p>Has the employee returned to work? (check one)</p> <input type="checkbox"/> Yes -Date Returned? <input type="checkbox"/> No -Estimated Date of Return?

<p>Permanent Control(s): Power company will be out to reroute the line on 9-27-13.</p>	
	<p>Continue to ensure locates are completed prior to drilling operations.</p>	
<p>Additional Comments: Stanley requested information (Crew Time line) <i>The crew moved into structure 381 and 382 at 6:00 am on Sept. 26th. First the crew drilled structure 382 and moved to 381 at 1:00 pm. The crew set up the site and no locate markings were found. The crew began drilling at 2:45 pm. They noticed that they struck the power line at 3:00 pm. They had taken out about three auger loads when they saw the line in the hole. Work immediately stopped and didn't recommence until the next day at 6:00 am after the utility company deemed the area safe. The hole stood open over the weekend and was poured on Monday Sept. 30th at 7:00 am. The crew finished the pour and moved out of the area at 3:00 pm.</i></p>		
<p>Responsible Manager/Director Comments:</p> <p>Signature:
