DAKOTA GASIFICATION COMPANY

Re: Case No. PU-593-96-11
Permit No. 84

On May 25, 2011, during the course of a routine patrol of the pipeline, DGC discovered that a butte located in Dunn County located north of our mainline valve no. 3 and just south of the Little Missouri River crossing had caved-in leaving our pipeline exposed in two areas. We have attached as Exhibit 1 a collection of photographs taken shortly after our discovery of the cave-in. DGC's pipeline is the upper pipeline of the two exposed pipelines that appear in the pictures. After an evaluation, DGC took the following actions: lowered the pipeline pressure to approximately 1,000 psi, suspended carbon dioxide deliveries to our two Canadian customers pending further investigation and provided the appropriate notification to the Office of Pipeline Safety. We have since employed engineering experts who have informed us that the longitudinal and bending stresses on the pipeline that occurred as a result of the cave-in are such that the exposed pipeline, as well as 50 feet on either side of the exposed area, must be replaced. Accordingly, this week we are completely de-pressurizing the line so as to perform the necessary

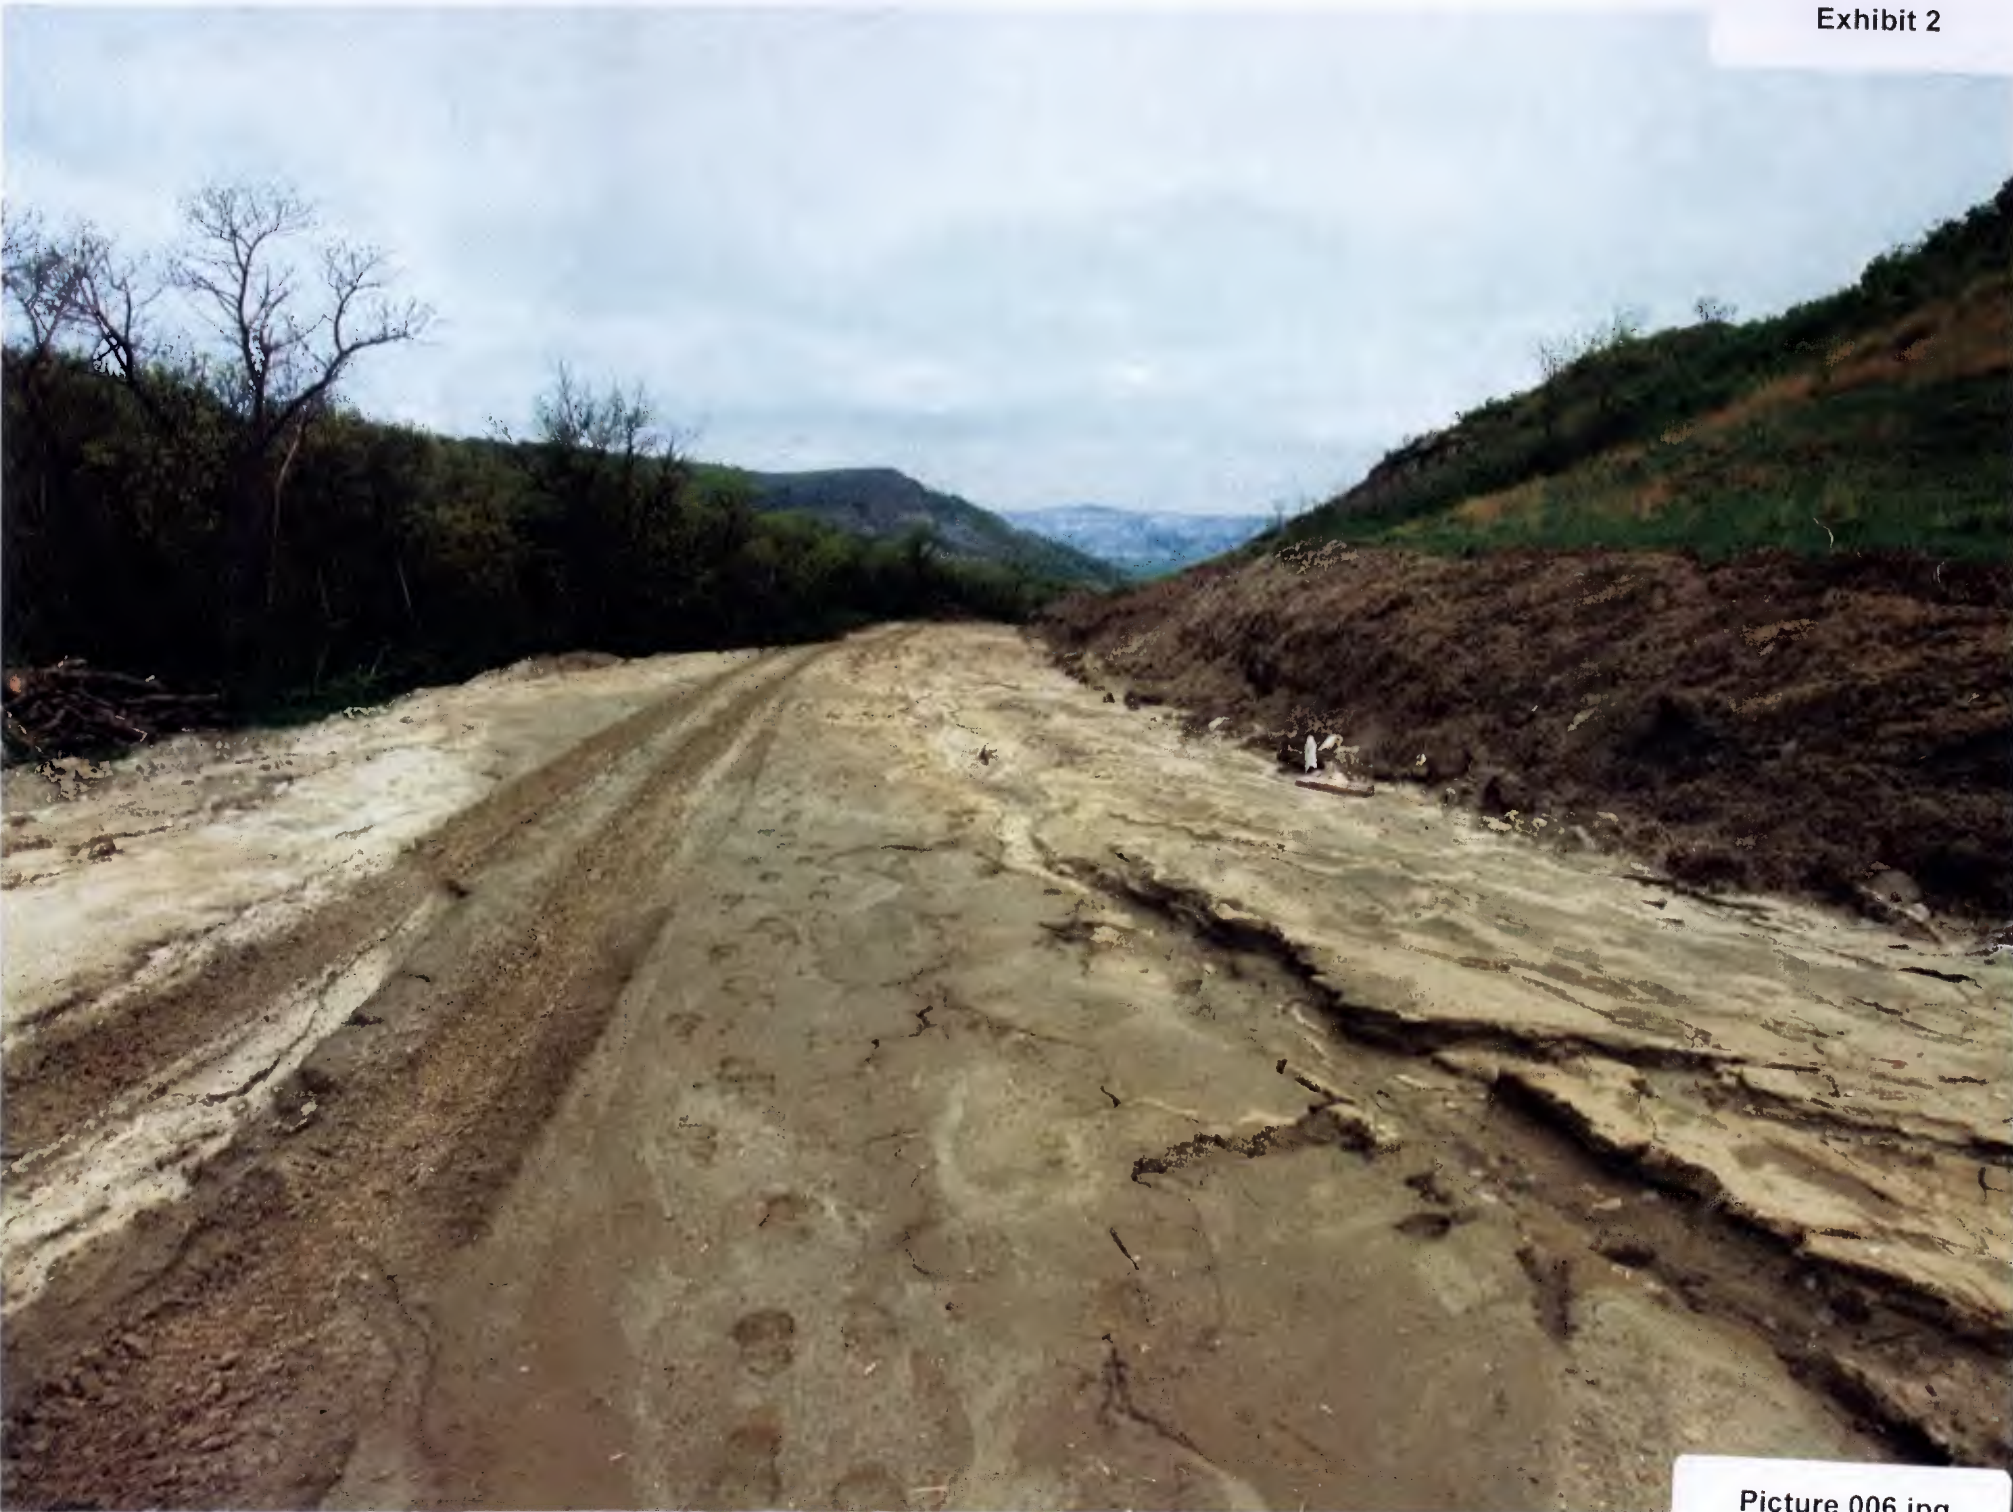
Picture 006.jpg

The attached photographs, which were taken on June 2, 2011, corroborate our suspicions. The photographs set forth in Exhibit 2 were taken in Section 35, T148N, R96W, Dunn County and illustrate that the Bridger pipe is exposed in several areas and that there are similar ridges of spoil material on the DGC right-of-way. The photograph labeled 006 shows a cut-out as a result of the complete lack of erosion control. Photograph 007 shows another hillside wash-out. The Exhibit 3 photographs were taken in Section 2, T147N, R96W, Dunn County and illustrate a similar pool of water in the Bridger right-of-way. The photographs in Exhibit 4 were taken on the north side of the Little Missouri crossing in Sections 23 and 26, T148N, R96W, Dunn County. Please note that in the photograph labeled 010 that there is less than 30 feet centerline to centerline. The photographs labeled 011 and 012 illustrate a large cut-out of a hillside. They, too, indicate the exposed Bridger pipeline. We were quite surprised to find a Caterpillar dozer buried in the Bridger right-of-way as shown in picture 025 in Exhibit 5 taken in Sections 6 and 7, T148N, R95W, Dunn County. Photograph 021 shows a cut-out approximately 20 feet wide. Photograph 022 raises the question as to whether the Bridger pipeline was undermined (look on opposite hill). The final set of pictures set forth in Exhibit 6 were taken in Sections 20 and 28, T149N, R95W, Dunn County and again illustrate the lack of proper backfilling and the use of the native material for this backfilling. Picture 026 again shows a large cut-out without any erosion control present. Photograph 029 shows severe damage to the hillside.
