# **Bridger Pipeline, LLC Inspection Report**

## **Phase 1 – Construction Phase**

**NORTH DAKOTA  
PUBLIC SERVICE COMMISSION**  
600 E. Boulevard Avenue  
Bismarck, ND 58505-0480

August 2011

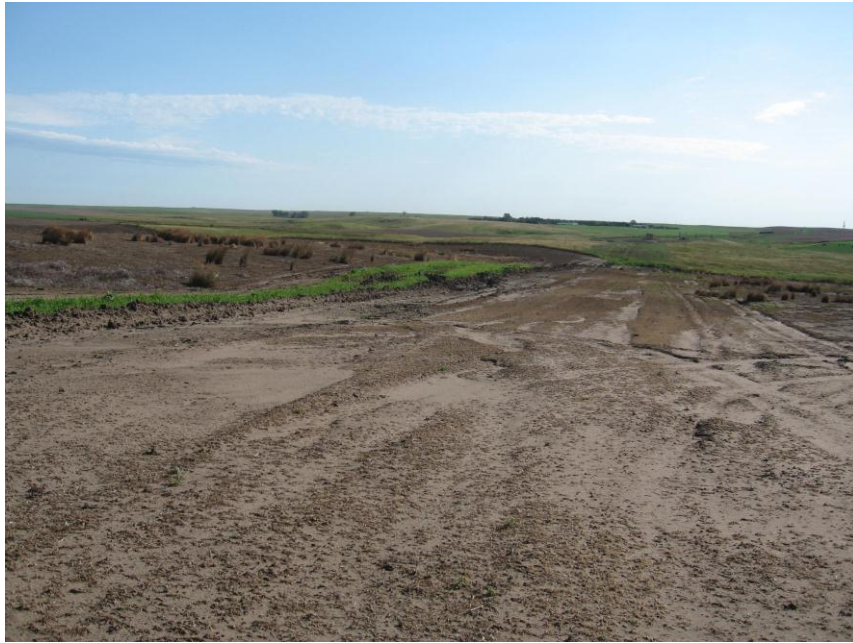
**Photo 1.** Direction: Northeast. This photo shows the right-of-way for the Bridger Pipeline. At the time of our site visit the right-of-way needed final restoration.

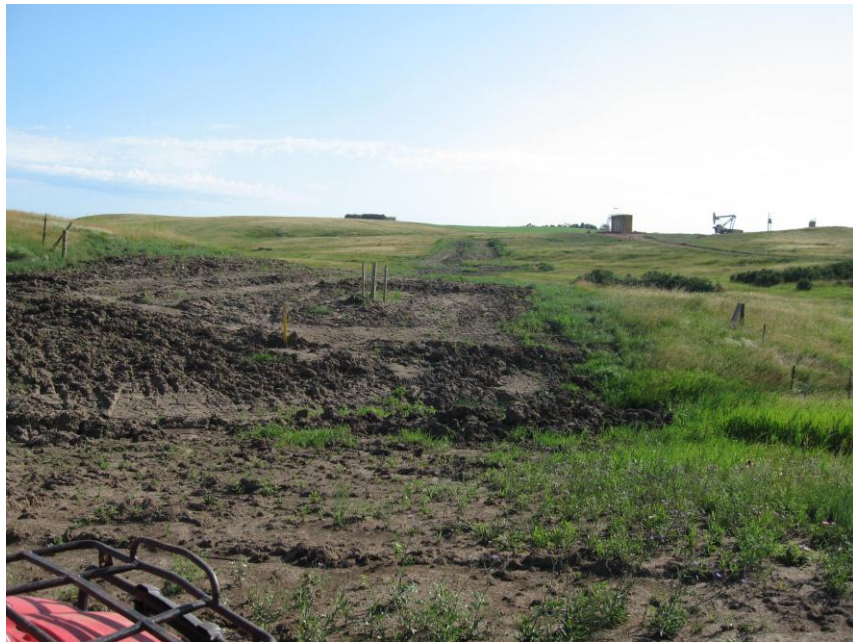
**Photo 2.** Direction: Northeast. This photo shows the right-of-way for the Bridger Pipeline. At the time of our site visit the right-of-way had wet soil conditions and needed final restoration.

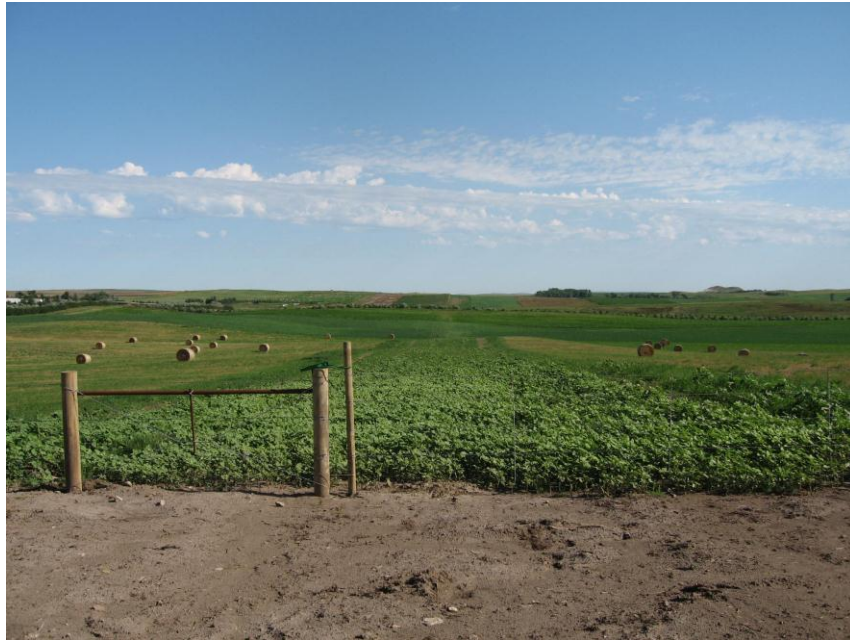
**Photo 3.** Direction: North. This photo shows the right-of-way for the Bridger Pipeline. At the time of our site visit the right-of-way had been planted by the farmer.

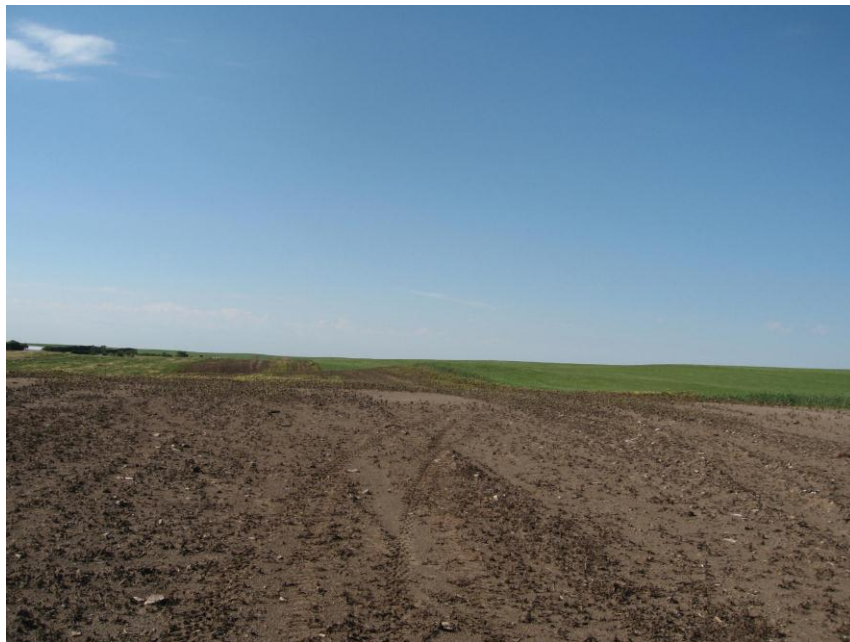
**Photo 4.** Direction: North. This photo shows the right-of-way for the Bridger Pipeline. At the time of our site visit the area shown had wet soil conditions and needed final restoration.

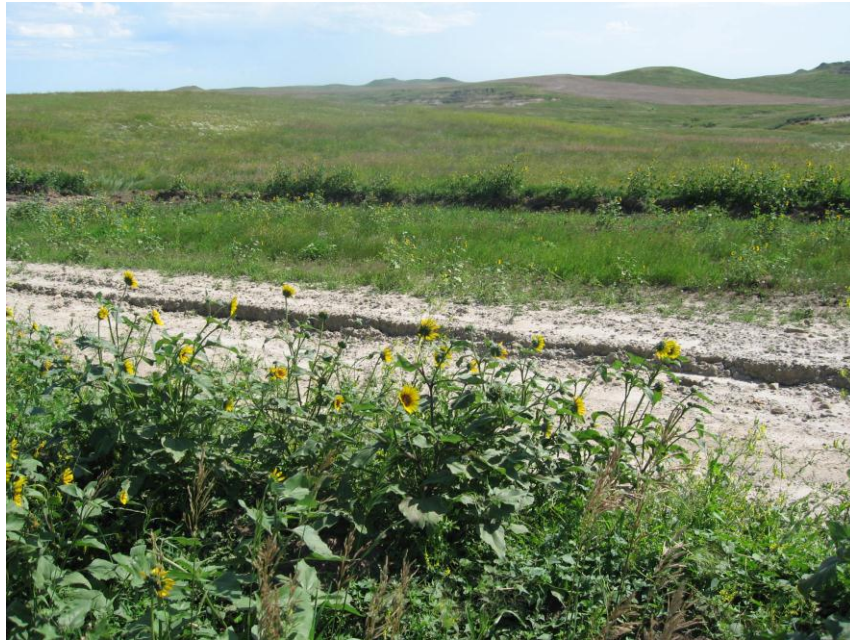
In one isolated area shown on photo 5 in Appendix B, settlement of the soil was observed over the pipeline trench to a depth of approximately 1 ½ feet for a span of approximately 150 feet in length. Bridger was notified of this area during the inspection process.

**Photo 5.** Direction: Northeast. This photo shows the right-of-way for the Bridger Pipeline. At the time of our site visit there was a one foot deep trench above the pipeline and the right-of-way needed final restoration.

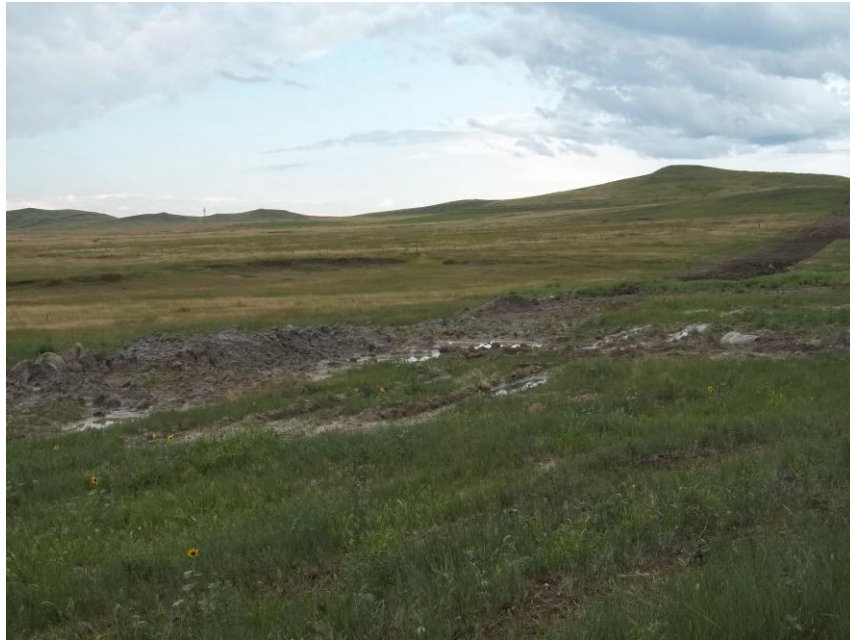
**Photo 11.** Direction: Southwest. This photo shows the right-of-way for the Bridger Pipeline. At the time of our site visit the area shown had isolated wet soil conditions, needed topsoil spread and final restoration to be completed.

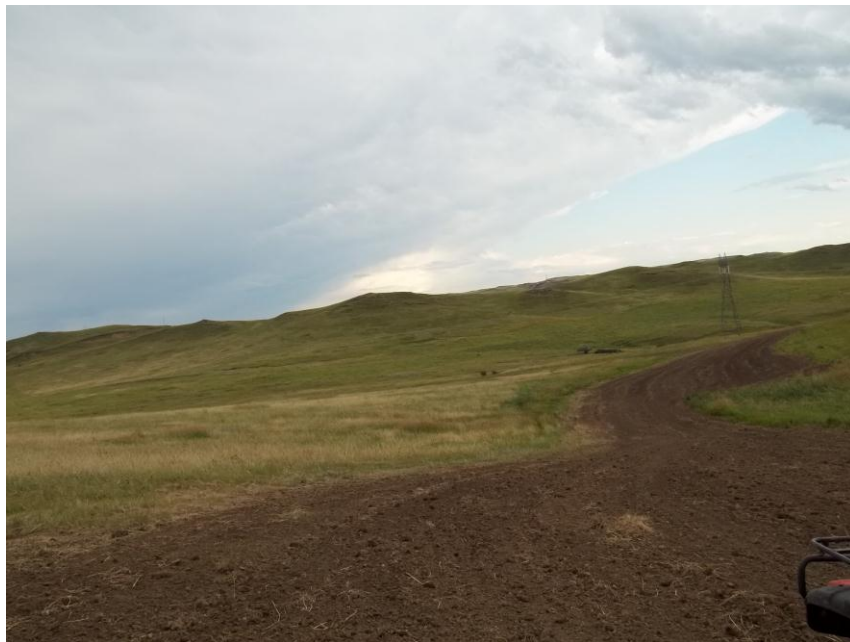
**Photo 12.** Direction: South. This photo shows the right-of-way for the Bridger Pipeline. At the time of our site visit the right-of-way needed final restoration.

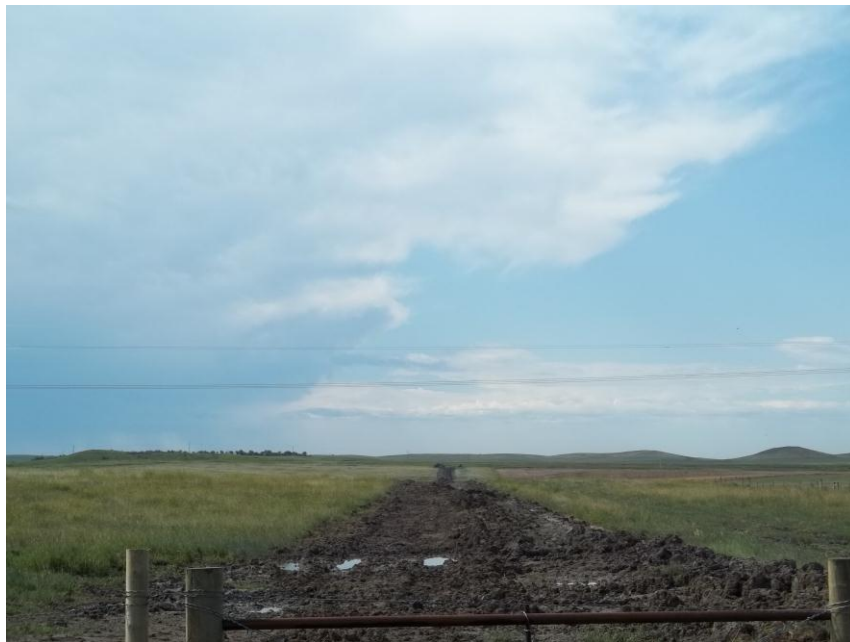
**Photo 16.** Direction: South. This photo shows the right-of-way for the Bridger Pipeline. At the time of our site visit the area shown had wet soil conditions, needed topsoil spread, and final restoration.

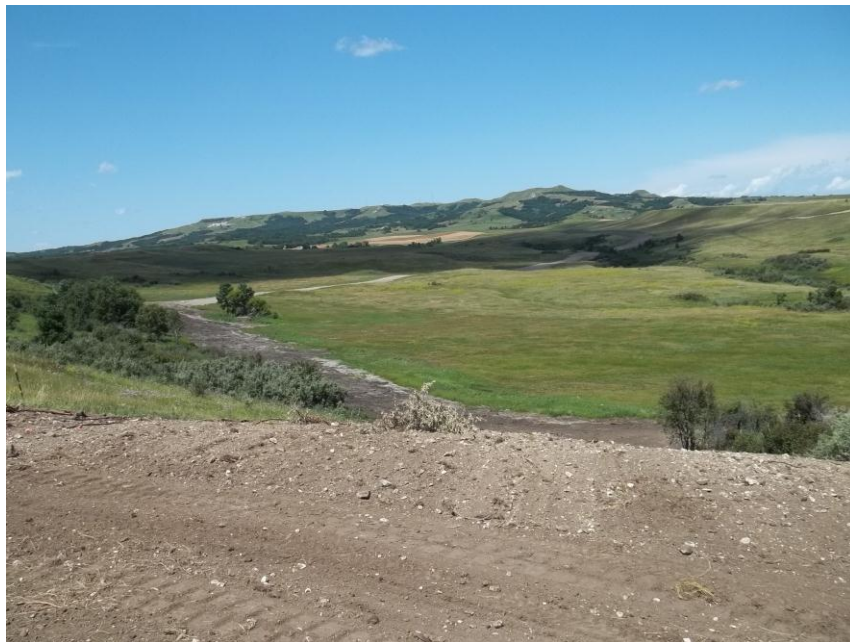
**Photo 40.** Direction: Northwest. This photo shows the right-of-way for the Bridger Pipeline. At the time of our site visit the area shown needed topsoil spread and final restoration.

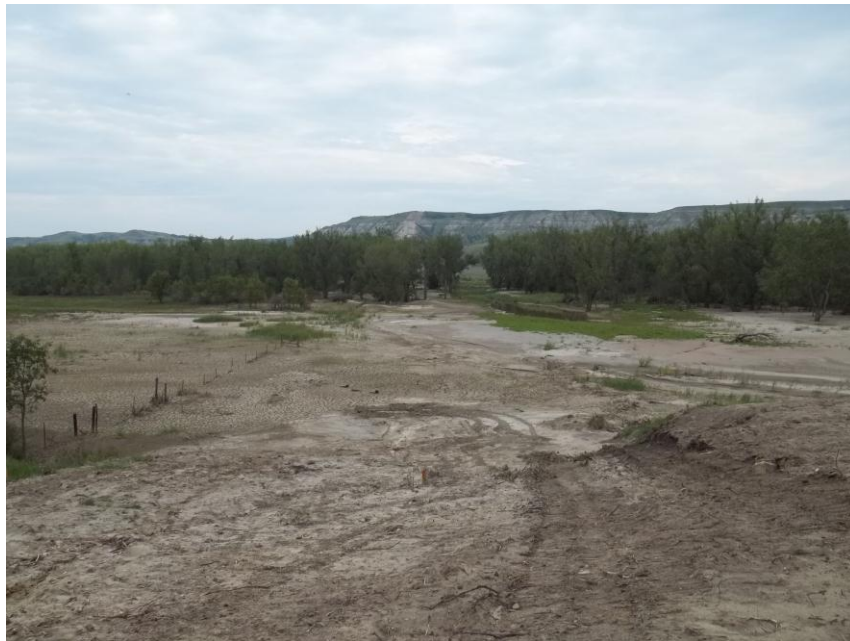
**Photo 64.** Direction: North. This photo shows the right-of-way for the Bridger Pipeline. At the time of our site visit the area shown had wet soil conditions and needed final restoration.

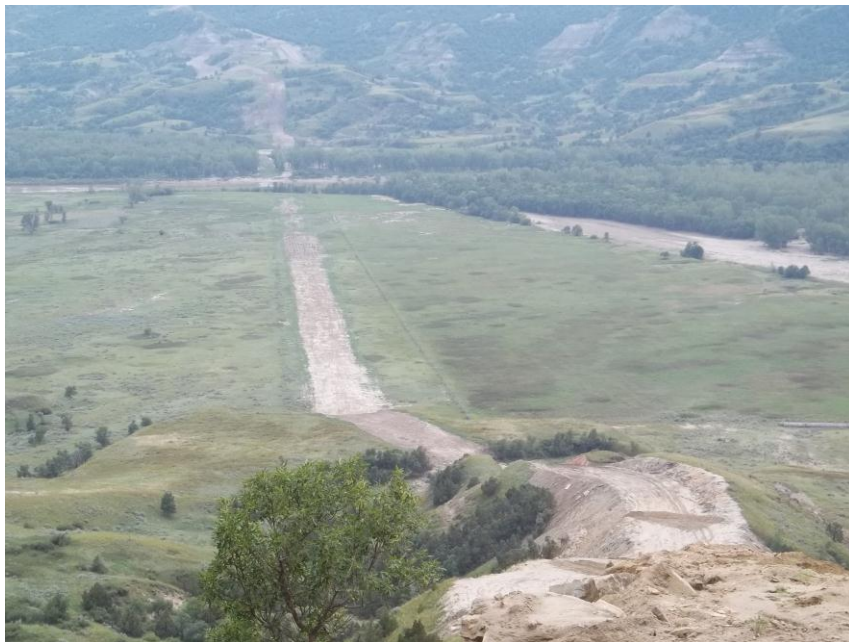
**Photo 68.** Direction: South. This photo shows the right-of-way for the Bridger Pipeline. At the time of our site visit the area shown needed slope contour fixed and final restoration.

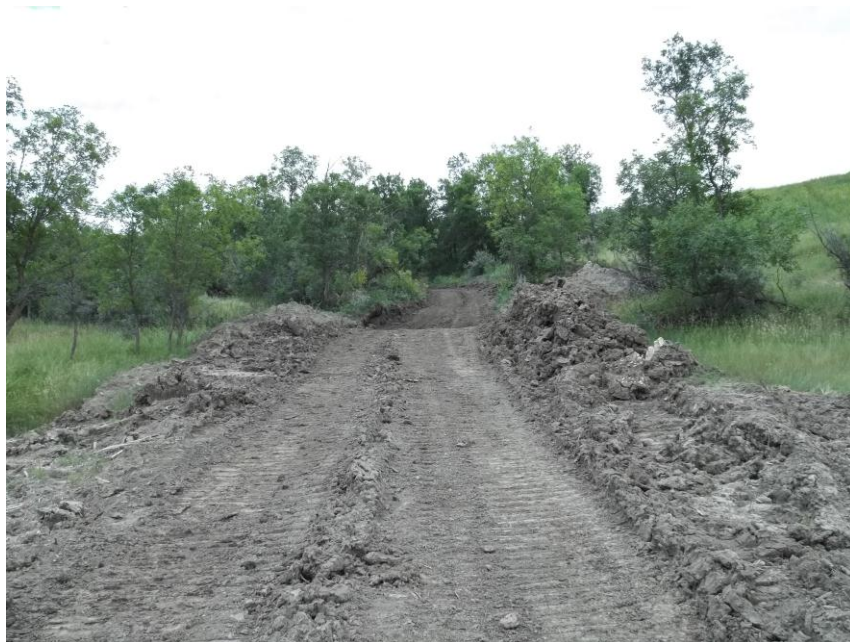
**Photo 79.** Direction: South. This photo shows the right-of-way for the Bridger Pipeline. At the time of our site visit the area shown needed topsoil spread and final restoration.
