***Bridger Four
Bears Pipeline
Phase 2
Construction
Inspection Report***

***Bridger Pipeline,
L.L.C.***

PU-09-750

June 2012

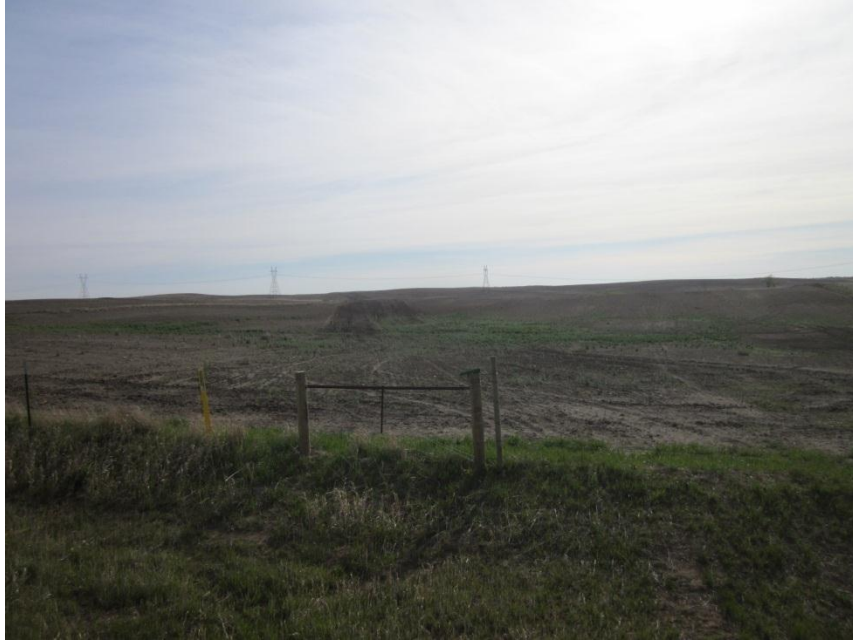
Photo 1. Direction: Northeast. Pipeline right-of-way through an agricultural field that had been planted over by landowner.

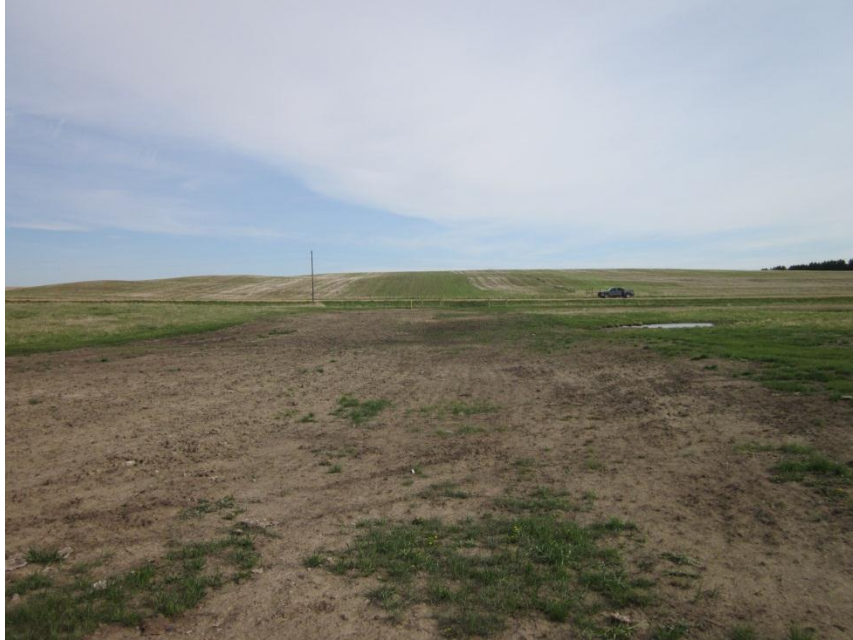
Photo 3. Direction: North. Pipeline right-of-way. No erosion or sedimentation was noted to the water body.

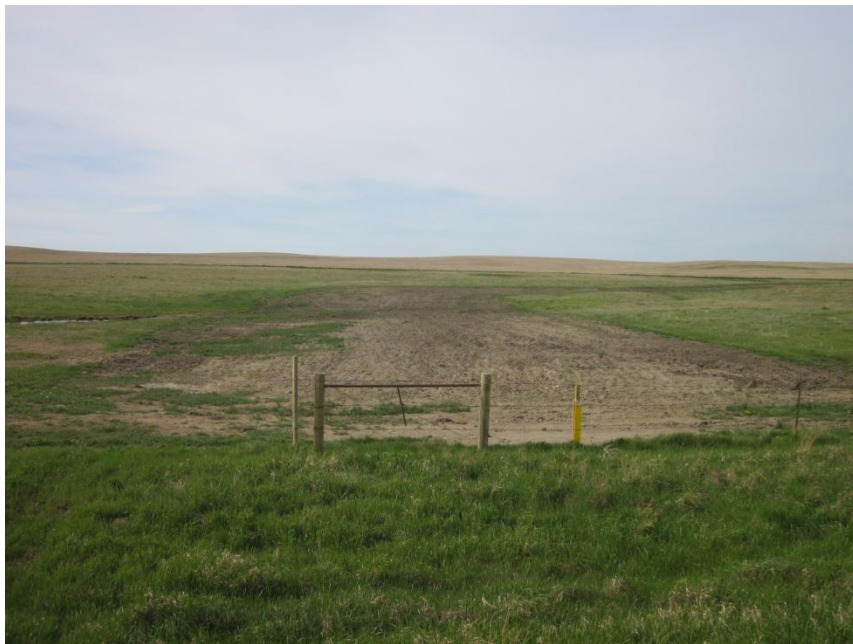
Photo 4. Direction: South. Pipeline right-of-way. Note repaired fence and signage where the pipeline crosses the fenceline.

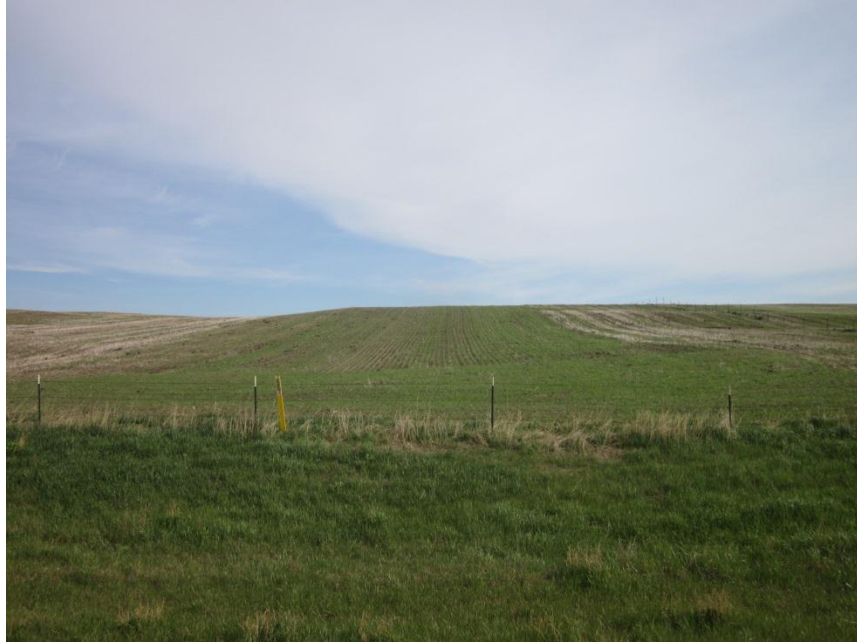
Photo 5. Direction: North. Pipeline right-of-way through an agricultural field. Field had been planted by landowner.

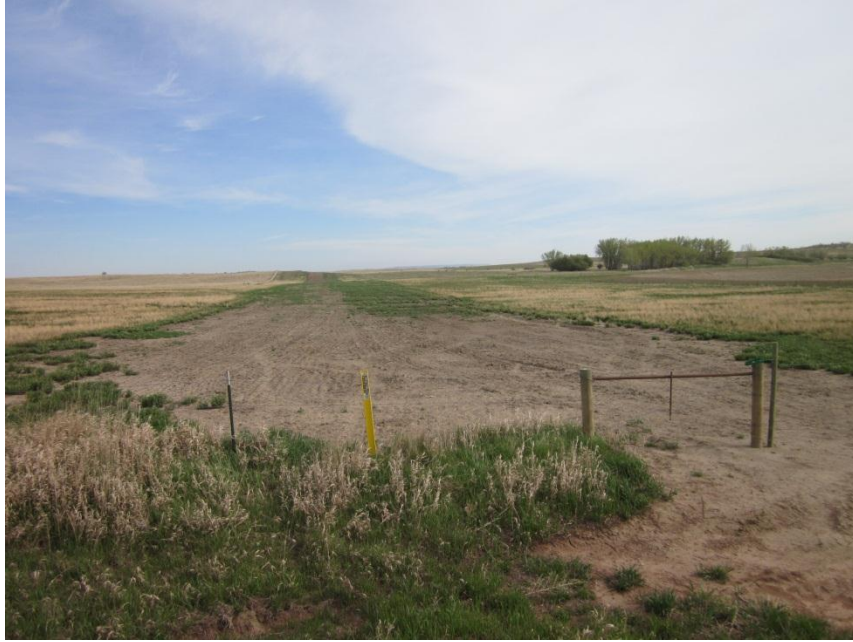
Photo 7. Direction: North. Pipeline right-of-way. Note repaired fence and posted signage.

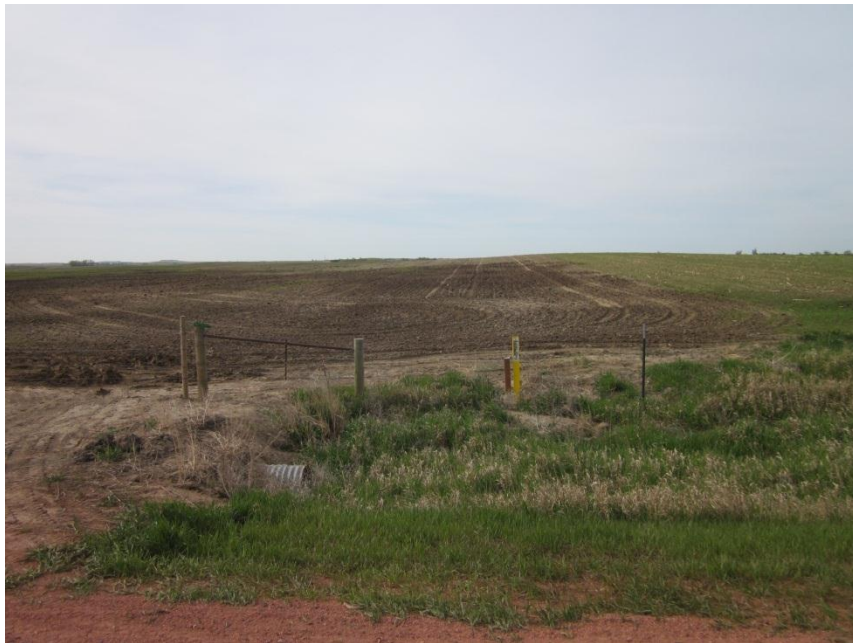
Photo 8. Direction: South. Pipeline right-of-way. Note repaired fence, gate, and posted signage.

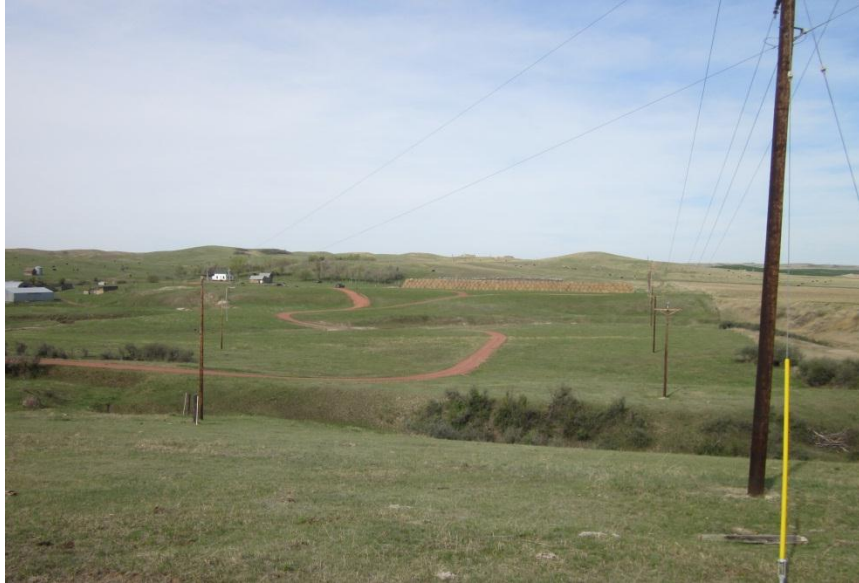
Photo 9. Direction: West. Photo shows a scoria access road constructed for Bridger’s pipeline. The road was well maintained and in good condition.

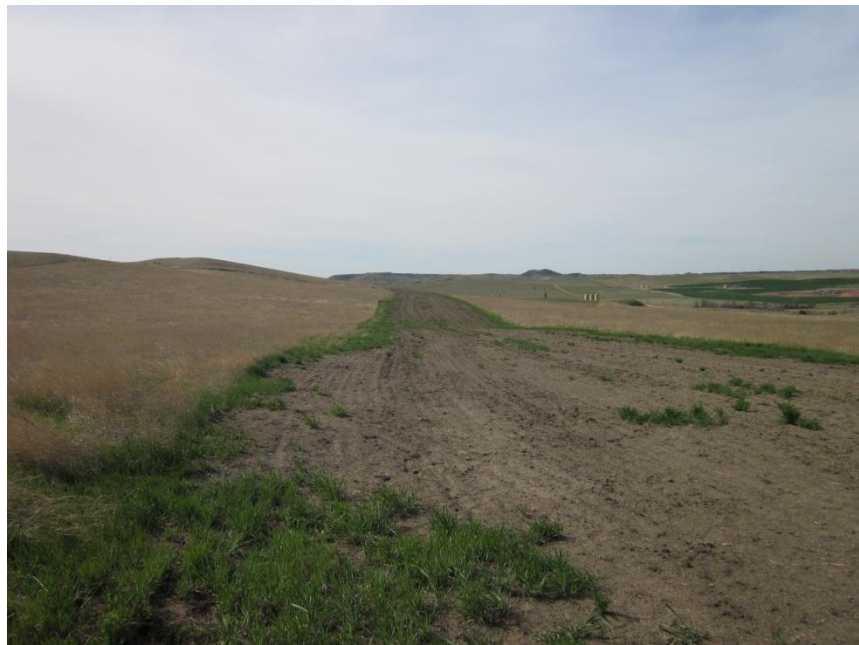
Photo 10. Direction: South. Pipeline right-of-way. Reseeding had occurred, but vegetation had yet to reclaim the disturbance.

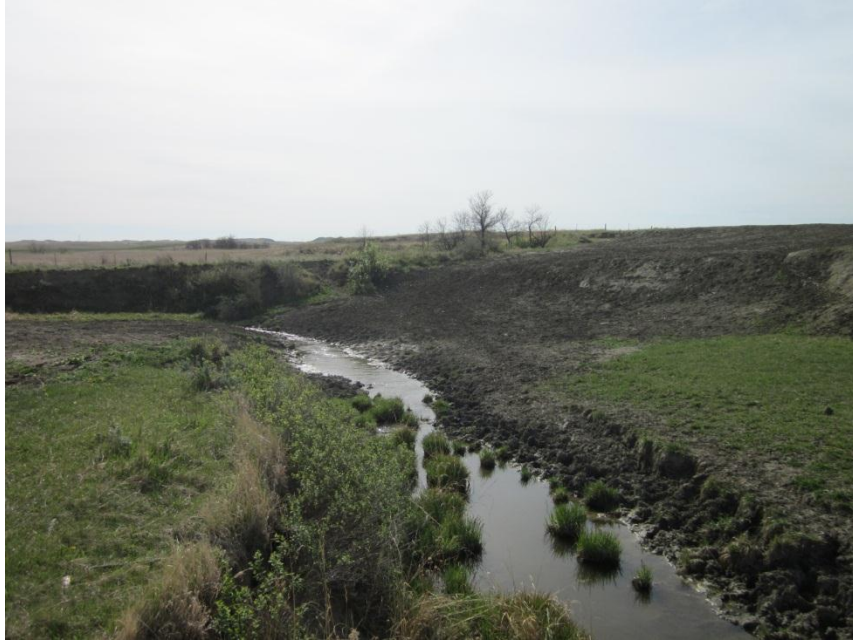
Photo 13. Direction: Southwest. Pipeline right-of-way. No erosion or sedimentation to the waterway was evident as a result of construction, but erosion controls were not in place at the time of the inspection. Steps to vegetate the slope should be done immediately to prevent erosion to the waterway

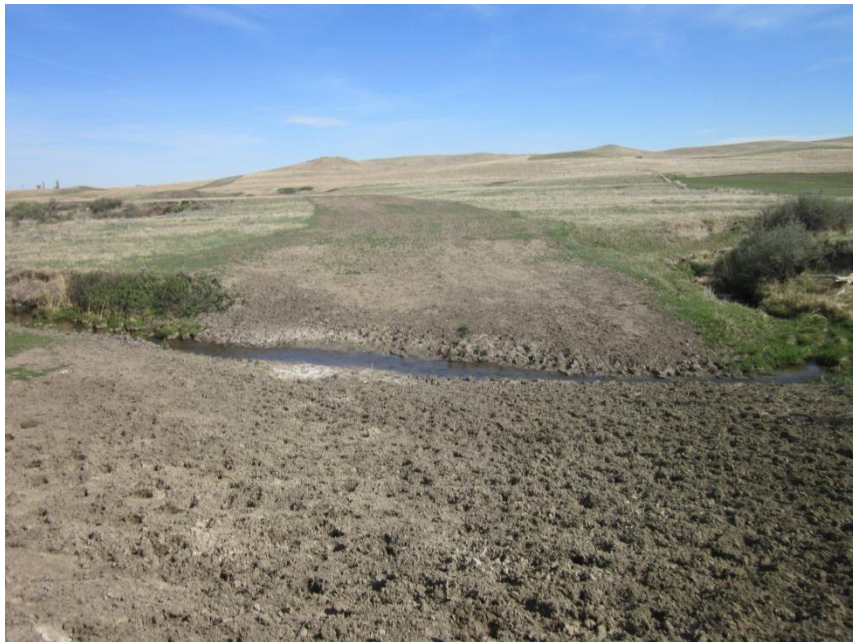
Photo 14. Direction: North. Photo shows Bridger's pipeline where it crosses Crooked Creek.

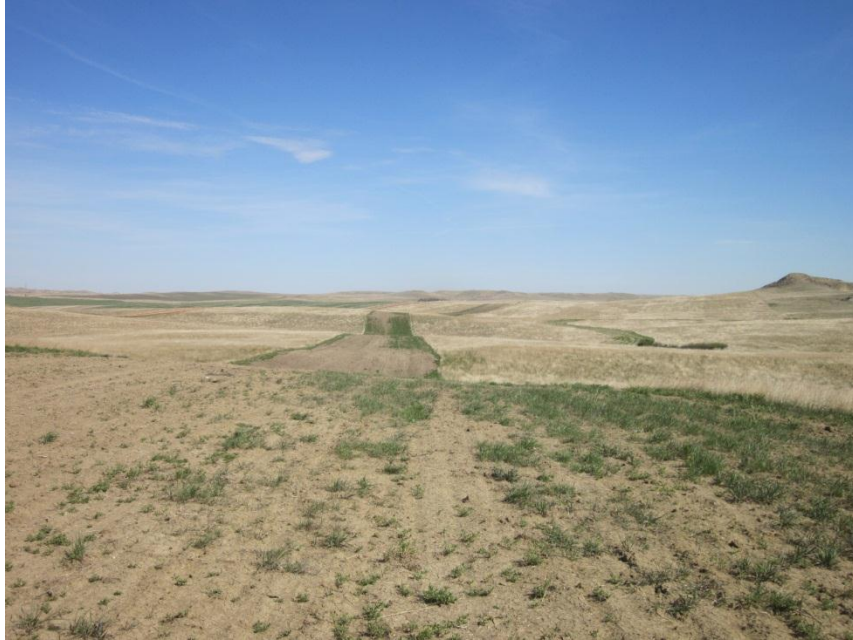
Photo 15. Direction: North. Pipeline right-of-way. Plants were beginning to reclaim some areas of disturbance.

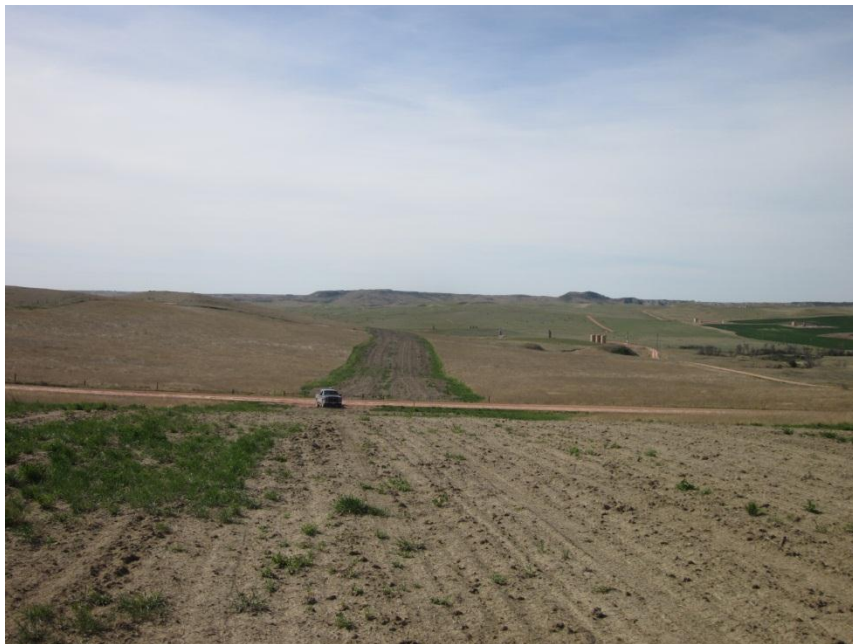
- *Graded Road Crossings Bored.* The Project bored under all graded roads throughout the route (**Appendix B, Photos 16, 46**). Wenck observed that the pipeline route was marked at these locations and that no settling or erosion to the roads was evident.

Photo 16. Direction: South. Pipeline right-of-way. Roadway was bored and in good condition.

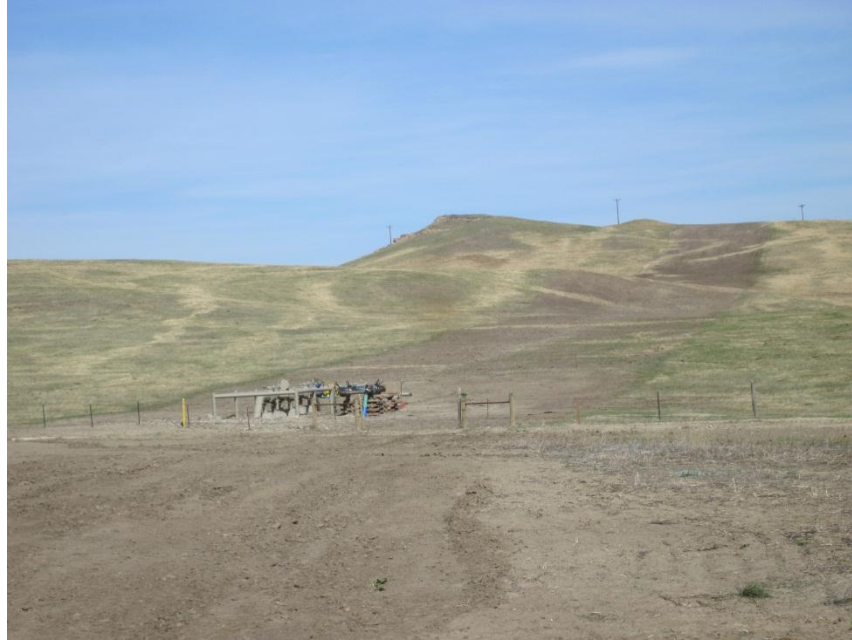
Photo 17. Direction: North. Pipeline right-of-way at the 15th St. valve setting. Note erosion control structures on the slope.

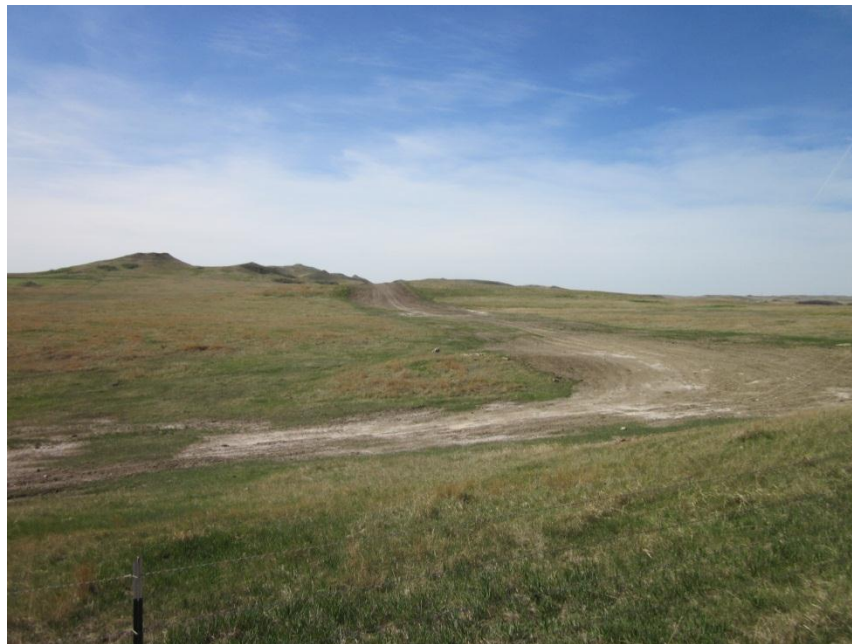
Photo 18. Direction: Southwest. Pipeline right-of-way. Reseeding had occurred, but vegetation had yet to reclaim the disturbance.

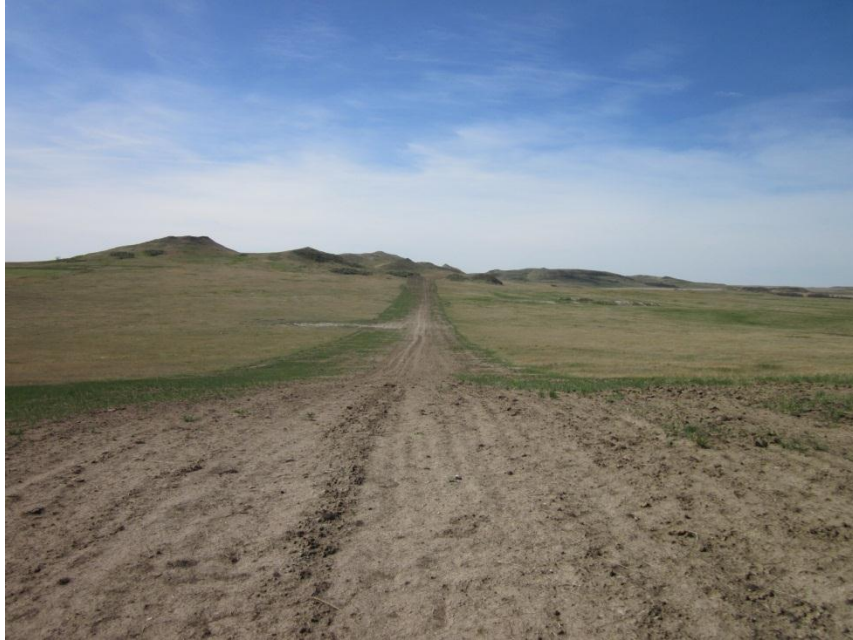
Photo 19. Direction: South. Pipeline right-of-way just north of Photo 18. Reseeding had occurred, but vegetation had yet to reclaim the disturbance.

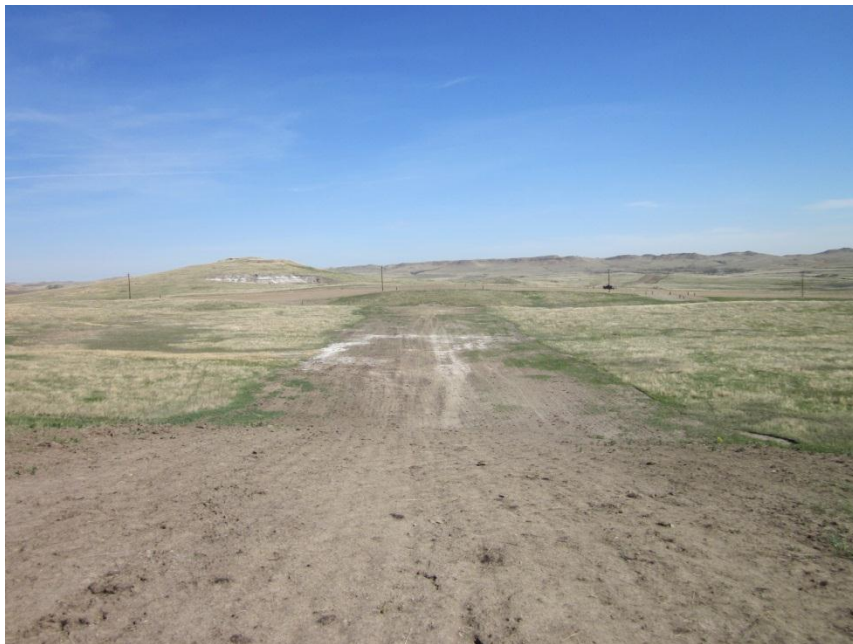
Photo 20. Direction: North. Pipeline right-of-way at the same location as Photo 19. Reseeding had occurred, but vegetation had yet to reclaim the disturbance.

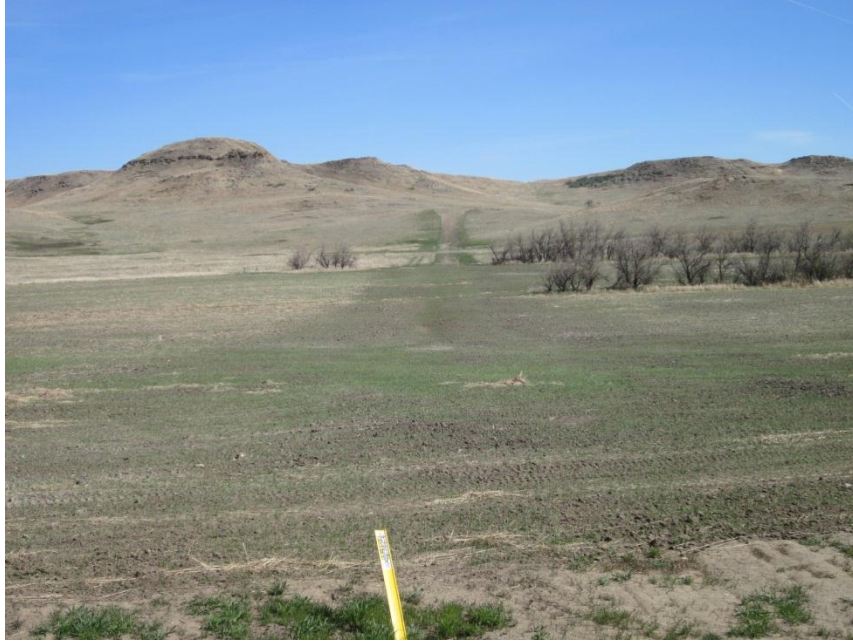
Photo 23. Direction: North. Pipeline right-of-way. Plants were beginning to reclaim the disturbance in this area.

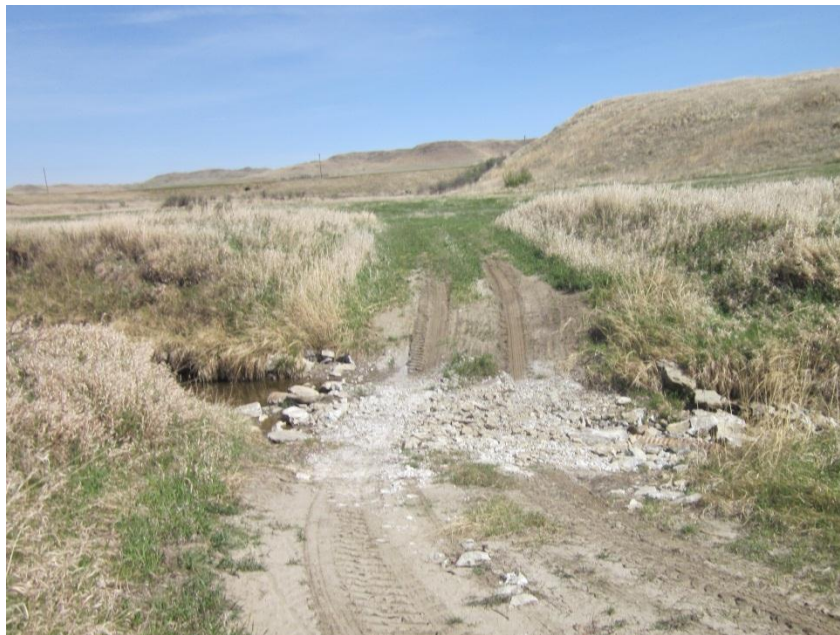
Photo 24. Direction: South. Access road for Bridger's pipeline where it crosses the Knife River. A culvert was used to preserve the waterway's natural flow patterns; no erosion or sedimentation was noted.

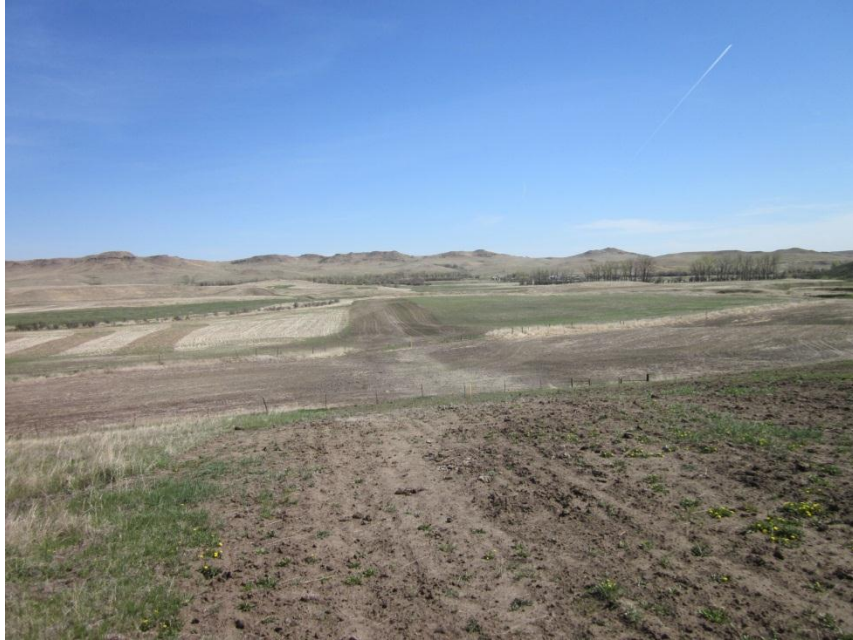
Photo 25. Direction: South. Pipeline right-of-way. Reseeding had occurred, but vegetation had yet to reclaim most areas.

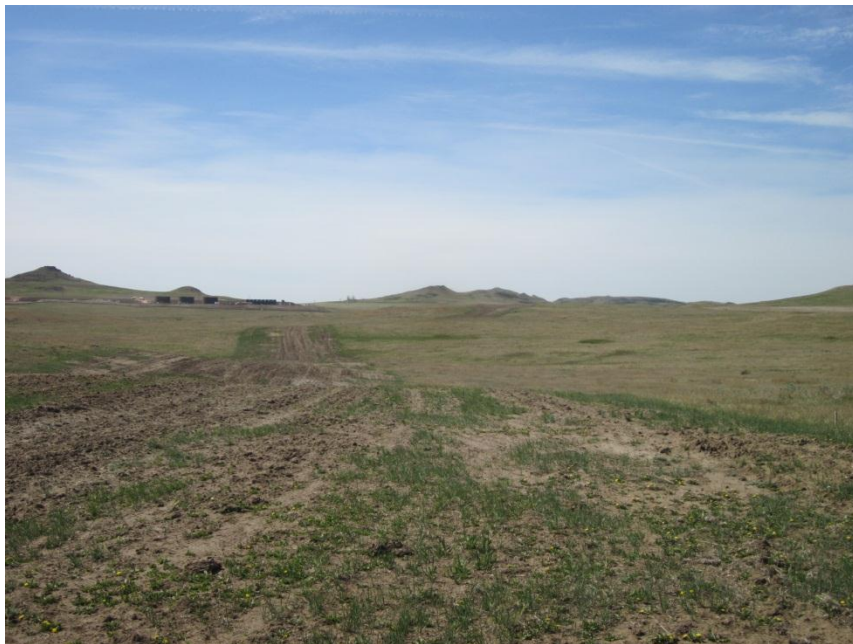
Photo 26. Direction: North. Pipeline right-of-way. Plants were beginning to reclaim the disturbance in this area.

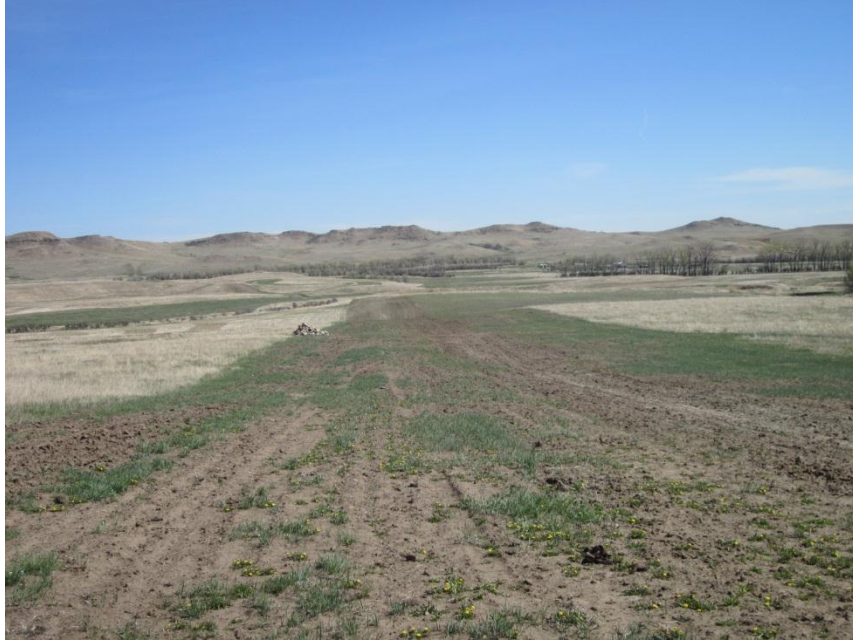
Photo 27. Direction: South. Pipeline right-of-way. Plants were beginning to reclaim the disturbance in this area.

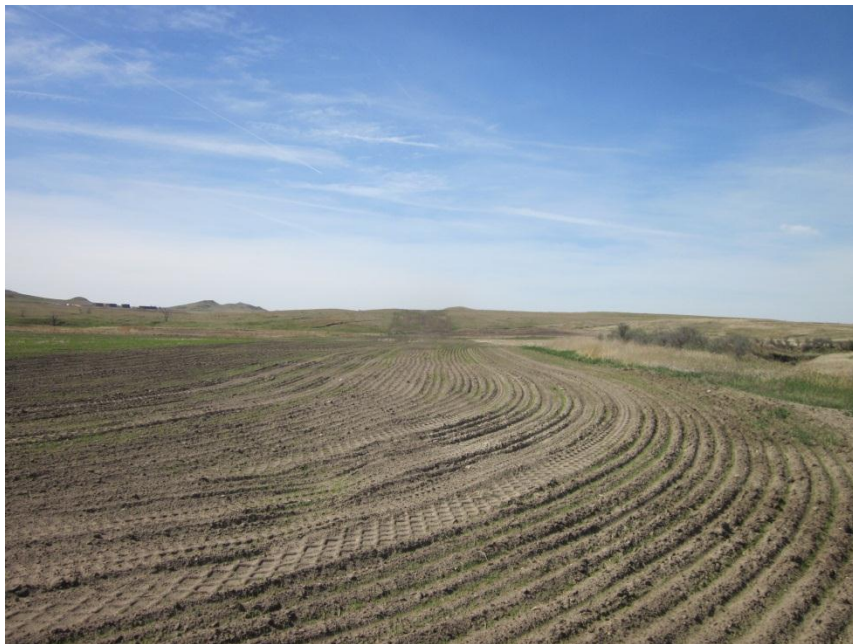
Photo 28. Direction: South. Pipeline right-of-way. This area had recently been planted by the landowner.

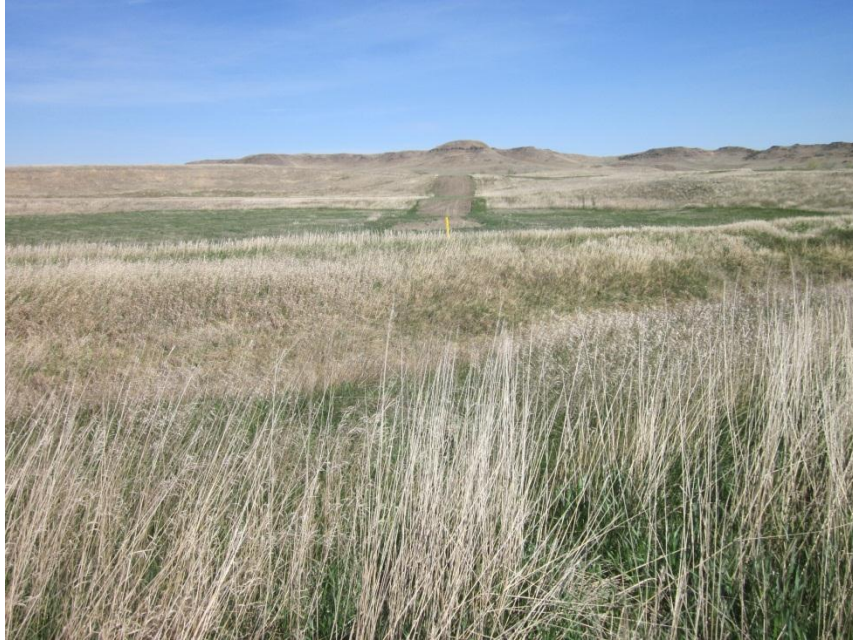
Photo 29. Direction: North. North of where Bridger’s pipeline bored under the Knife River. No erosion or sedimentation to the waterbody was evident.

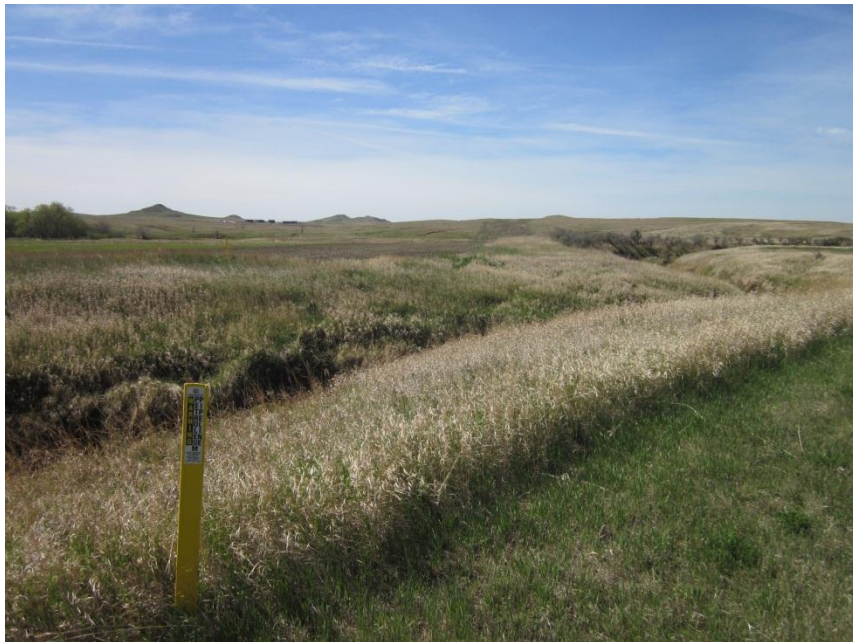
Photo 30. Direction: South. South of where Bridger’s pipeline bored under the Knife River. No erosion or sedimentation to the waterbody was evident.

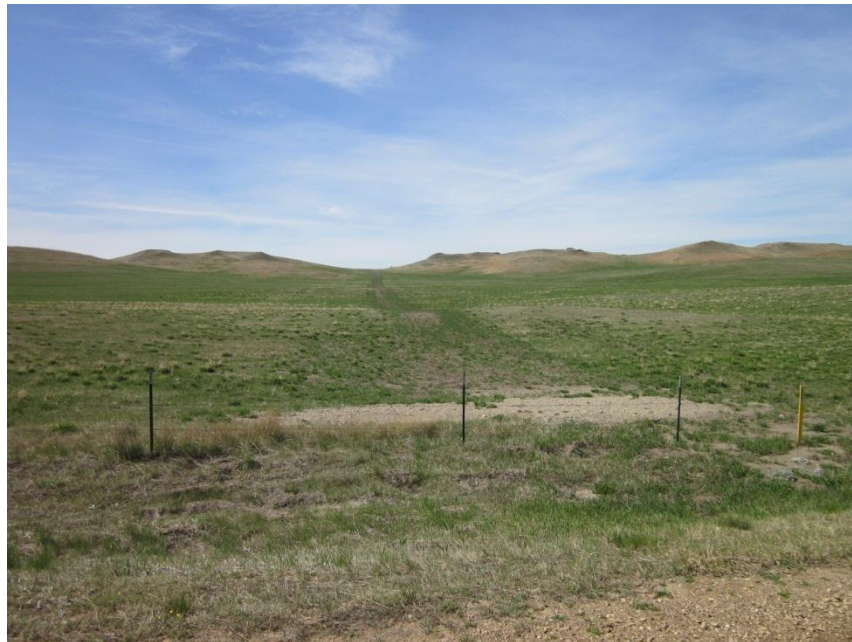
Photo 32. Direction: South. Pipeline right-of-way. This area was nearly completely reclaimed by vegetation.

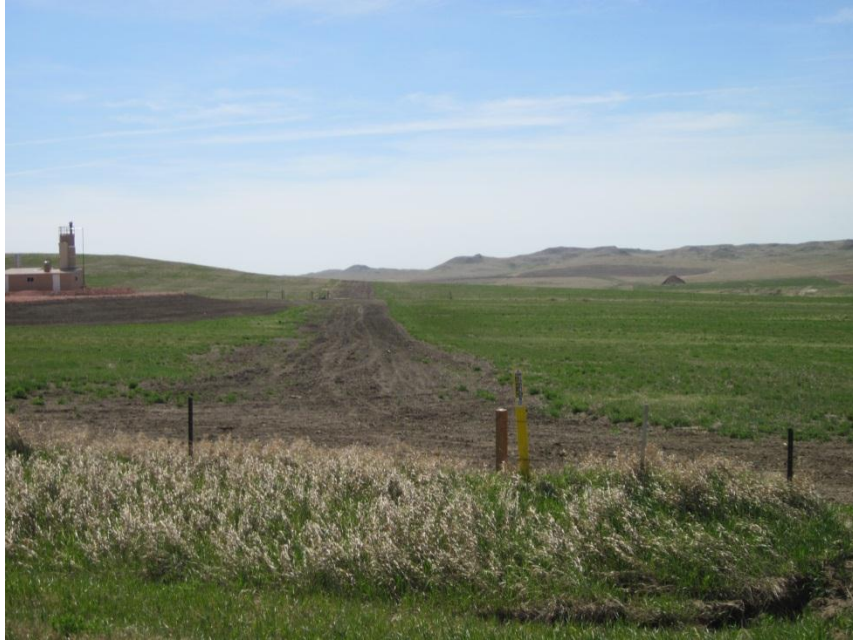
Photo 33. Direction: South. Pipeline right-of-way. Reseeding had occurred, but vegetation had yet to reclaim the disturbance.

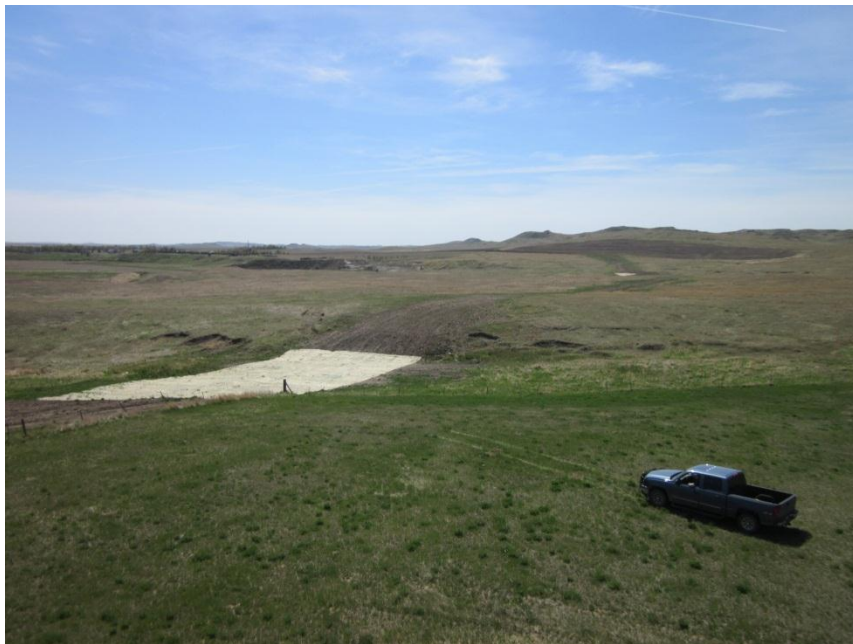
Photo 34. Direction: Southeast. Pipeline right-of-way. Grass mats had been placed for erosion control at the request of landowner.

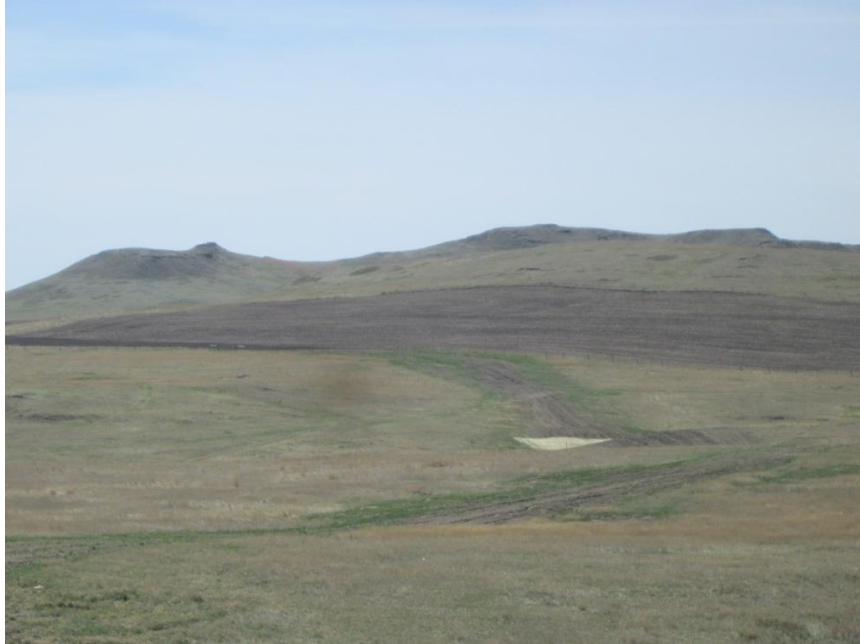
Photo 35. Direction: Southeast. Pipeline right-of-way. Grass mats had been placed for erosion control at the request of landowner.

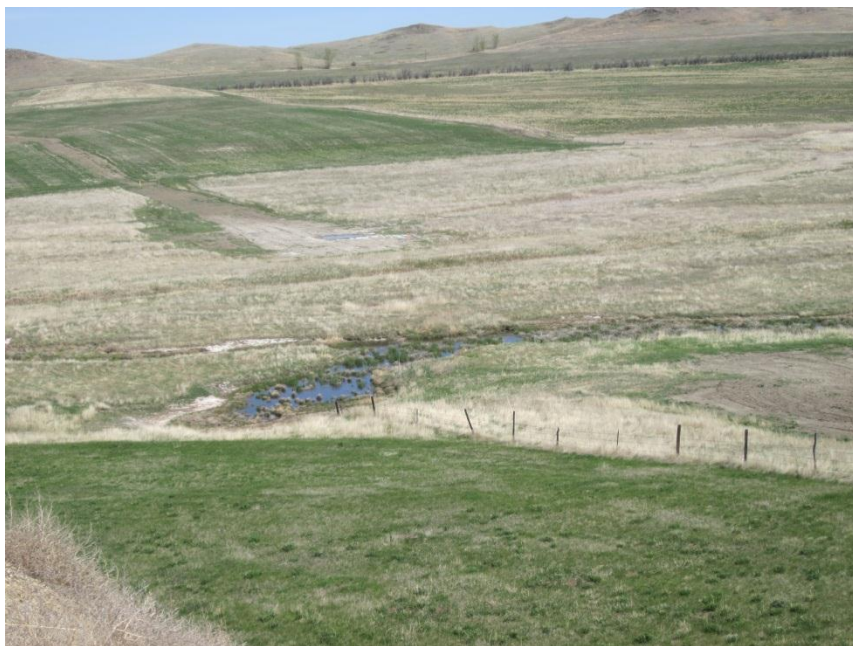
Photo 36. Direction: Northeast. Pipeline right-of-way where it was bored under the Little Knife River. No erosion or sedimentation to the waterbody was evident.

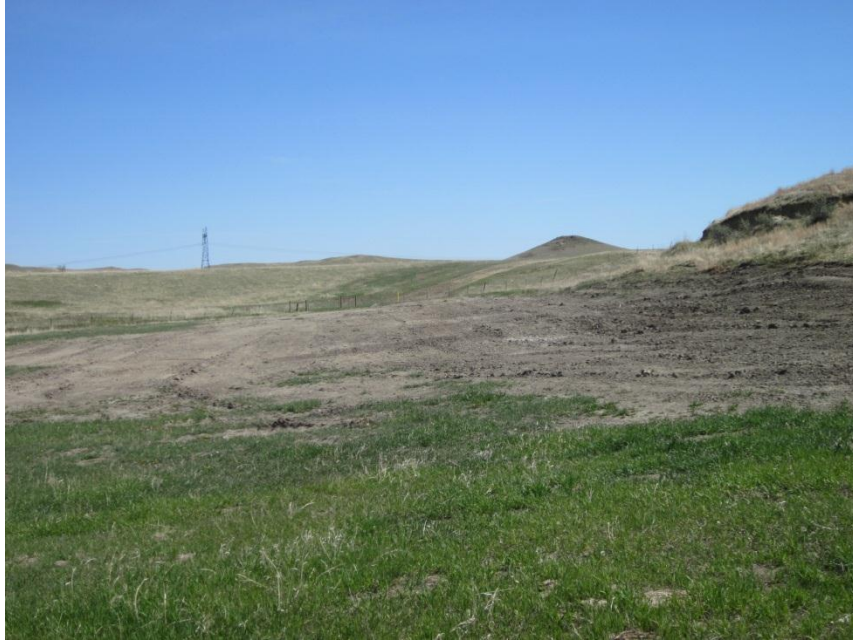
Photo 37. Direction: Northeast. Pipeline right-of-way. A seep in the side of the hill caused erosion problems during construction, but restoration appeared to have ameliorated any permanent construction impacts.

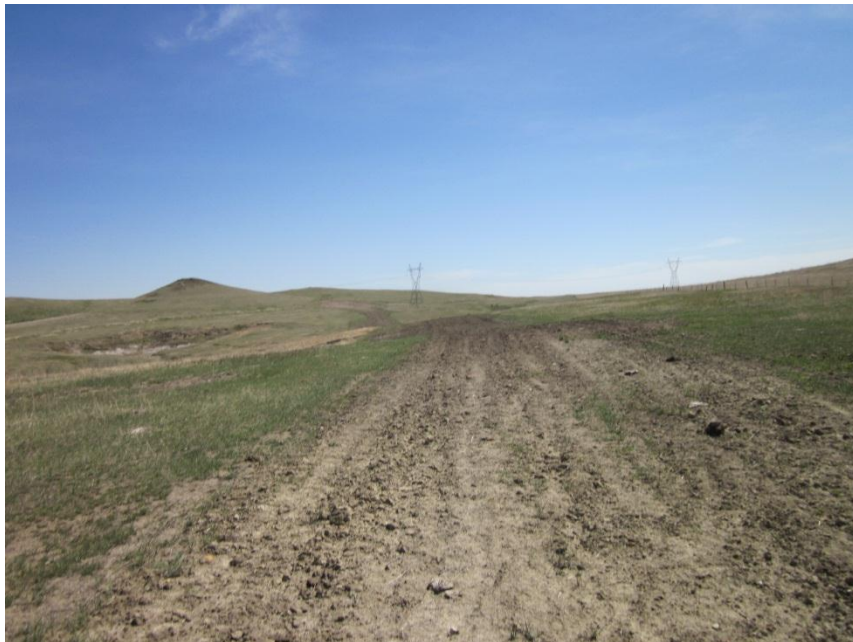
Photo 38. Direction: Northeast. Pipeline right-of-way. Reseeding had occurred, but vegetation had yet to reclaim the disturbance.

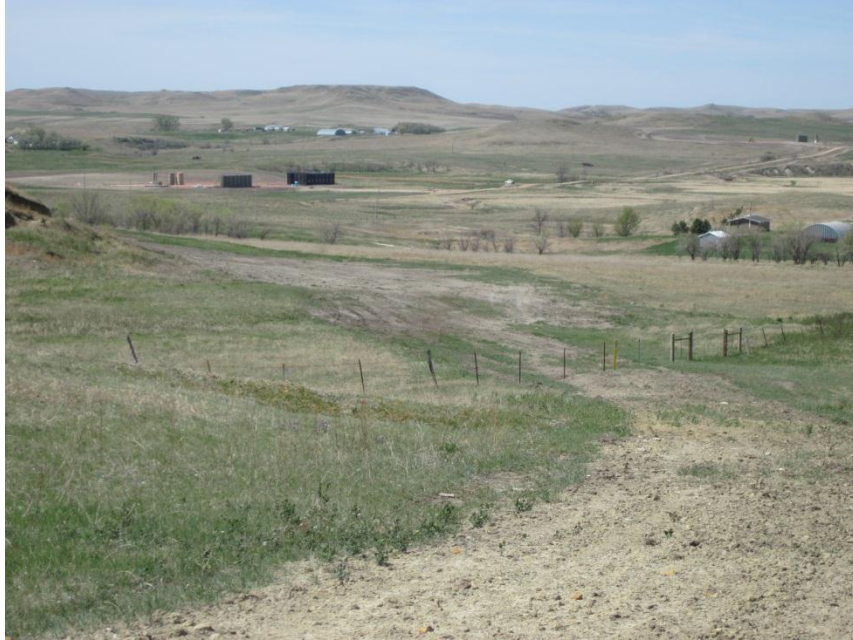
Photo 39. Direction: Southwest. Pipeline right-of-way. Reseeding had occurred, but vegetation had yet to reclaim the disturbance.

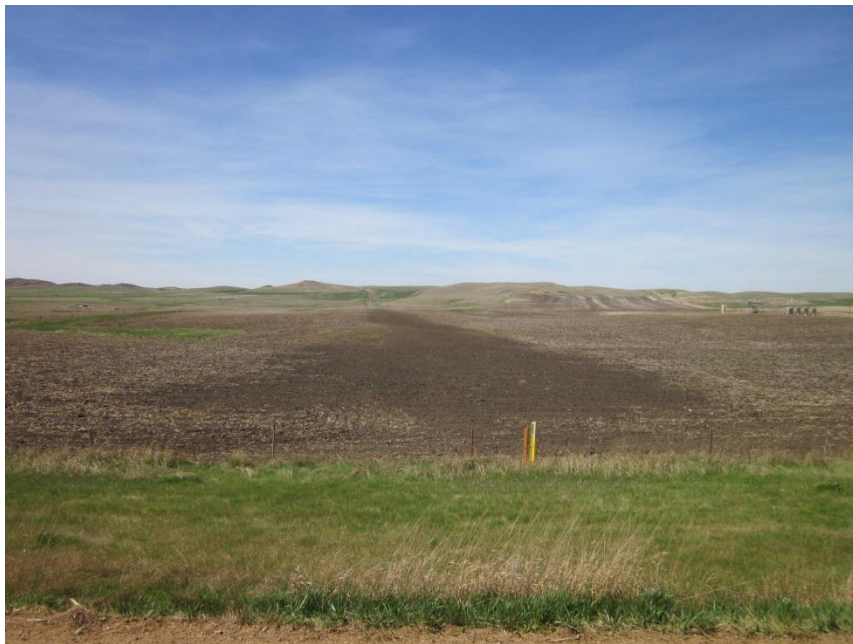
Photo 40. Direction: Southeast. Pipeline right-of-way. It appeared the landowner had seeded the field at the time of the inspection.

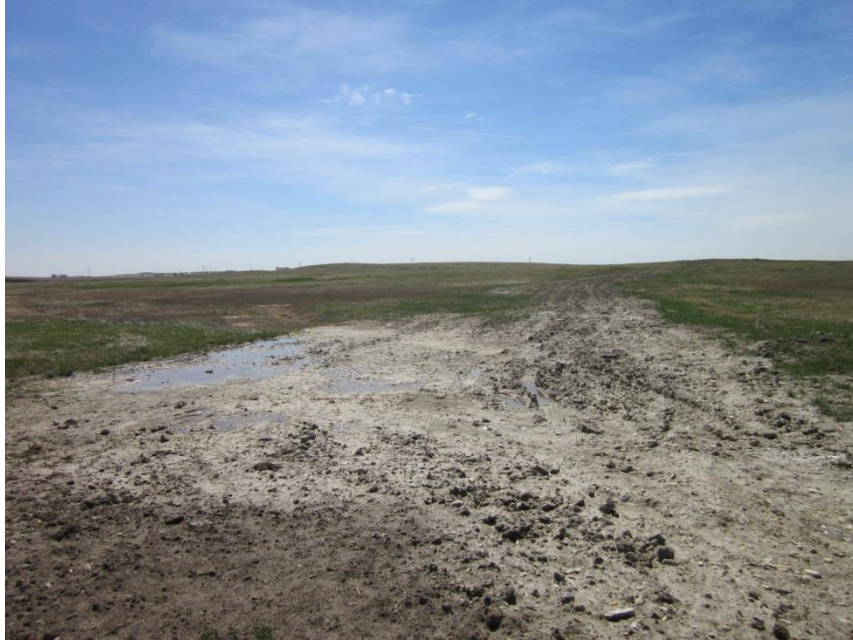
Photo 41. Direction: South. Photo shows the right-of-way of Bridger’s pipeline north of a wetland crossing. There was some ponding of water along the right-of-way.

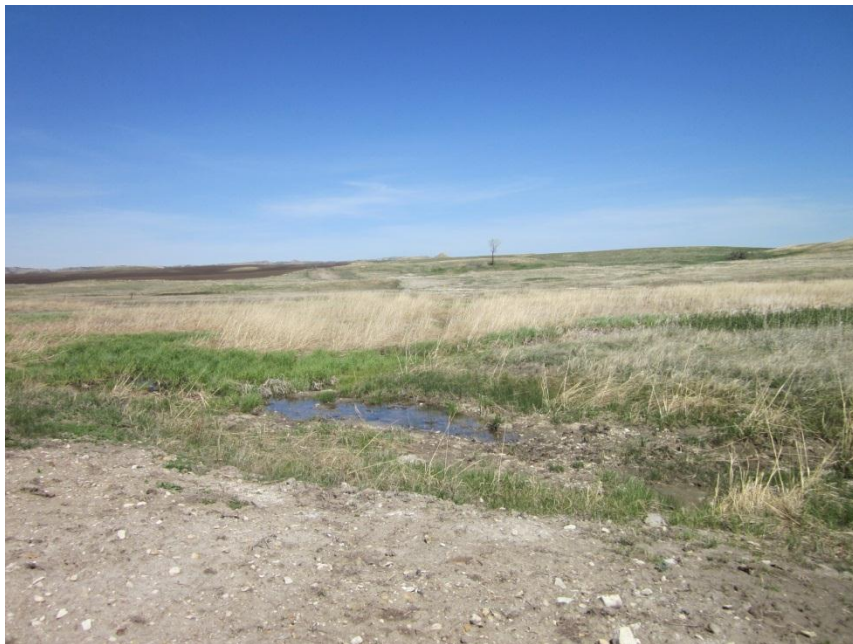
Photo 42. Direction: South. Photo shows an area where Bridger’s pipeline bored under a wetland. No erosion or sedimentation to the water body was evident. Some ponding was noted on the right-of-way.

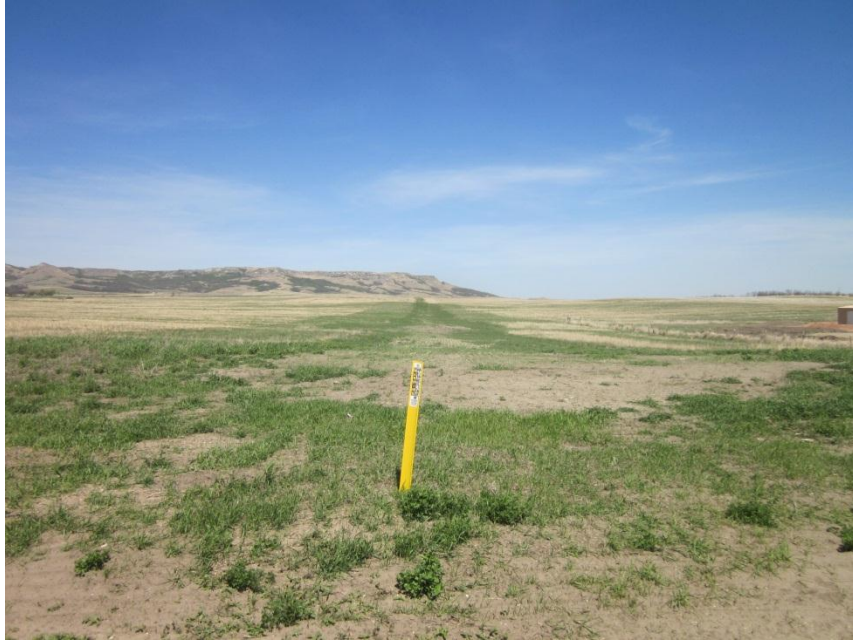
Photo 43. Direction: North. Pipeline right-of-way. Vegetation appeared to have reclaimed some areas.

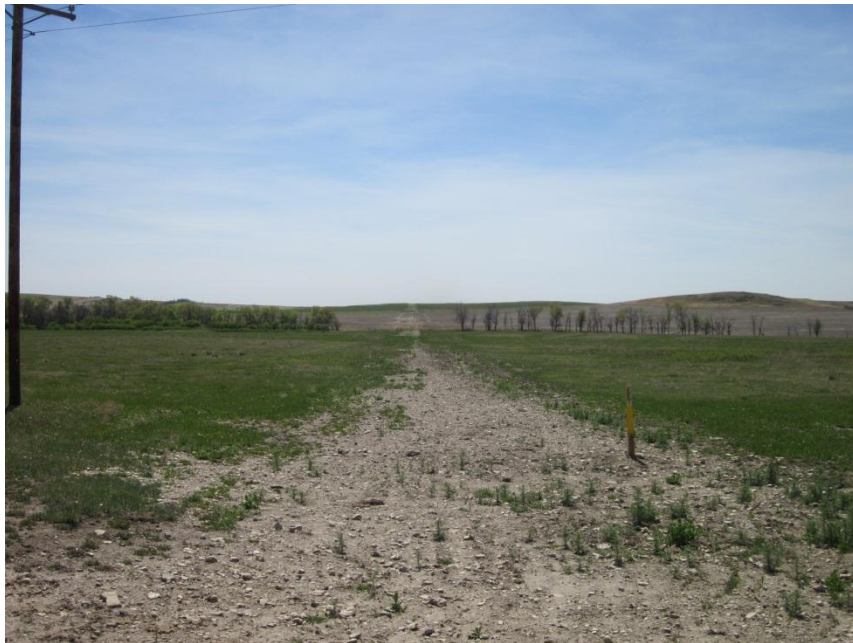
Photo 44. Direction: South. Photo shows the right-of-way of Bridger's pipeline in an area with rocky soils. Rocks had been picked prior to reseeding but it appeared some resurfaced.

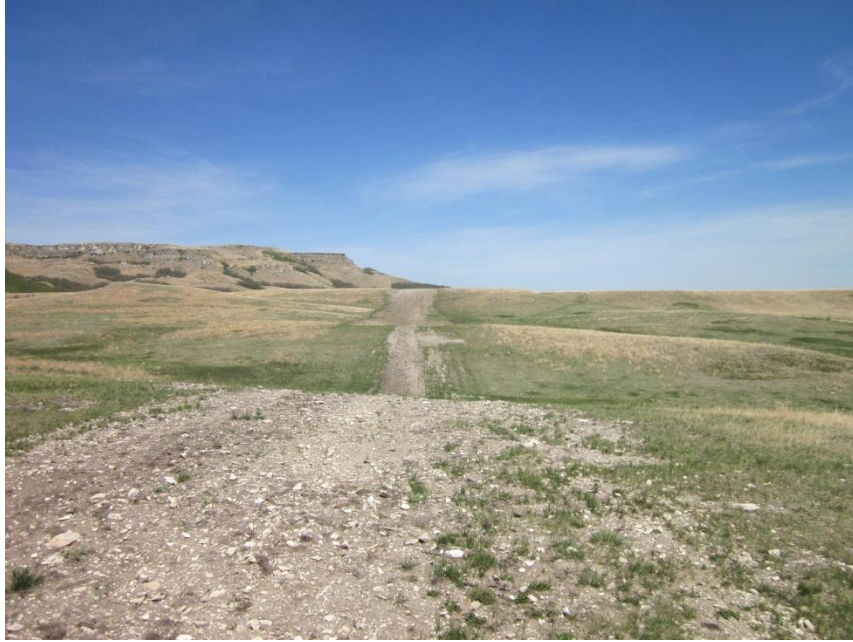
Photo 45. Direction: North. Photo shows the right-of-way of Bridger’s pipeline in an area with rocky soils. Rocks had been picked prior to reseeding but it appeared some resurfaced.

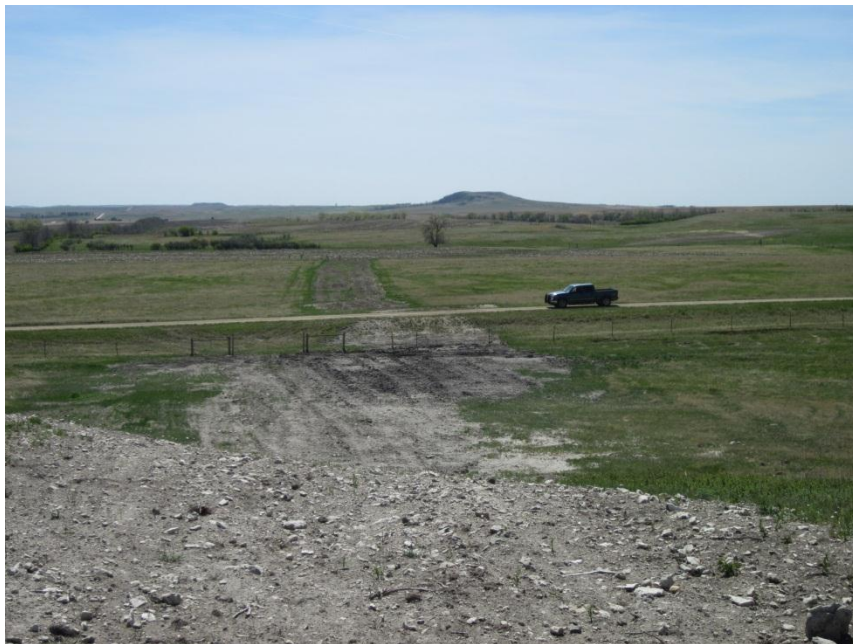
Photo 46. Direction: South. Photo shows the right-of-way of Bridger’s pipeline. Roadway was bored and in good condition.
