***Bridger Four
Bears Pipeline
Phase 2
Construction
Inspection Report***

***Bridger Pipeline,
L.L.C.***

PU-09-750

June 2012

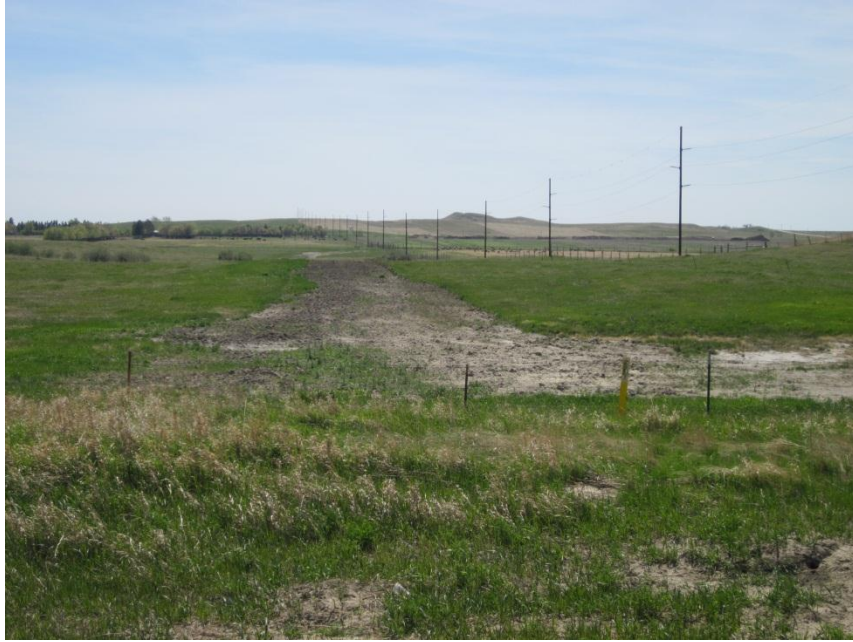
Photo 47. Direction: South. Pipeline right-of-way. Disturbance was beginning to be reclaimed by vegetation in some areas.

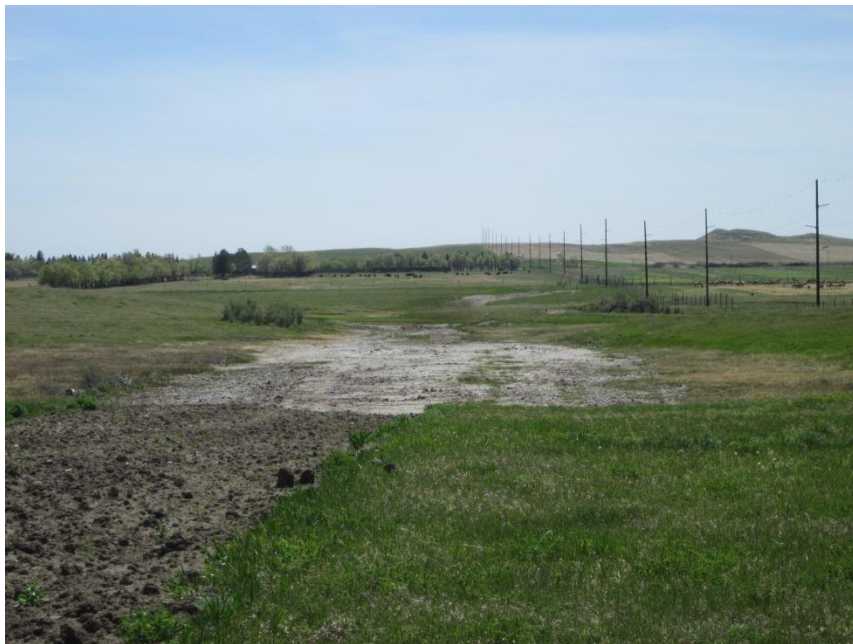
Photo 48. Direction: South. Pipeline right-of-way. This wet area had caused construction problems, but restoration appeared to have ameliorated any permanent impacts.

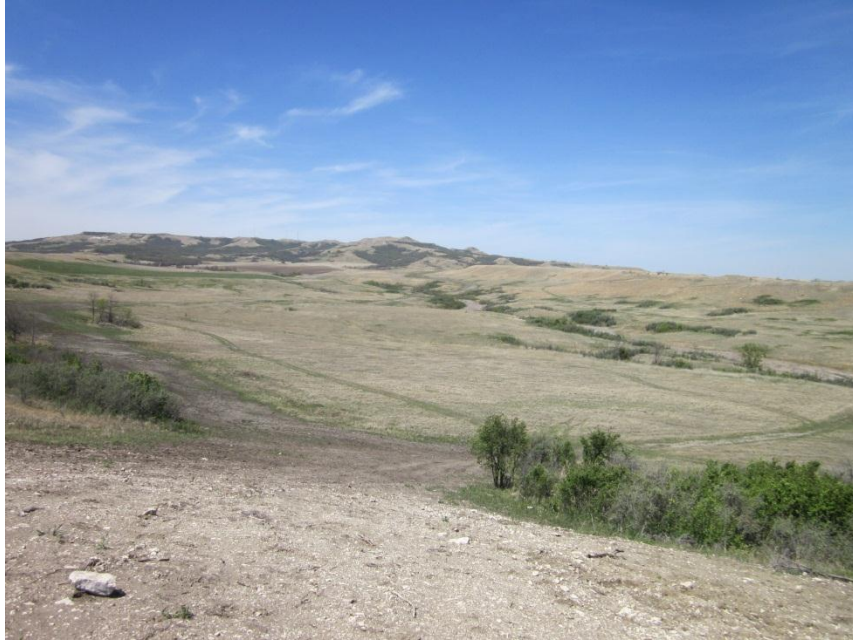
Photo 49. Direction: Northeast. Pipeline right-of-way. Disturbance appeared to have been limited to 50ft where the pipeline routed through this wooded area.

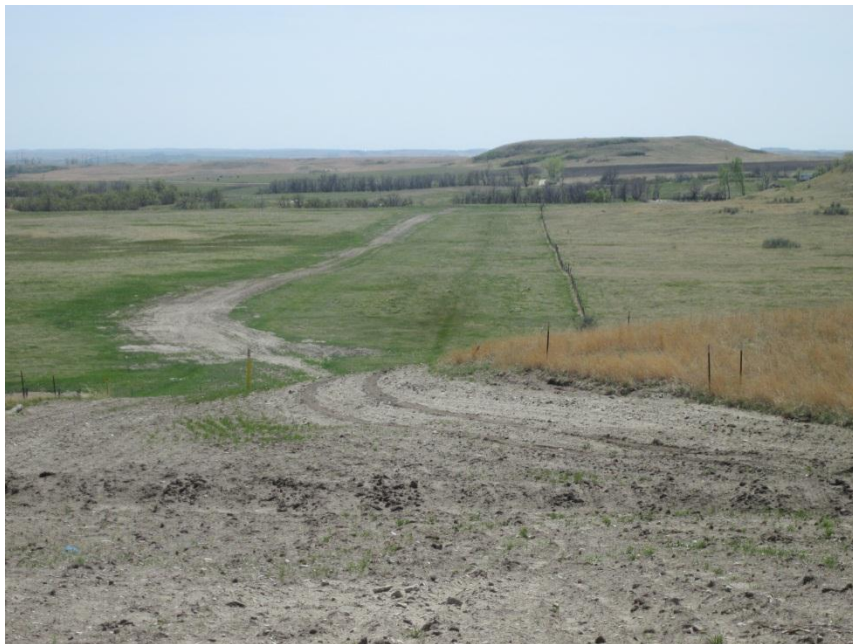
Photo 50. Direction: South. Pipeline right-of-way. Vegetated area in the right side of photo was a historic site that had been avoided.

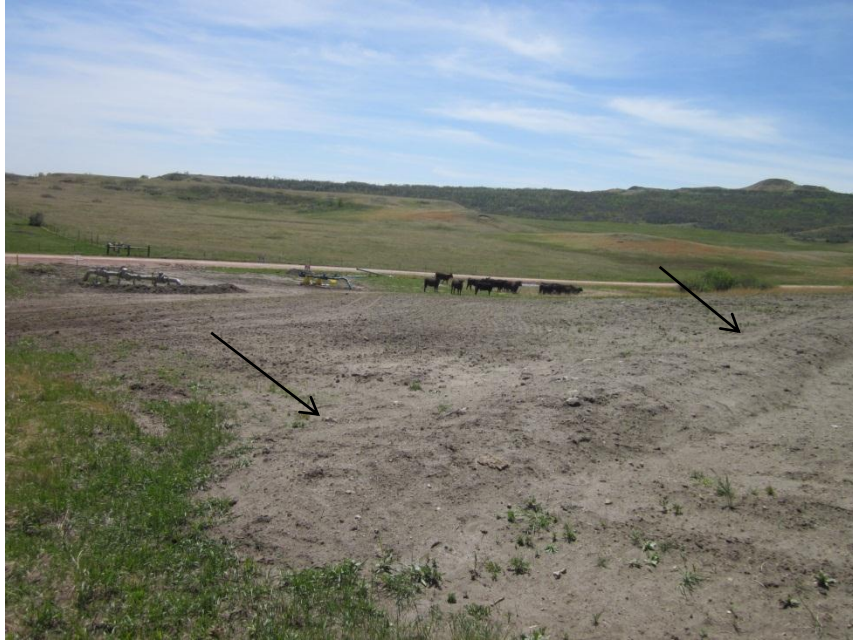
Photo 51. Direction: Southwest. Photo shows erosion control water bar (indicated by arrows) in place at Bridger's 7th St. valve setting.

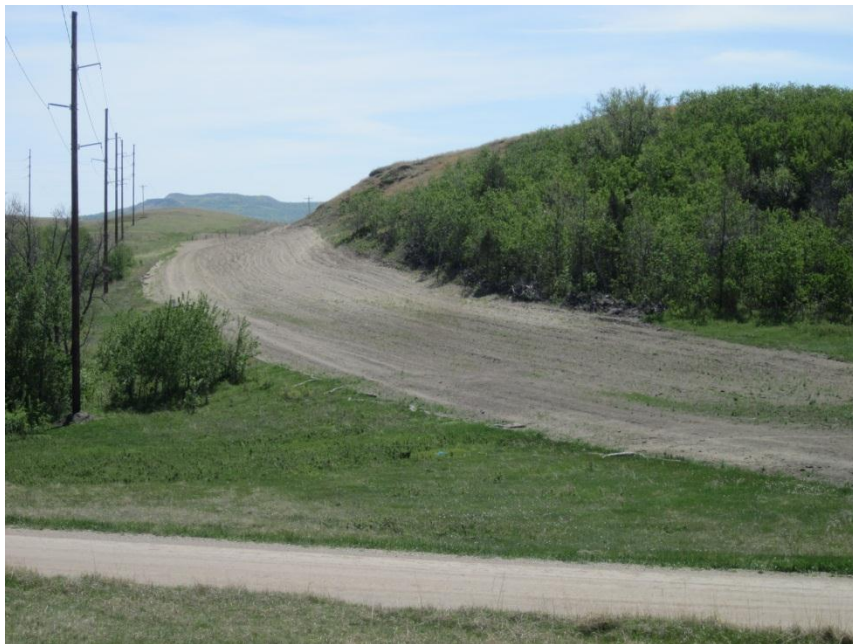
Photo 52. Direction: South. Pipeline right-of-way. Disturbance had been limited to 50ft where the pipeline routed through this wooded area.

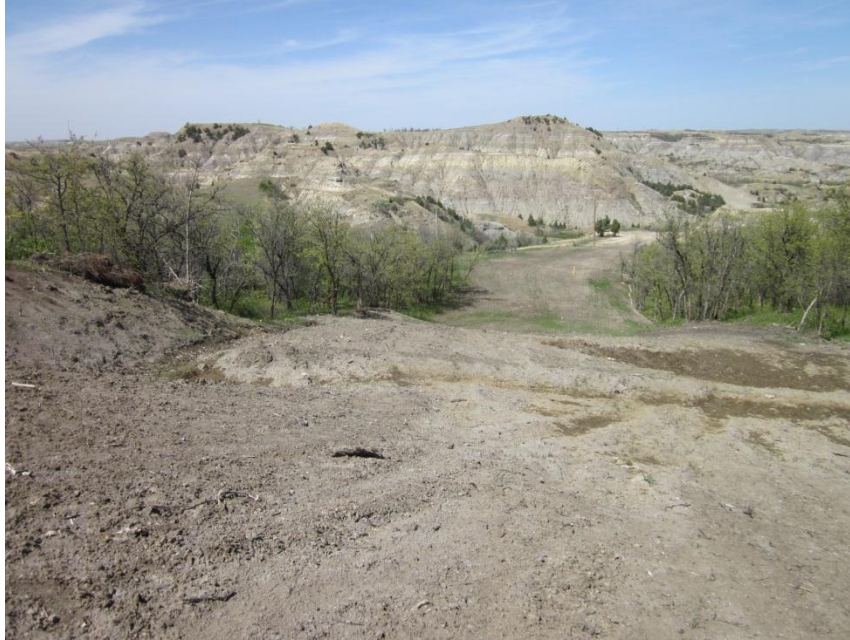
Photo 53. Direction: South. Pipeline right-of-way. Drainage problems caused major erosion in this area last year. Restoration by hauling in soil and channeling water (Photo 54) through the area appeared to have controlled erosion.

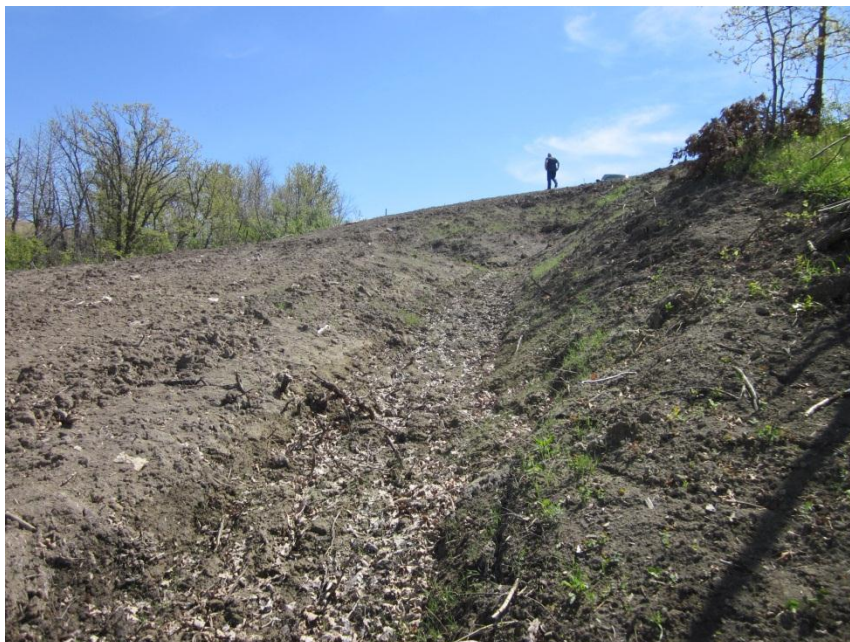
Photo 54. Direction: North. Channel created to prevent erosion. Note some vegetation growing on the slope, which should further stabilize the area. However, this area should be monitored closely to make sure vegetation fully recolonizes the area.

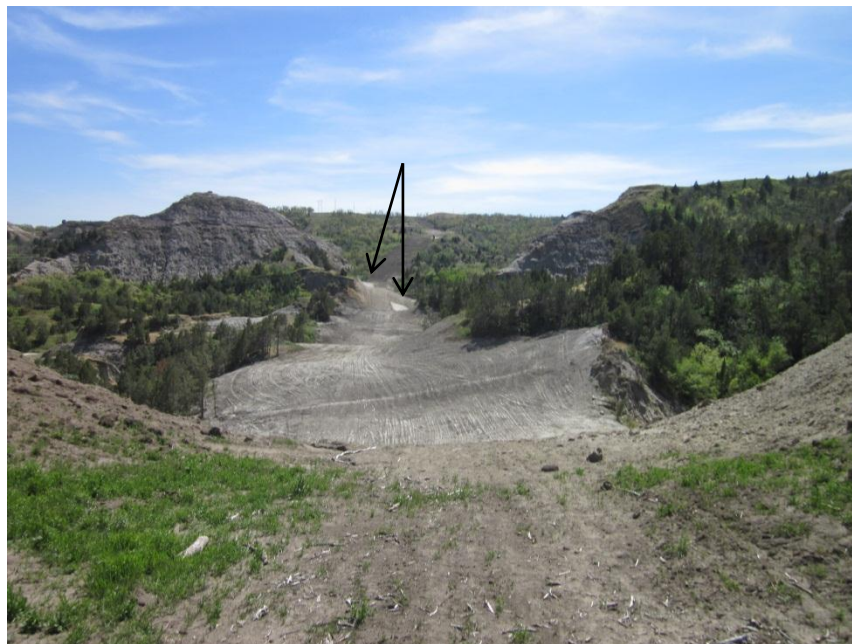
Photo 56. Direction: South. Pipeline right-of-way. Note grass mats in place to prevent erosion (indicated by arrows).

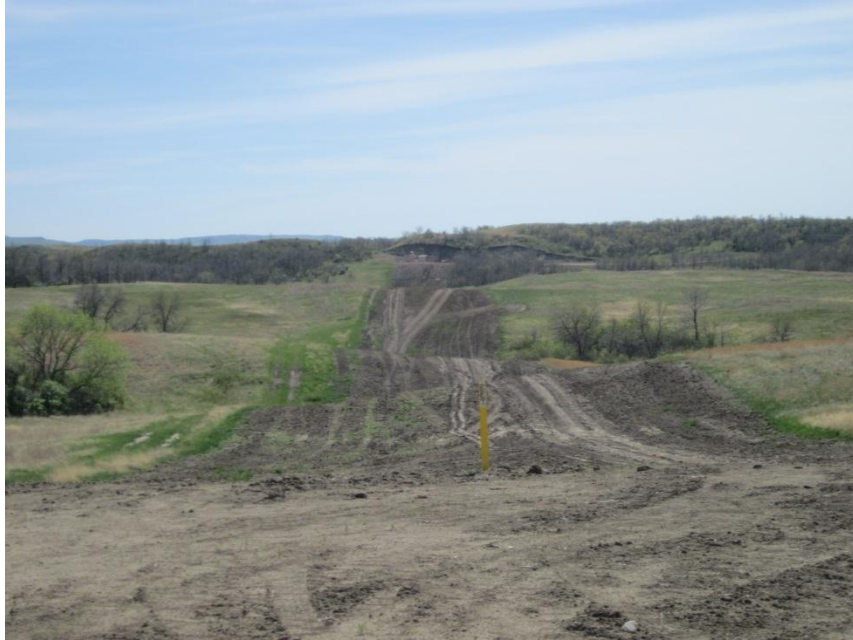
Photo 57. Direction: South. Pipeline right-of-way. Restoration and reseeded had occurred, but vegetation had yet to reclaim the area.

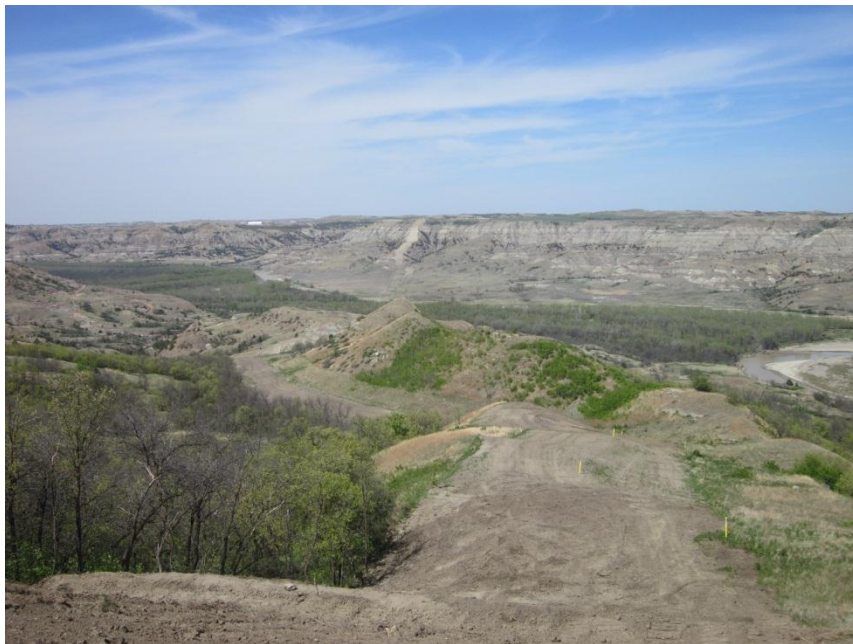
Photo 58. Direction: Northwest. Low soil cohesion caused major erosion problems. Soil was hauled in and water bars were installed. The slope appeared to be stabilized.

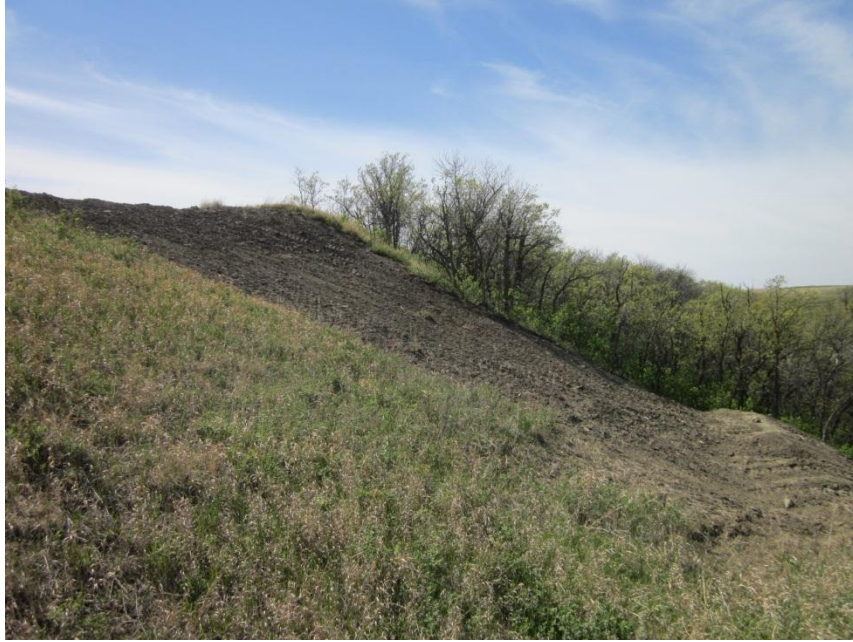
Photo 59. Direction: West. Note water bar and soil recontouring on the slope.

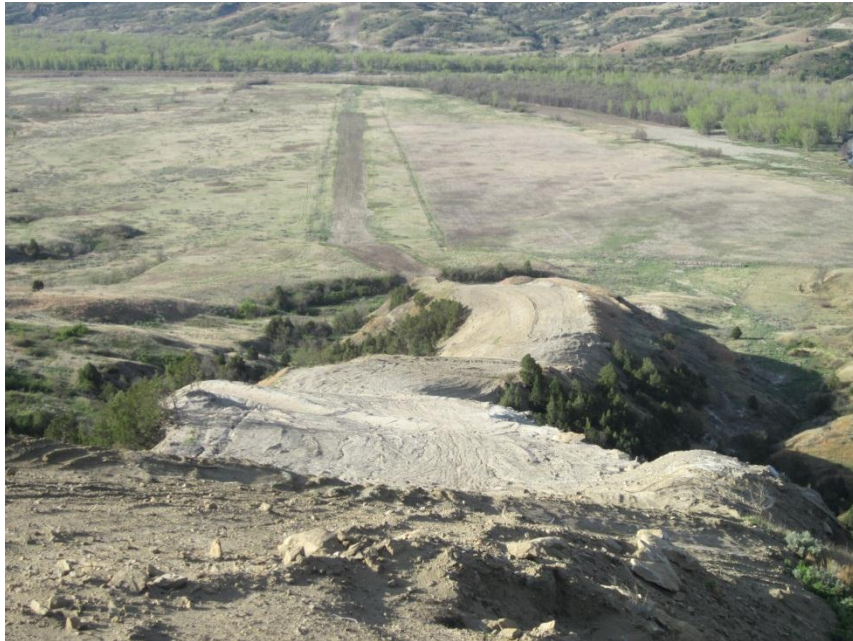
Photo 60. Direction: South. Photo shows the right-of-way of Bridger's pipeline north of the Little Missouri. Recontouring and water bars controlled erosion, but vegetation had yet to reclaim the slope.

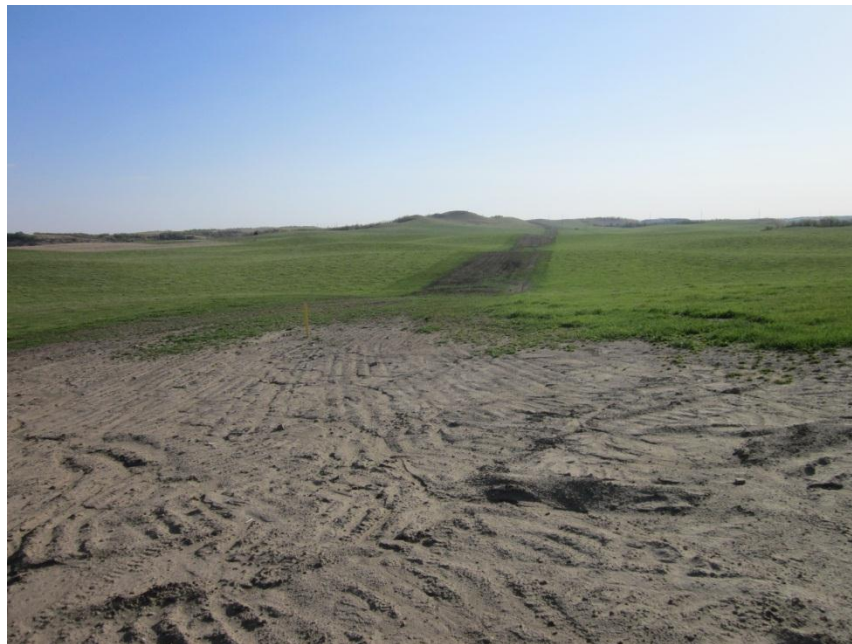
Photo 62. Direction: Northeast. Pipeline right-of-way. Vegetation had reclaimed some areas of the right-of-way.

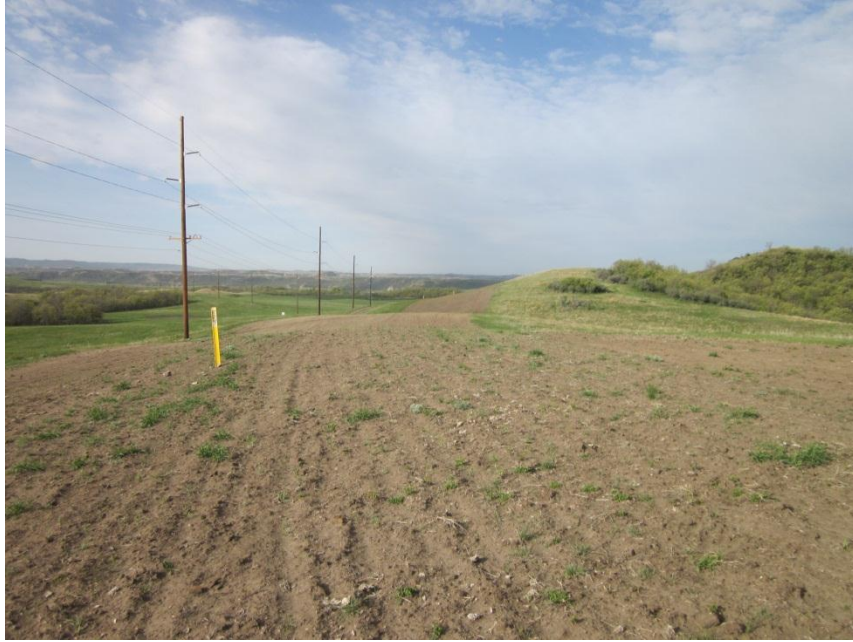
Photo 63. Direction: East. Pipeline right-of-way. Reseeding had occurred, but vegetation had yet to reclaim the disturbance.

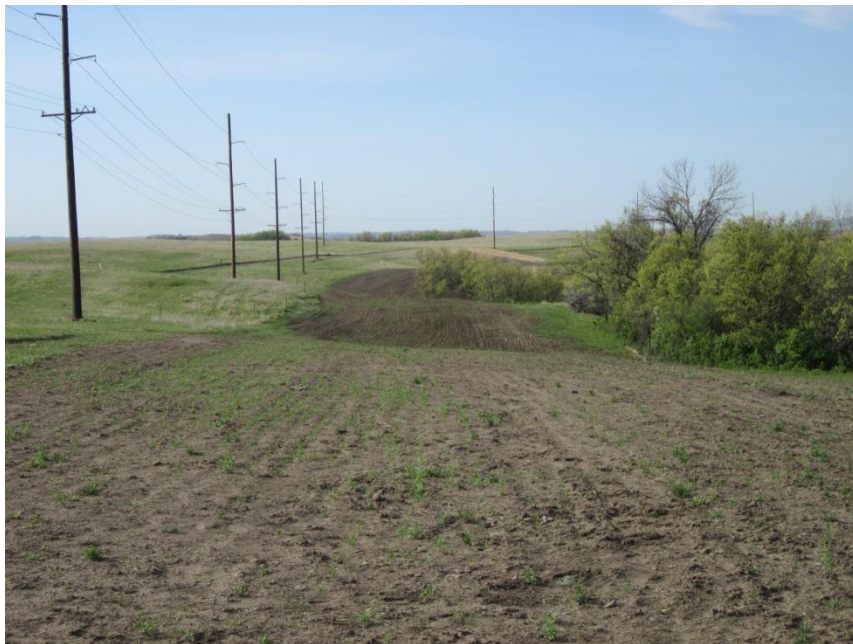
Photo 64. Direction: South. Pipeline right-of-way. Disturbance to the woody area was minimal and the corridor limited to 50ft.

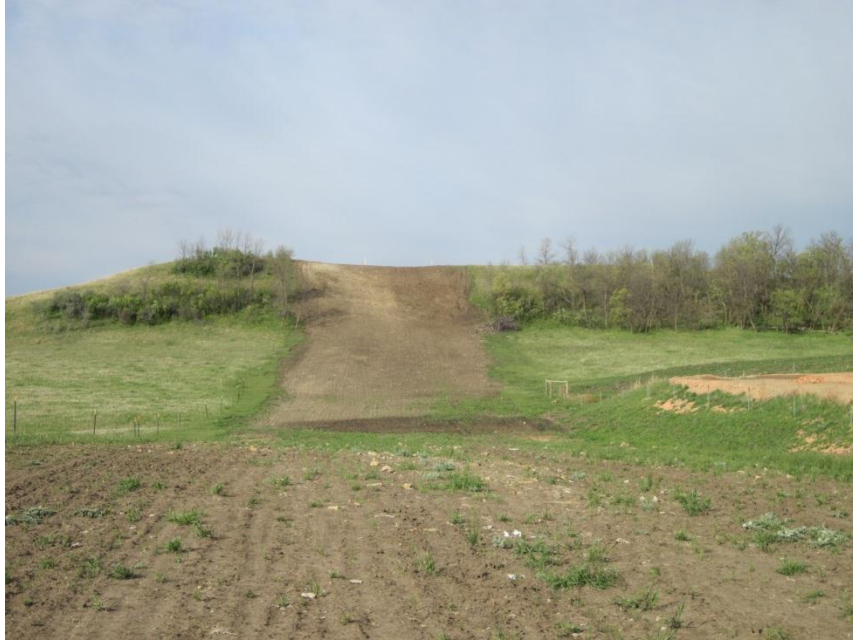
Photo 65. Direction: West. Photo shows the right-of-way of Bridger’s pipeline routing through a wooded area. The cut appeared to have been limited to 50ft.

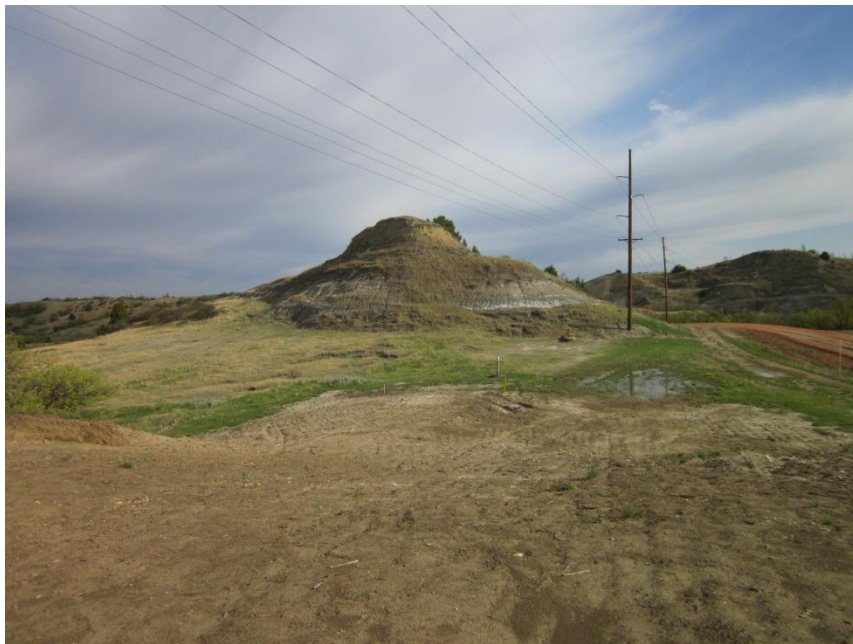
Photo 66. Direction: North. South of where Bridger’s pipeline bores under a badland butte.

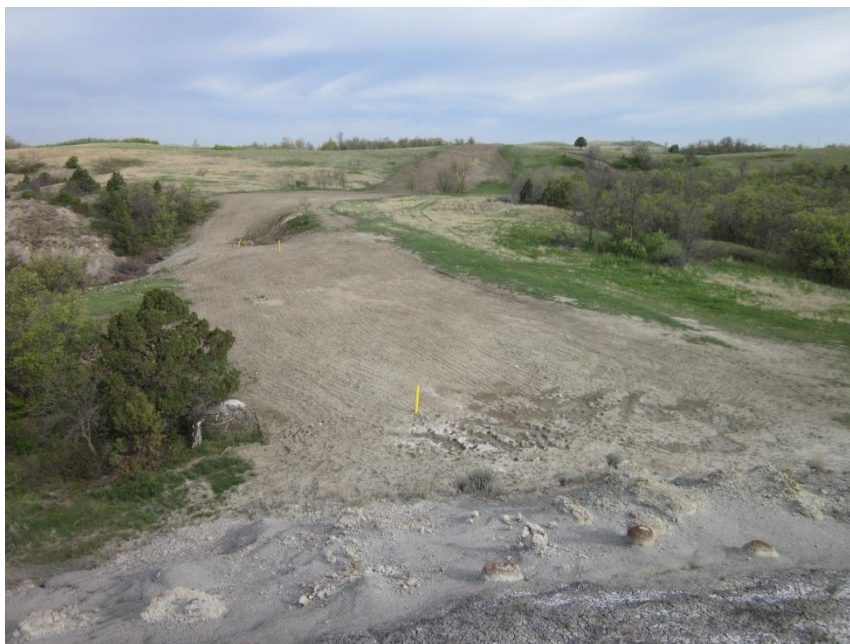
Photo 68. Direction: South. Pipeline right-of-way. Reseeding had occurred, but vegetation had yet to reclaim the area.

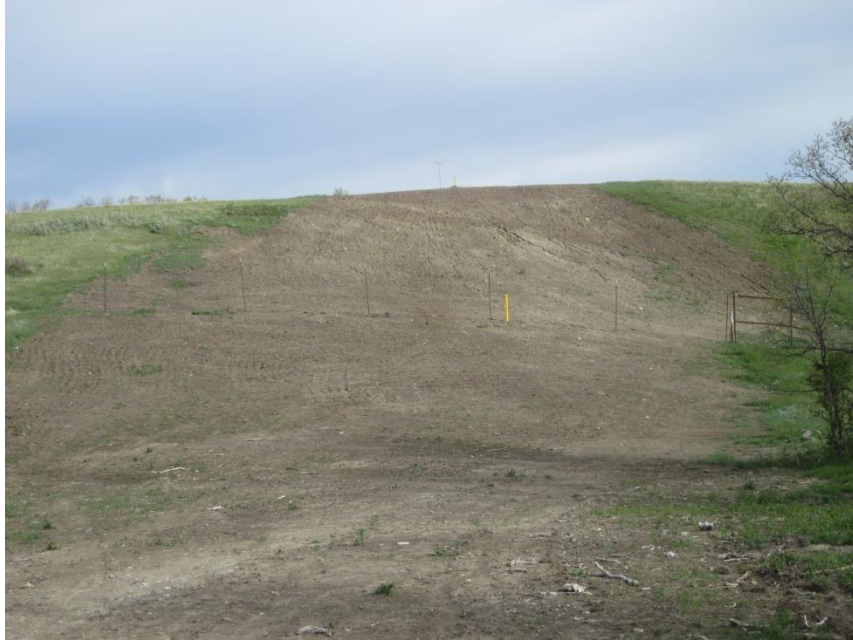
Photo 69. Direction: North. Pipeline right-of-way. Note buffalo fence that had been replaced.

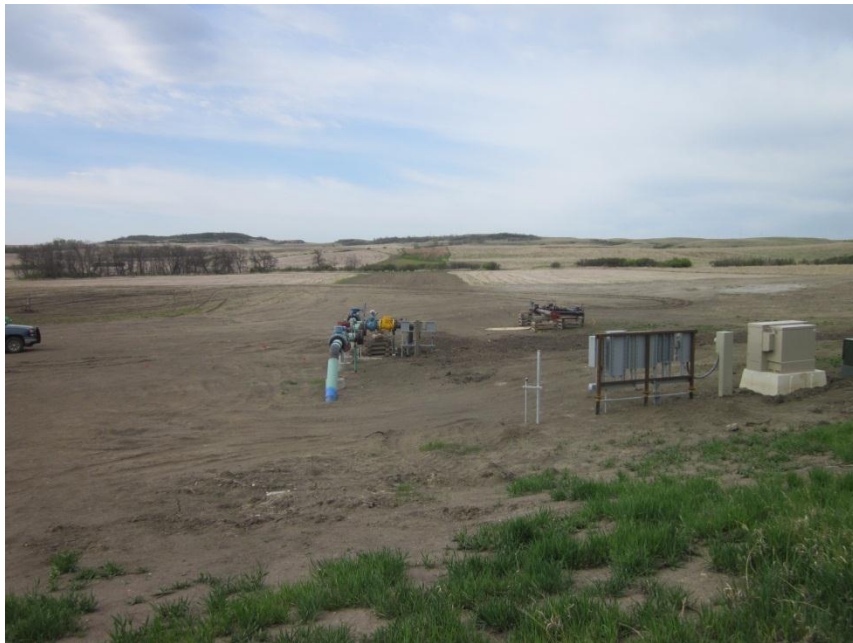
Photo 70. Direction: South. Photo shows the right-of-way of Bridger's pipeline 73rd interconnect.

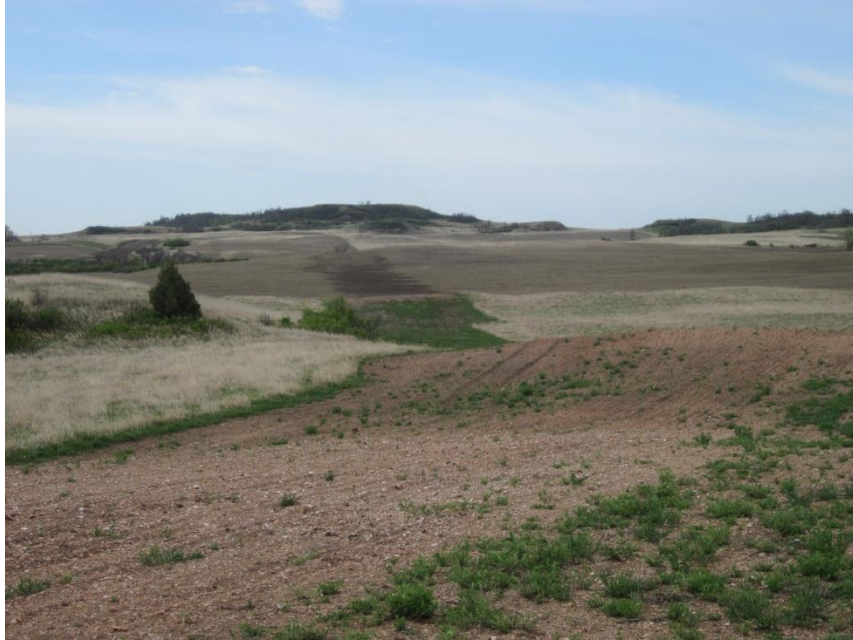
Photo 71. Direction: South. Pipeline right-of-way. Vegetation appeared to be reclaiming some areas here.

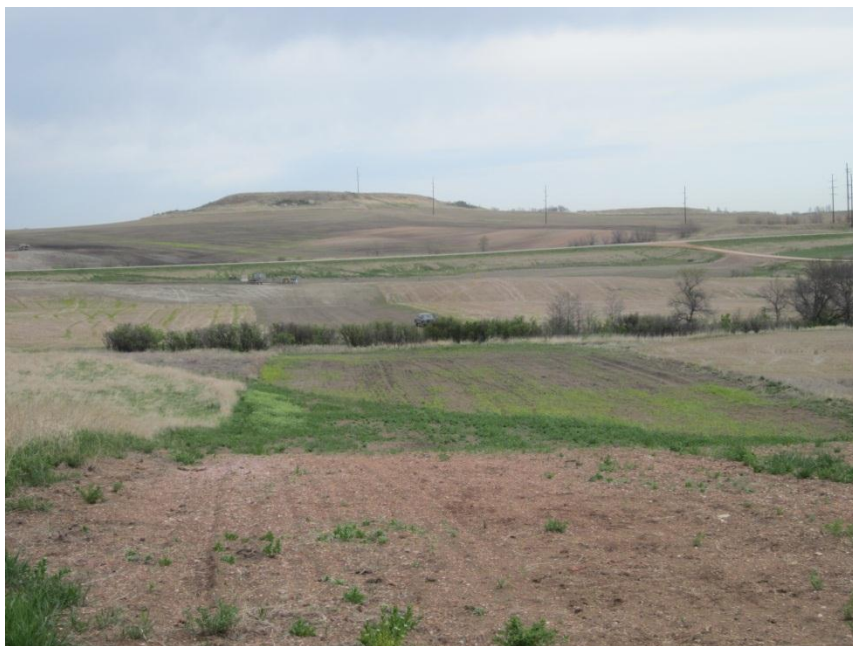
Photo 72. Direction: North. Photo shows the right-of-way of Bridger's pipeline where it bores under a tree row. Vegetation appeared to be reclaiming some areas here.

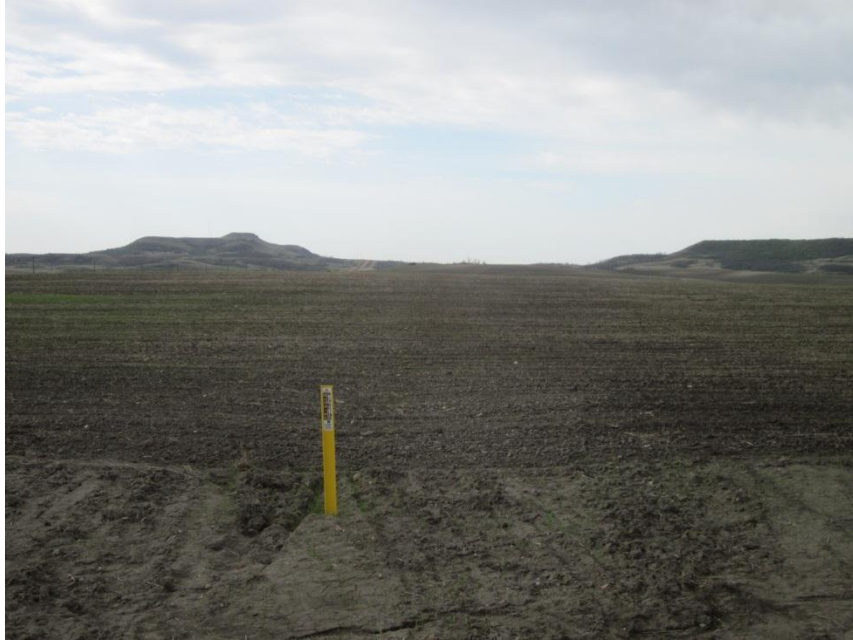
Photo 73. Direction: South. Pipeline right-of-way. Area had been replanted by landowner.

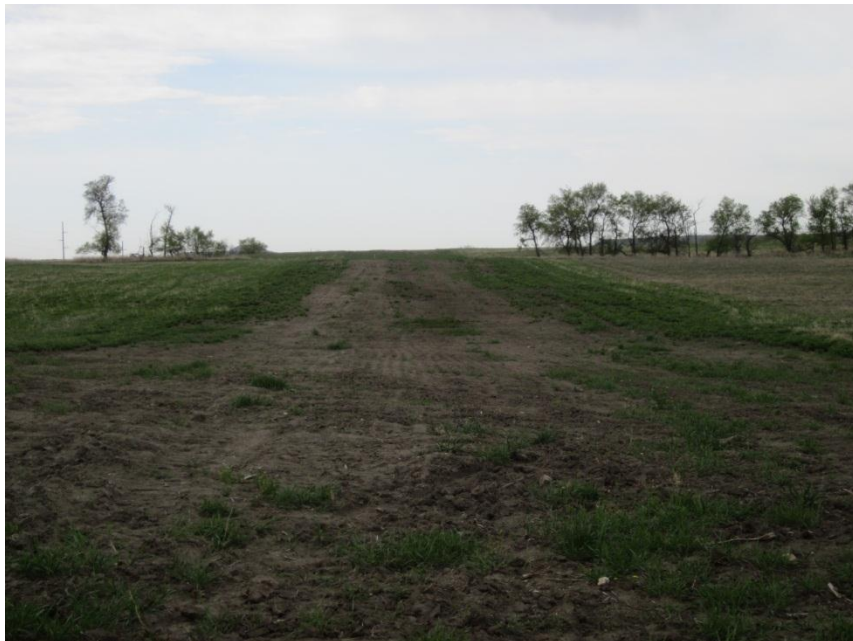
Photo 74. Direction: South. Photo shows a tree row that had been cut for Bridger's pipeline. It appeared that disturbance had been minimized.

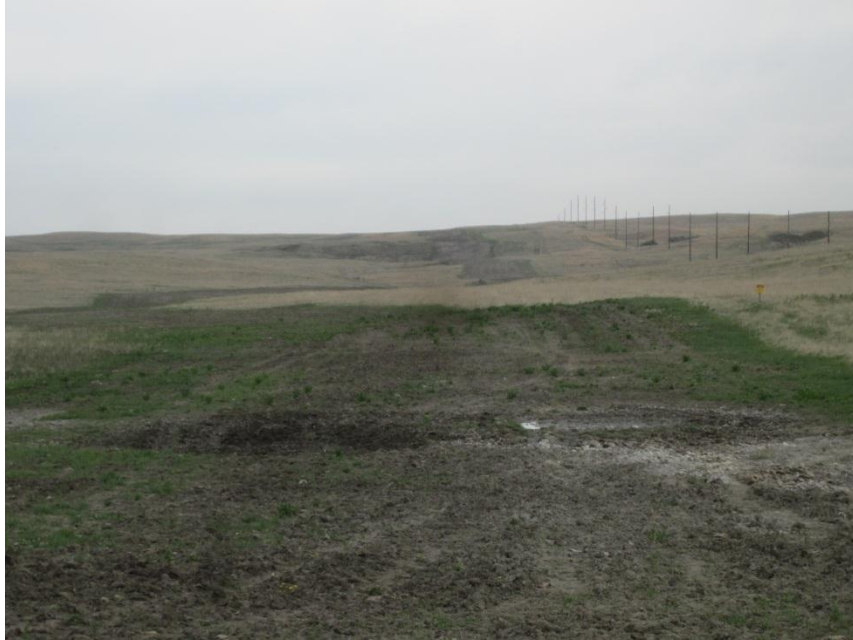
Photo 75. Direction: North. This wet area had very minimal ponding within the right-of-way of Bridger's pipeline.

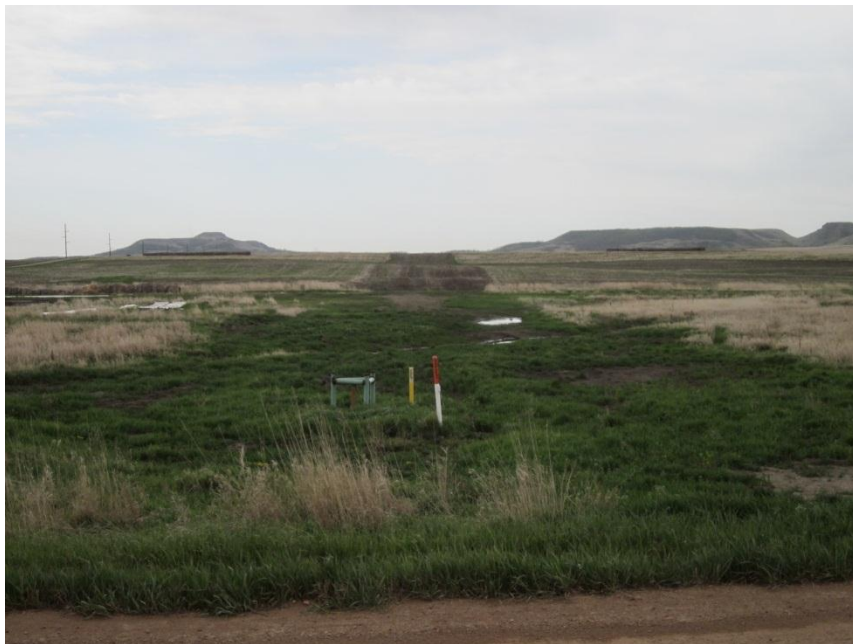
Photo 76. Direction: South. Pipeline right-of-way. Vegetation appeared to have reclaimed some of the area.

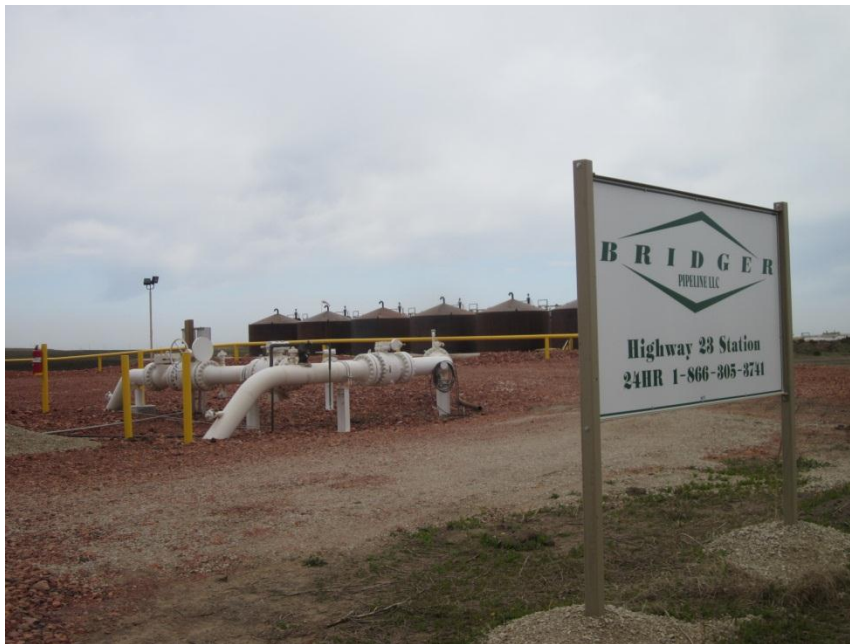
Photo 78. Direction: West. Station 23, the end of Bridger's pipeline.
