# Memorandum

Subject: Basin Electric Power Cooperative, Minot Wind & PrairieWinds ND1, Decommissioning Plan & Cost (Case No. PU-10-078)

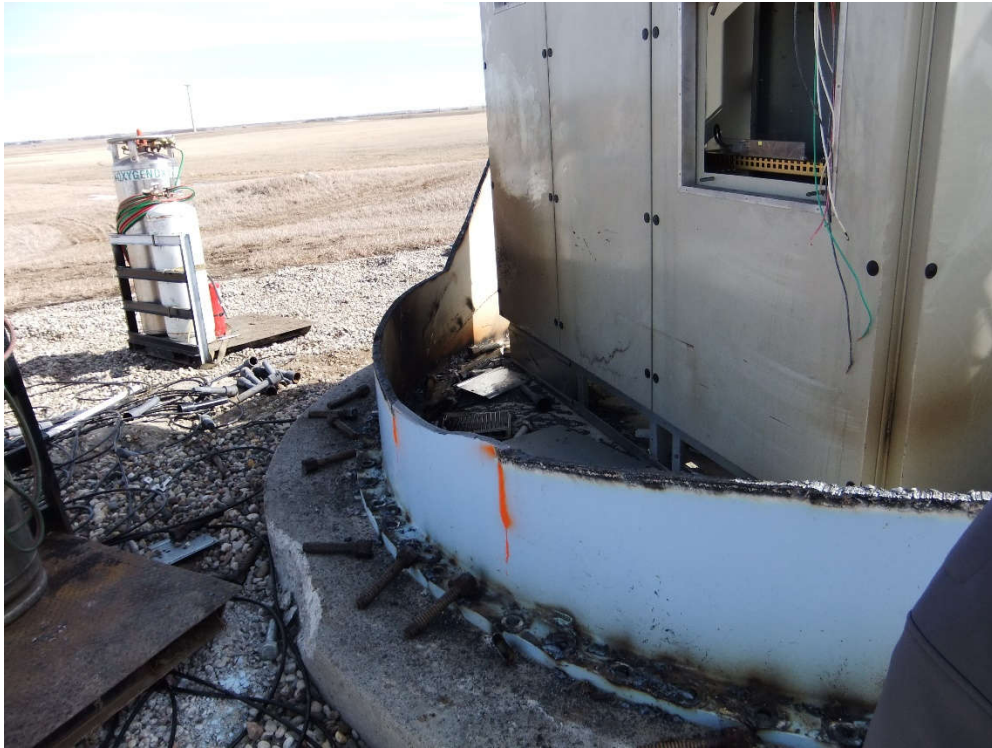
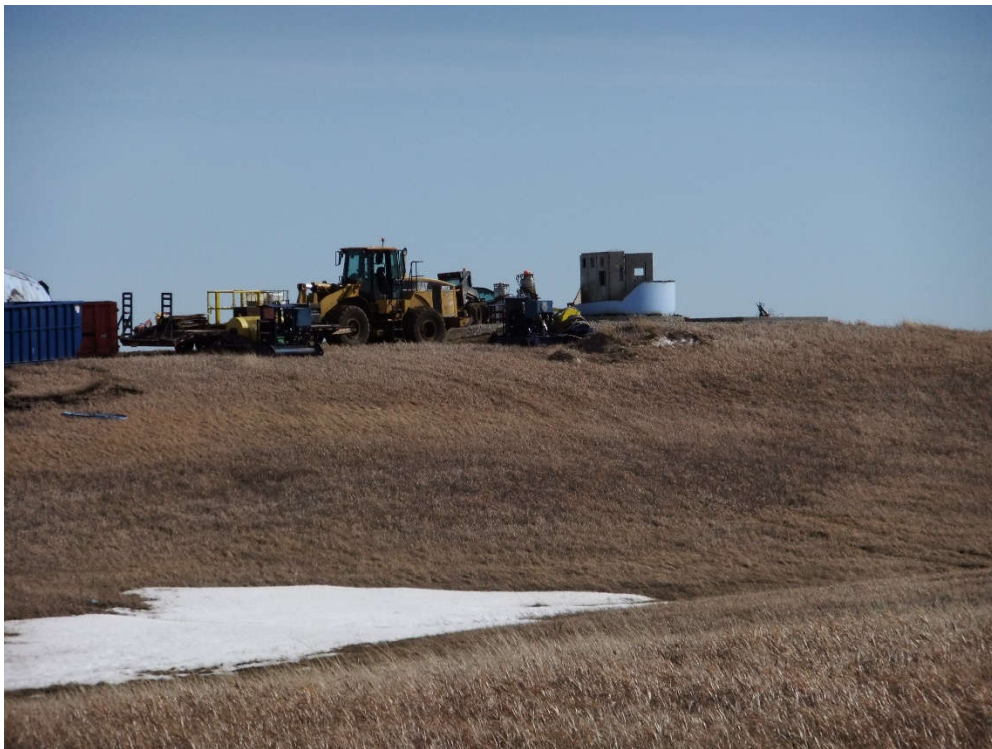
On March 18, 2022, Commission Staff visited the two facilities subject to decommissioning. Each site was decommissioned using a “felling” approach, whereby the base of the hub is partially cut (pictures 1 and 2), and the turbine is pulled to the ground with a machine initially designed to raise blades to the nacelle (picture 3). Such felling process eliminates the need for cranes to lower the turbine to the ground.

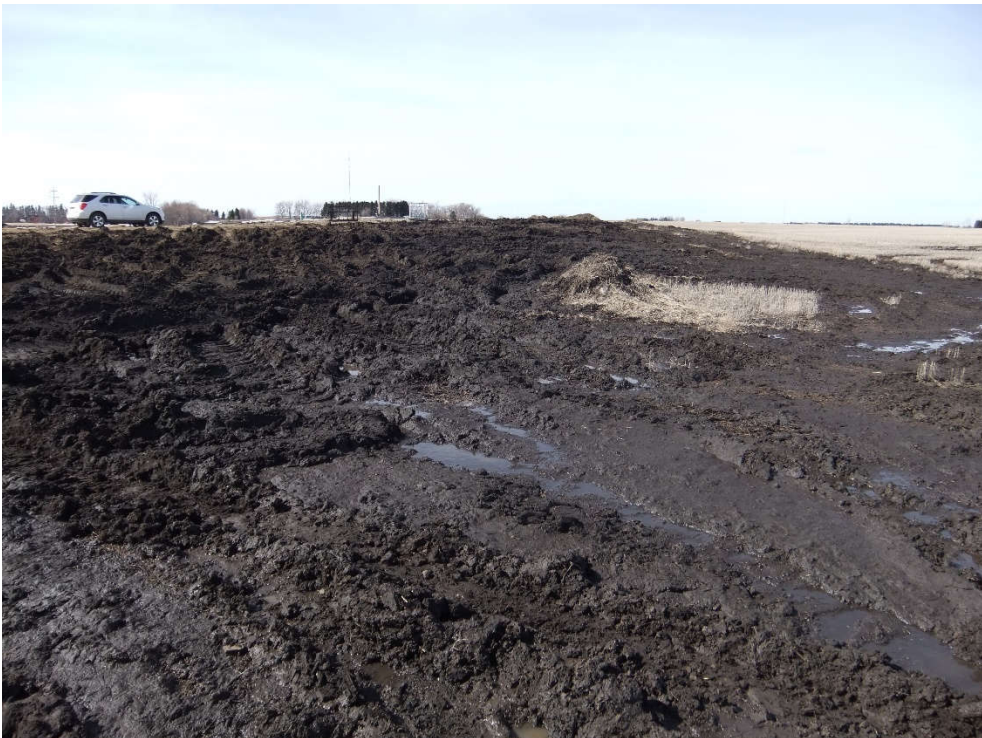
Picture 4:

Site 1 (picture 4) had completed decommissioning the entire turbine with only the foundation and underground cables remaining. The site was disturbed by heavy equipment traversing the area and disturbing the soil (picture 5). This was because in the middle of decommissioning, the area experienced its first warm days of the season, and according to the contractor, the frost came down approximately four inches. The mud made it difficult to determine the amount of fiberglass which remained to be cleaned up. A few locations had pieces of fiberglass that remained lodged in the mud (picture 6). Overall, the site appeared relatively clean from fiberglass debris based on visual inspection (pictures 7 and 8).

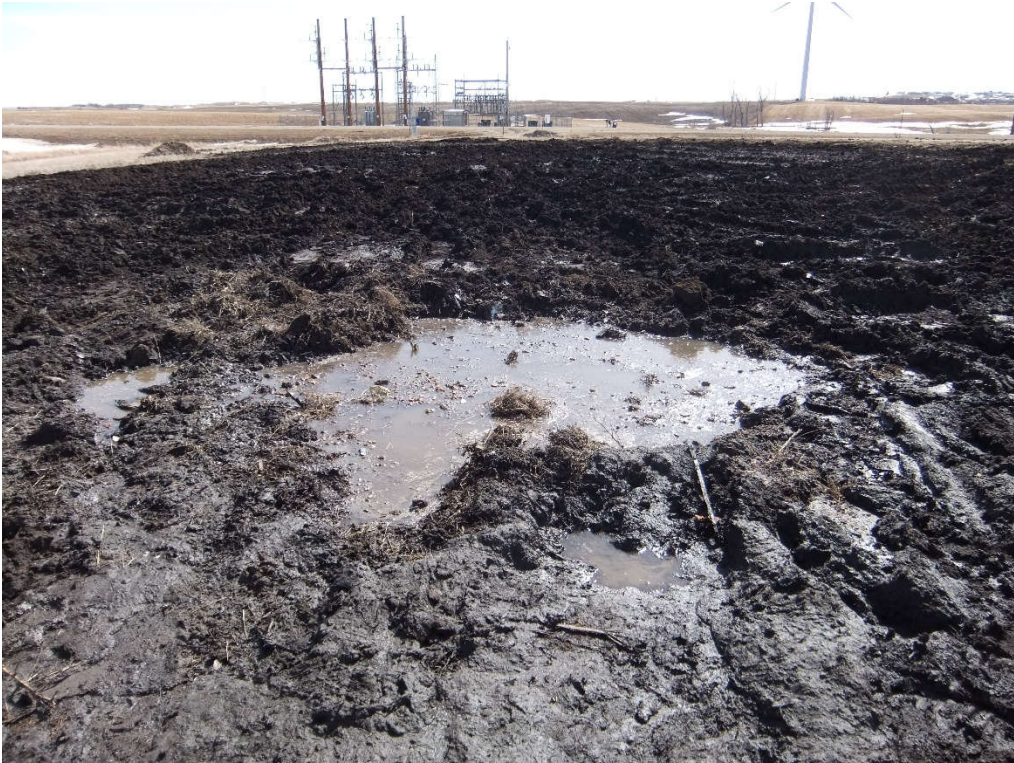
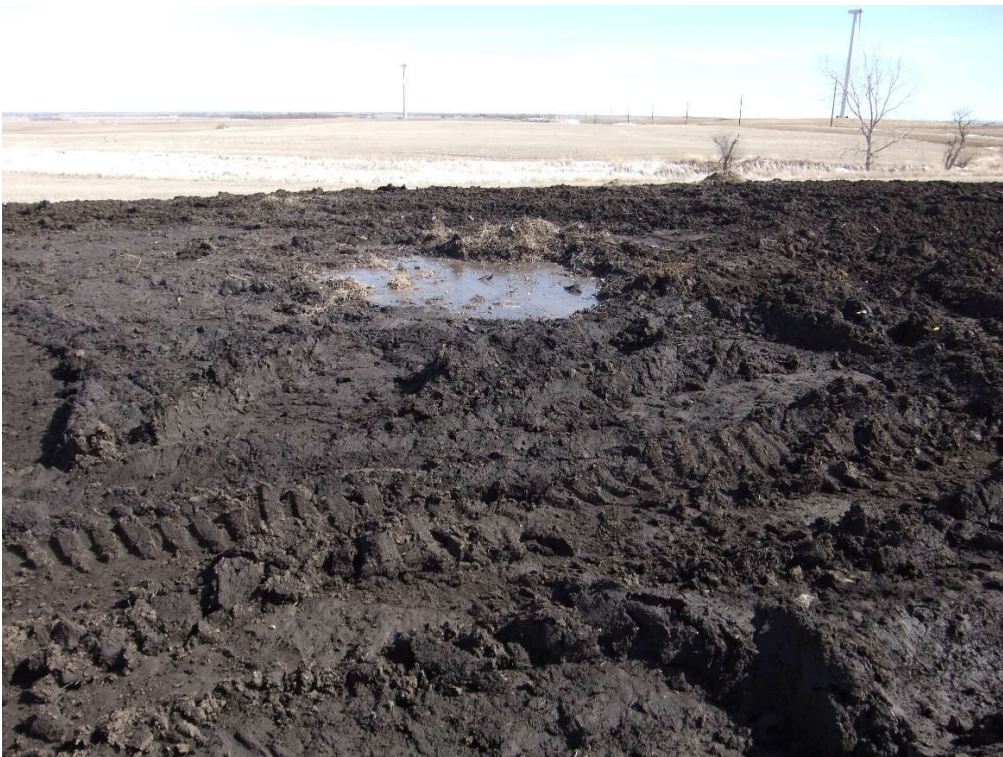
The only visual sign of soil impactation was an area approximately 8 feet in diameter (pictures 9 and 10) where the housing of the turbine made impact. Although the depth of the area was difficult to determine because of the water, Staff subsequently had discussions with the contractor who estimated the impact depth to be 3 feet.

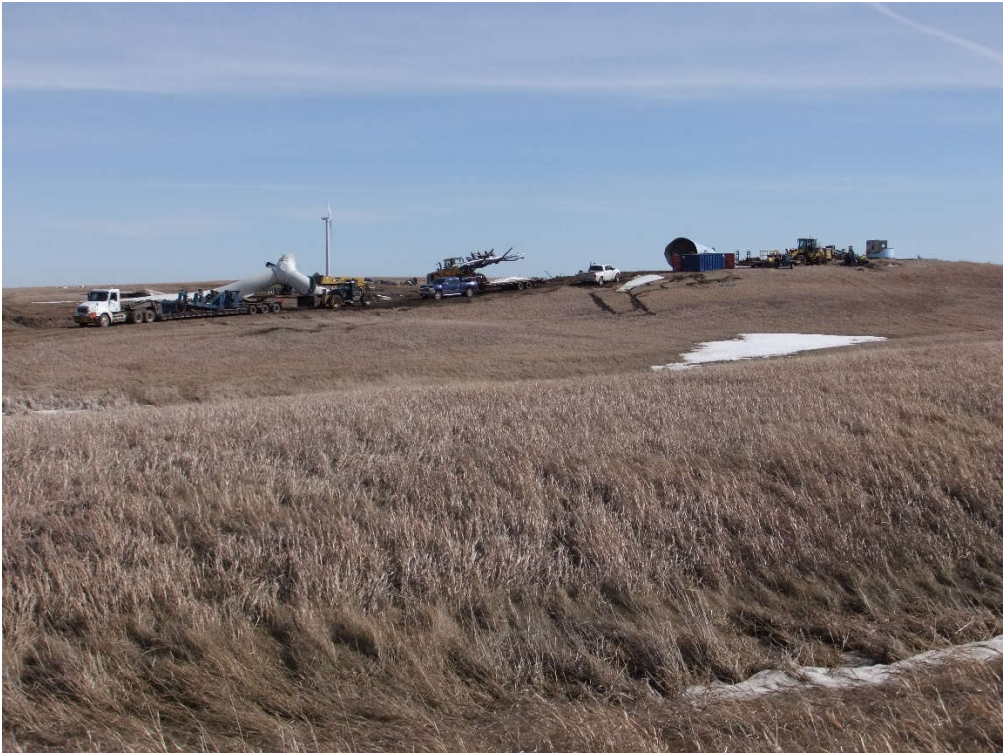
Picture 11:

Site 2 (picture 11) was in the process of decommissioning, and some components remained to be cleaned up. The site was on a bluff, and the contractor felled the turbine with the blades up, because they were unable to yaw it such that the turbine would fall blades down. This site did not have the muddy conditions present at Site 1, and

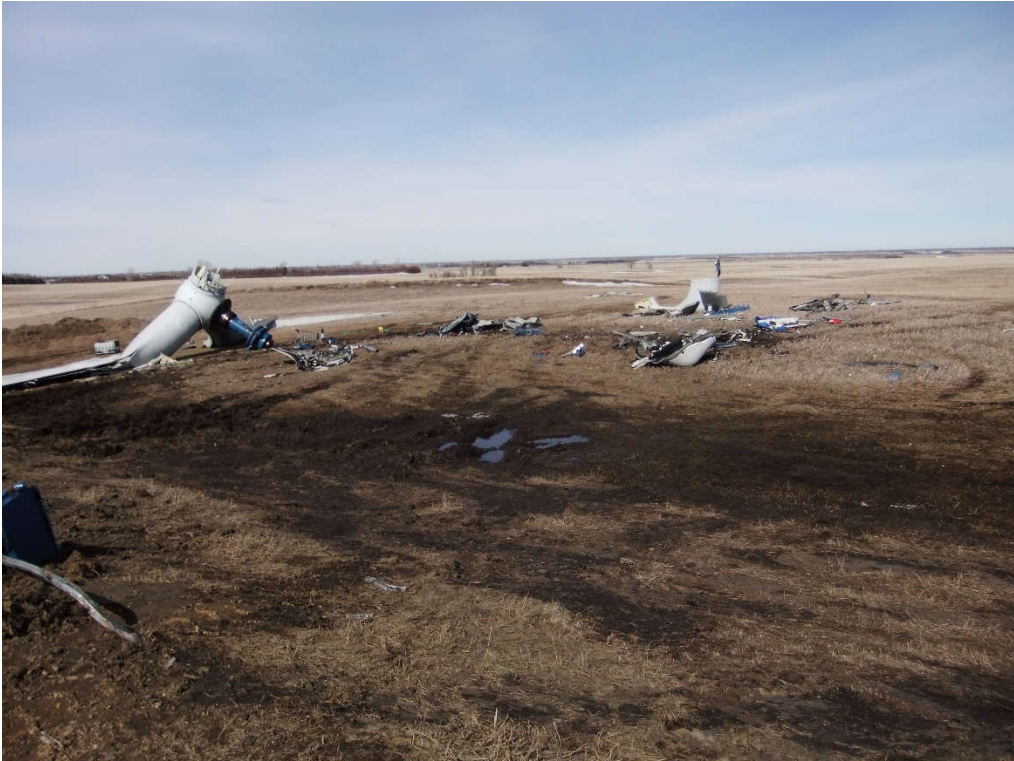
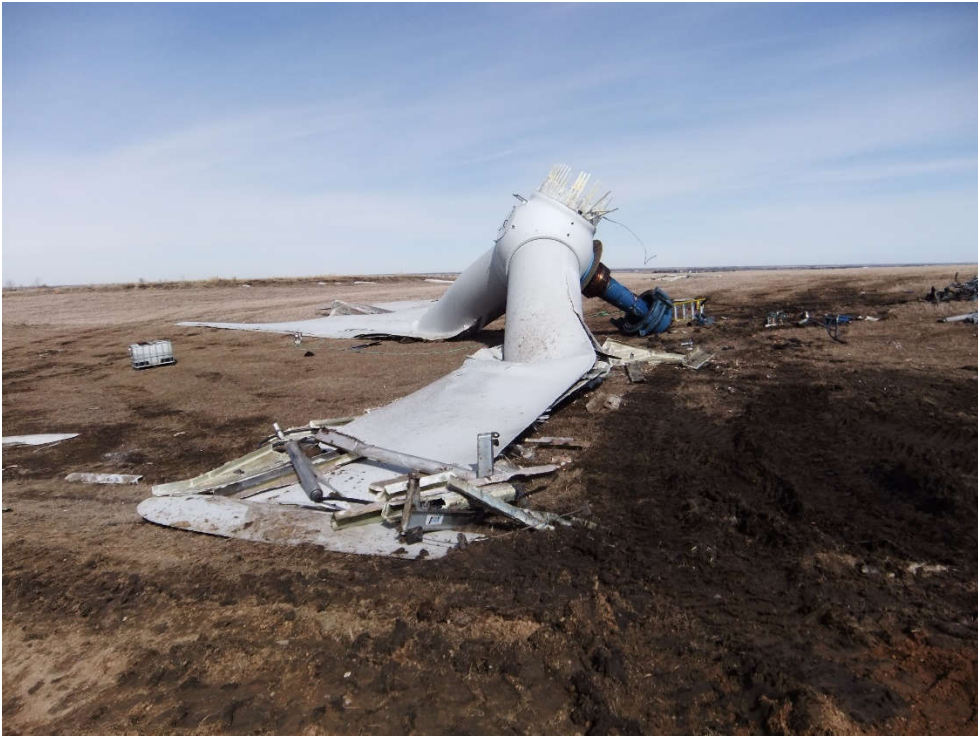
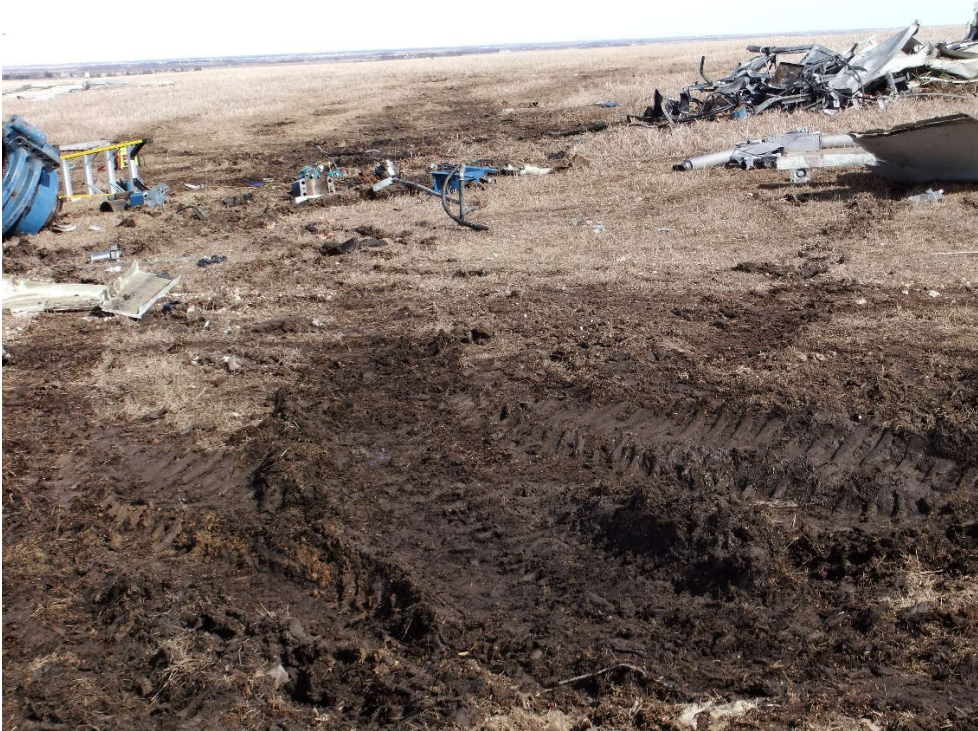
although the contractor was in the cleanup process, the site was relatively free of small fiberglass pieces based on where they were in the cleanup process. The blades did not appear to fracture into several shards, likely the result of the resin cementing the fiberglass together throughout the blade (pictures 12-14).

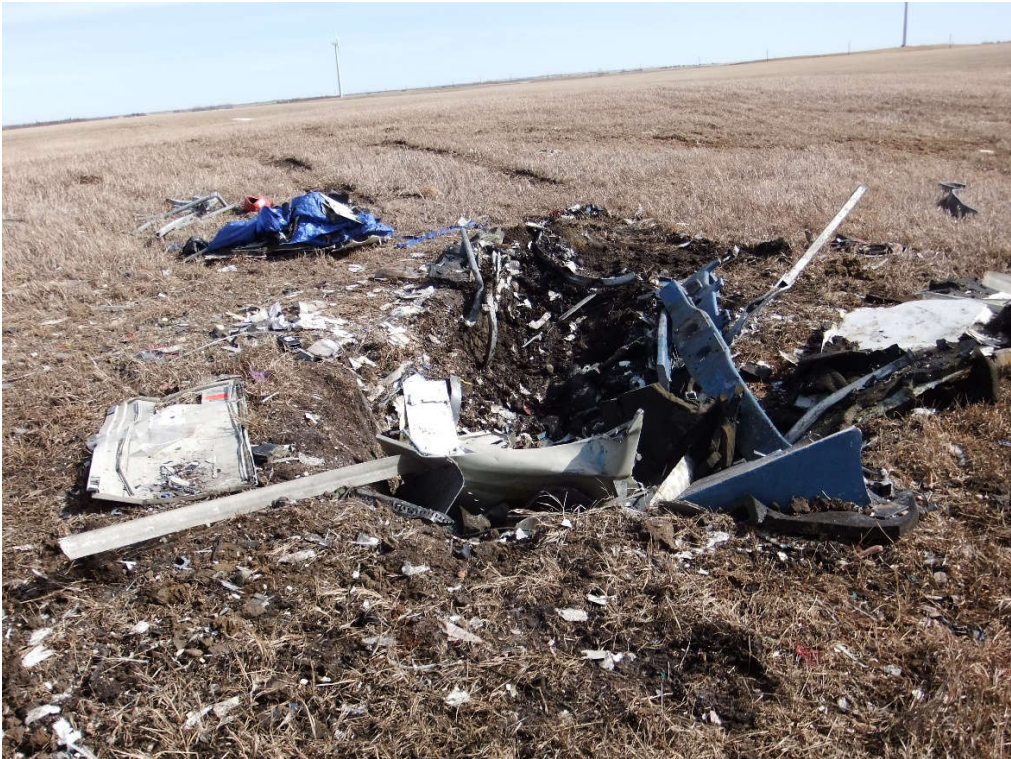
Picture 15:

Site 2 had one visual sign of soil impaction (picture 15). Although it's not clear from the picture, the generator for this unit was still in the ground, and the contractor subsequently estimated the impact depth to be six feet.
