**RE: Final Construction Inspection Report for the Merricourt-Ellendale Transmission Line  
PU-10-164**

***Merricourt-  
Ellendale  
Transmission Line  
Construction  
Inspection Report***

***Montana-Dakota  
Utilities Co.***

April 2012

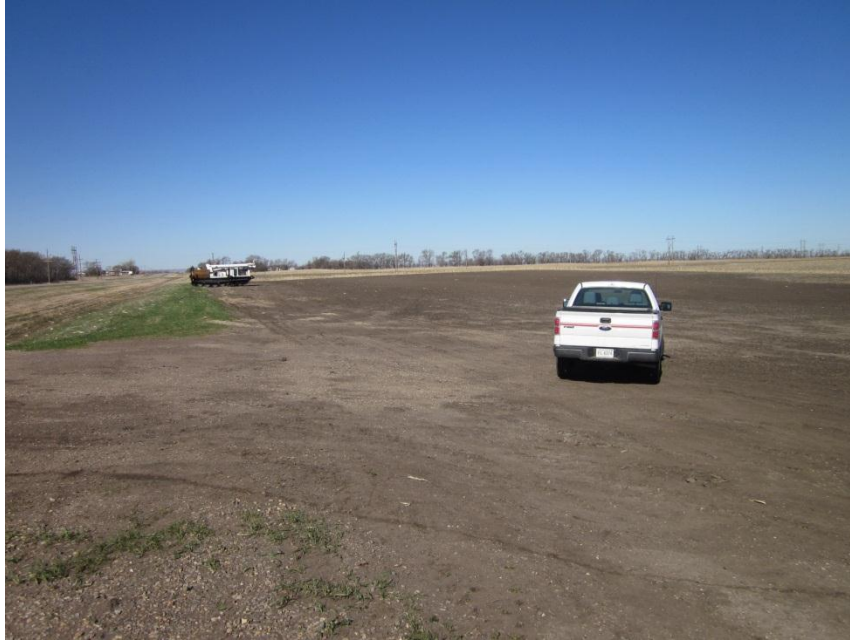
**Photo 1.** Direction: North. Webster’s laydown site (About 1.75 miles west of Ellendale) that was not used due to wet soil conditions early in the season. In good condition with no erosion or other impacts noted. Tracked vehicle in left background will be removed on completion.

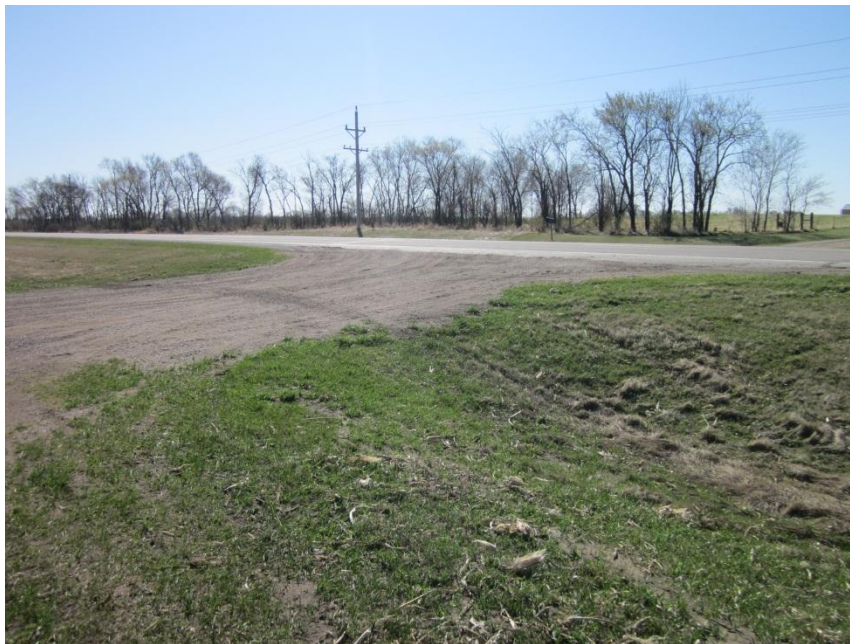
**Photo 2.** Direction: Southeast. Approach to Webster’s laydown area.

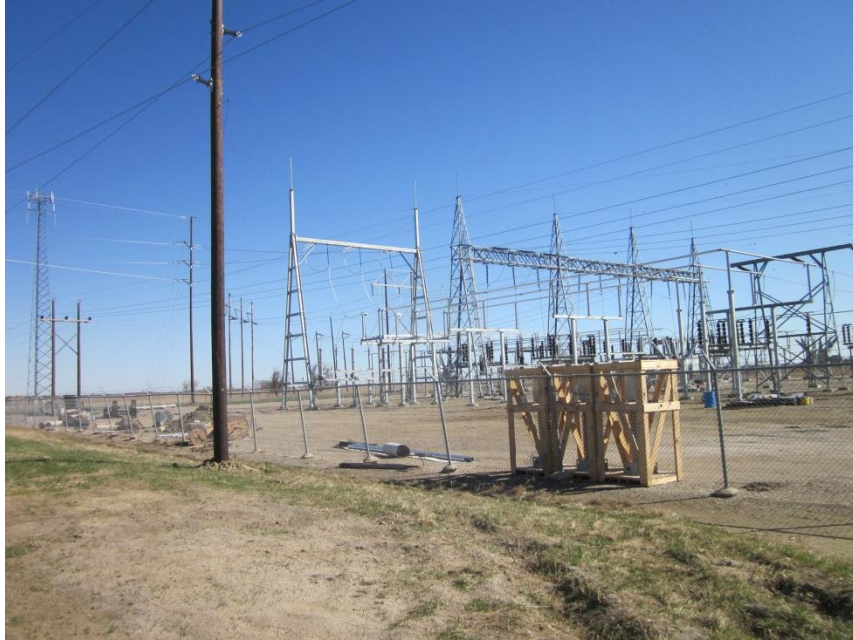
**Photo 3.** Direction: Northeast. Ellendale substation showing upgraded North bay at the east end of the transmission line. Substation was west of Ellendale in the NW  $\frac{1}{4}$  of NW  $\frac{1}{4}$  of Section 10, Township 129N, Range 63W, Dickey County. No erosion problems evident and station looked to be in order.

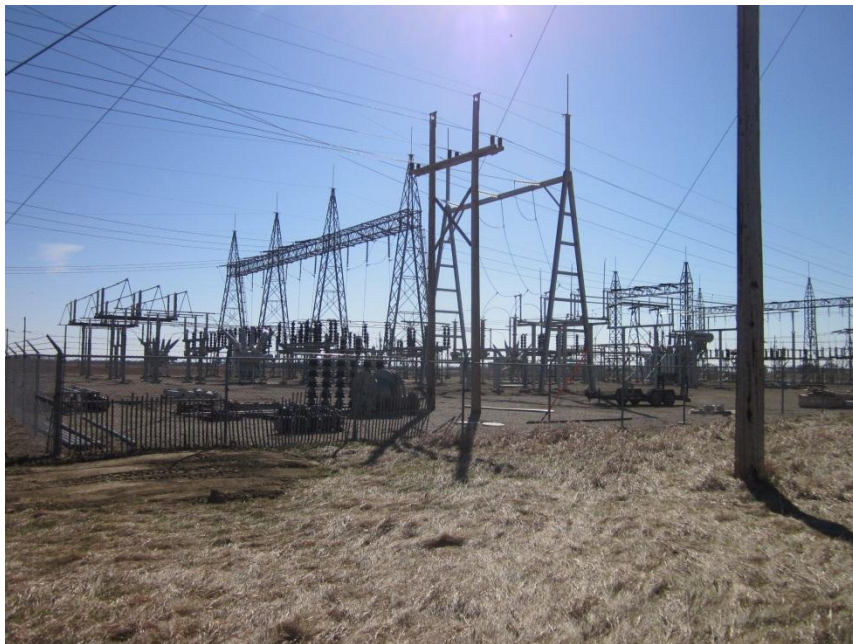
**Photo 4.** Direction: Southeast. Ellendale substation.

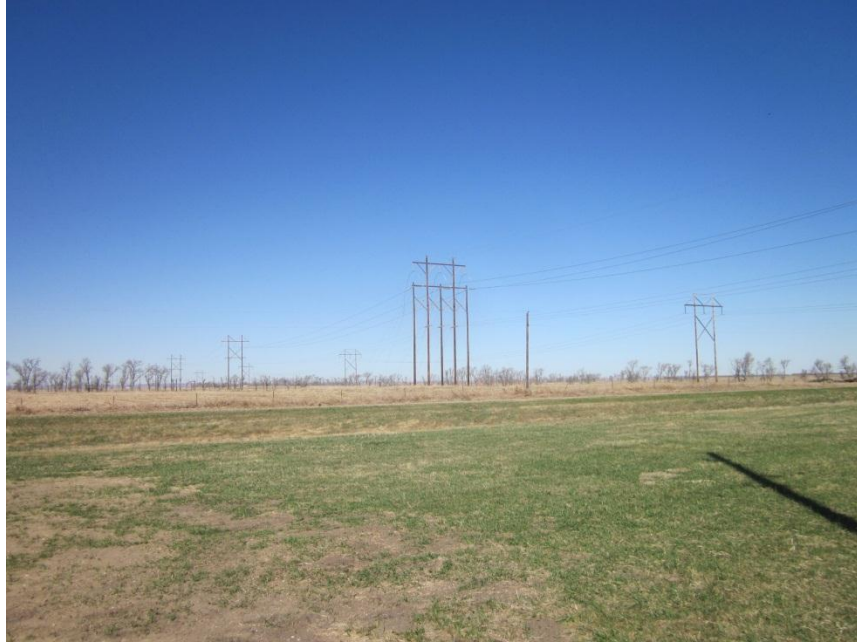
**Photo 5.** Direction: Northwest. New line leaving the Ellendale substation, which is located just behind where this photo was taken. Notice new line (larger structure on the left) parallels an existing line out of the substation.

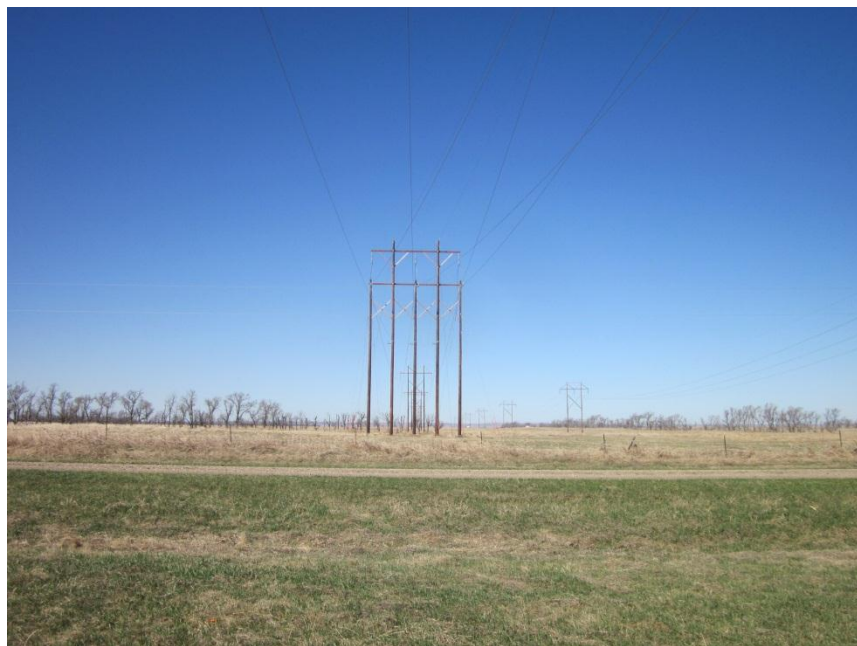
**Photo 6.** Direction: West. Double circuit transmission line leaving substation traveling west.

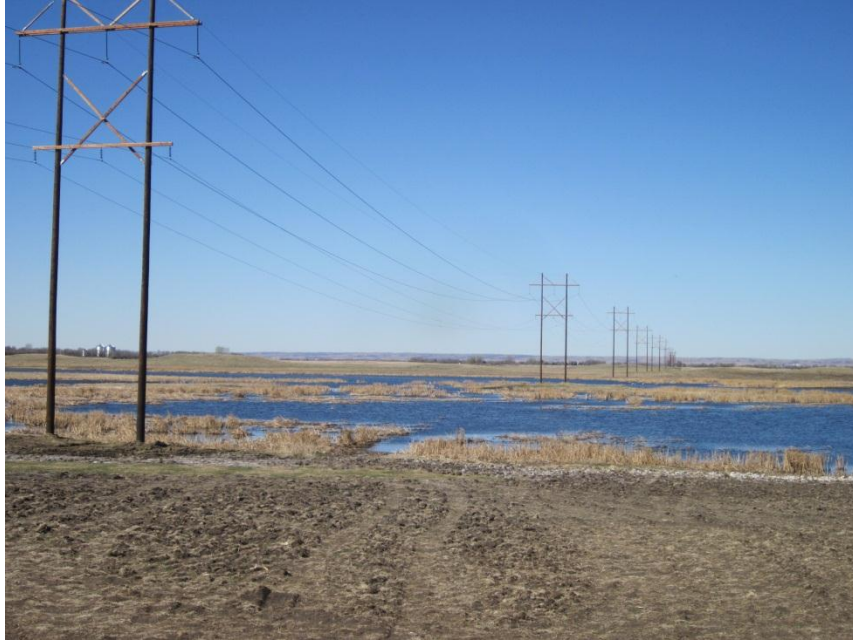
**Photo 7.** Direction: Southwest. Transmission line crossing wetland about 3 miles west of the Ellendale substation. Notice poles are not located in water but on small island. Disturbance to wetlands was minimal, but still needed final restoration.

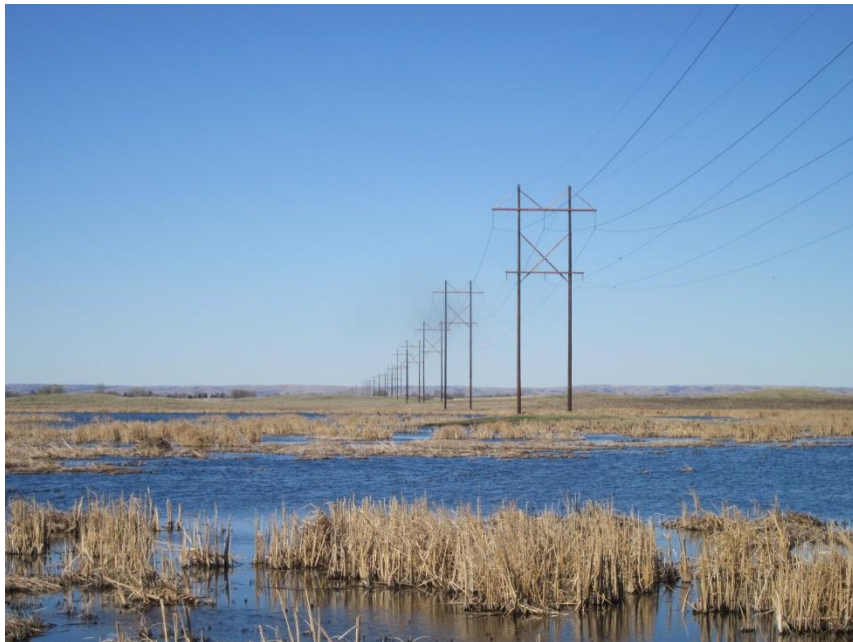
**Photo 8.** Direction: West. This is a closer picture of the wetland crossing shown in Photo 8. Note structure is not located in wetland, but on small island.

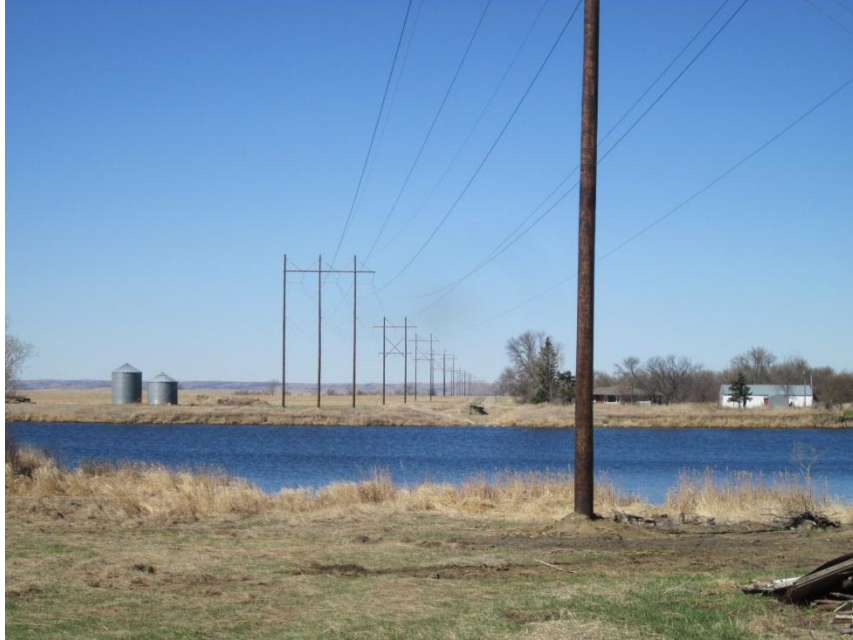
**Photo 9.** Direction: West. Transmission line crossing Pheasant Lake 5 miles west of Ellendale substation. Poles were about 20-30 ft. from water, with no visible disturbances to the shoreline.

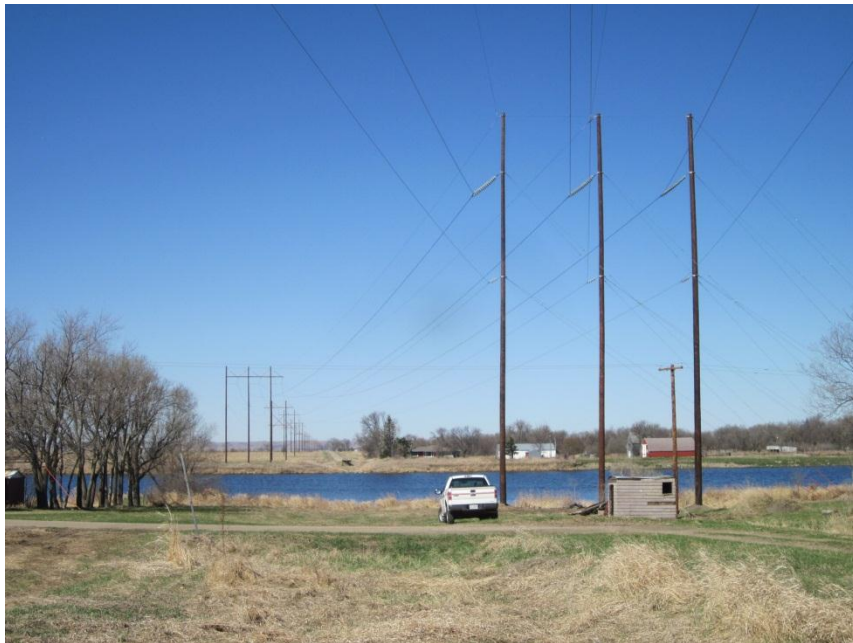
**Photo 10.** Direction: West. Pheasant Lake crossing. Line jogs slightly to north, avoiding property to the south.

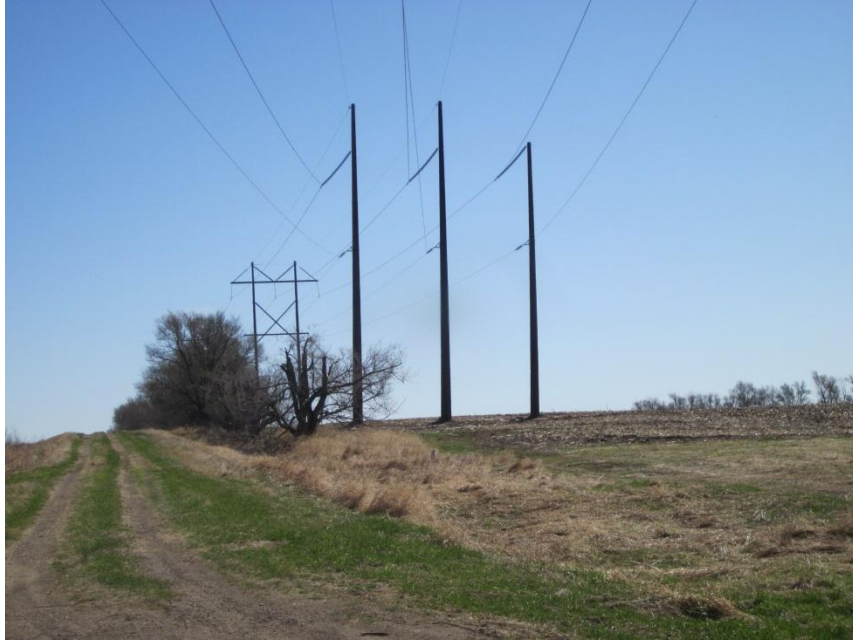
**Photo 11.** Direction: East. At Pheasant Lake crossing, looking back east toward the Ellendale substation.

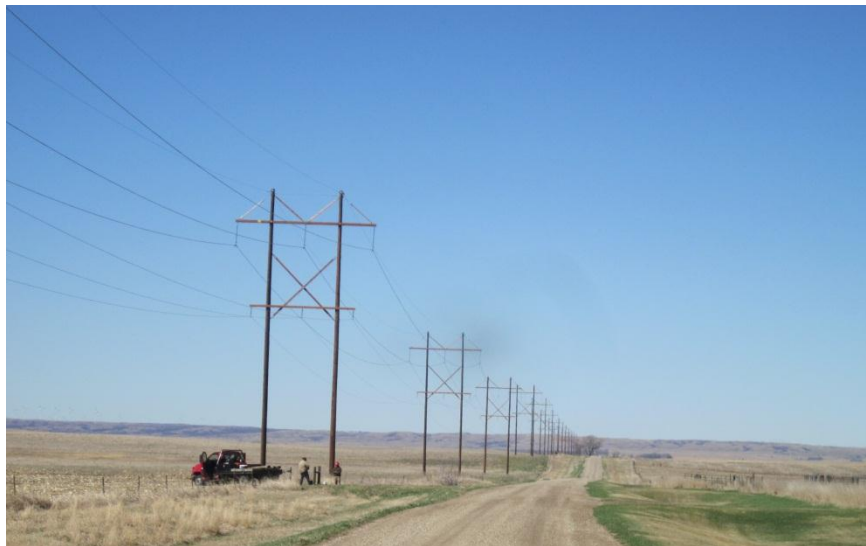
**Photo 12.** Direction: West. Linemen repairing fences used for access during structure construction.

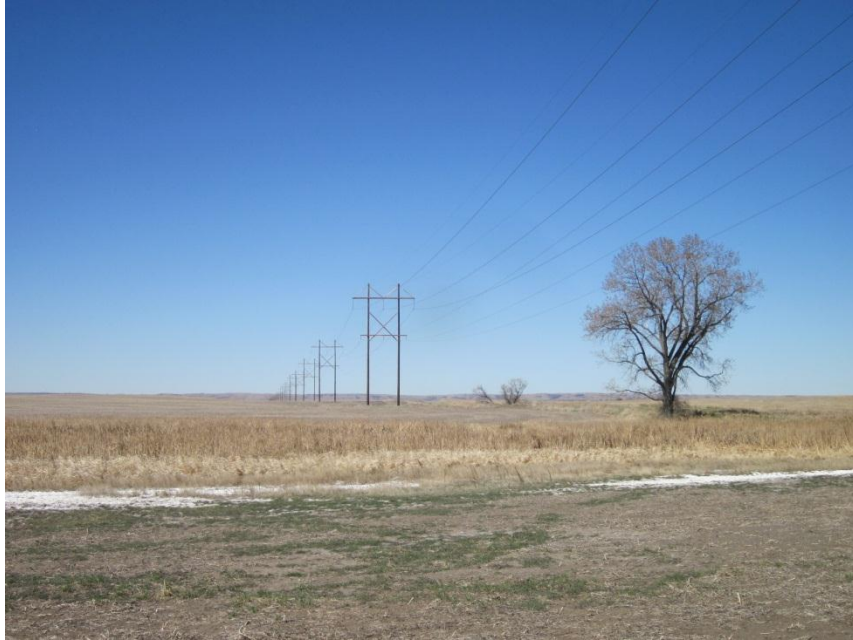
**Photo 13.** Direction: West. Transmission line spanning a cattail slough approximately 8 miles west of the Ellendale substation.

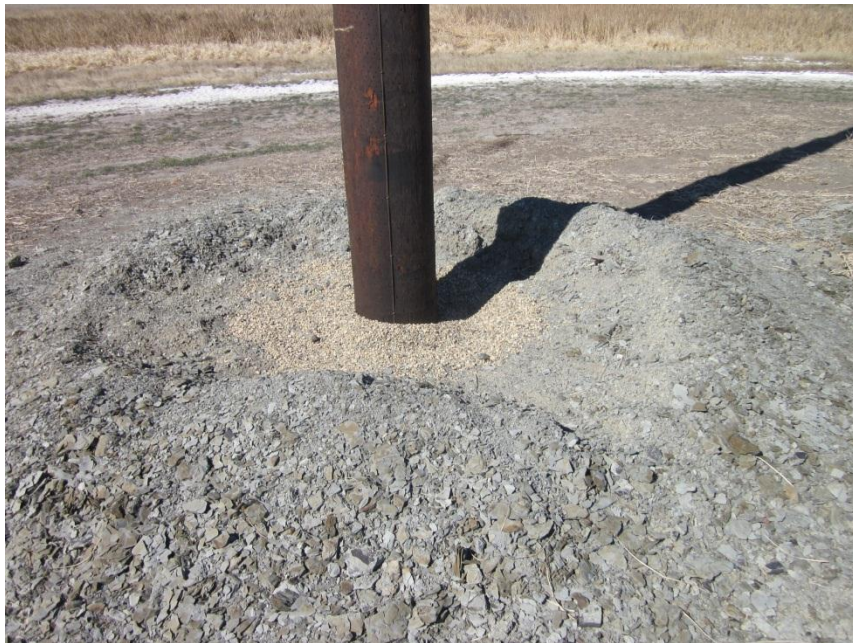
**Photo 14.** Example post hole filled with aggregate. Shale surrounding the hole was debris from underlying material as a result of post hole drilling. Upon final restoration, material will be cleaned, spread, or hauled away.

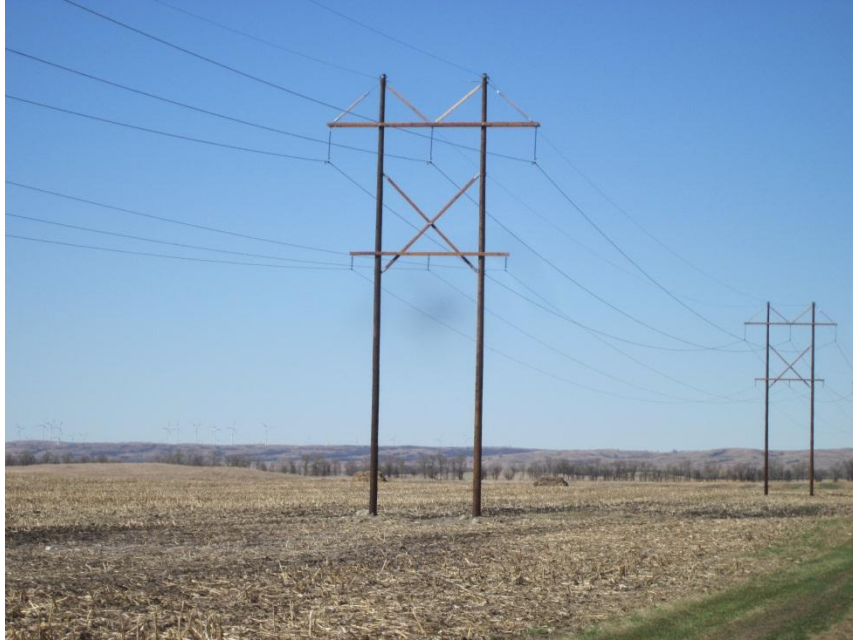
**Photo 15.** Direction: Southwest. Example H-Frame structure showing double circuit line. This structure is just north of where ND Highway 11 turns north.

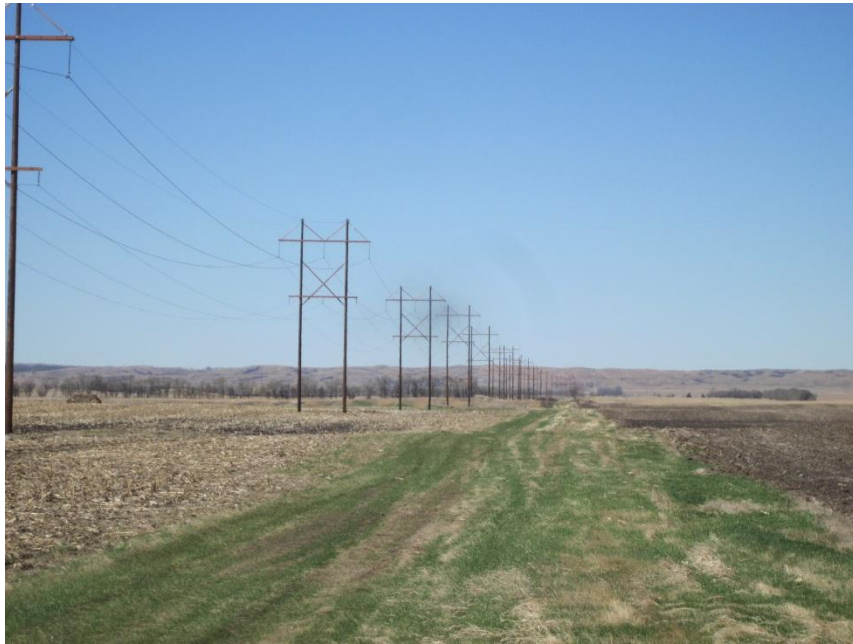
**Photo 16.** Direction: West. Ridge in the distance is where transmission line turns to the northwest.

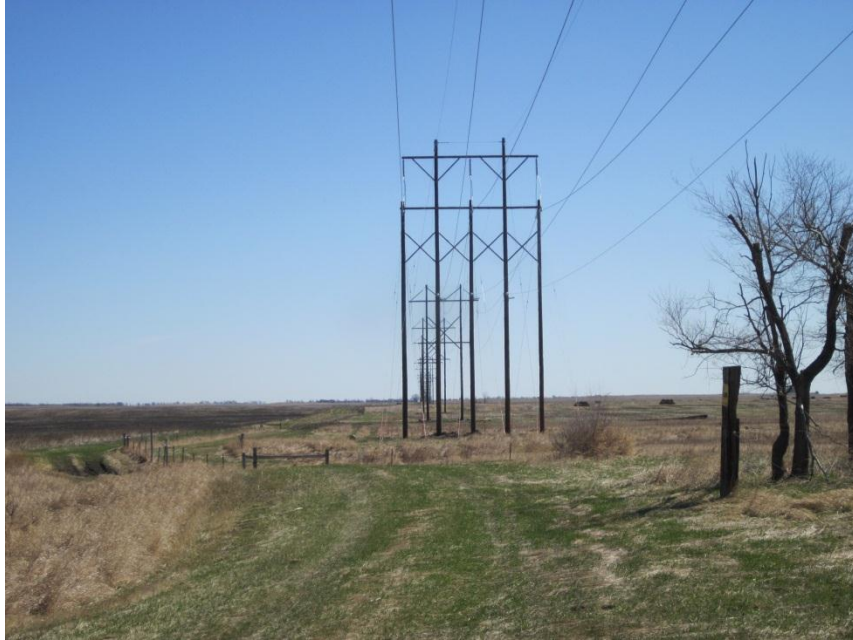
**Photo 17.** Direction: East. Example storm structure nearby a low wet area that was spanned by the line.

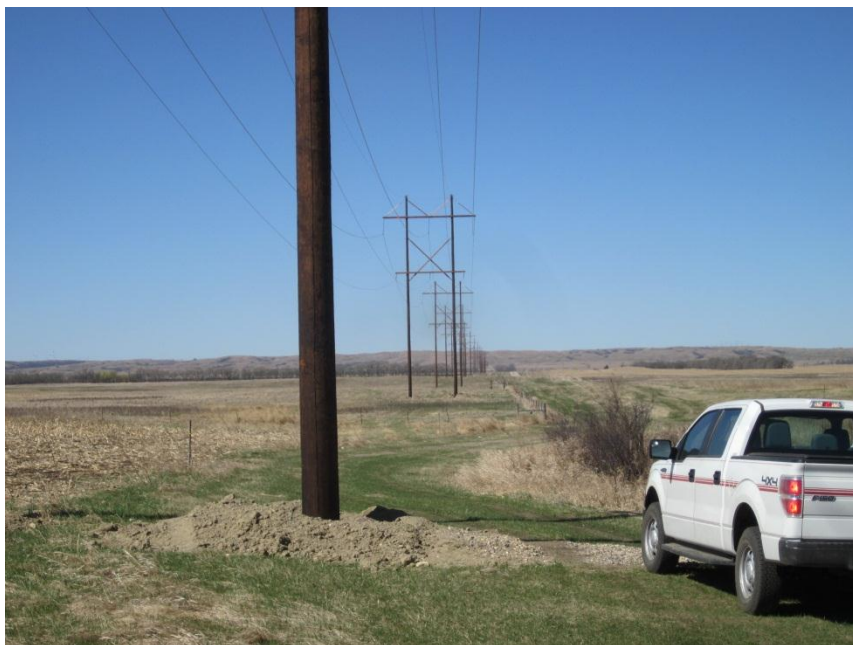
**Photo 18.** Direction: West. Example of post hole debris that still needs final restoration.

At the time of the site inspection, final restoration and reseedling had yet to occur on the Project site. Final restoration of debris surrounding structure poles, temporary staging areas, and other construction disturbances along the route needs to be completed upon Project completion to be considered in full compliance.

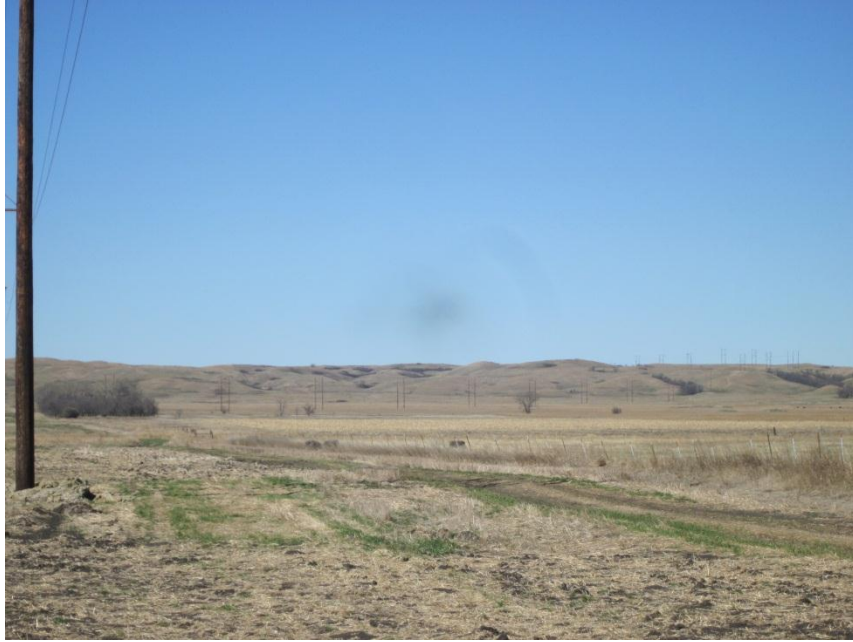
**Photo 19.** Direction: Northwest. Transmission line running northwest along ridge about 13 miles west of Ellendale substation.

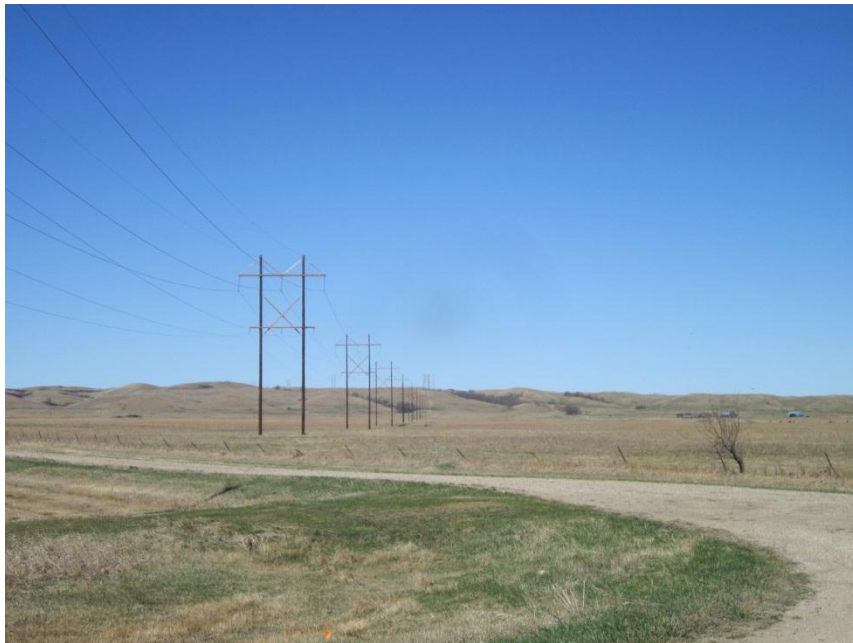
**Photo 20.** Direction: Northwest. Line running northwest over ridge in the distance.

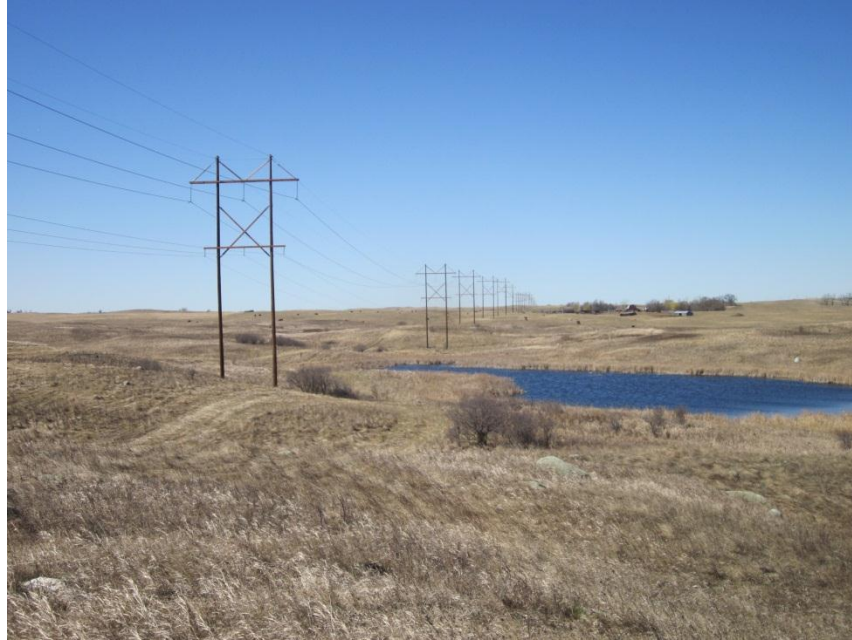
**Photo 21.** Direction: West. Crossing of wetland within the LSB WPA located in Section 6 of Township 129N Range 65W, Dickey County. Pole locations were outside of wetland areas and no disturbance to wetlands was noted.

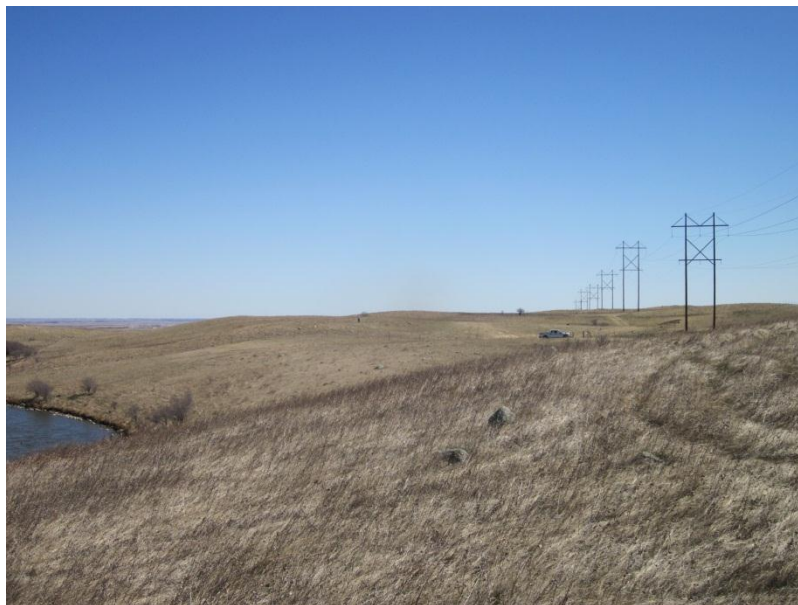
**Photo 22.** Direction: East. Note the distance of the transmission line from the largest wetland in the LSB WPA in the far left of the photo.

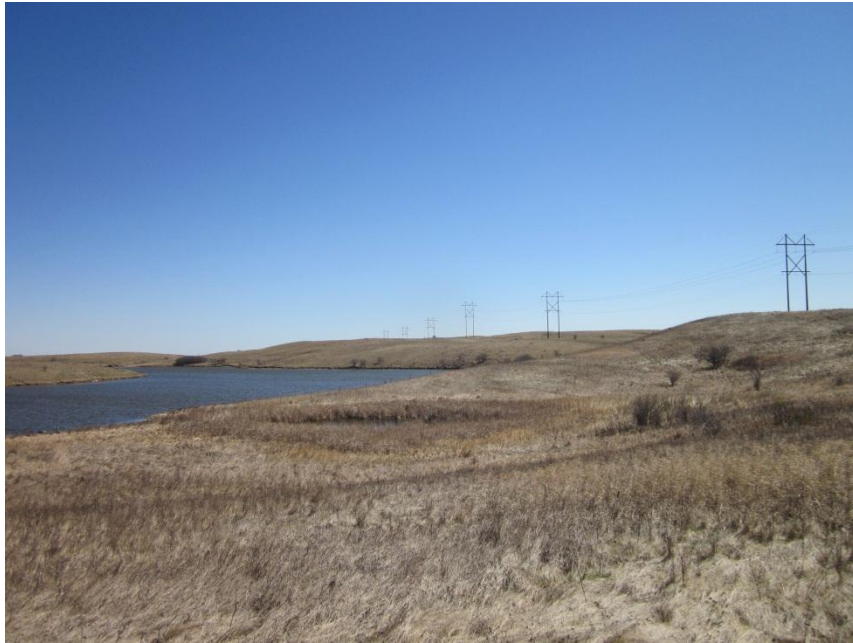
**Photo 23.** Direction: Southwest. Another photo showing distance of transmission line from largest wetland in LSB WPA.

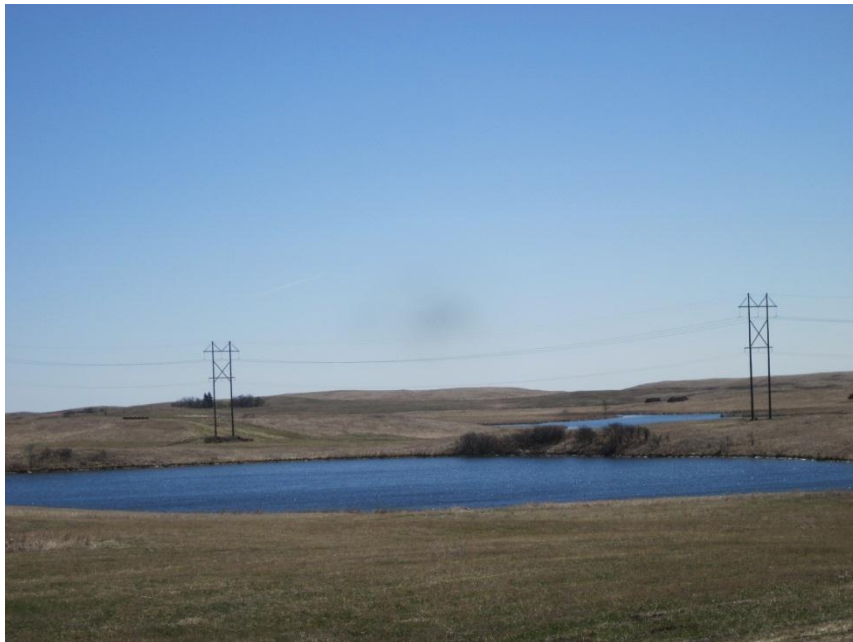
**Photo 24.** Direction: Southwest. One mile west of the LSB WPA at another wetland crossing. Note distance of transmission line poles from the water.

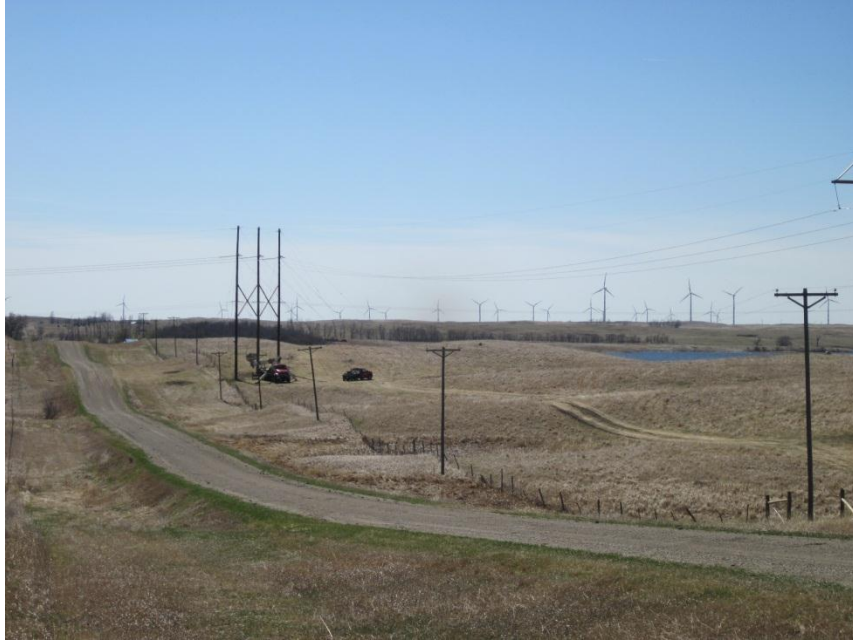
**Photo 25.** Direction: Linemen working on line approximately 17.2 miles from Ellendale substation. After this point, line is single circuit until it terminates at the Merricourt substation.

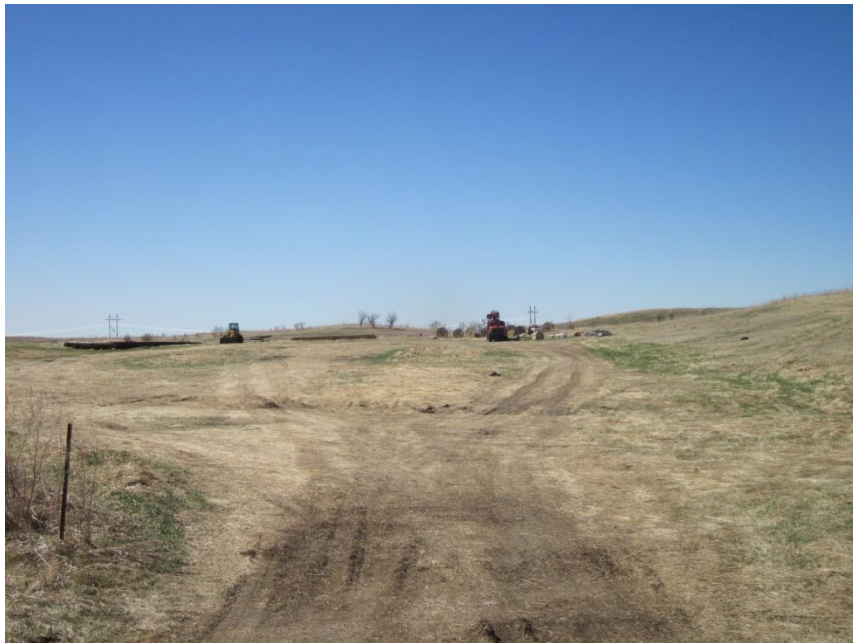
**Photo 26.** Direction: West. Laydown area leased from landowner Greg Brokaw located in the NE ¼ of the NE ¼ of Section 16, Township 130N, Range 166 W, Dickey county. Laydown area will be used through October 2012 for other line maintenance work nearby. Area seemed in good order without excessive disturbance or erosion present.

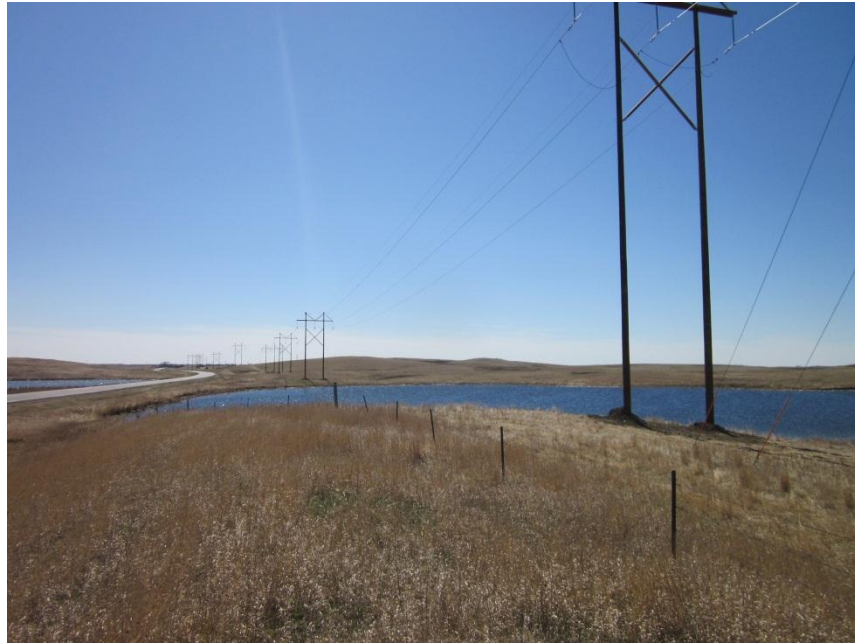
**Photo 27.** Direction: South. Transmission line crossing a water body about 1 mile north of Brokaw laydown area. Note distance of structures from water. No erosion into water body was noted.

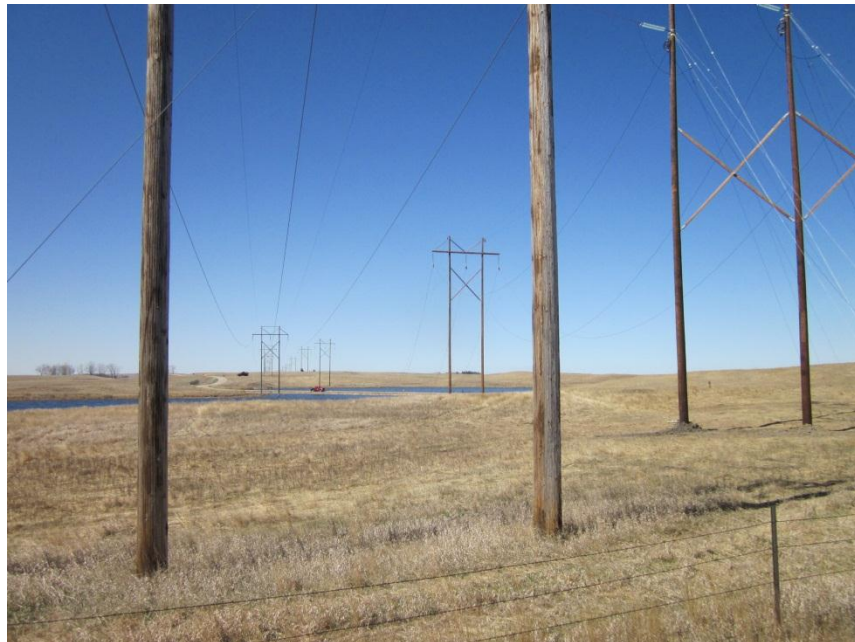
**Photo 28.** Direction: West. Same location as Photo 29. Existing transmission line in photo, new line to the right. Transmission line spans wetlands with no poles in water and no erosion to water body evident.

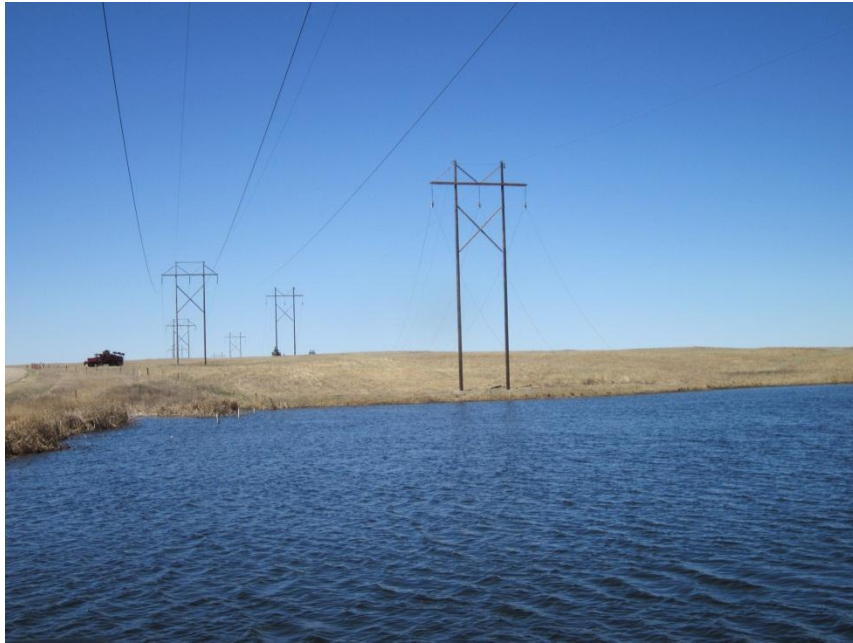
**Photo 29.** Direction: South. On the far side of wetland crossing from Photo 30. Note lines have not yet been connected to structures from here to the Merricourt substation.

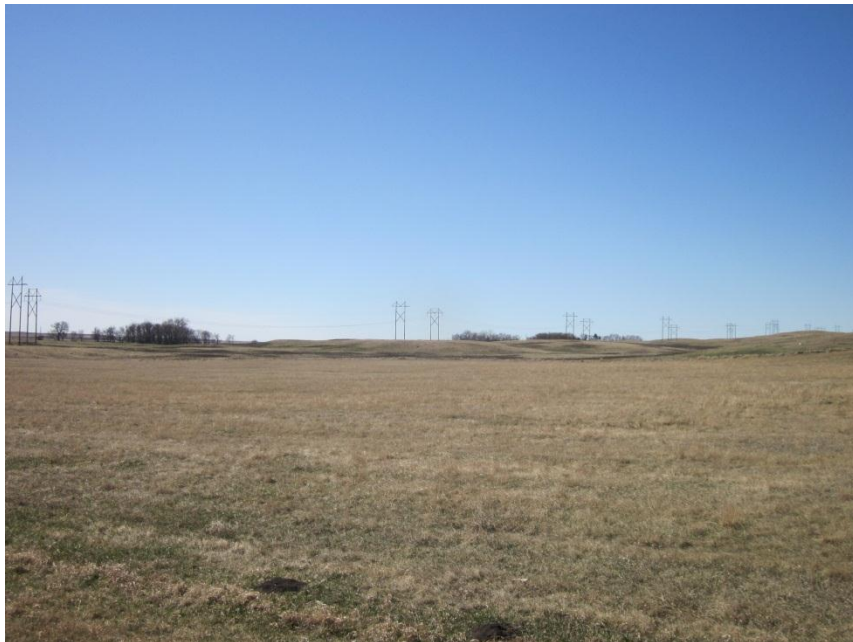
**Photo 30.** Direction: Southeast. Example span of line within 5 miles of Merricourt substation.

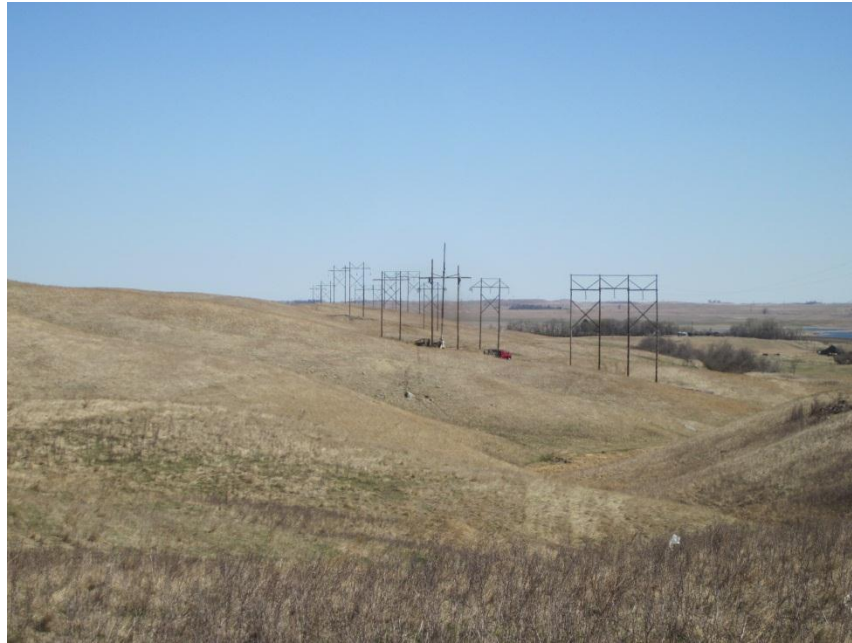
**Photo 31.** Direction: East. Final few structures being erected within sight of Merricourt substation. Photo was taken at southeast corner of Merricourt substation.

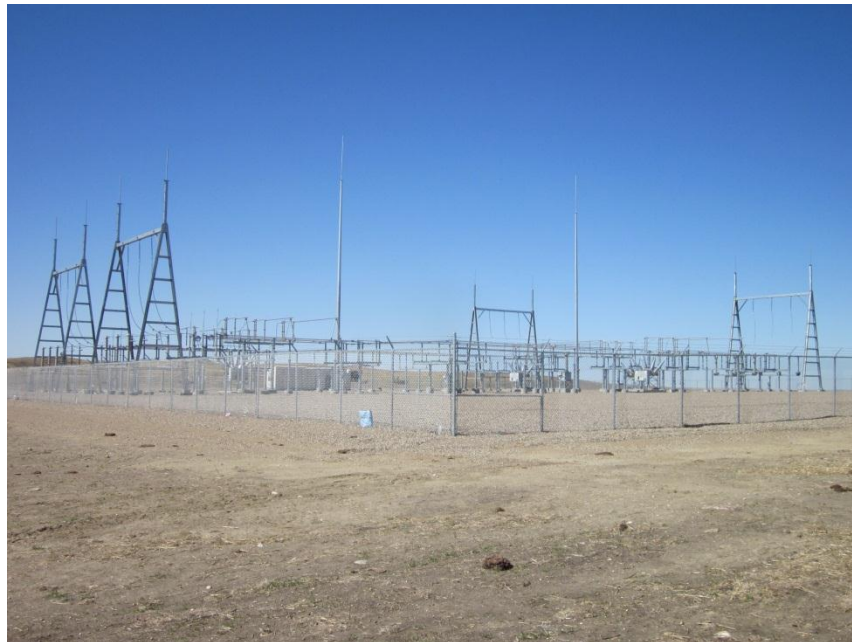
**Photo 32.** Direction: Northwest. The new Merricourt substation where the transmission line will terminate in Section 34, Township 131N, Range 67W, McIntosh county. No erosion or other issues were evident. During the inspection, final construction activities were ongoing at the substation.

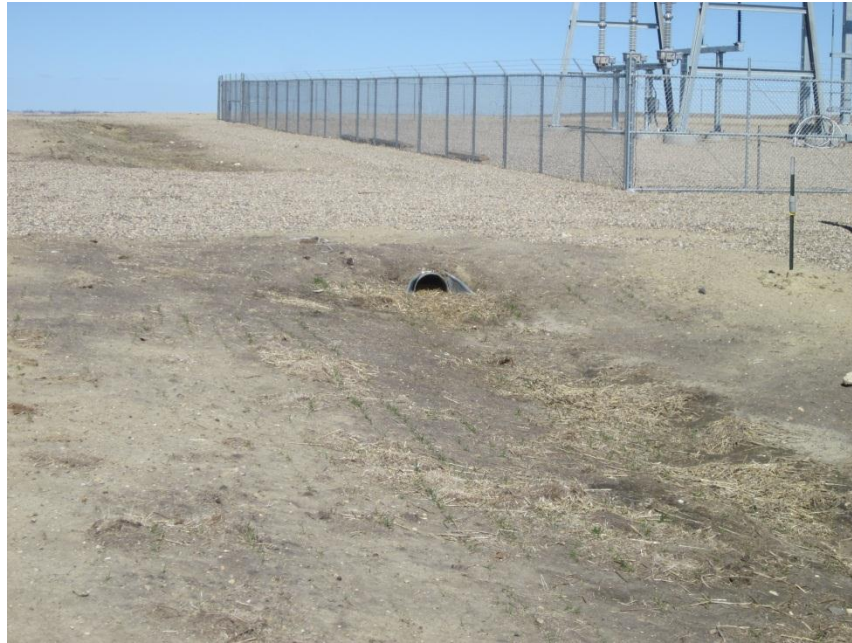
**Photo 33.** Direction: North. Example of storm water and erosion control measures with culvert underneath access road to substation.

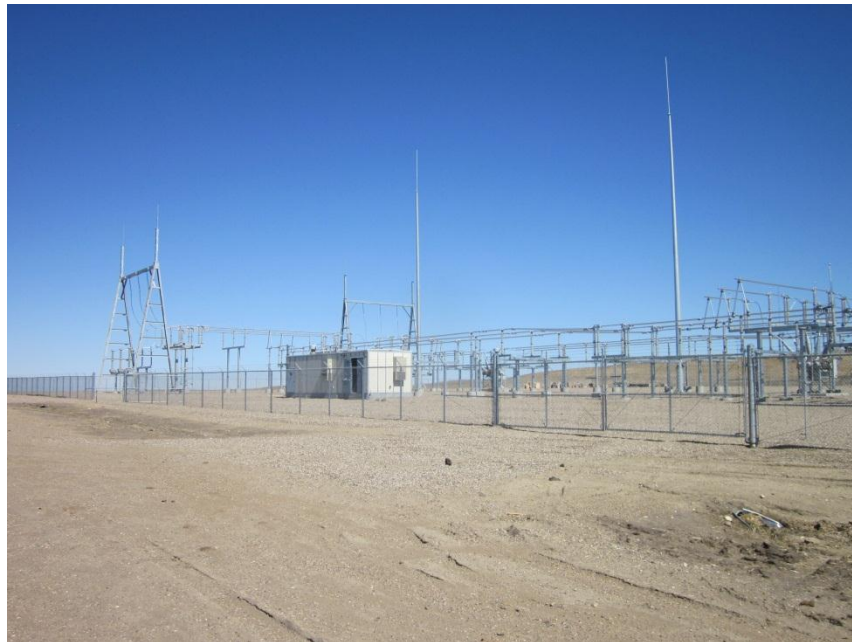
**Photo 34.** Direction: Northeast. Merricourt substation showing storm water control culverts and approaches. Substation appeared to be in good order with no erosion or other impacts noted.
