## Project Inspection Report

**Project Name:** Hiland Operating LLC 8-inch Natural Gas Liquids Pipeline, McKenzie County ND

**PSC Case Number:** PU-10-554

**Inspector:** Katie Schmidt, E3 Environmental, LLC      **Date:** 11/28/2012      **Time:** 9:00 am

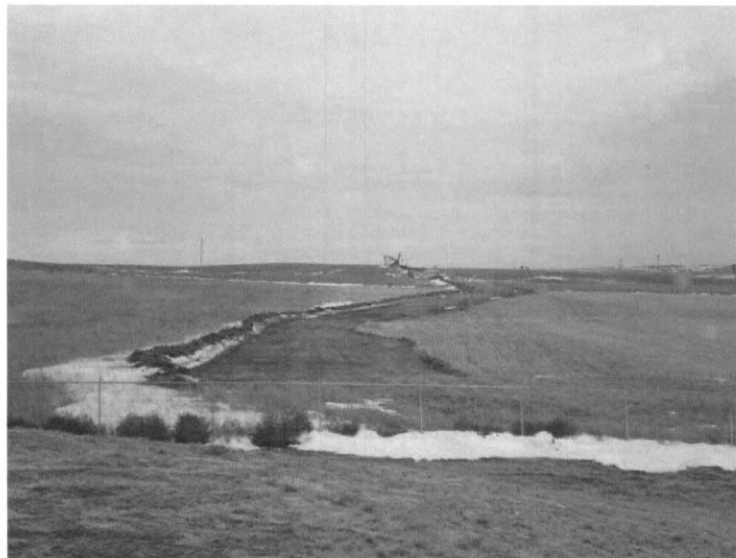
Photo 1: Looking west from Hiland Operating Plant at Project ROW, at this location pipe has been placed in the ground however topsoil has not been replaced, also ROW staking is present

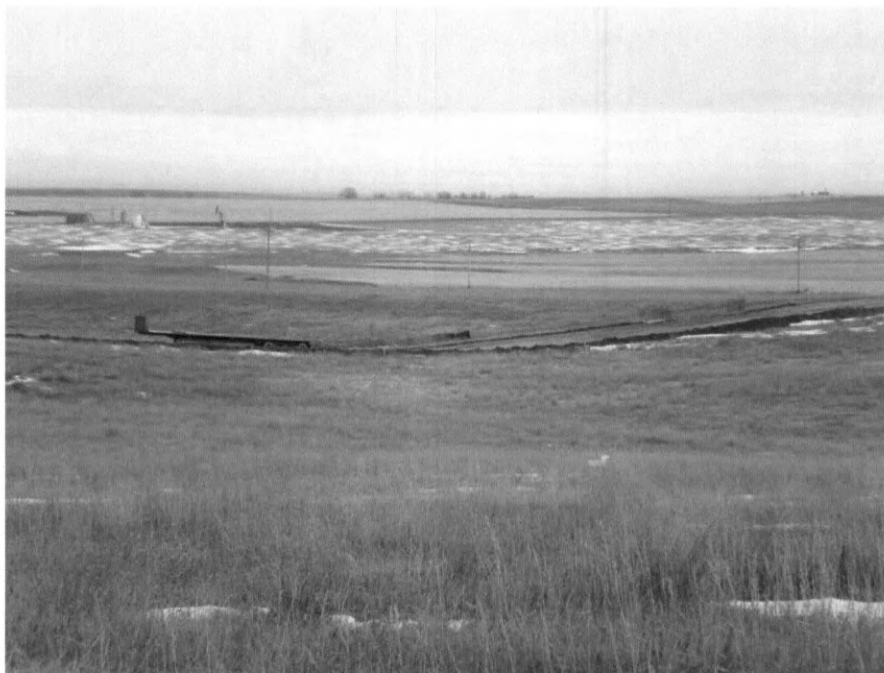
Photo 2: Looking north at ROW from County Rd 16 at 1<sup>st</sup> drainage way crossing, not presence of silt fence on the north side of the ROW and the orange safety fence to mark the location of other pipelines crossing the construction ROW. The pipe has been placed in the ground at this location.

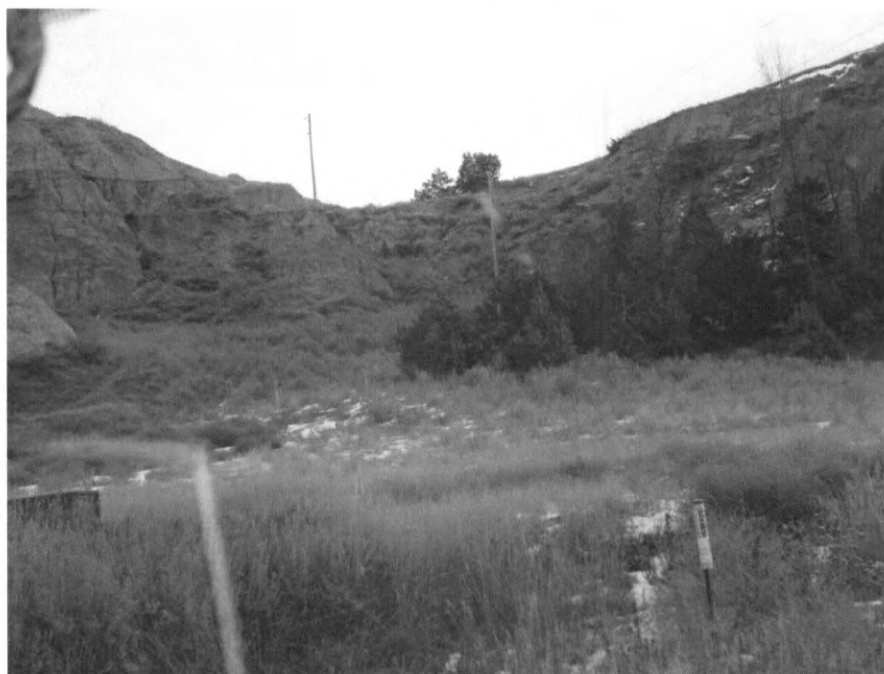
Photo 3: Looking west at ROW from 157<sup>th</sup> Ave NW/34<sup>th</sup>/156<sup>th</sup> , no clearing conducted but staking complete. Approximate location of identified population of *Townsendia exscapa* is at top of hill in background between transmission pole and shrubs.

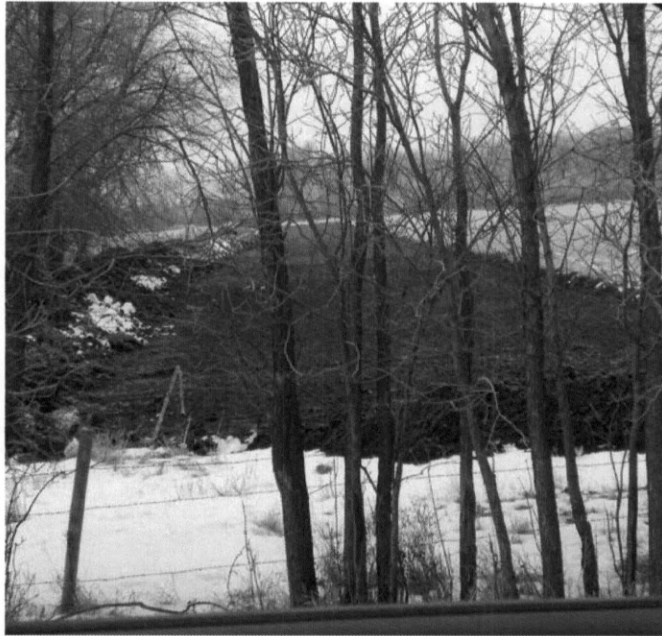
Photo 4: Looking west from 157<sup>th</sup> Ave NW/34<sup>th</sup>/156<sup>th</sup> ; ROW clearing has occurred, no construction, ROW staking present.

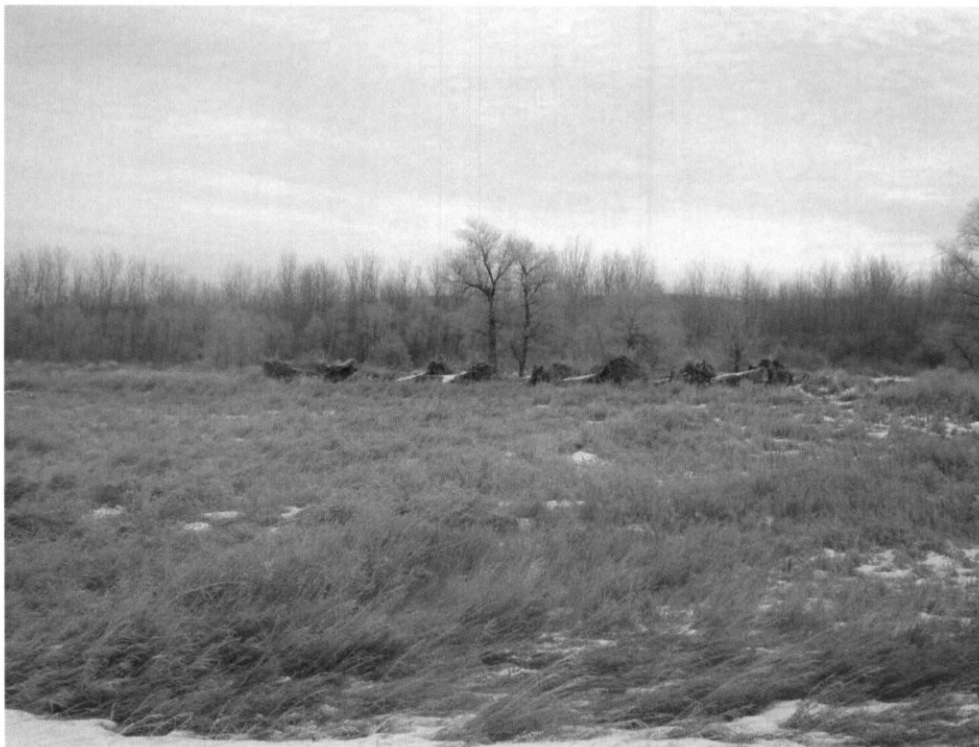
Photo 5: Looking west from 158<sup>th</sup> Ave towards Yellowstone River, ROW staking not present, prep for HDD of river being conducted on East side of road, see Photo 6.

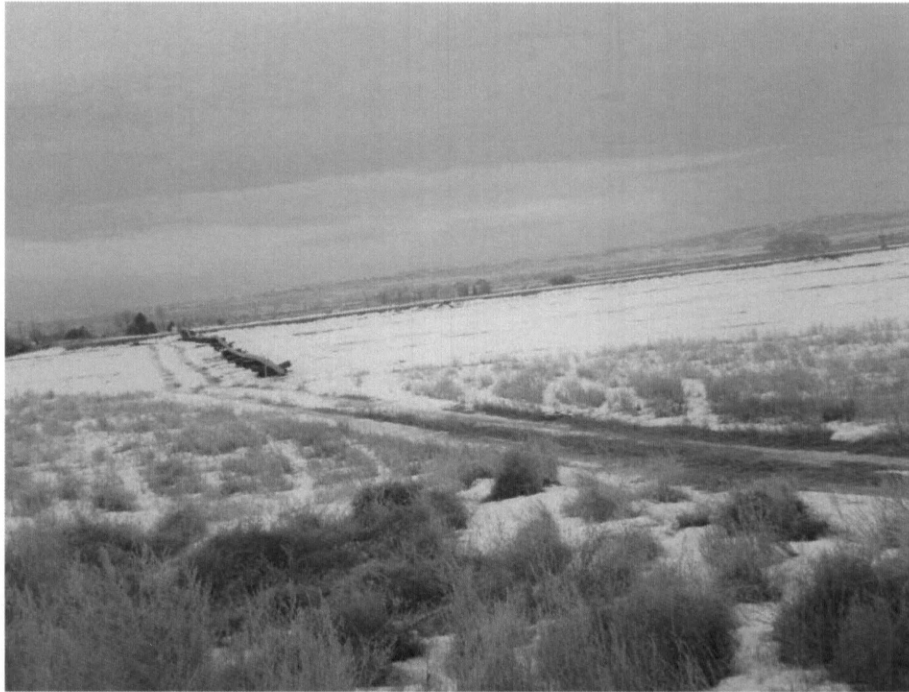
Photo 6: Looking east from 158<sup>th</sup> Ave, ROW staking present, pipe stringing almost complete in prep for HDD of Yellowstone River.

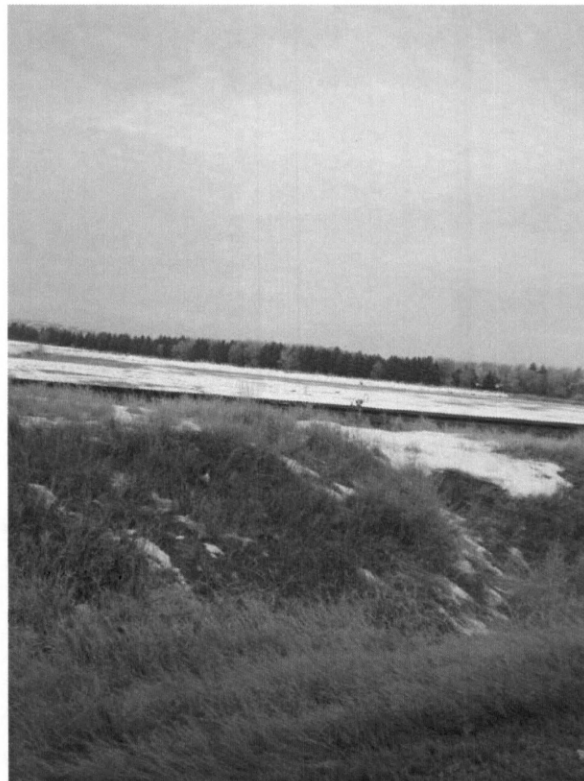
Photo 7: Looking west from Hwy 58, RR tracks in foreground, staking present for Project, no clearing has occurred.
