## Project Inspection Report

**Project Name:** Hiland Operating LLC 8-inch Natural Gas Liquids Pipeline, McKenzie County ND

**PSC Case Number:** PU-10-554

**Date:** 11/28/2012

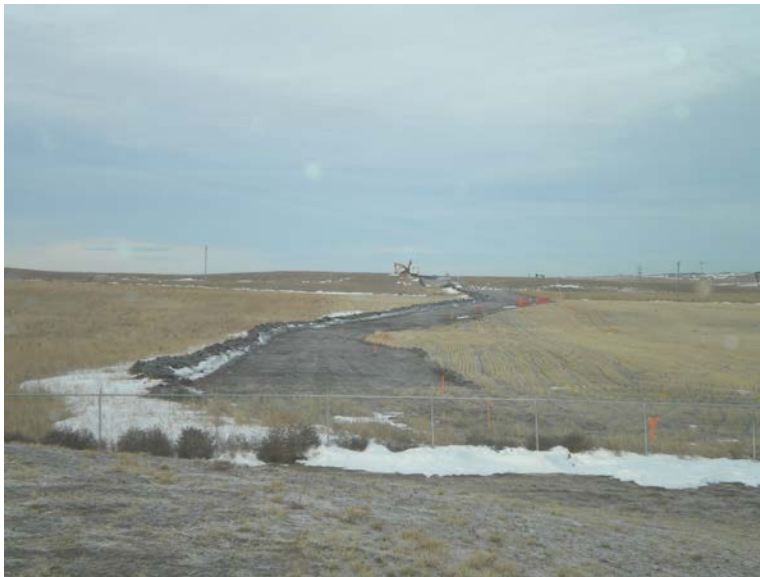
Photo 1: Looking west from Hiland Operating Plant at Project ROW, at this location pipe has been placed in the ground however topsoil has not been replaced, also ROW staking is present
