Project Inspection Report

Project Name: Hiland Operating LLC 8-inch Natural Gas Liquids Pipeline, McKenzie County ND

PSC Case Number: PU-10-554

Date: 11/28/2012

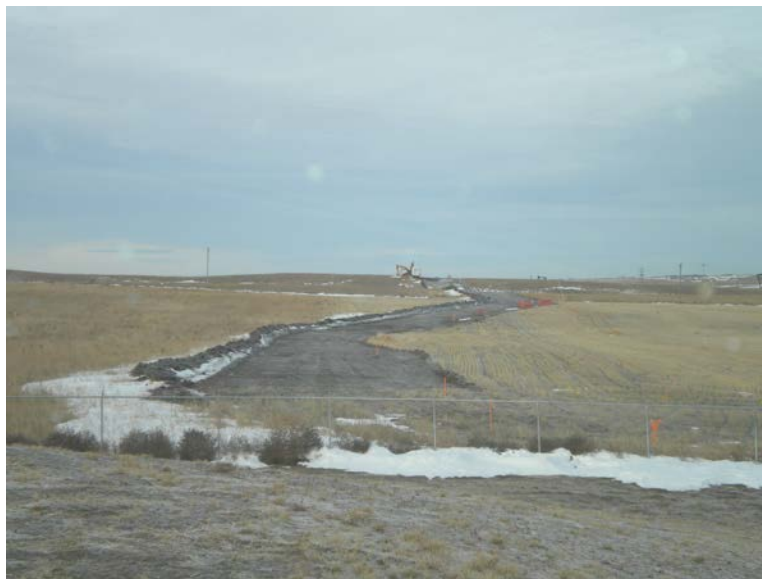
Photo 1: Looking west from Hiland Operating Plant at Project ROW, at this location pipe has been placed in the ground however topsoil has not been replaced, also ROW staking is present

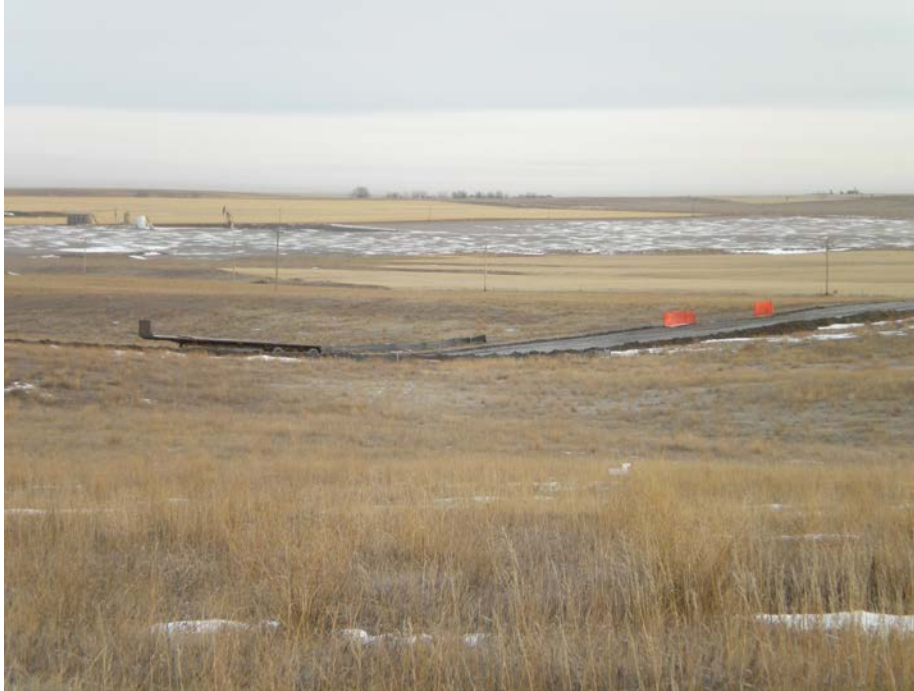
Photo 2: Looking north at ROW from County Rd 16 at 1st drainage way crossing, not presence of silt fence on the north side of the ROW and the orange safety fence to mark the location of other pipelines crossing the construction ROW. The pipe has been placed in the ground at this location.

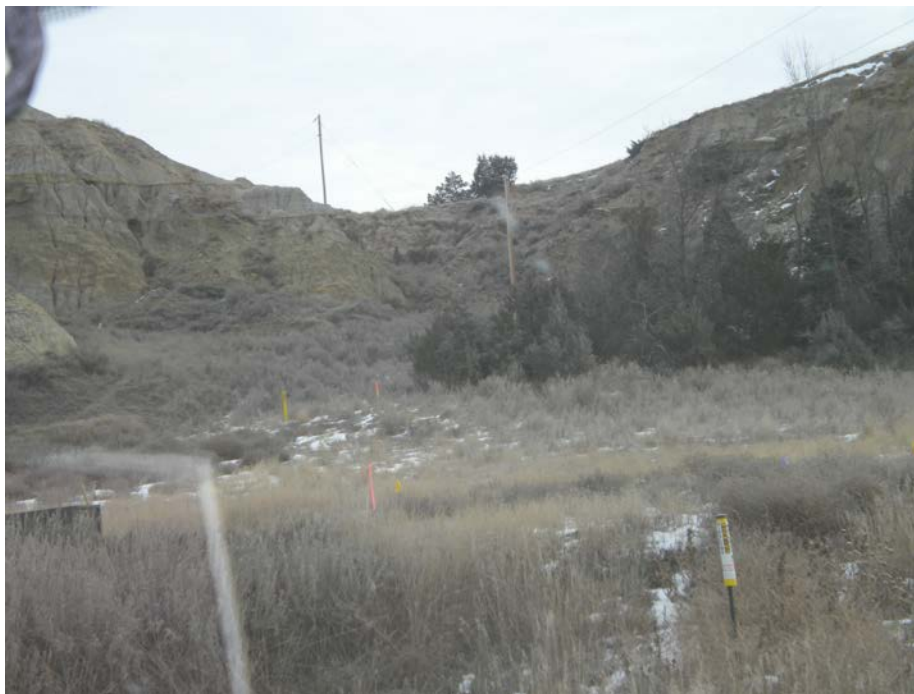
Photo 3: Looking west at ROW from 157th Ave NW/34th/156th , no clearing conducted but staking complete. Approximate location of identified population of *Townsendia exscapa* is at top of hill in background between transmission pole and shrubs.

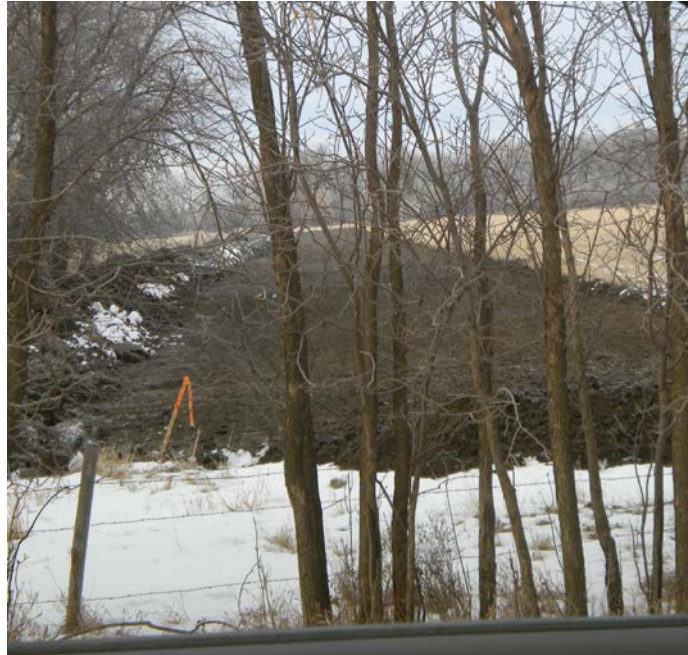
Photo 4: Looking west from 157th Ave NW/34th/156th ; ROW clearing has occurred, no construction, ROW staking present.

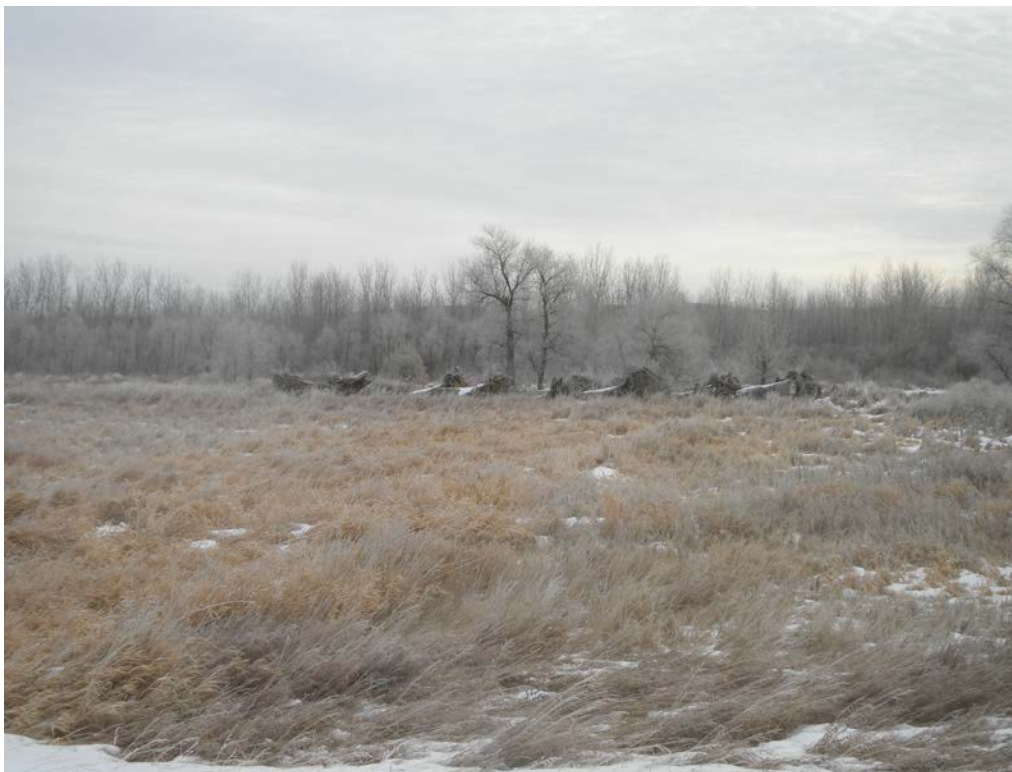
Photo 5: Looking west from 158th Ave towards Yellowstone River, ROW staking not present, prep for HDD of river being conducted on East side of road, see Photo 6.

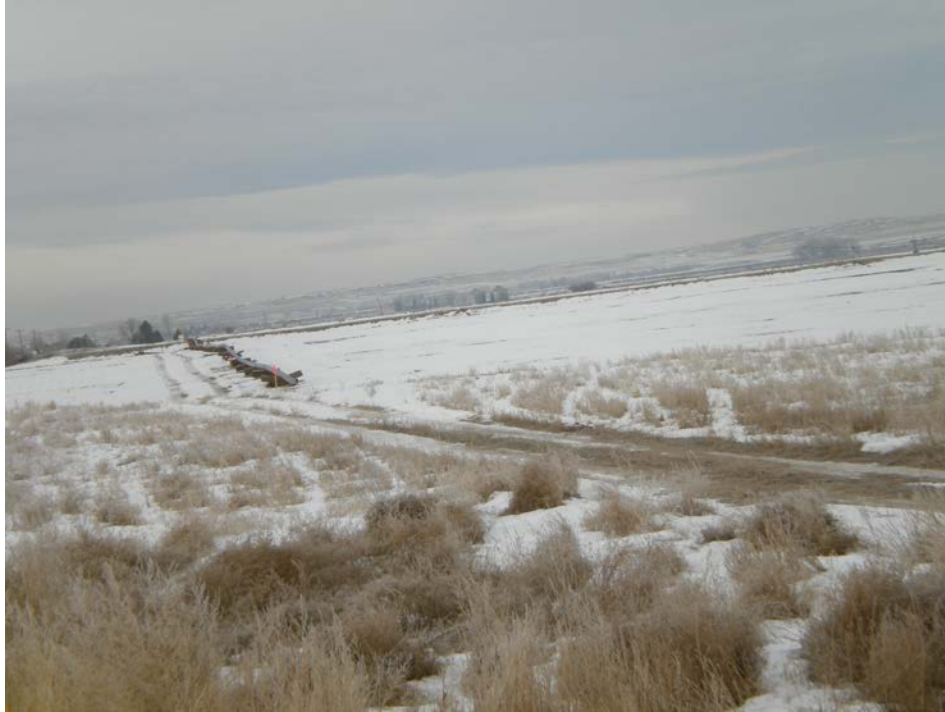
Photo 6: Looking east from 158th Ave, ROW staking present, pipe stringing almost complete in prep for HDD of Yellowstone River.

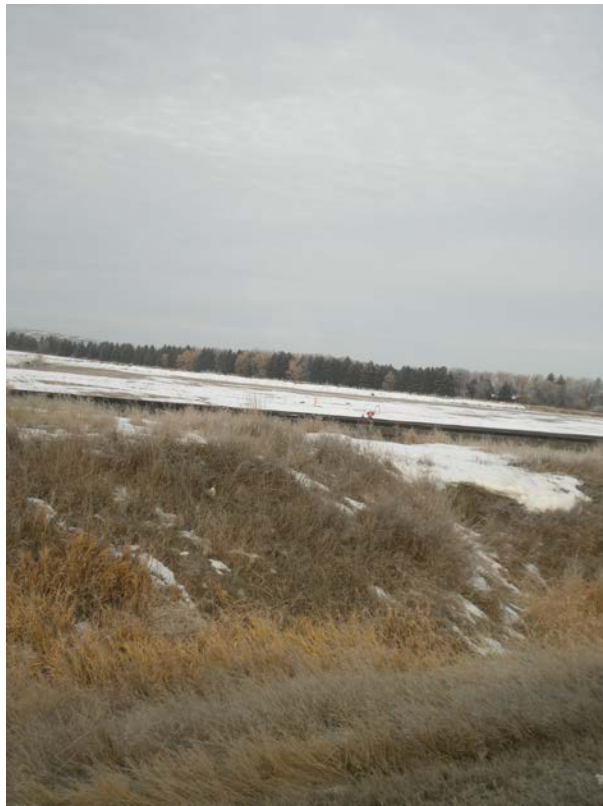
Photo 7: Looking west from Hwy 58, RR tracks in foreground, staking present for Project, no clearing has occurred.
