CONSTRUCTION INSPECTION REPORT

Hiland Operating, LLC
5.1-mile-long, 8-inch Natural Gas Main and
Lateral Pipeline Project
McKenzie County, North Dakota

Project #4288

December 27, 2012

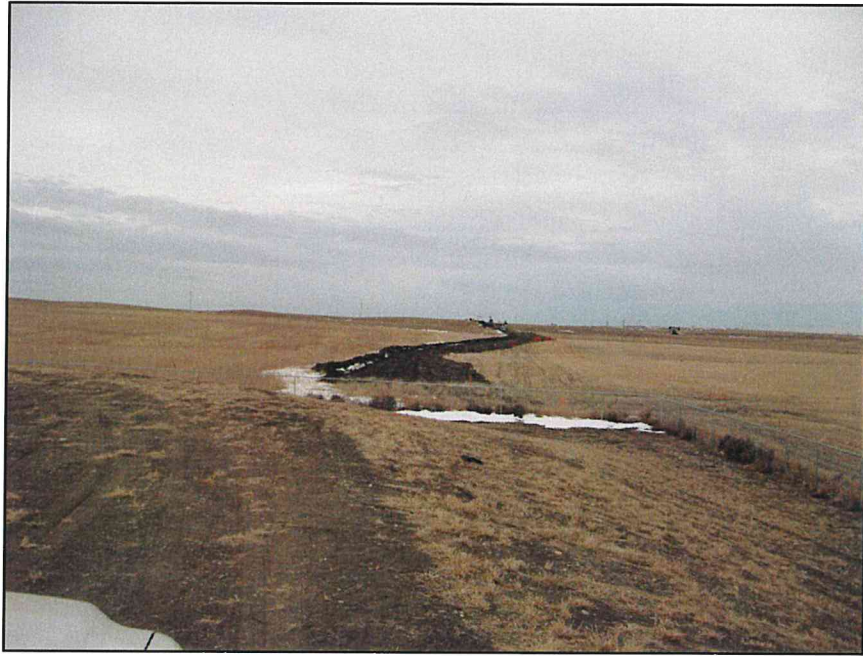
Photo 1. Taken facing west from the Hiland Operating Gas Plant. The Project pipeline crosses a wheat stubble field. The Hiland Operating 6-Inch Natural Gas Liquids pipeline (PU-12-554) project is in construction within the same ROW approximately 25' north of the existing pipeline.

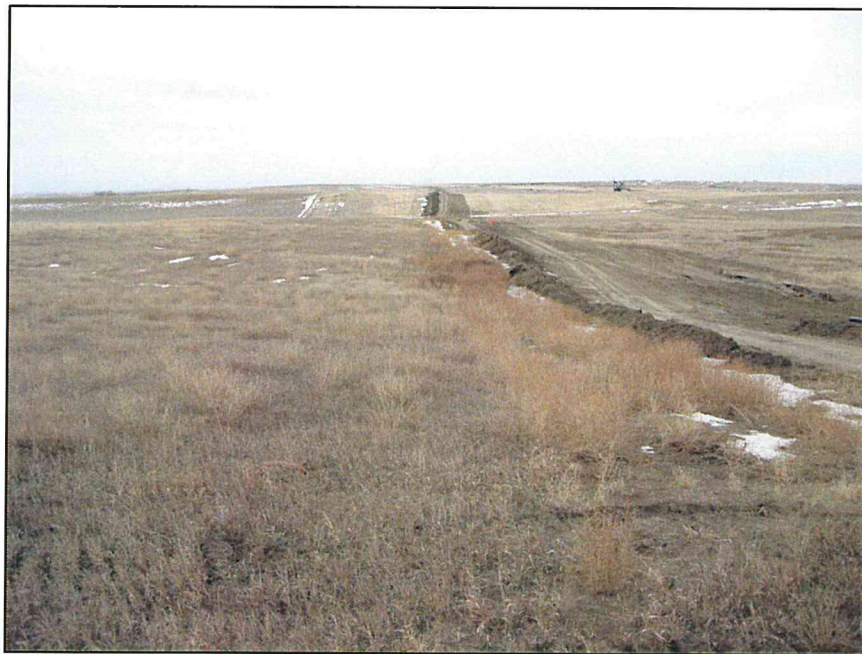
Photo 2. Taken facing west from the section line between Sections 6 and 1. The ROW has been reseeded (decadent alfalfa and smooth brome) and can be seen just south of the topsoil windrow.

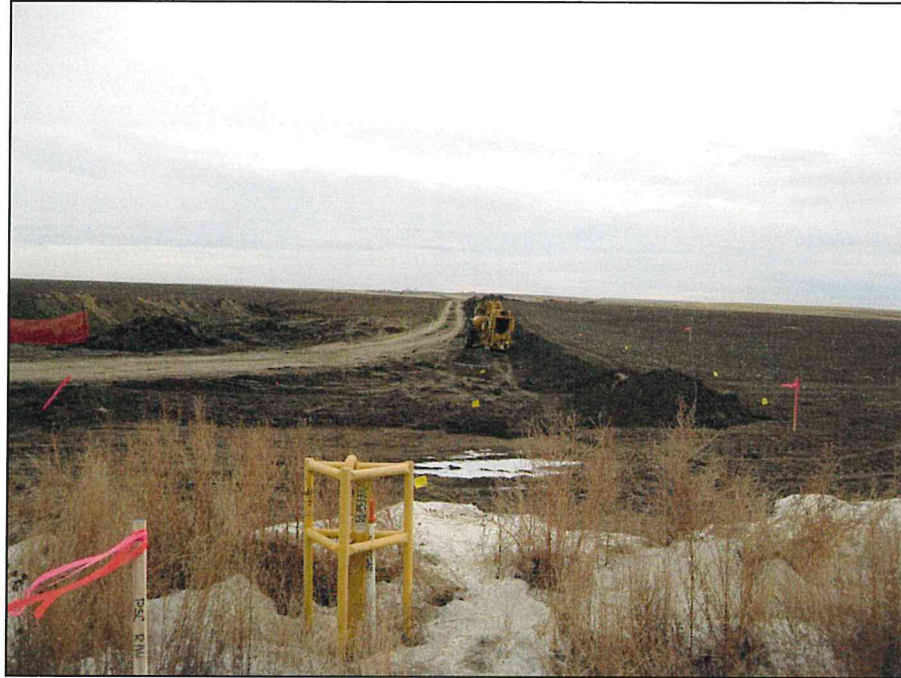
Photo 3. Taken on the eastern side of Section 2 facing east. The ROW crosses a plowed agriculture field. The Project pipeline is located beneath the topsoil windrow from the PU-12-554 project.

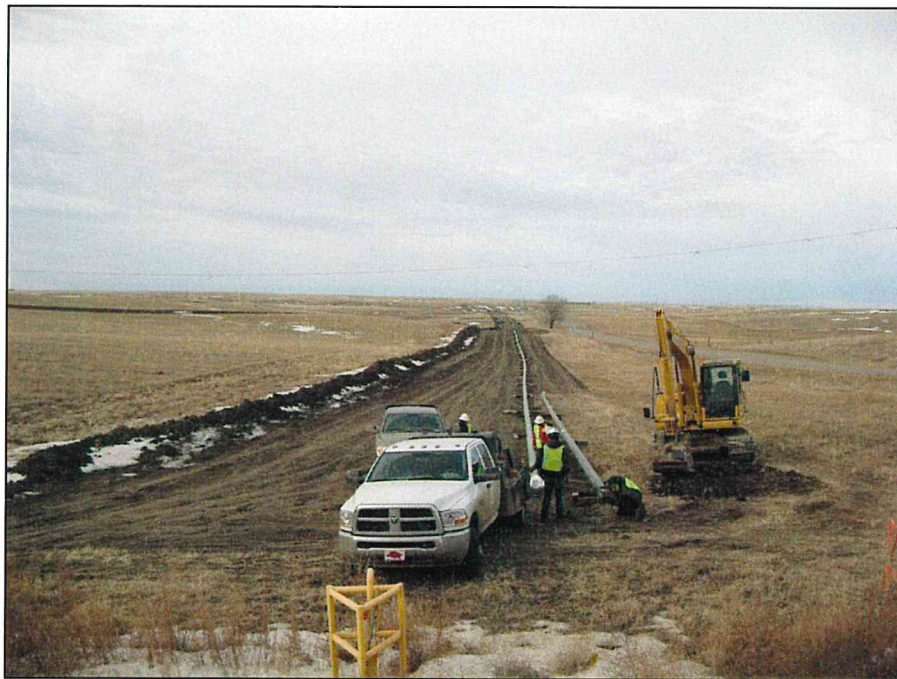
Photo 4. Taken in the northeast quarter of Section 3 facing west. The ROW crosses an alfalfa field. Successful new vegetative growth (approximately 10-15ft) can be seen to the left of the topsoil windrow in photo.

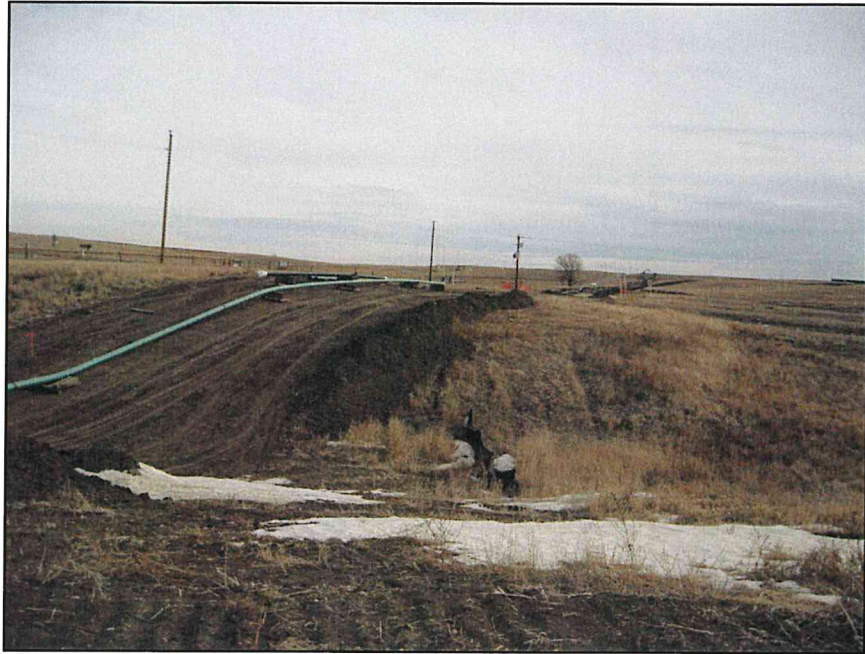
Photo 5. Taken facing east at the confluence of the main pipeline and the lateral pipeline in the northwest quarter of Section 4.

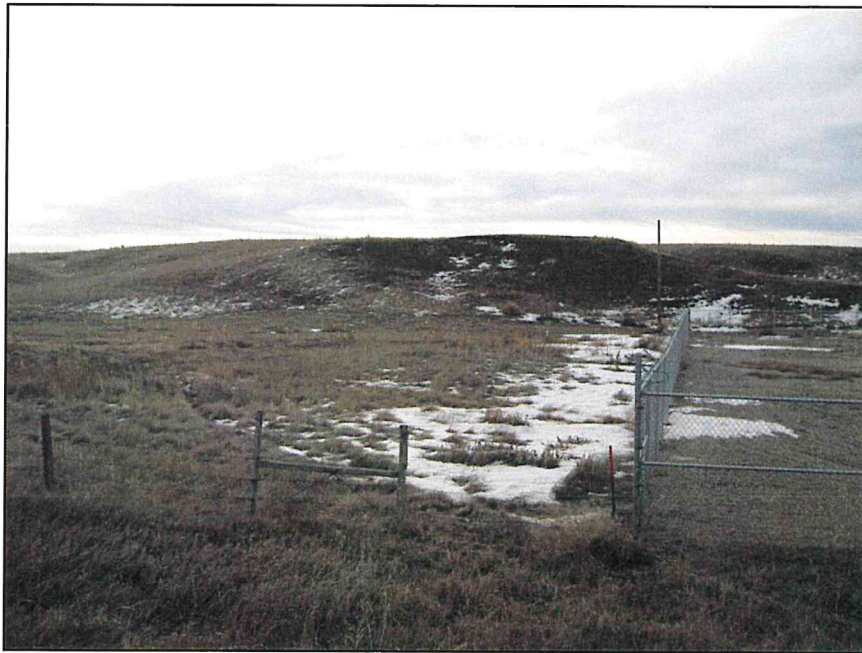
Photo 6. Taken facing south at the main pipeline termination point in the northwest quarter of Section 4. The reseeding in the native grassland appears to have been accomplished adequately.
