North Dakota Public Service Commission
STAFF REPORT
October 4, 2010

Public Service Commission
Service Reliability – Northern States Power
Investigation

Case No. PU-10-577

North Fargo Power Disruption Technical Review

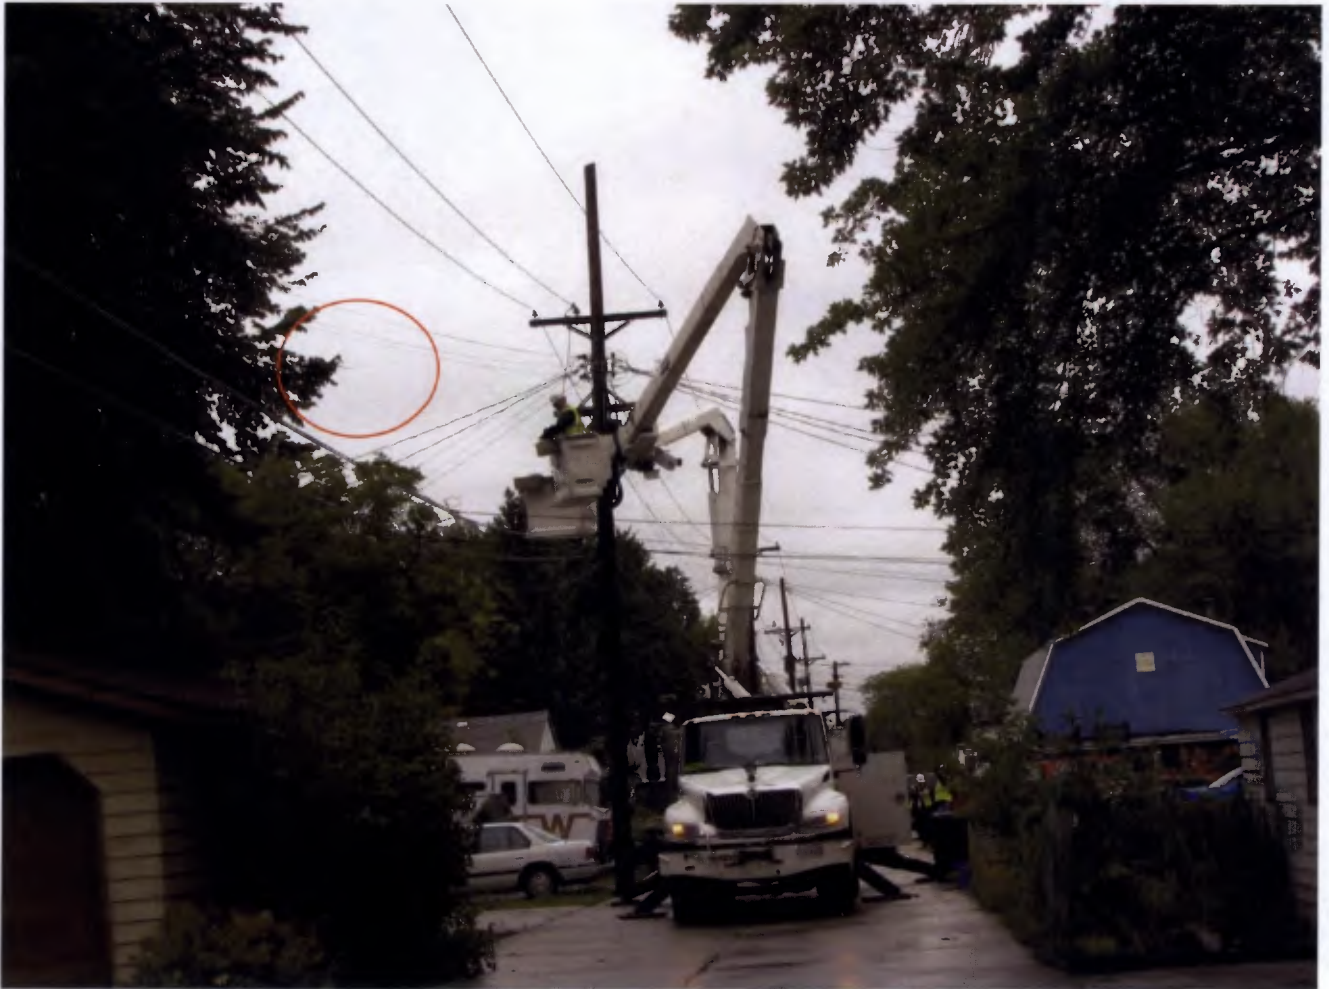
Picture # 1

While removing the fuses in the field, crews noticed a tree branch extending underneath the lower secondary line, just south of T53 (see pictures in Attachment B). Based on observations made by a Fargo engineer on site it appears that the branch, with burn marks and damaged bark, appears to have been moved by the wind into the secondary line causing it to make contact with the neutral wire. Our maintenance records show that the trees near this line were trimmed according to guidelines (see Attachment C) during the spring of 2008. This area is on a four year line clearance cycle, with the next trimming scheduled for spring 2012. Above average precipitation in Fargo and the passage of three summer growth seasons since the previous pruning may have contributed to the branch extending far enough to contact the line.

Picture was taken from the south end of the alley between 7th and 8th streets, looking to the north. Crews are working near the T53 transformer. The contacting tree branch on the west side of the alley is slightly visible (see red circle) below the secondary wires.

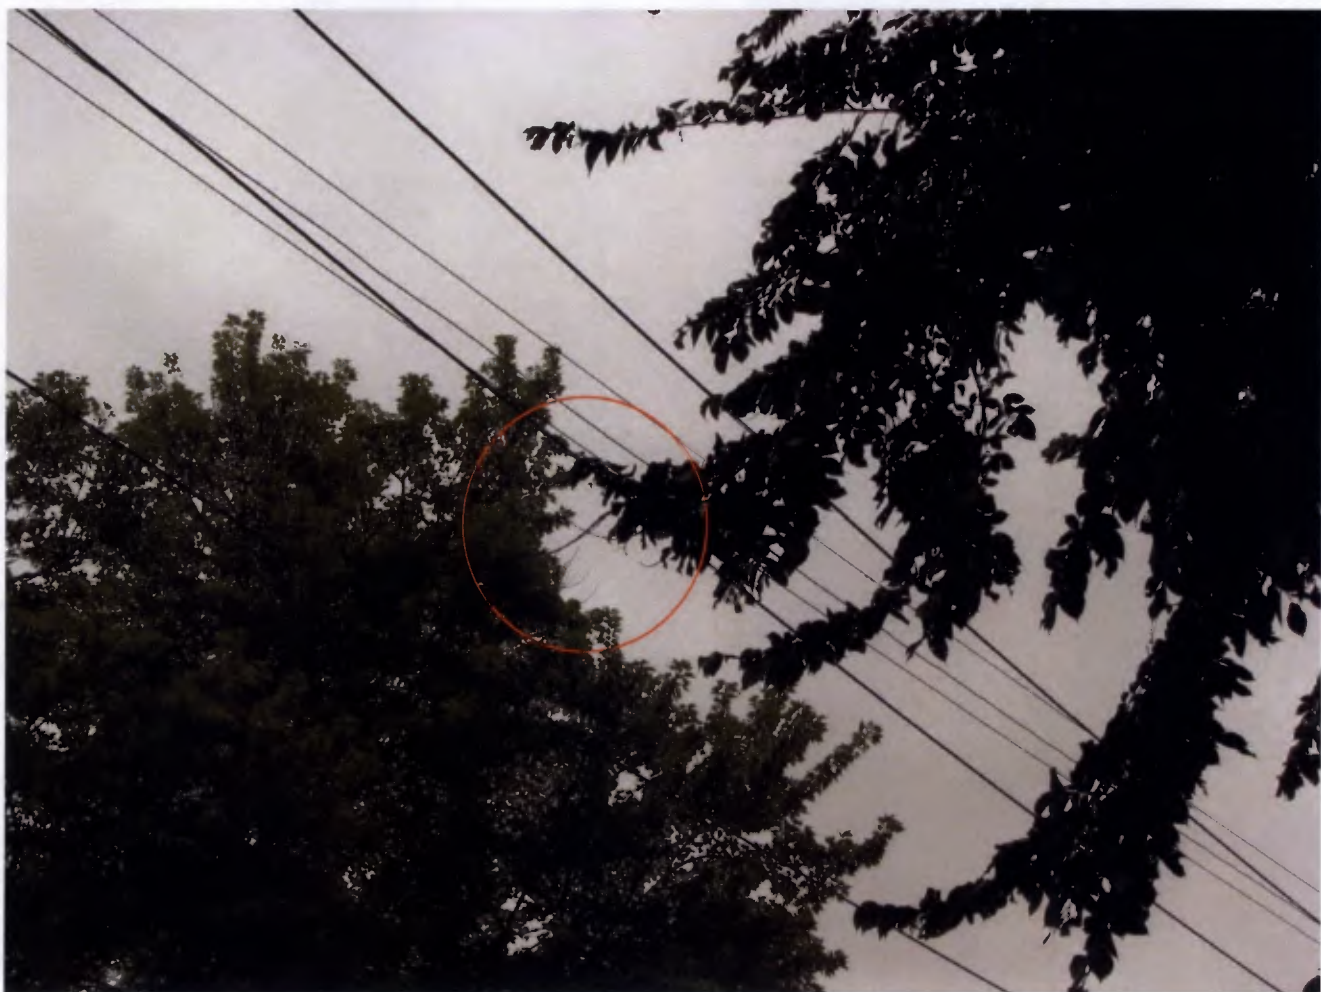
Picture # 2

This picture was taken from a position below and slightly north and west of the contacting branch. The damaged branch extensions without foliage are visible below the secondary lines (red circle).

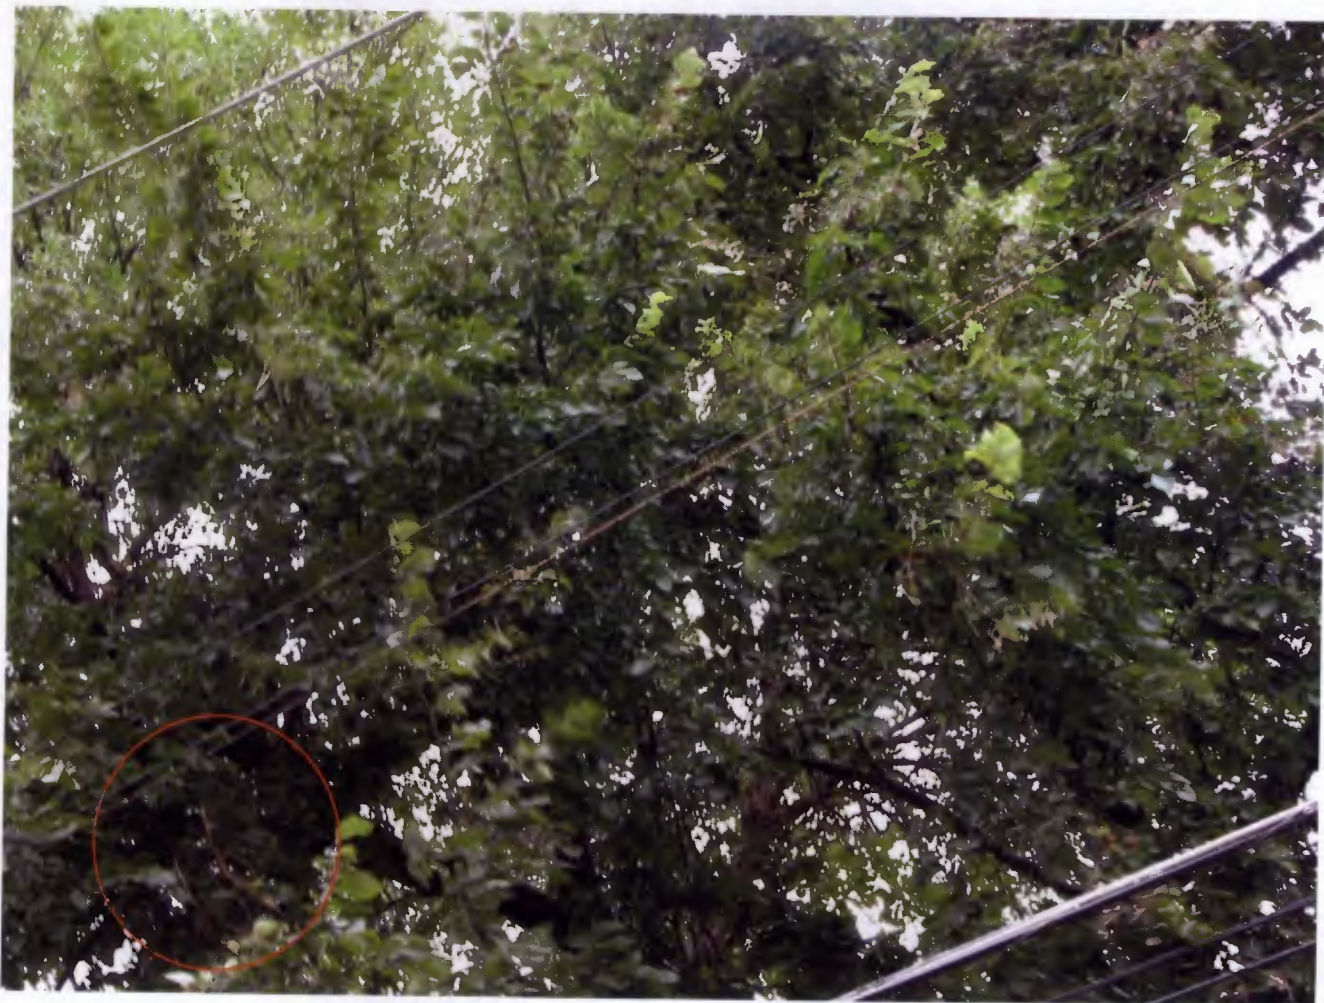
Picture # 3

This picture was taken from a position below and slightly north and east of the contacting branch. The secondary and neutral conductors are visible above the smaller, bare branch extensions (red circle). The clean copper wire on the lower secondary line just north of the branch is evidence of damage caused by tree contacts.

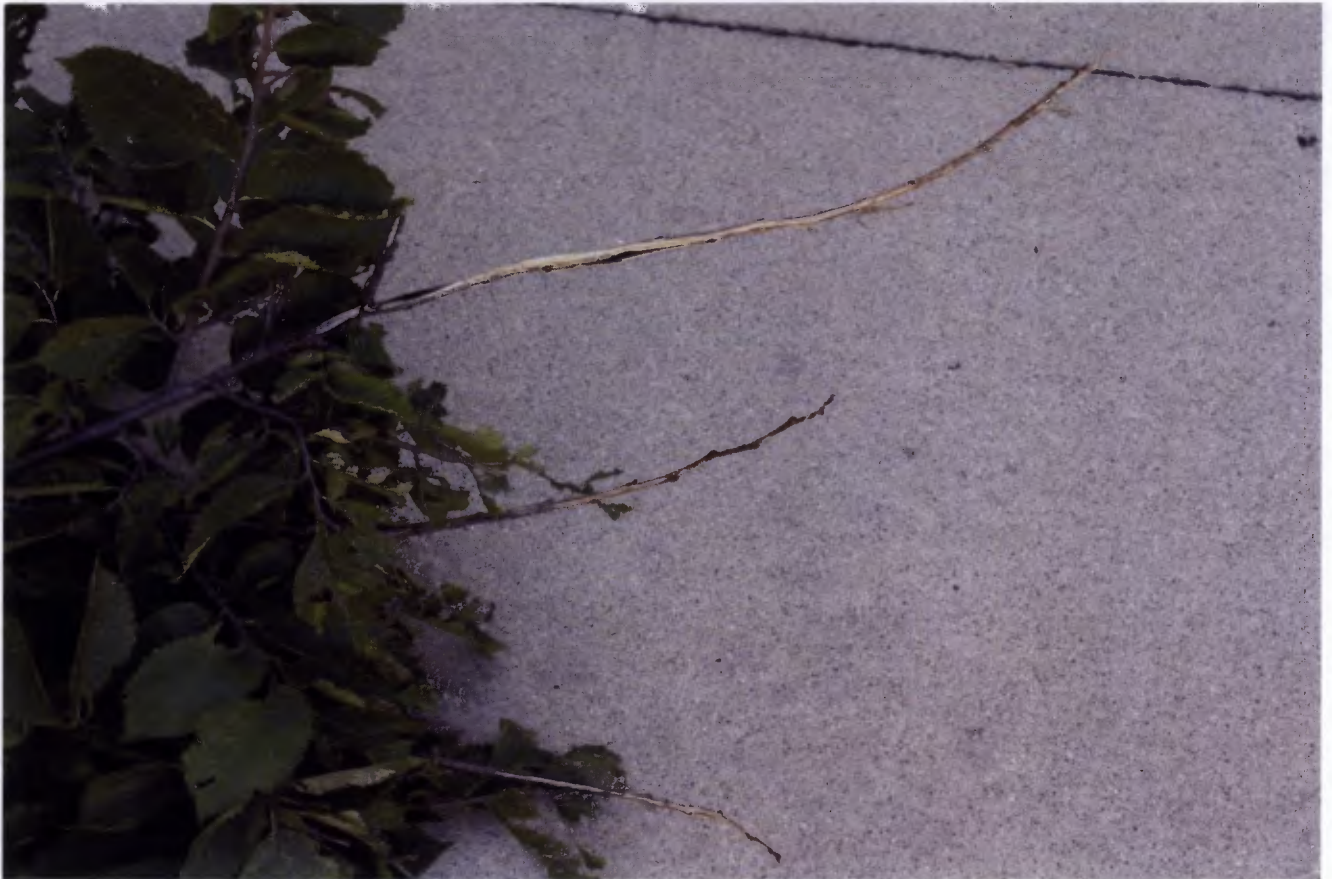
Picture # 4

Close-up of removed elm tree branch showing worn bark and burned areas caused by contact with the secondary wires. The smaller, outer branches lacking foliage were extending underneath the secondary lines.

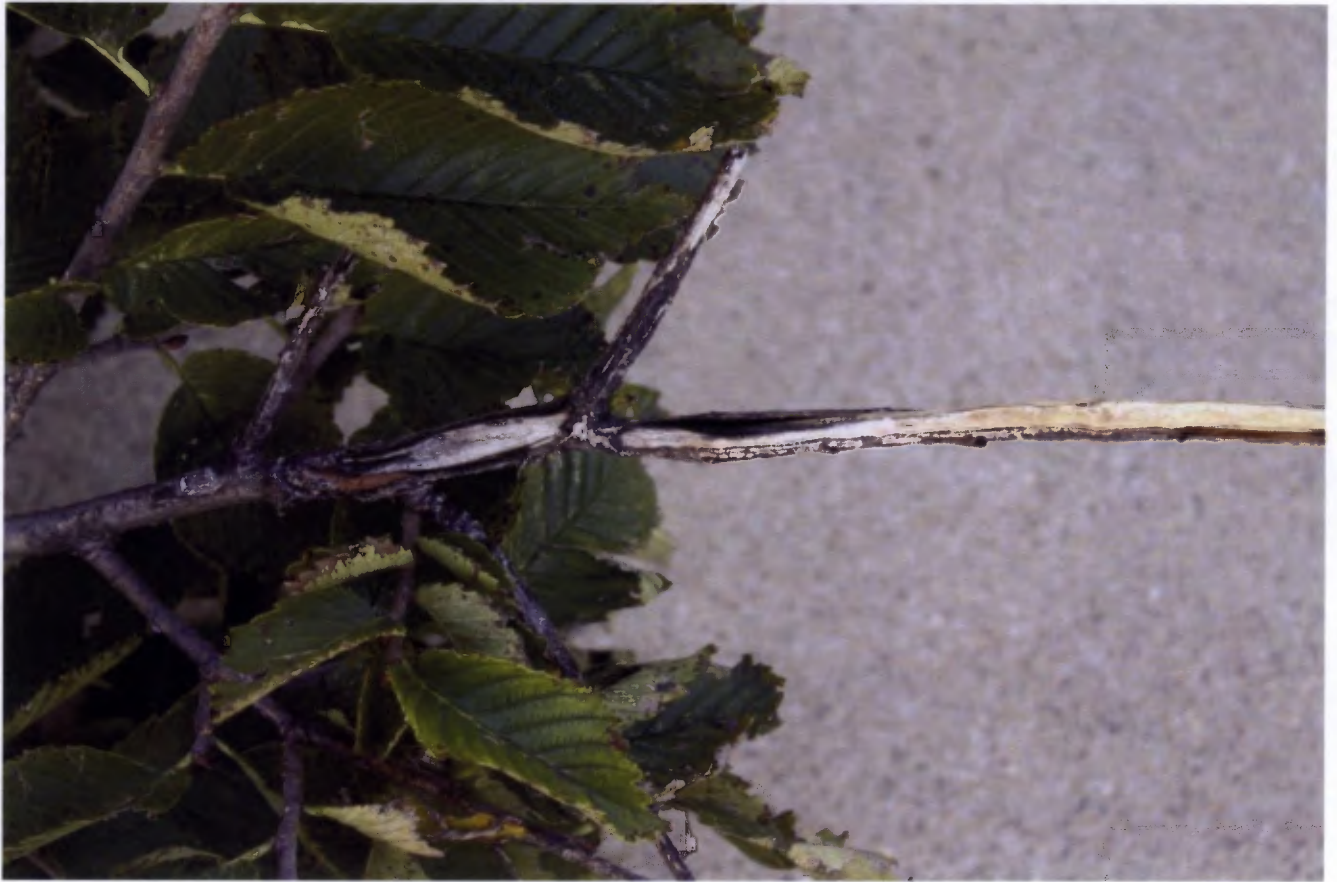
Picture # 5

Closer view of removed branch showing the area of primary damage.

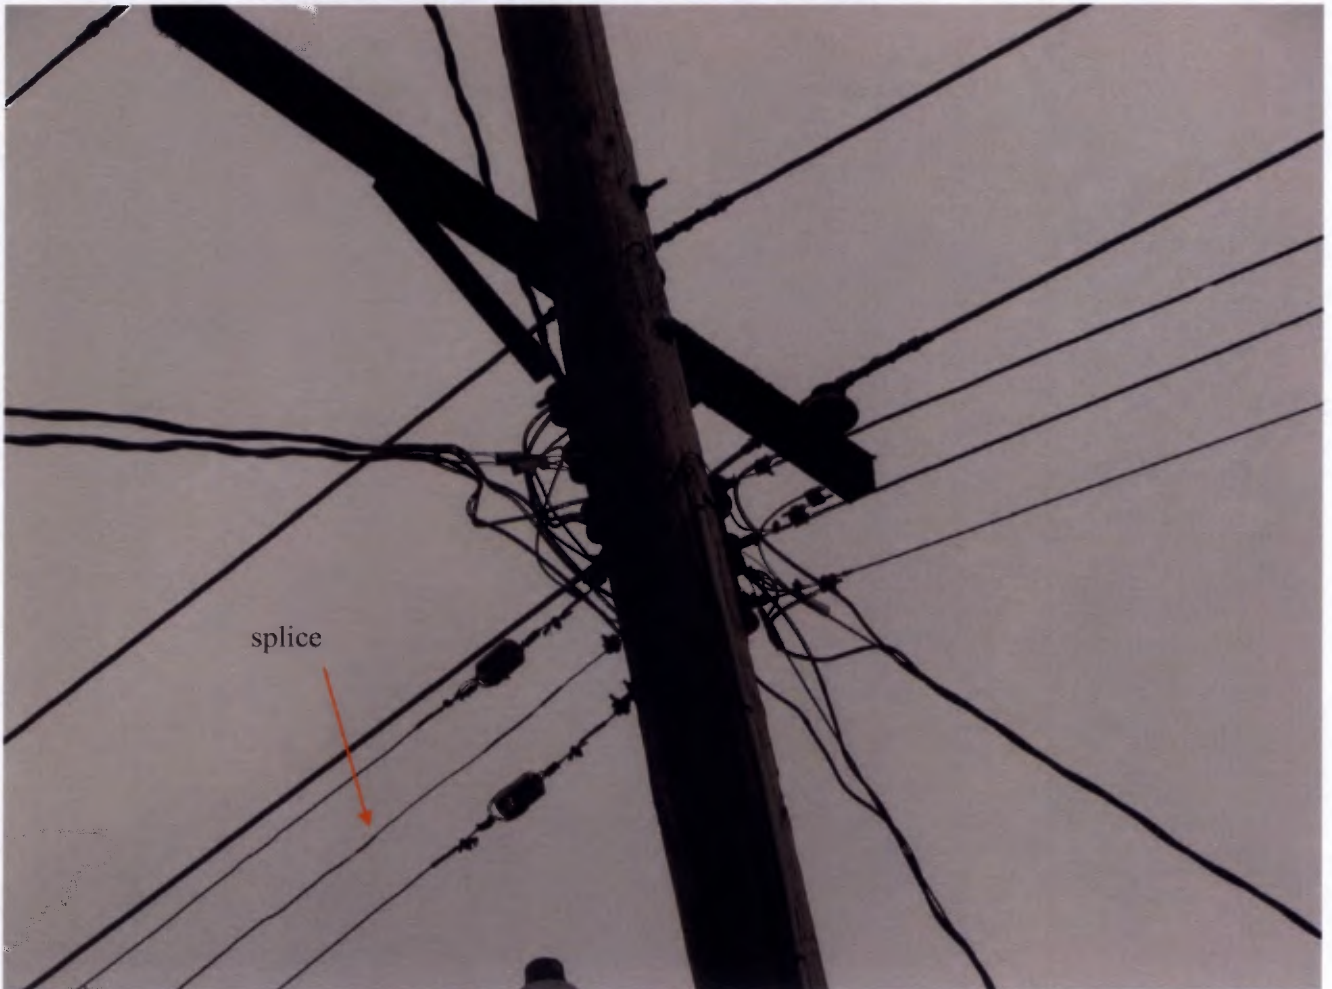
Picture # 6

Pole and associated wiring located between transformers T53 to the south and T52 to the north. In the repairs made on August 27, new neutral wire was installed on the spans south and north of T53 and spliced to the existing neutral wire at a point just south of this pole (see arrow).

The crew opened the fuses at T53 and T52 to isolate the system. They installed new neutral conductor for the two spans on either side of T53 and connected the existing neutral conductor on the span south of T52. They reconnected the ground wire at each transformer pole and installed a new secondary lead to T52. Finally, they closed the fuses and took voltage readings. The voltage readings were within the acceptable range.

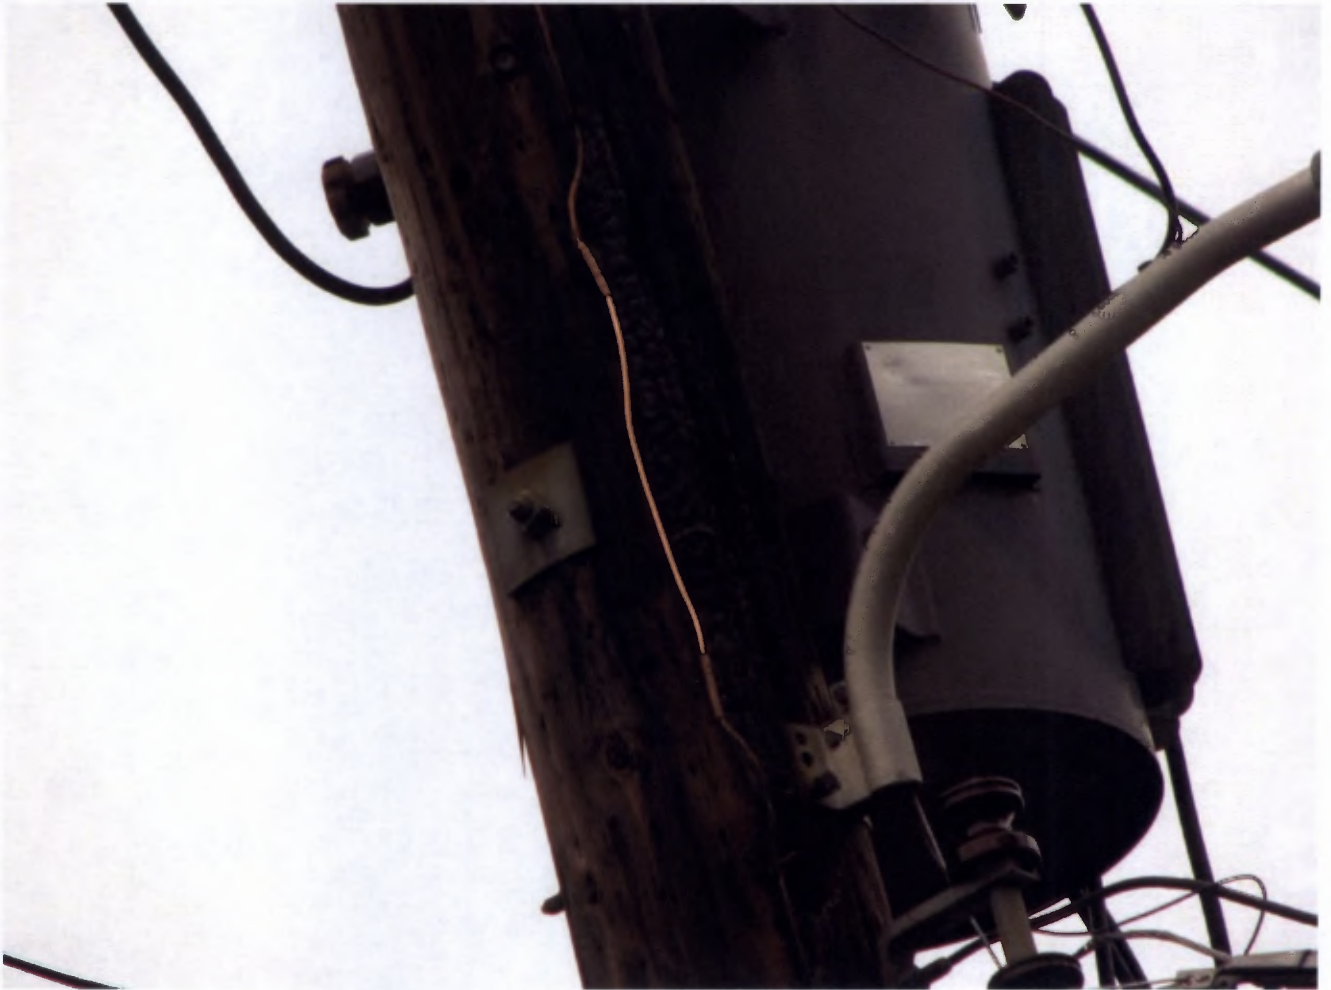
Picture # 7

Pole near north end of the alley where transformer T52 is hanging. Shiny copper portion of the ground wire is the new wire spliced to the existing ground as part of the repairs performed on August 27. Pole shows burn marks from the damage to the ground wire during the fault.

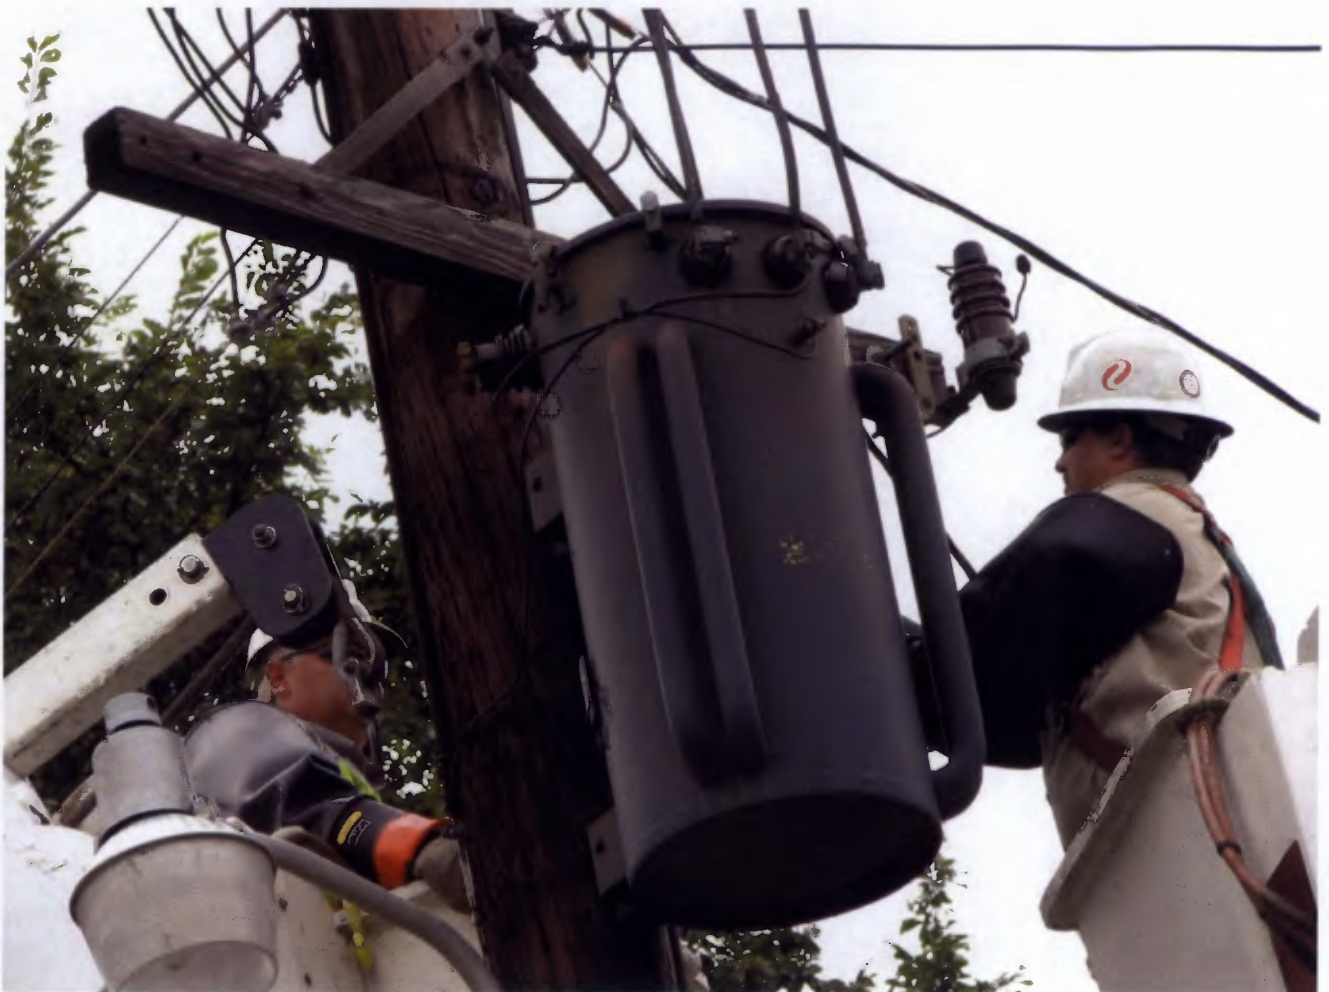
Picture # 8

The fuses on the 4 kV side of transformers T52 and T53 were removed and brought back to the Fargo service center for inspection. The standard size fuse for this application would be a 25T, and this was the size serving T52. It was determined that a 30T fuse was serving T53. This larger fuse has similar time-current characteristics of operation as the 25T. Even if the fuse had been a 25T it most likely would not have operated.

Transformer T53 located near the south end of the block. Ground wire serving this transformer also burned open (not visible here). Crews are removing the fuses for inspection.

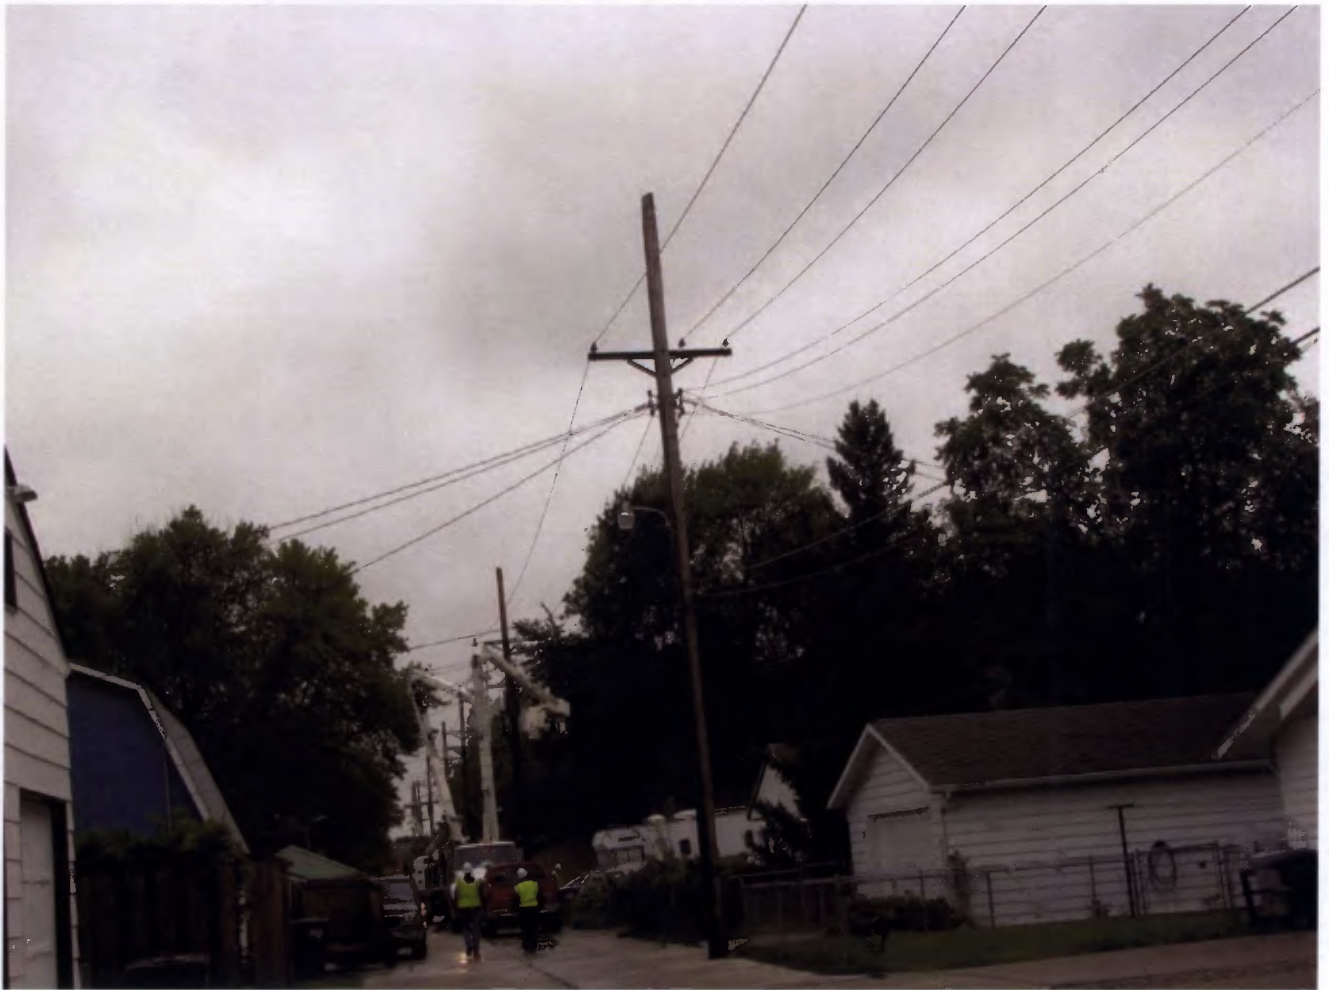
Picture # 9

View of the alley from the north end. Trees on the right and near the far south end of the alley are where the contacting branch was located.
